Destructive Testing of IDOT Bridge Structure Number 020-3087

Research Report No. FHWA-ICT-20-008

Destructive Testing of IDOT Structure Number 020-3087

August 2020

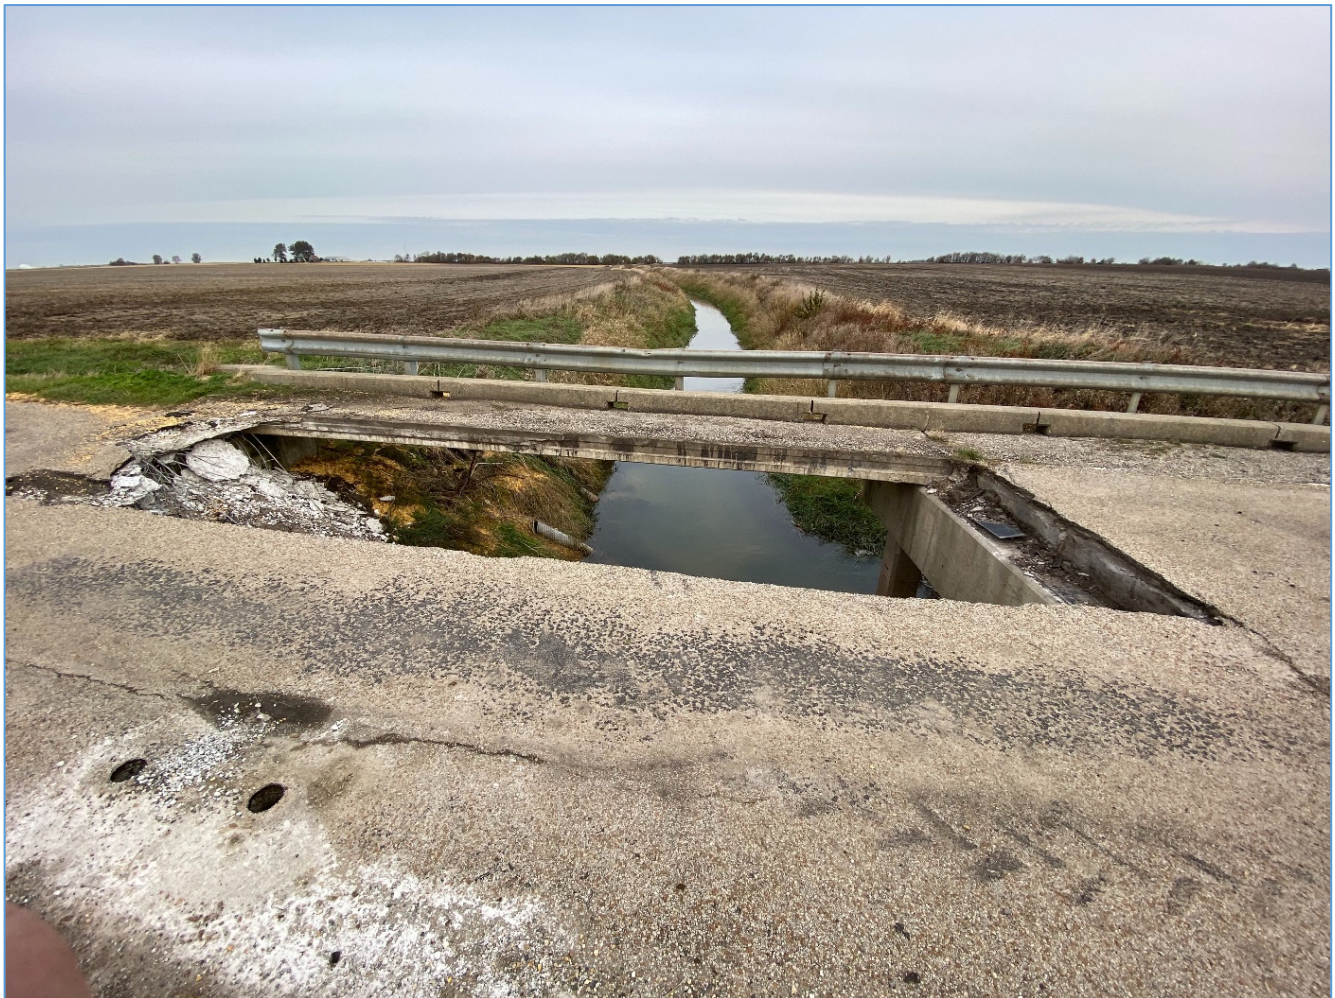
Figure 3. Photo. A picture of structure number 020-3087 after the failure of two beams, taken in November 2019 by the authors.

On October 1, 2019, the bridge was damaged by a tractor pulling a loaded single-axle grain wagon crossing the span. The load caused the collapse of two interior beams on the north side of the western span. The southern beams on the west and east spans were undamaged. The weight of the grain wagon is not known.

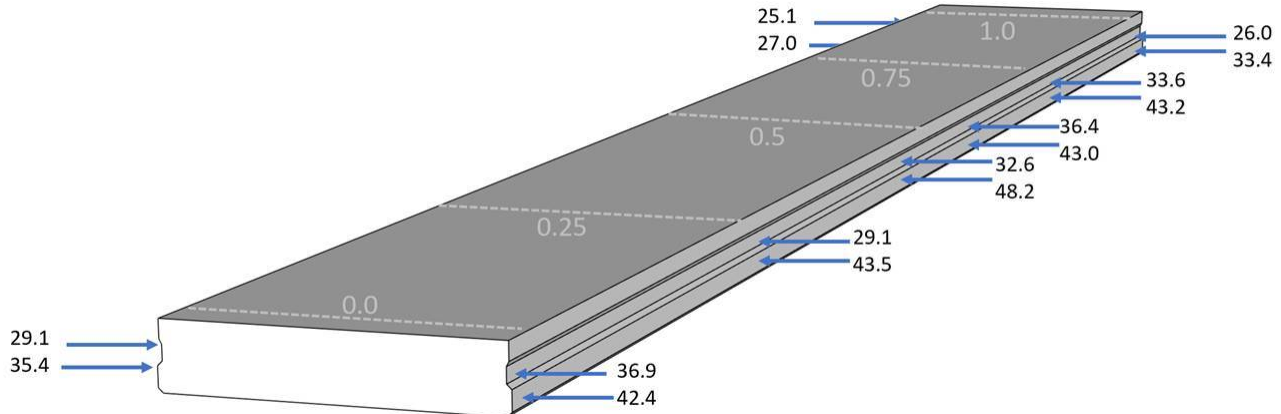
Figure 5. Photo. Schematic of a PPC bridge beam showing average rebound numbers at various locations.

The rebound hammer test results were used to determine that the concrete quality was not significantly different at the beam ends, compared to the midspan location. This result justified the decision to support the beam near its ends.

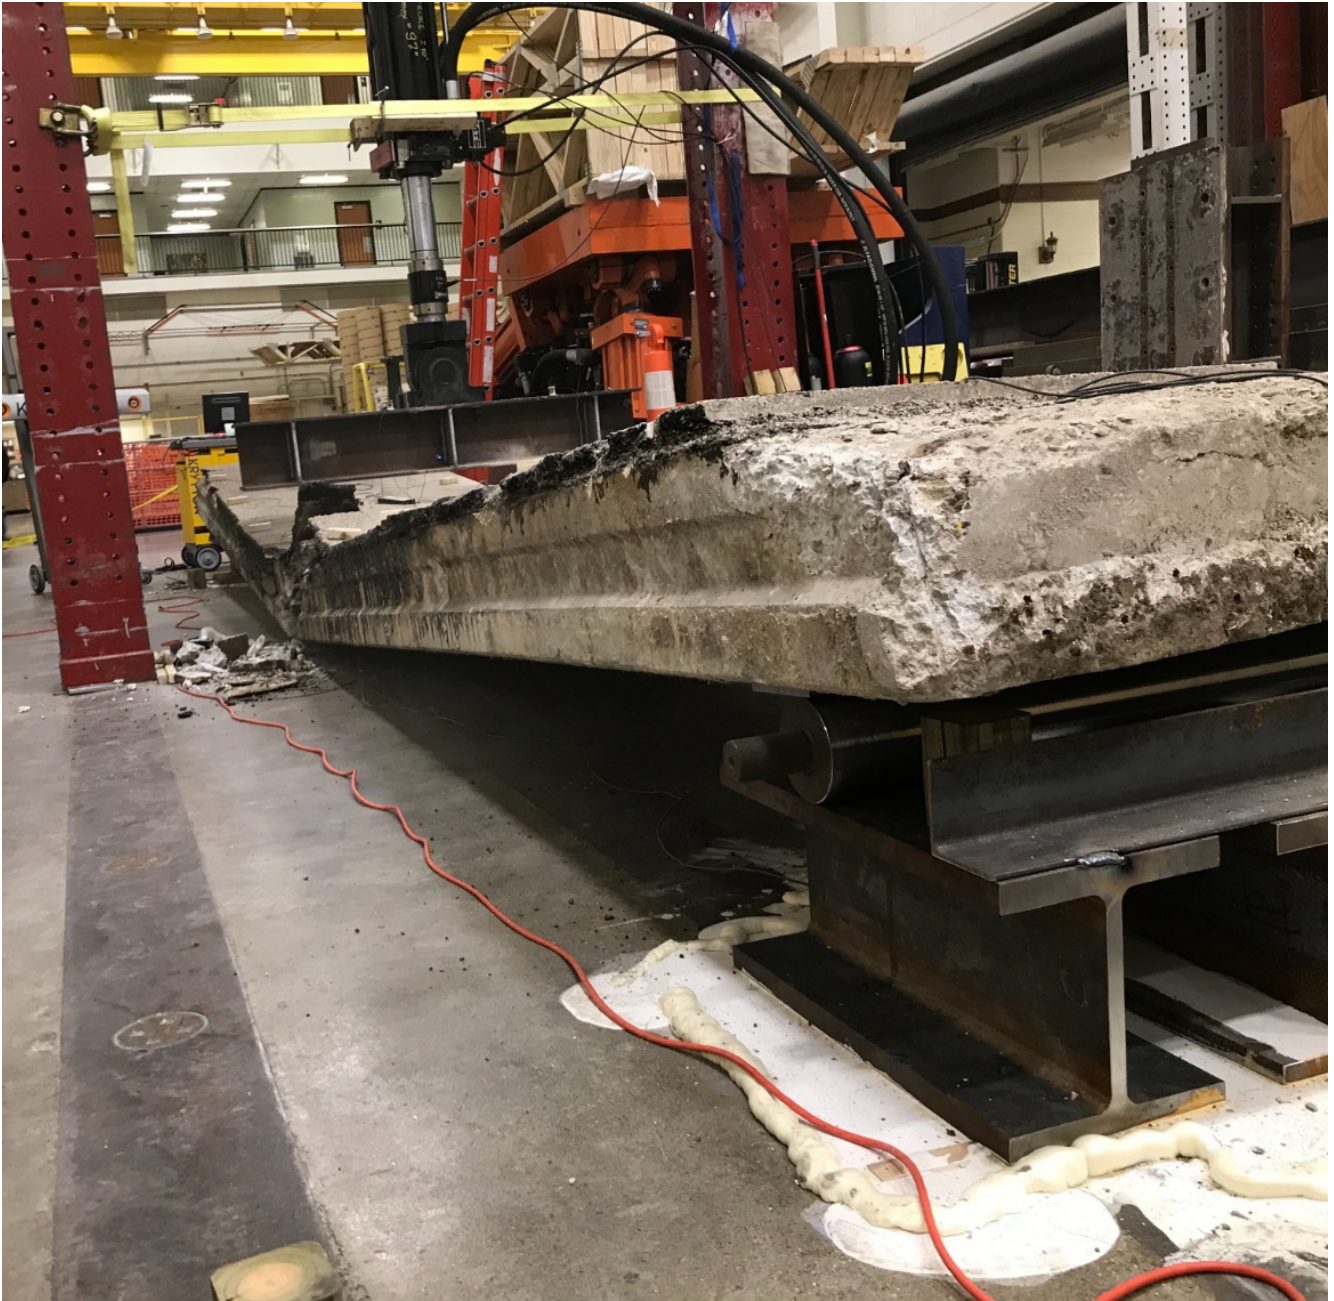
Figure 10. Photo. Test specimen after completion of the test.
