Evaluation of Premature Cracking in Urban Concrete Pavement

Research Report No. FHWA-ICT-21-001

A report of the findings of
ICT PROJECT R27-193-4
Premature Cracking Mechanism for
Jointed Plain Concrete Pavement

January 2021

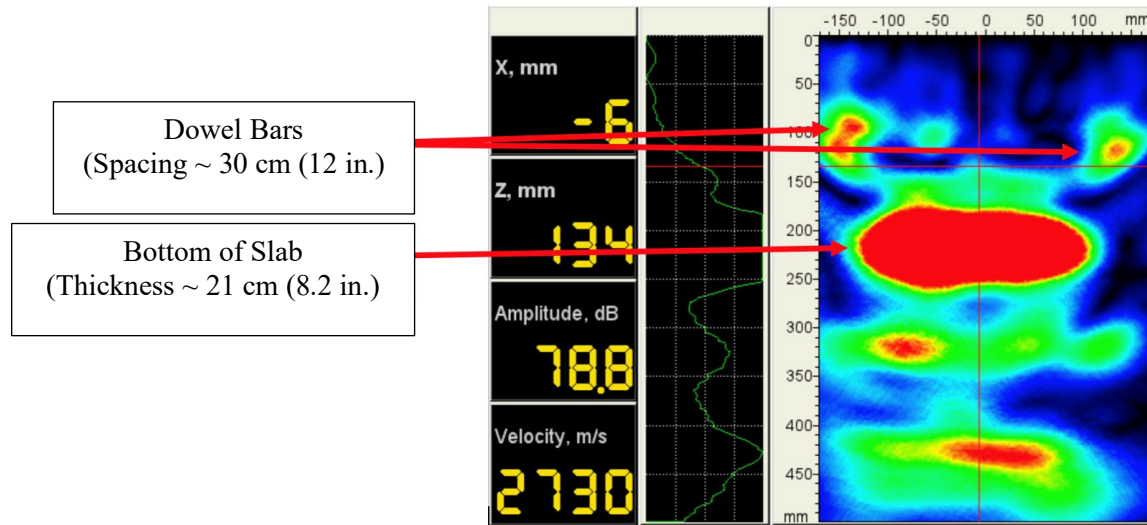
The recorded ultrasonic image can be used to detect slab thickness, dowel and tie bar placement (depth and spacing), and whether a contraction joint is activated. Figure 3 shows an example of the tomographic image taken from a specific project and its interpretation.

Figure 3. Photo. Ultrasonic tomographic image from example concrete pavement section.

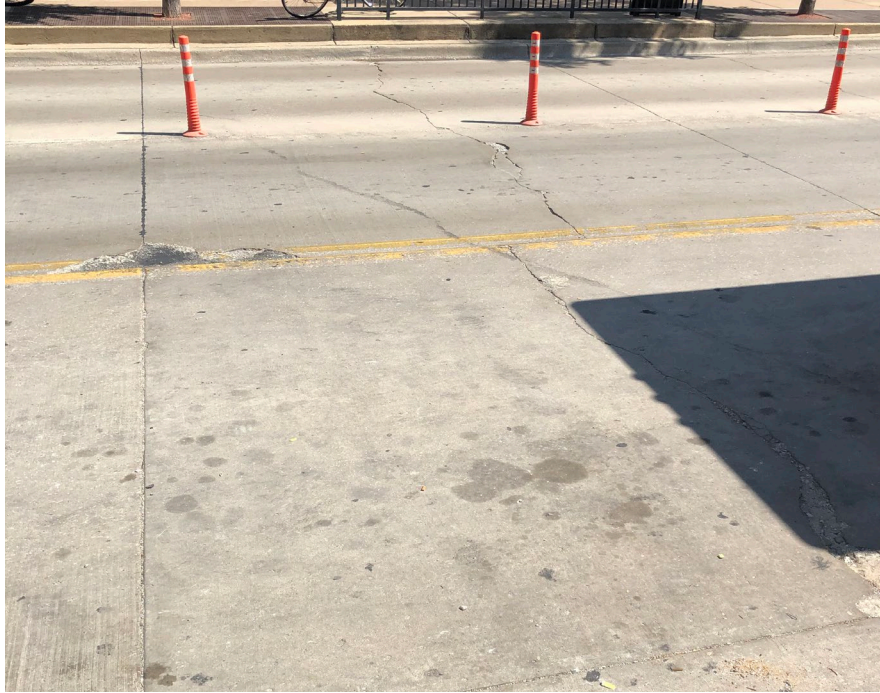
Green Street is in the heart of the University of Illinois at Urbana-Champaign. The road had a full reconstruction around 2005 and developed transverse cracking distresses within the first few years. Figure 20 shows an image of Green Street with the commonly observed transverse cracking.

Figure 20. Photo. Transverse cracking on Green Street (Champaign, IL).

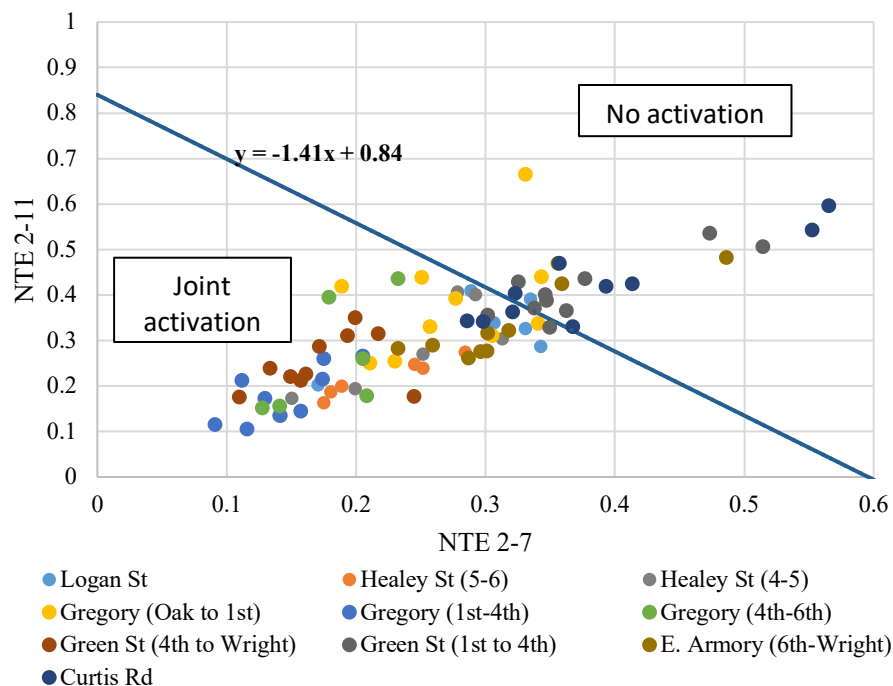
Figure 28. Graph. Hyperplane joint activation results.

This MIRA analysis shows that some joints may not be activated and could be contributing to premature cracking. Additionally, these joints were all tested a minimum of 5 years after

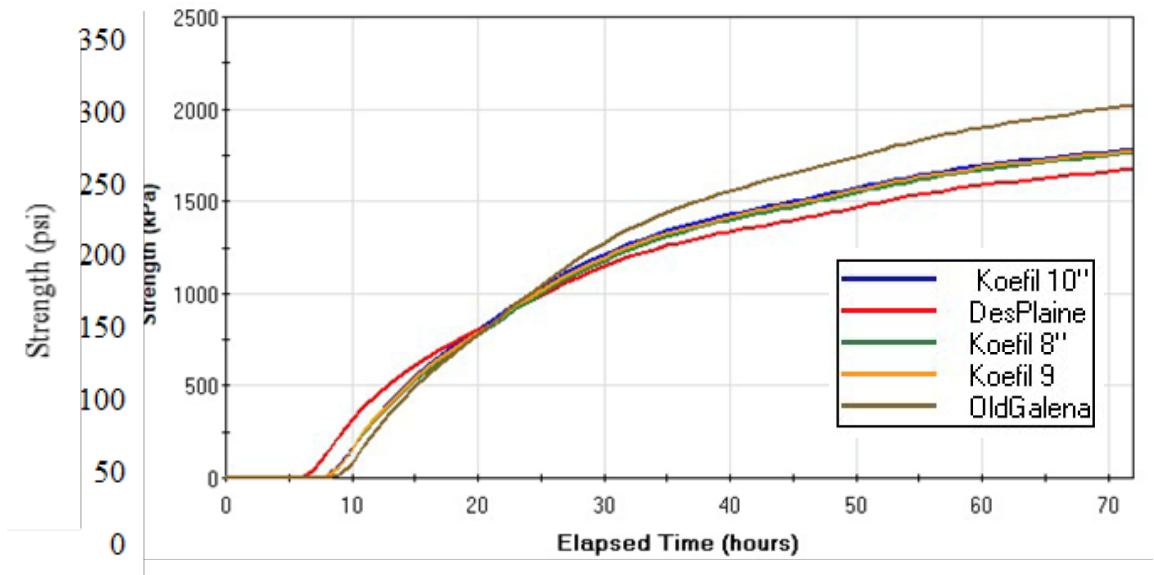
HIPERPAV estimates the concrete mixture tensile strength and stress development based on the mixture components and environmental conditions. Figure 29 shows the tensile strength development for the first 72 hours of the concrete mixtures presented in Table 22. The hardening profile was similar for all the mixtures. However, the Des Plaines mixture design shows slightly faster strength development, but the lowest strength gain after 72 hours. The Old Galena mixture design showed the greatest strength gain at the end of the 72-hour evaluation.

Figure 29. Graph. Tensile strength development for three concrete mix designs.

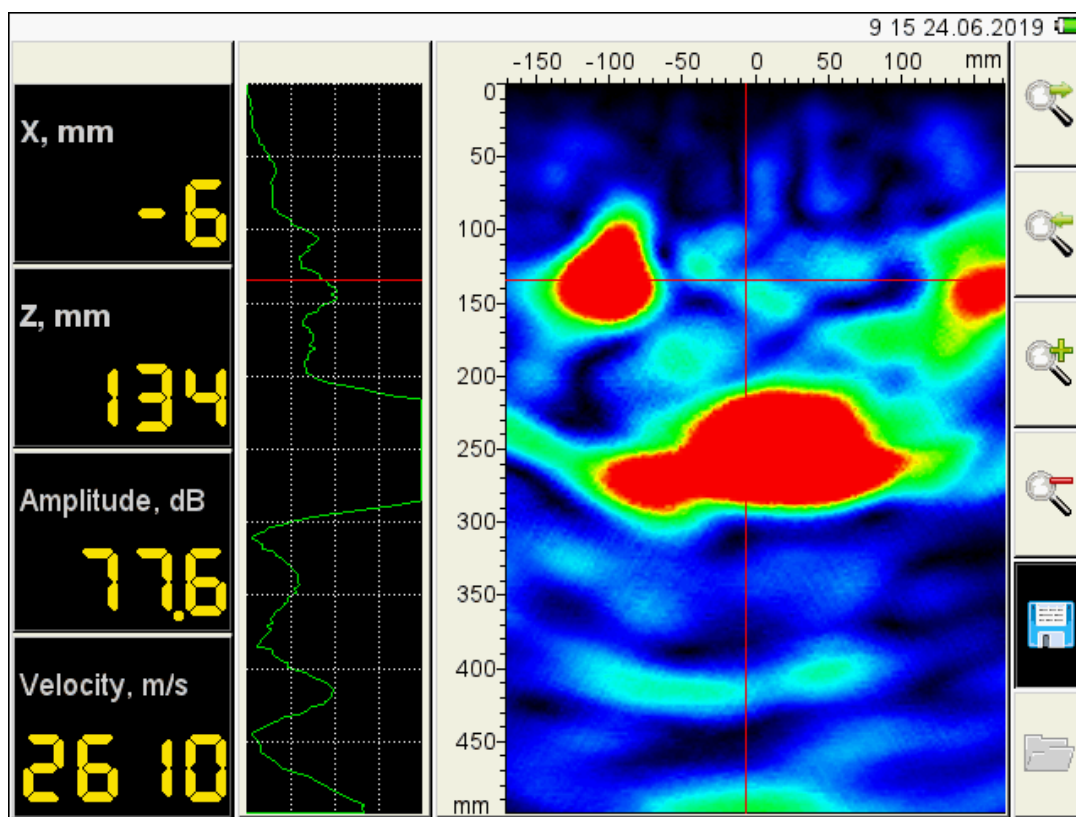
Figure 33. Photo. Ultrasound image of IL 30 with SS 55.

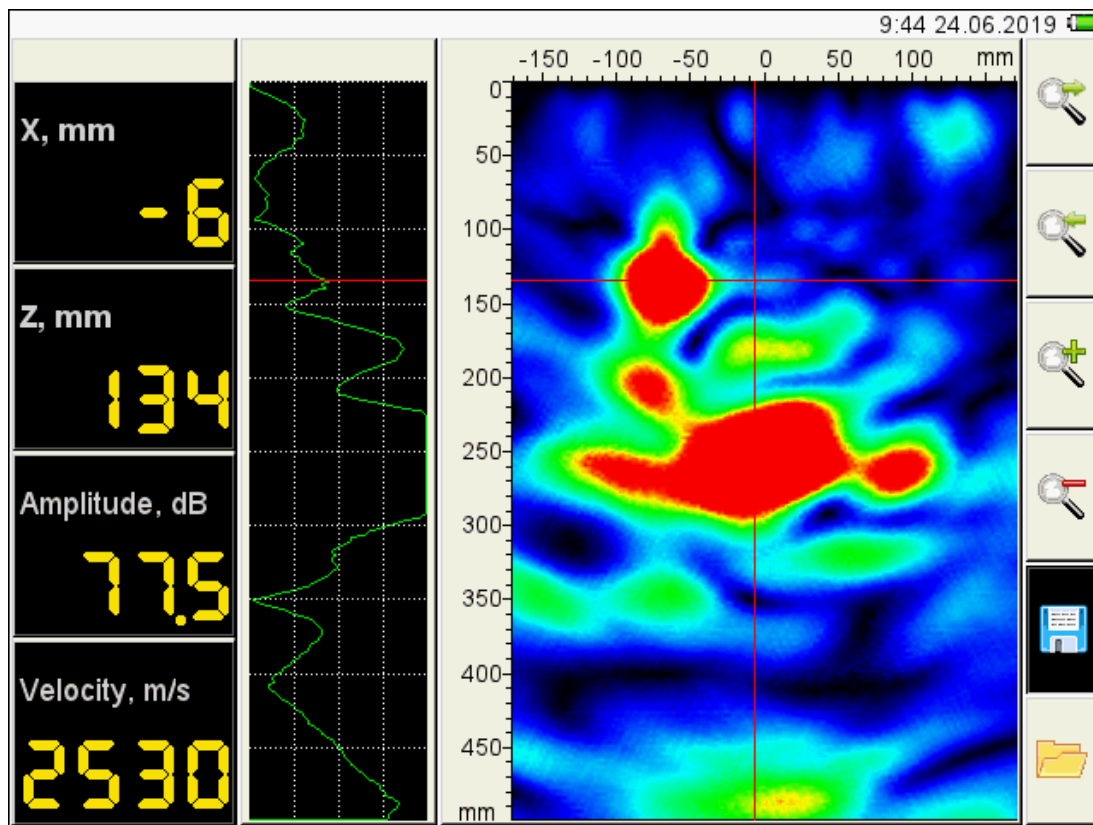
Figure 35. Photo. Ultrasound image of IL 59 from IL 30 to IL 80.

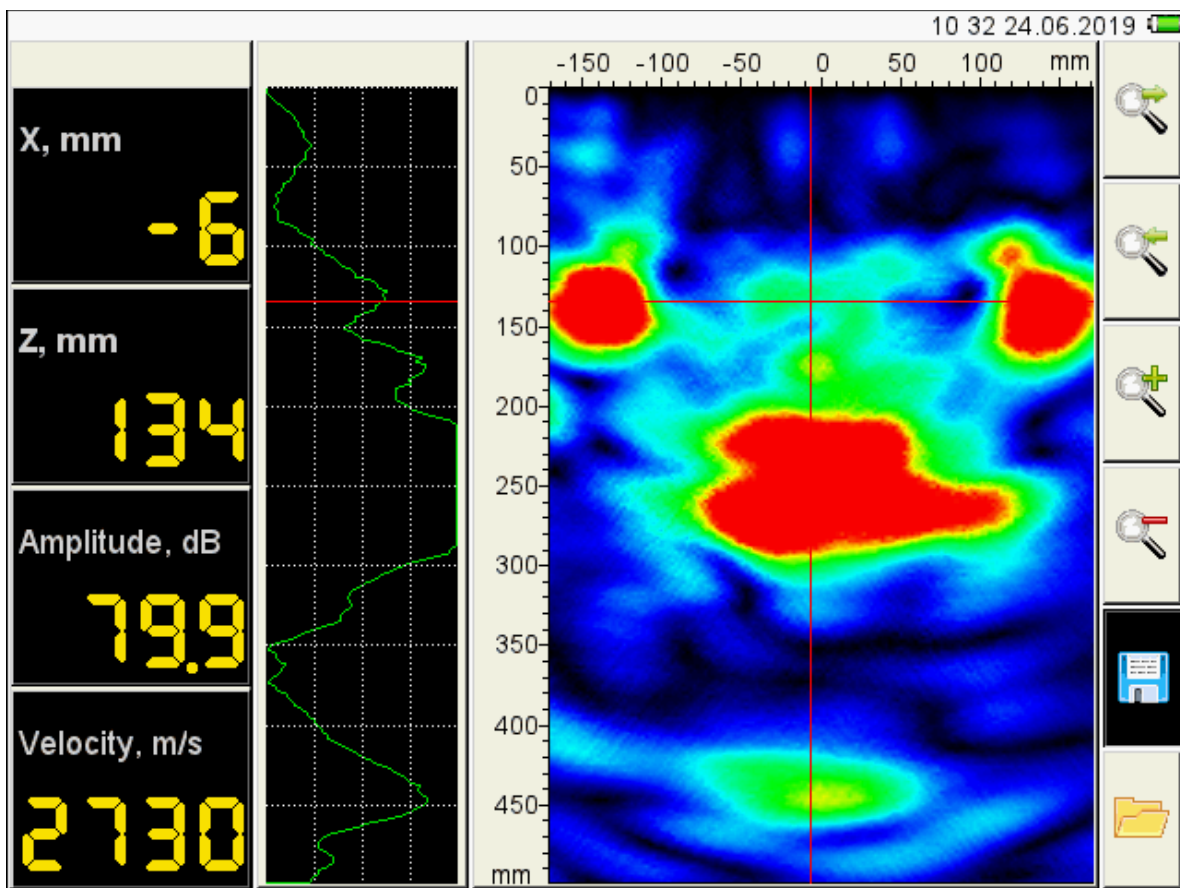
Figure 38. Photo. Ultrasound image of IL 59 with IL 88.

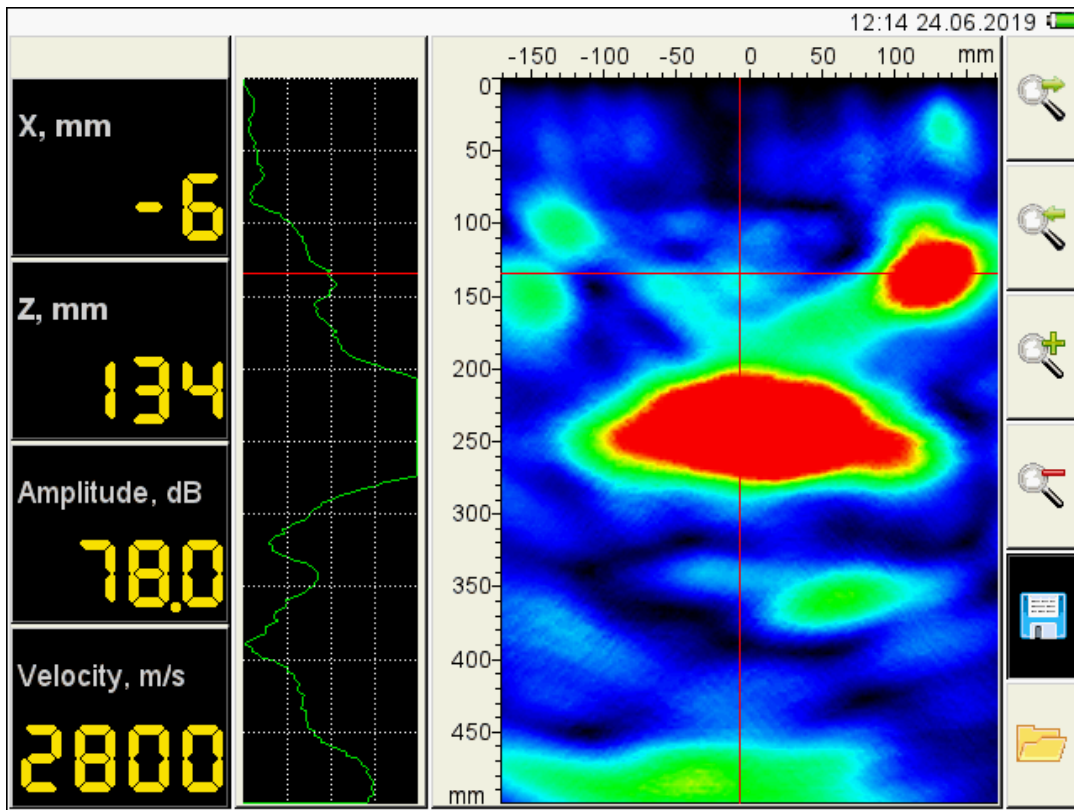
Figure 40. Photo. Ultrasound image of IL 62 from Penny Road to Eastings Way.

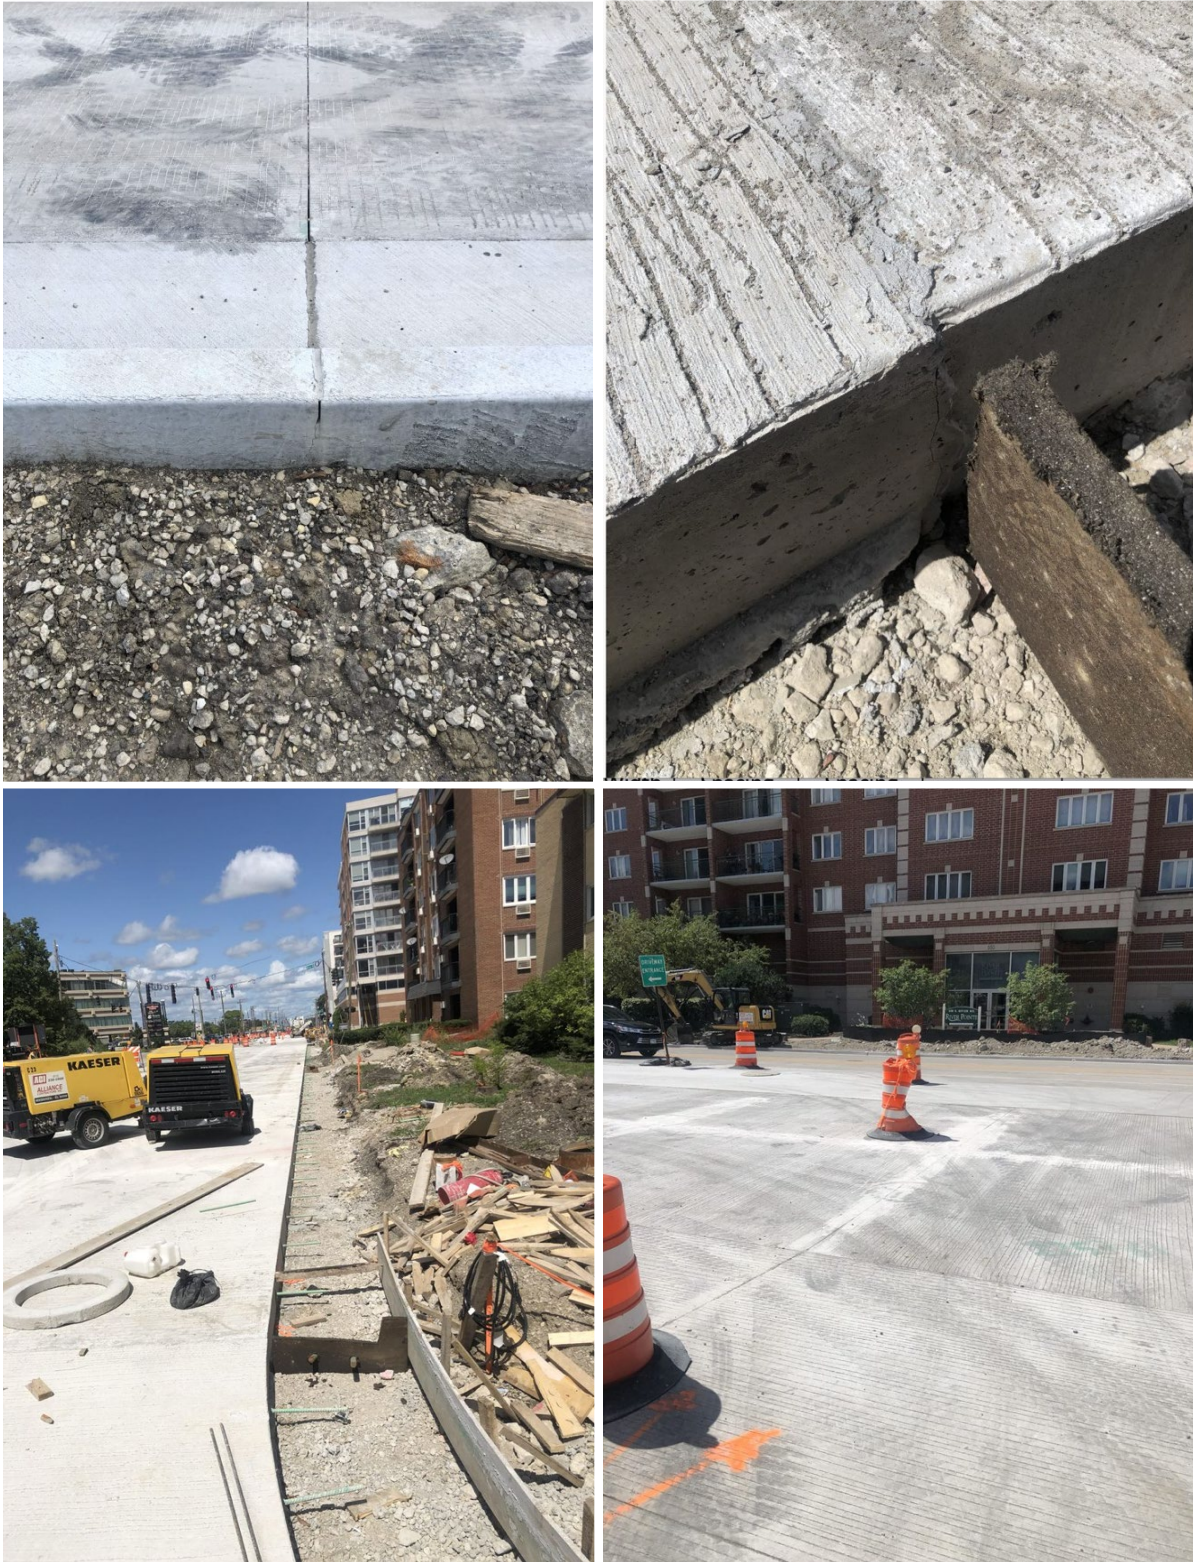
Figure 44. Photos. River Road (under construction).

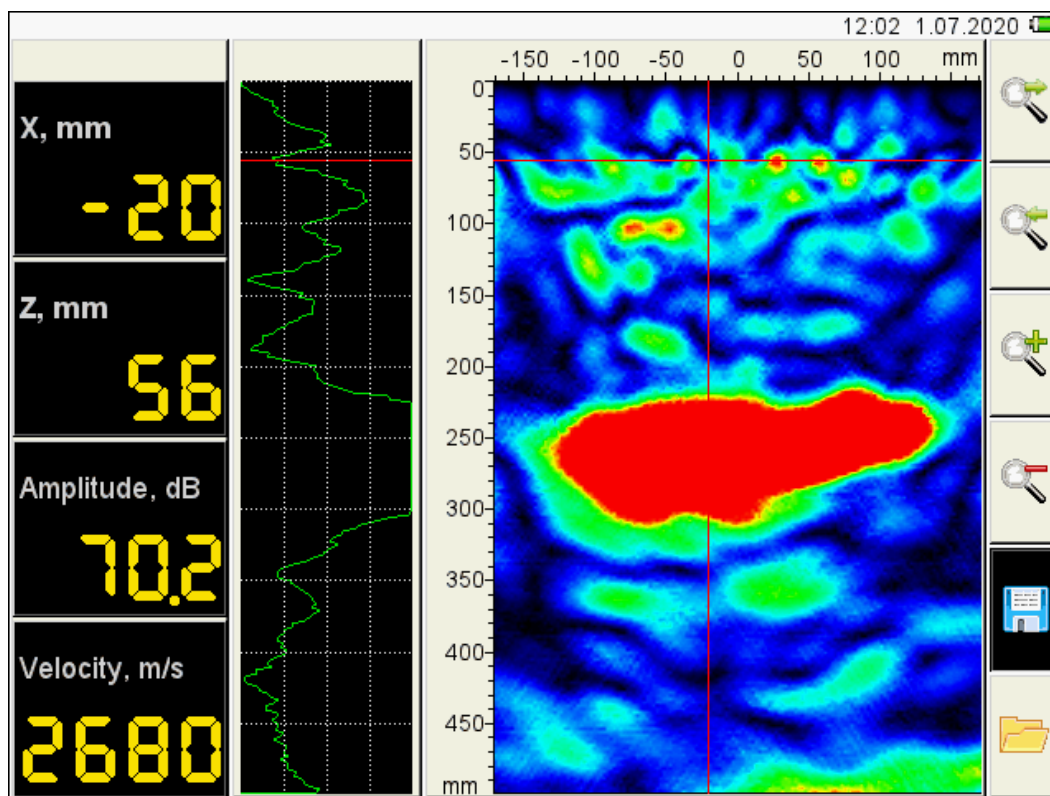
Figure 47. Photo. Ultrasound image of US 20 at Galena, IL.

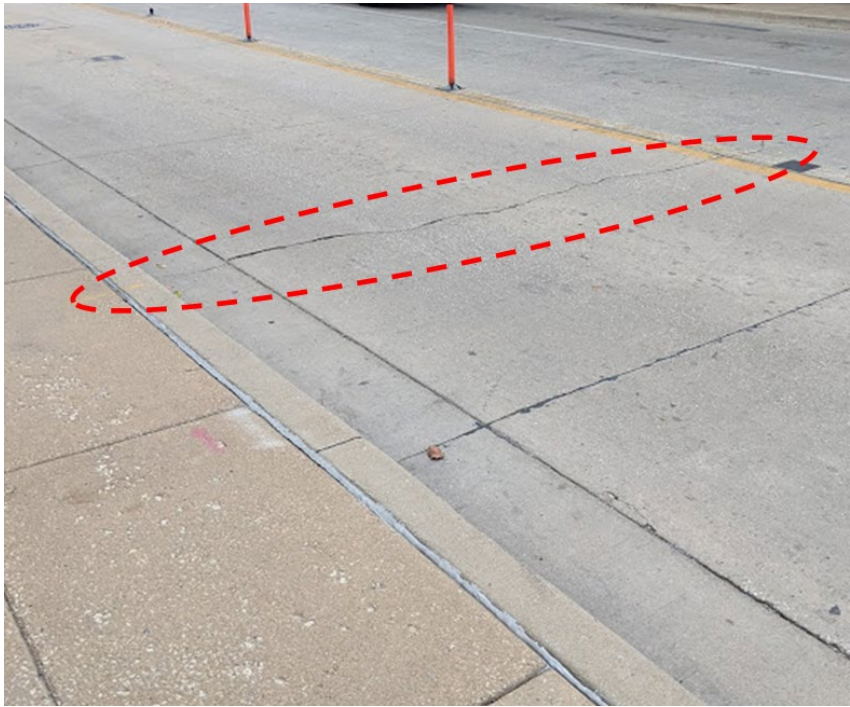
Street is a very busy street in Champaign, Illinois, which made testing more challenging than other sections. Therefore, only three to four adjacent joints were able to be evaluated per location. Table 92 summarizes the results of the joint evaluation conducted on the three testing locations on Green Street between Wright Street and Fourth Street in Champaign, Illinois. From this ultrasonic joint analysis, all joints tested along Green Street are activated and are not likely the main contribution to the transverse cracking (see Figure 129).

Figure 128. Photo. Transverse crack on Green Street near Wright Street.

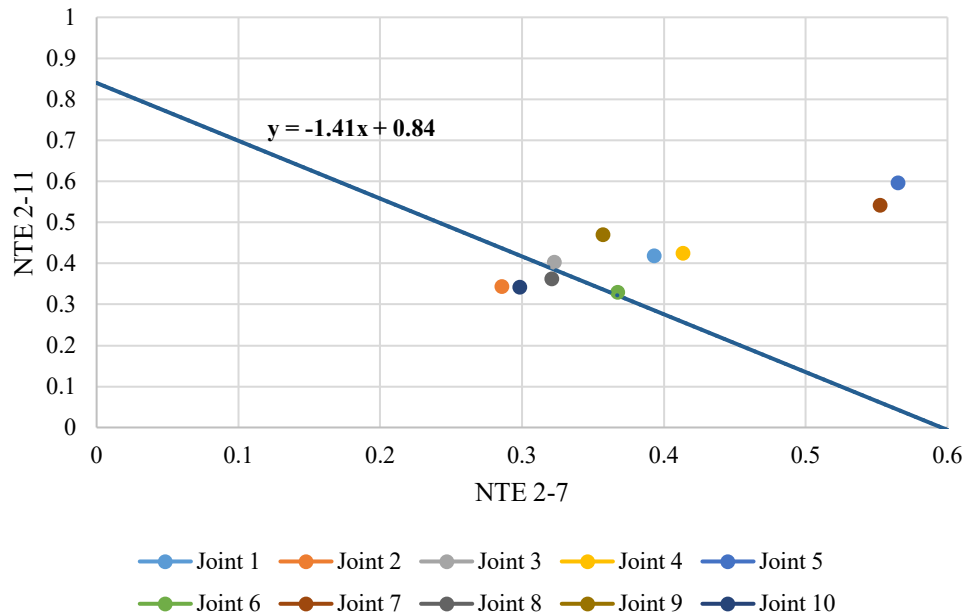
Curtis Rd. near Wynstone Dr.	8	No crack between Joints 7 and 8; Transverse crack between Joints 8 and 9	10/28/2020	Inconclusive ¹
Curtis Rd. near Wynstone Dr.	9	Transverse crack between Joints 8 and 9; Transverse crack between Joints 9 and 10	10/28/2020	Not activated
Curtis Rd. near Wynstone Dr.	10	Transverse crack between Joints 9 and 10	10/28/2020	Inconclusive ¹

Figure 133. Graph. Curtis Road joint activation analysis NTE results.
