Longitudinal Cracking Investigation on I-72 Experimental Unbonded Concrete Overlay

Research Report No. FHWA-ICT-22-002

ICT PROJECT R27-SP48

February 2022

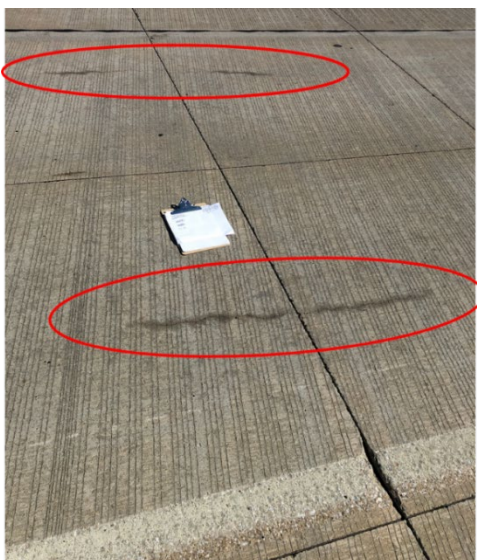
Concrete overlays are an accepted option to rehabilitate existing roadways. A research project was initiated to investigate an experimental short-jointed unbonded concrete overlay (UBOL) constructed in 2015 near Riverton, Illinois, that was exhibiting longitudinal cracking and lane-shoulder faulting. This concrete overlay on I-72 was supported by a dense-graded hot-mix asphalt (HMA) and nonwoven geotextile fabric (NWGF) interlayers in the eastbound and westbound directions, respectively. The purpose of the research was to assess the potential mechanisms causing the longitudinal crack development within the wheel paths and the lane-shoulder faulting in the eastbound direction only. The typical longitudinal cracking occurring on I-72 eastbound can be seen in **Figure S1**.

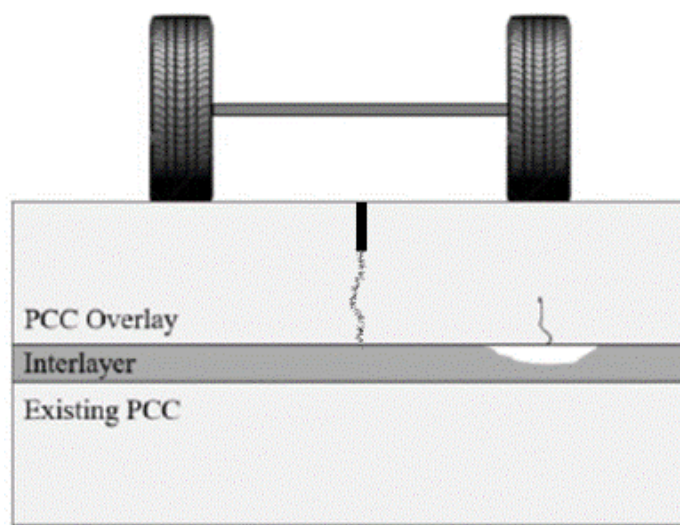
Figure 2. Schematic. Tensile crack development from void in HMA interlayer (Souder et al., 2020).

The primary failure mode for UBOLs with short slabs appears to be longitudinal cracking occurring directly in the wheel path, indicating repeated loading contributes to development and propagation. The longitudinal cracking initiates at the transverse joint and likely develops from damage within the HMA interlayer from fatigue, localized stripping and erosion, and/or consolidation (Alland et al., 2016; Khazanovich et al., 2020). This damage can result in a void, gap, or settlement beneath the overlay in the wheel path. As traffic accumulates, the deformation or gap increases and results in an increase in the tensile stress at the bottom of the concrete slab and eventually leads to a bottom-up crack to develop if the flexural capacity of the concrete is exceeded (Figure 2). Longitudinal cracking is less likely to occur prematurely as a function of erosion when a NWGF interlayer is employed, as this is an erosion-resistant material and unlikely to consolidate based on its initial density and thickness. Bonded concrete overlays of asphalt (BCOA) with 6×6 ft (1.8×1.8 m) panels experience a similar distress mechanism when the interfacial bond deteriorates over time and the longitudinal cracking initiates at the transverse joint (Li & Vandenbossche, 2013).

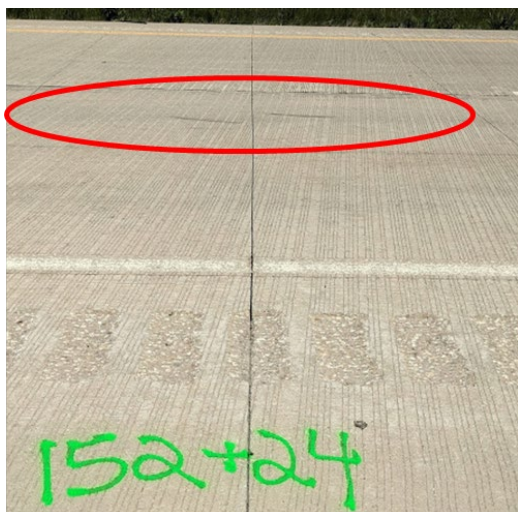
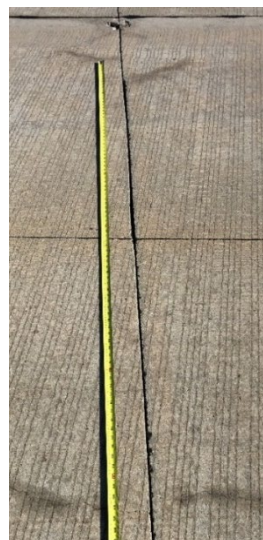
Figure 3. Photos. I-72 eastbound longitudinal cracking at the transverse joints within the wheel path of the driving lane with longitudinal cracks in the (a) inside wheel path and (b) both wheel paths.

A. Longitudinal cracking in inner wheel path only B. Longitudinal cracking in both wheel paths

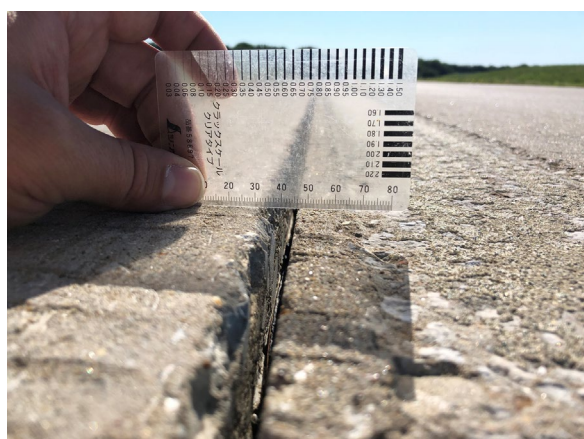
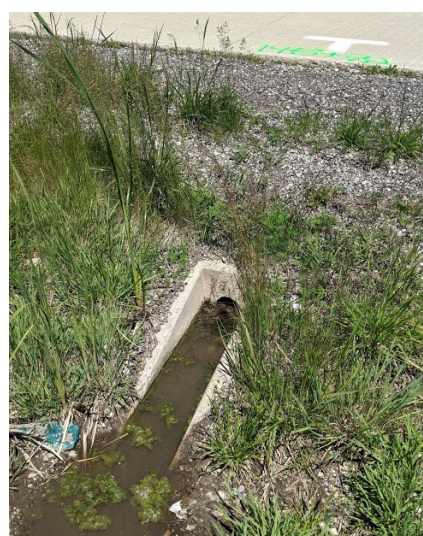
Figure 4. Photos. I-72 eastbound (a) longitudinal joint faulting along the driving lane and shoulder and (b) edge drain outlets with standing water.

In addition to longitudinal cracking, longitudinal faulting along the lane-shoulder joint is also occurring in the eastbound direction at some locations. The shoulder-edge elevation is higher than the driving lane. A potential mechanism includes stripping and erosion, as several drain outlets were observed to be clogged and filled with water (Figure 4). This can also influence longitudinal crack development if moisture is being stored beneath the pavement and in the joints. Another potential contribution to the longitudinal faulting is the condition of the existing CRCP. Prior to placement of the interlayer and overlay, there was edge deterioration along this joint in the existing CRCP because of D-cracking. Areas with severe deterioration were repaired prior to placing the interlayer.

A. Longitudinal joint faulting B. Standing water in drain outlets

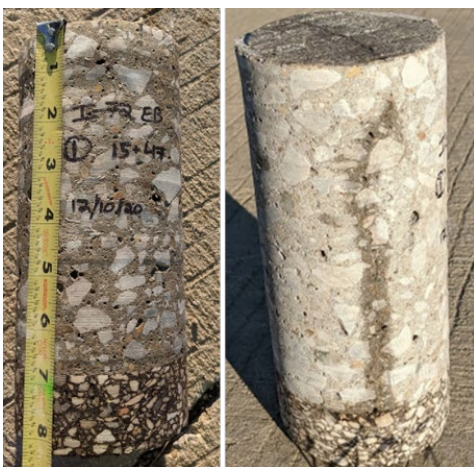
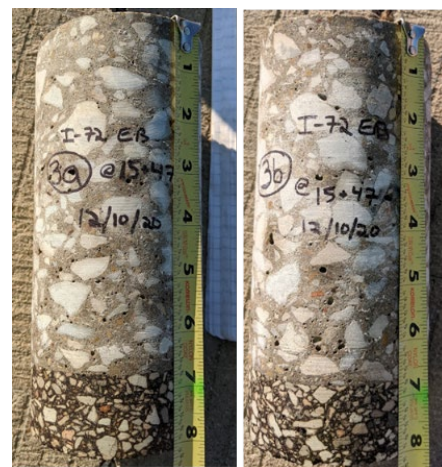
A. 15+47 EB

Outer wheel path (approach joint):
Over longitudinal crack

Right edge panel (Leave slab):
NOT in wheel path

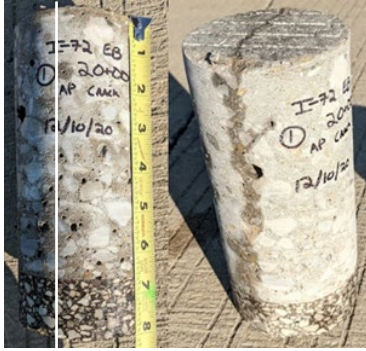
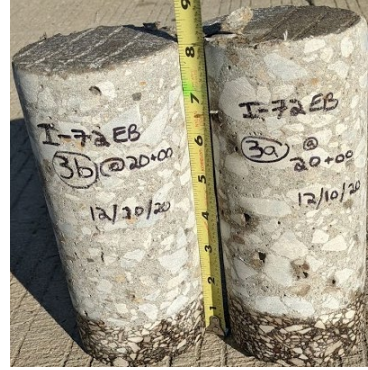
B. 20+00 EB

Outer wheel path (approach joint):
Over longitudinal crack

Right edge panel (Leave slab):
NOT in wheel path

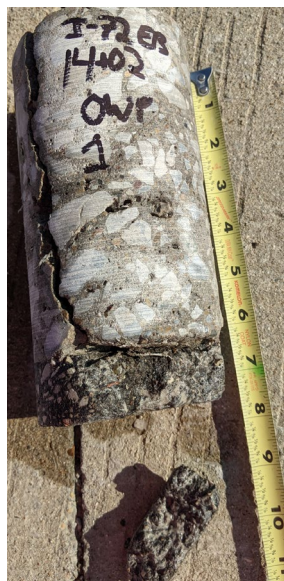
A. 14+02 EB OWP longitudinal crack on leave; stripping on leave only

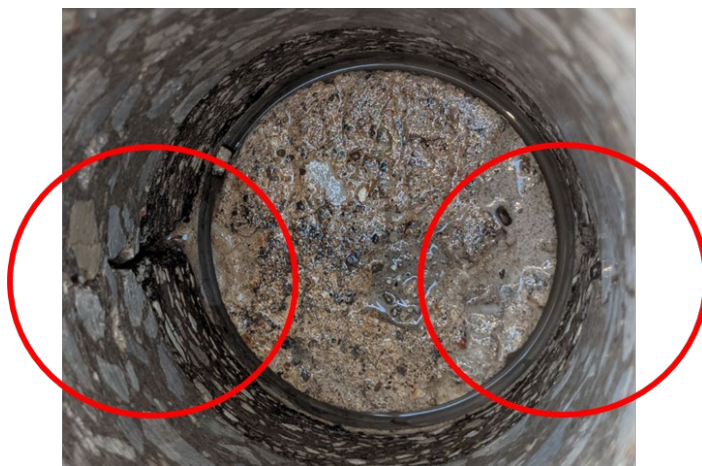
B. 14+02 EB OWP crack deterioration in HMA at transverse joint

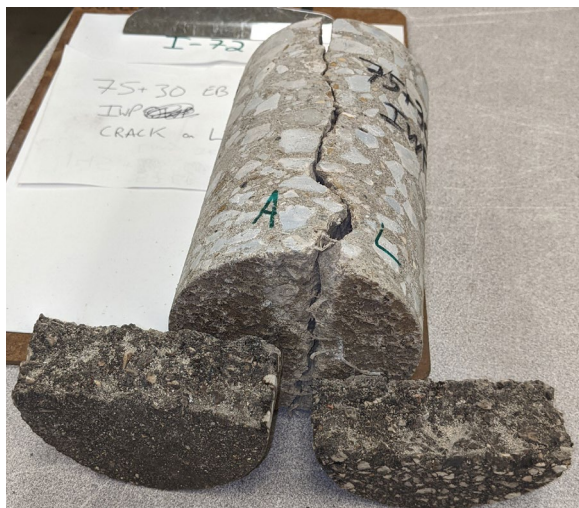
C. 75+30 EB IWP longitudinal crack on leave; stripping on leave only

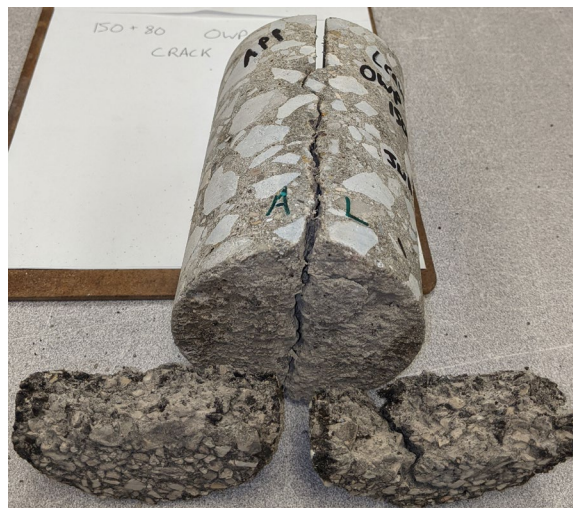
D. 150+80 EB OWP longitudinal crack on leave; stripping at bottom of HMA interlayer

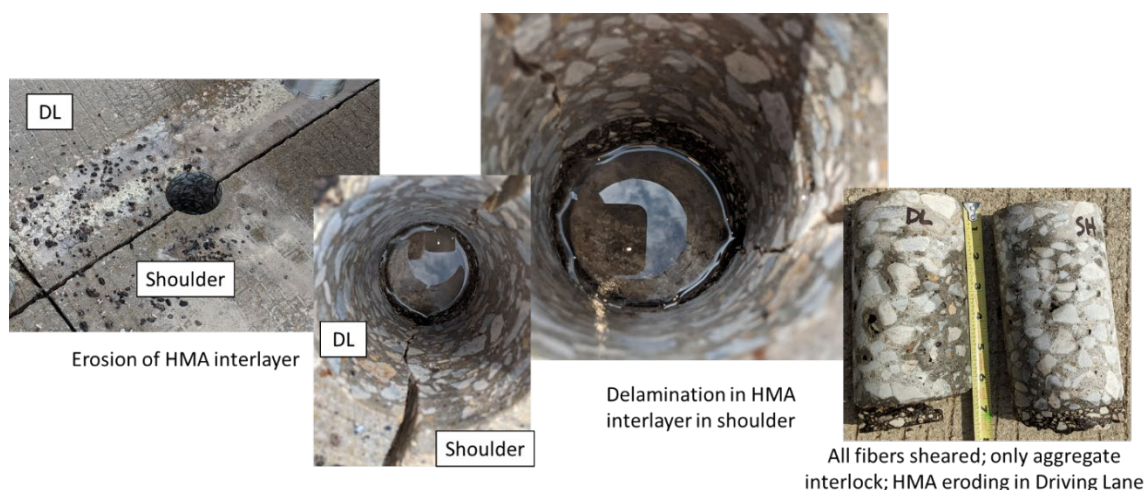
Figure 8. Photos. Core over the longitudinal lane-shoulder joint from June 2021.

The coring results from directly over the lane-shoulder longitudinal joint also indicated stripping and erosion was occurring. The stripping and erosion at this location appears to be more severe than the transverse joint, as the HMA crumbled during coring (see Figure 8). Thicknesses of the HMA interlayer were not able to be determined based on the asphalt stripping and erosion. The magnitude of longitudinal lane-shoulder faulting has caused all fibers to shear, resulting in only aggregate interlock between interfaces. Figure 8 shows the core location, inside the core hole, and the two halves of the core. It also appears as if there is some form of delamination within the HMA interlayer in the shoulder. It is difficult to determine if the shoulder is moving up a little, the driving lane moving down, or a combination of both.

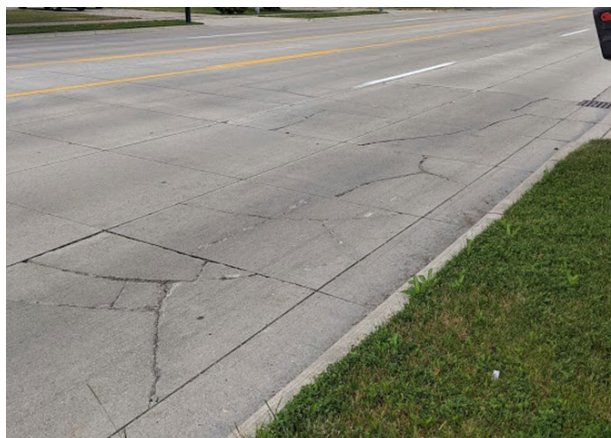
Figure 11. Photo. Little Mack Avenue (southbound) in St. Clair Shores, Michigan (UBOL with NWGF interlayer).

The first state surveyed was Michigan. Three UBOL sections examined in Michigan near the Detroit Metropolitan Area included Little Mack Avenue in St. Clair Shores, Gratiot Avenue in Detroit, and Hall Road in Woodhaven. The first section, Little Mack Avenue, was constructed in 2011 and has a 6 × 6 ft (1.8 × 1.8 m) short-jointed UBOL with a 4 in. (102 mm) slab thickness. The existing PCC was experiencing joint deterioration and resulted in milling 4 in. (102 mm), placing a NWGF interlayer and then the 4 in. (102 mm) PCC overlay. This is a 2 mile (3.2 km) project with four total lanes, two lanes in each direction. The section is in an urban area with curb and gutters. This section did not include dowels or tie bars, but included sealed joints. The average annual daily traffic reported prior to design in 2010 was 13,400 with 2.3% trucks. From the visual survey, the southbound lanes had distress present, including faulting, spalled cracks, shattered slabs with transverse and longitudinal cracking, longitudinal faulting, and a potential longitudinal reflective crack spanning a quarter of the length of the project in the southbound direction. Additionally, a clicking sound was observed when vehicles drove in the southbound direction over the faulted joints. Since construction, numerous slabs have been replaced. The northbound lanes are exhibiting significantly less distress, even though the PCC overlay thickness was approximately the same according to the ultrasonic tomography device, MIRA. It is possible that there is directional truck traffic, i.e., heavy vehicles traveling south towards Detroit and resulting in higher fatigue in the southbound direction versus the northbound. Overall, this section is very thin; with surface drainage only with the curb and gutter, a bathtub effect likely exists underneath the thin slabs leading to the numerous fatigue cracks. Figure 11 shows the severely distressed southbound driving lane of Little Mack Avenue.

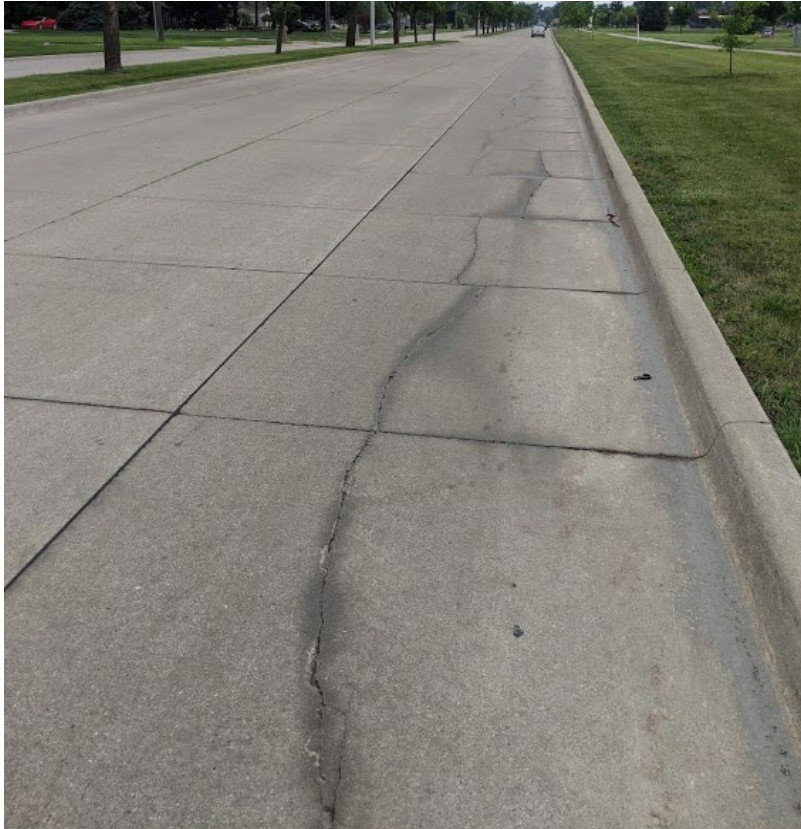
Figure 13. Photo. Hall Road (northbound) in Woodhaven, Michigan (UBOL with dense-graded interlayer).

signs of black silty-sandy material with high number of fines. It is likely this is the material being pumped and potentially the HMA interlayer is eroding away.

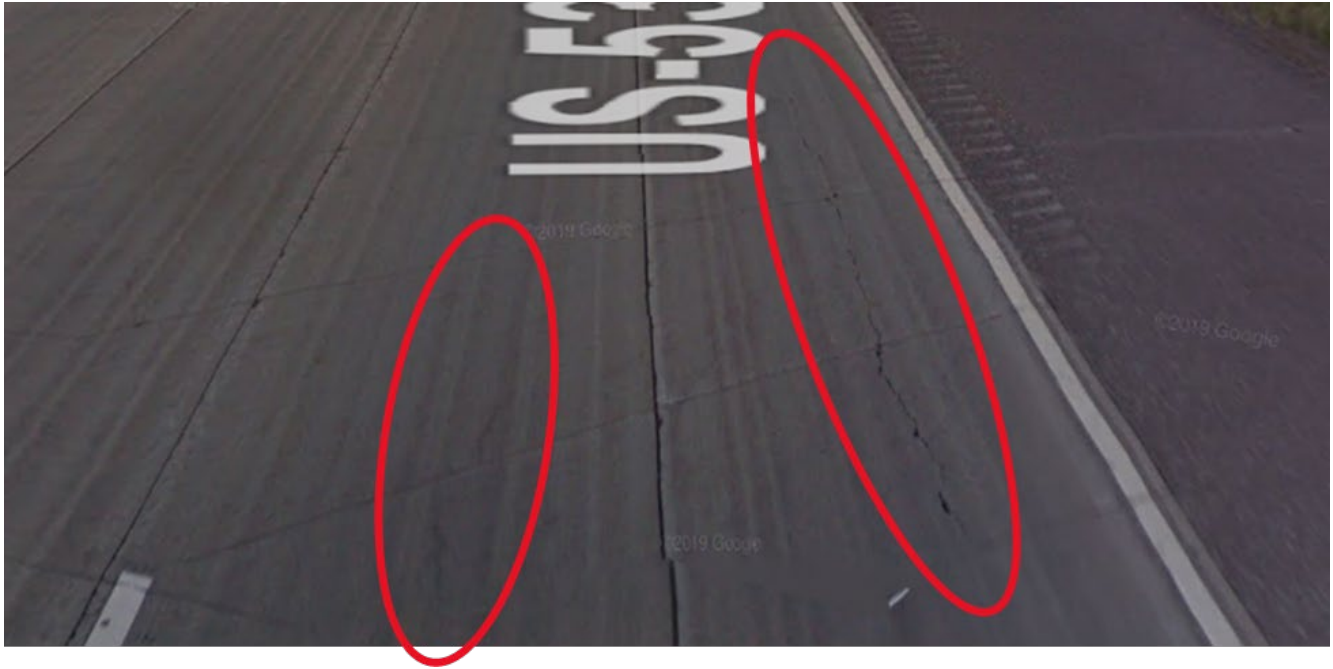
Figure 14. Photo. TH-53 (southbound) near Duluth, Minnesota (Google Earth 2021).

× 1.8 m) section consisted mainly of longitudinal cracking within the inner and outer wheel paths, spanning multiple slabs. The southbound section of TH-53 started undergoing rehabilitation and reconstruction starting in summer 2021 and, thus, no higher resolution photographs of the current distresses were available. Figure 14 presents the observed longitudinal cracking on TH-53 within the 6 × 6 ft (1.8 × 1.8 m) section.

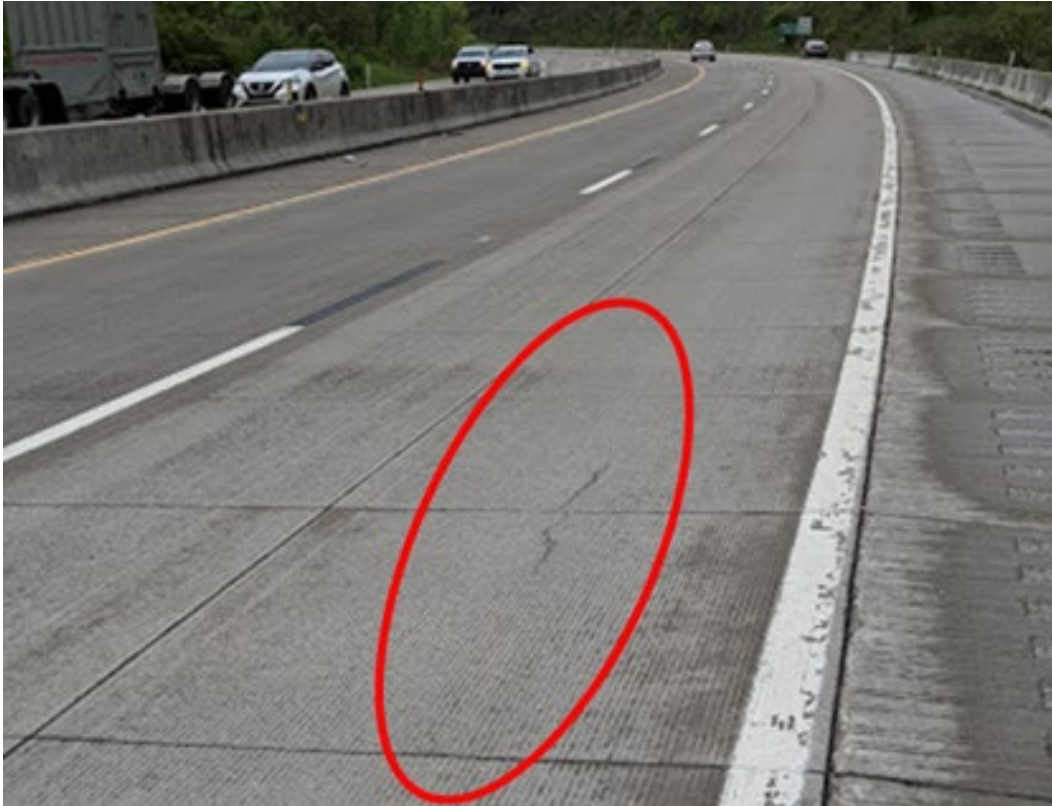
Figure 15. Photo. Pennsylvania SR-50 (eastbound) UBOL longitudinal cracking.

longitudinal crack that initiated at the transverse joint in the outer wheel path of the eastbound driving lane.

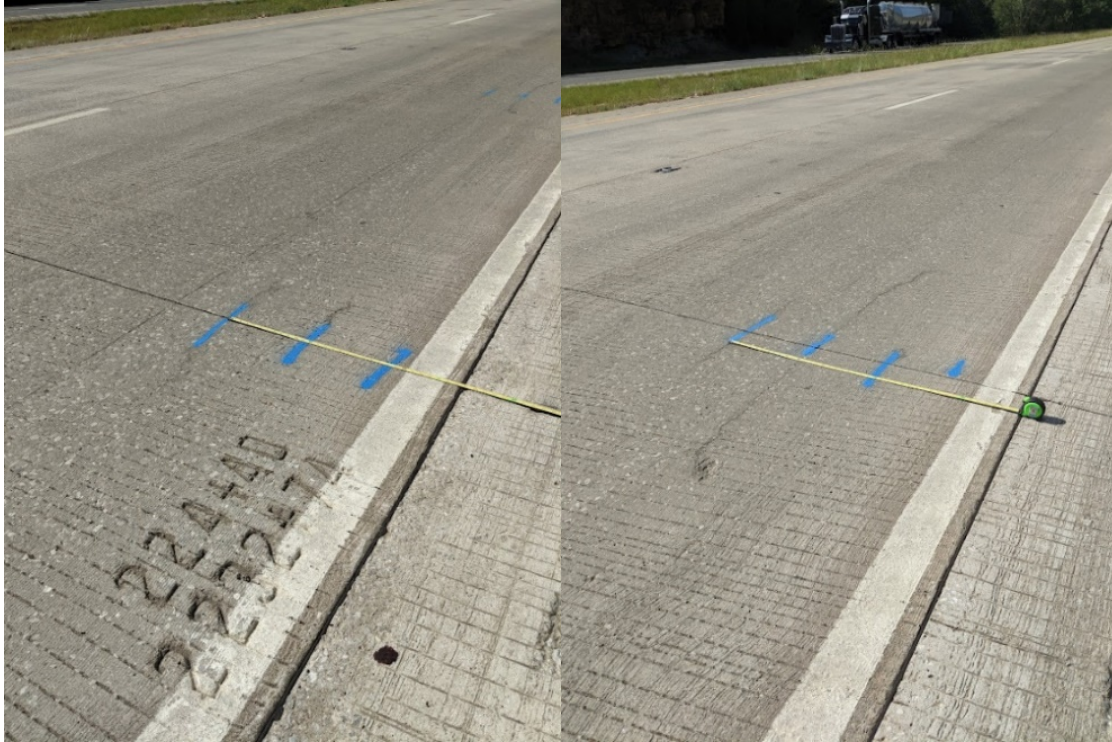
Figure 16. Photos. I-57 longitudinal cracking in the outer wheel path directly over dowel bars.

After potential evidence of stripping was observed for some UBOLs with dense-graded HMA interlayers, there was concern for a recently constructed UBOL with conventional JPCP design in southern Illinois. Therefore, an additional site visit was conducted to assess the stripping and longitudinal cracking potential. The UBOL section on I-57 in Union and Johnson Counties was constructed in 2015 and 2016. This section was thicker than I-72 with a 9.75 in. (248 mm) overlay and a 3.25 in. (83 mm) dense-graded HMA interlayer on an existing 10 in. (254 mm) JRPC. This UBOL had 1.5 in. (38 mm) dowels at transverse joints, centerline tie bars, tied concrete shoulder, sealed longitudinal joints, and conventional joint spacing of 15 × 12 ft (4.6 × 3.7 m). The longitudinal cracking observed is located within both wheel paths of the driving lane. From the site visit and MIRA device, cracks were determined to be directly over the dowel bars, given they were spaced 12 in. (305 mm) on center, directly over the dowels. A dowel bar inserter was used on this project and potentially resulted in some form of vertical tilt of the dowels in some locations, leading to high stress concentrations and eventually crack development. Another potential mechanism causing the longitudinal cracks to develop could be related to poor consolidation of the concrete during dowel insertion. The longitudinal cracking is likely directly related to the dowel bars. This cracking was only observed at a few locations in the southbound direction in the driving lane.

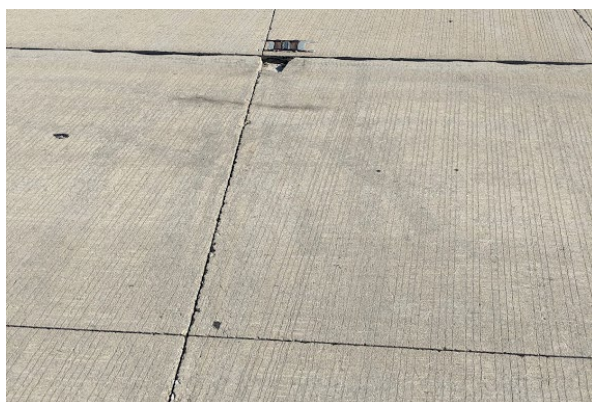
The prominent distress in the EB direction was longitudinal cracks in the wheel paths (WP) of the driving lane (each panel). On average, cracks appear to be 2 ft [0.6 m] in length on each panel and a total of 4 ft [1.2 m] across transverse joints. Longitudinal cracking spanning a full slab or greater was not observed. Approximately 30 locations had longitudinal cracking occurring across the transverse joint (tested two sections of 1,000 ft [305 m] and 3rd section of 100 ft [30.5 m]). This distress has been commonly seen in UBOL with HMA interlayers (Alland et al. 2016 and Souder et al. 2020). A possible mechanism for this distress is permanent deformation in the HMA layer (densification or shear flow) resulting in a void, gap, or settlement beneath the PCC in the wheel path. As traffic accumulates the deformation or gap increases, resulting in an increase in the tensile stress at the bottom of the PCC and eventually leads to a bottom-up crack to develop if the flexural stiffness and strength of concrete is not sufficiently high (See Figure 23-C below). With the lower vertical pressure reaching the HMA interlayer, this mechanism is less likely. The vertical pressure on the interlayer is likely less than 25 psi (172 kPa) if the joint is ignored.

A. Long. cracking in the inner wheel path

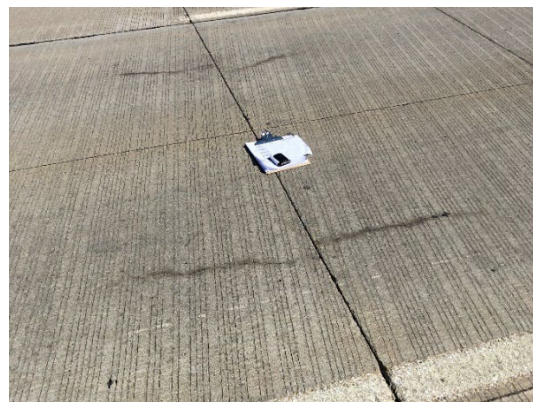
B. Long. cracking in both wheel path (inner and outer)

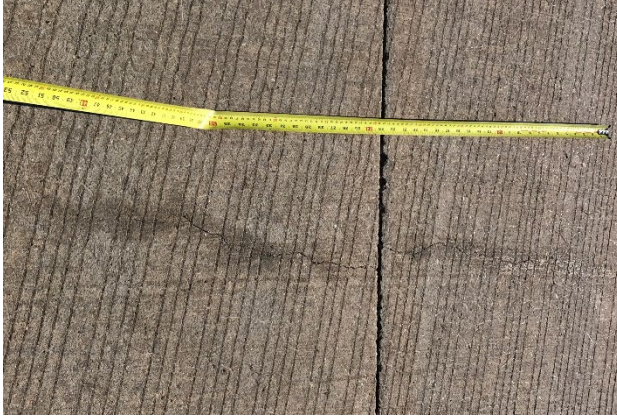
A. Length of long. crack
(approx. 4 ft [1.2 m] across the trans. jt.)

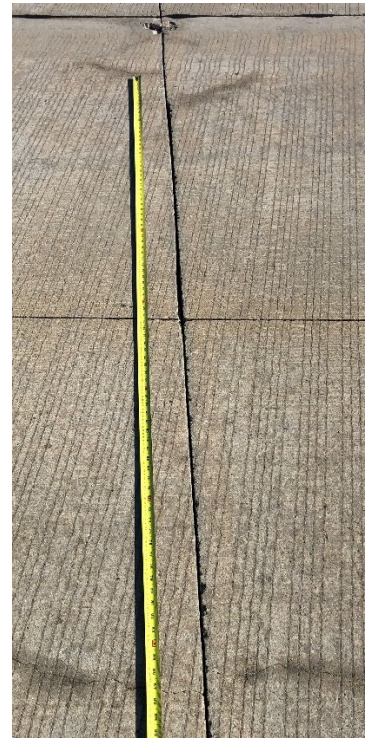
B. Distance between long. cracks at the
trans. jt. (approx. 7.5-8 ft [2.3-2.4 m])

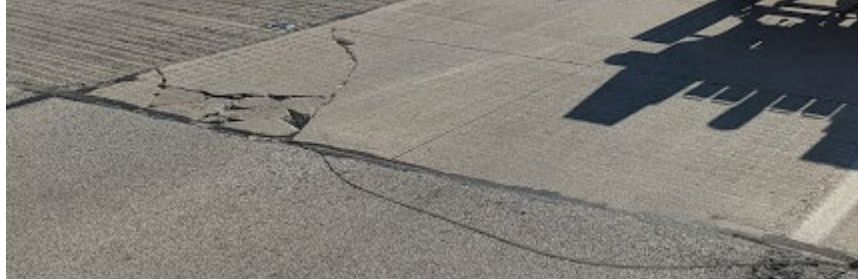
Figure 25. Photo. Distress photo of shattered slab in I-72 (72G92) eastbound.

- At the project start on the eastbound, the left panel in the driving lane is shattered. This is likely from the construction process when starting the UBOL versus the existing HMA surface layer. This panel needs to be replaced with a full-depth repair.

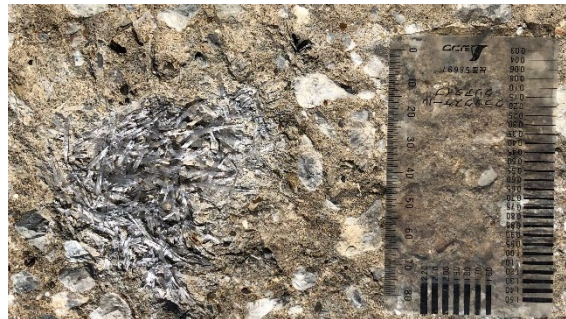
Figure 26. Photo. Clumping of fibers in I-72 (72G92) eastbound.

- Clumping of the fibers was observed once. It appears the mixing was done very well and fibers were distributed evenly throughout concrete material production and construction.

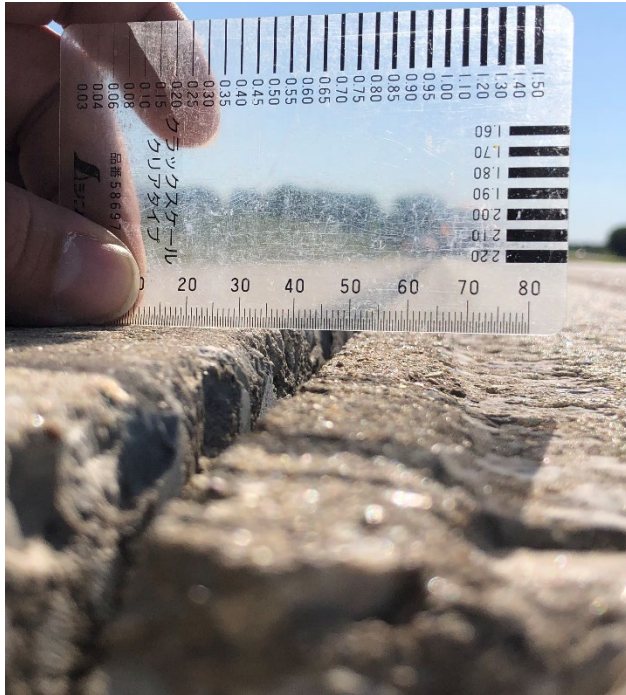
- If this joint had a steel tie bar, the separation and differential elevation may have been limited and potentially negated. It is also possible that separation could have occurred along the longitudinal joint within the driving lane (6 ft [1.8 m] offset from shoulder). There is a construction joint in the centerline between the passing and driving lane with steel tie bars. This joint was remaining tight.

A. Lane/shoulder jt. elevation difference
(shoulder = approx. 0.16 in. [4 mm] higher than driving lane)

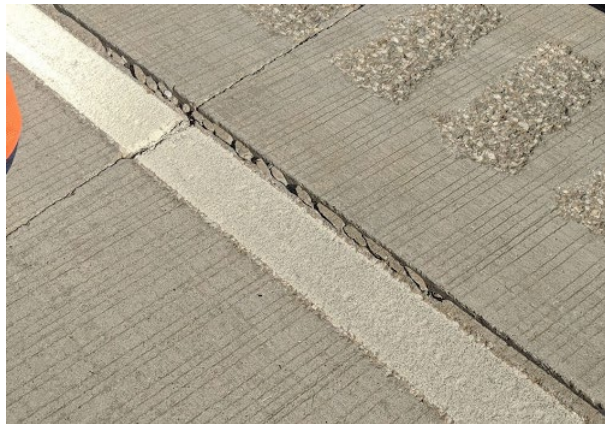
B. Potential distress occurring from elevation difference

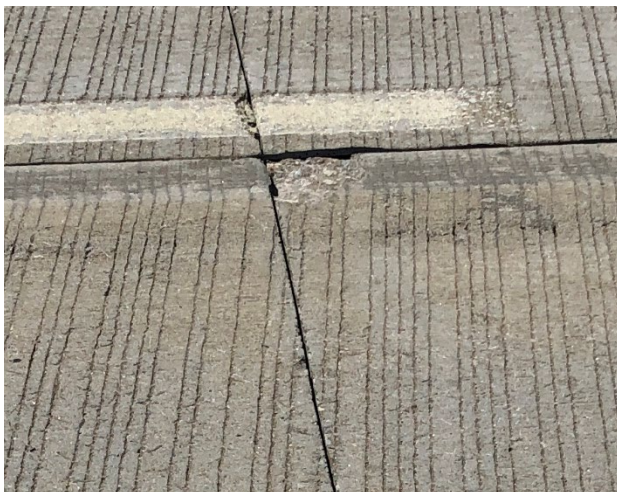
- Corner spalling is also occurring on the leave joint in the driving lane along the centerline longitudinal joint. It appears to be a form of chipping or spalling with a radius of 4 in. (102 mm). No other significant distresses were observed over the test sections.

A. Corner distress on leave joint left panel in driving lane

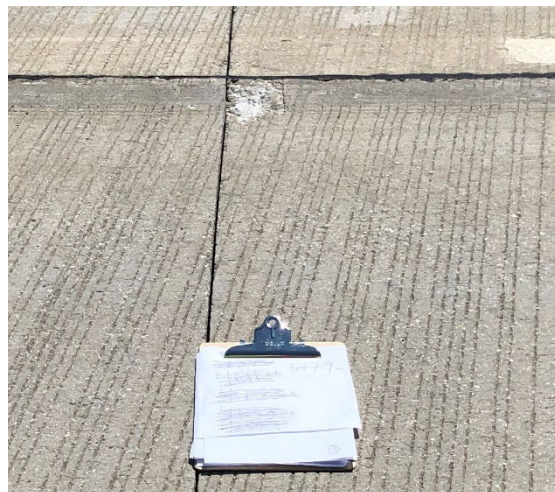
B. Corner distress on leave joint left panel in driving lane

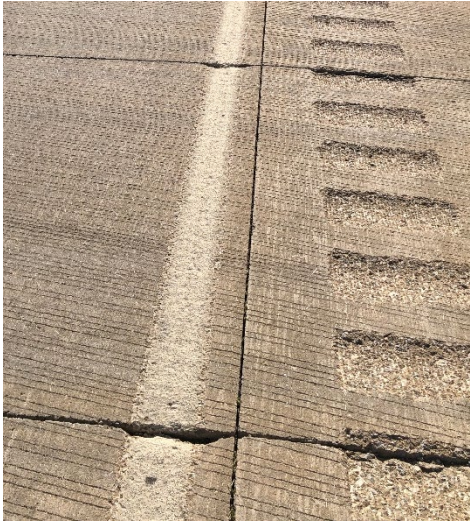
- All approach slabs have the distress shown in the figure below. It appears the grooving for recessed pavement marking operation resulted in spalling of the approach slab. This can result in small corner spalls to eventually occur.

A. Grooving effect on approach joint spalling

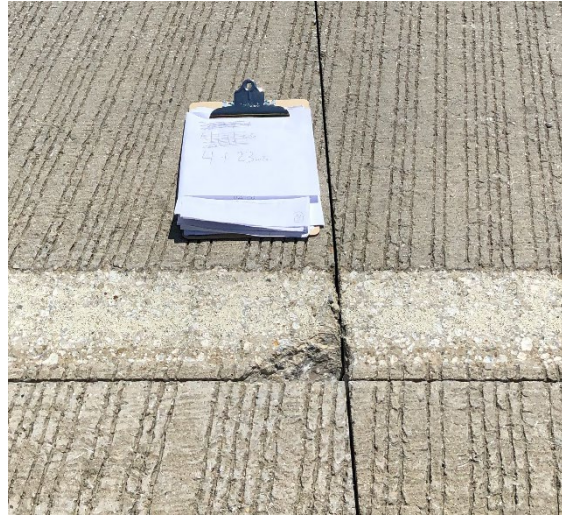
B. Grooving effect on approach joint causing corner spalling

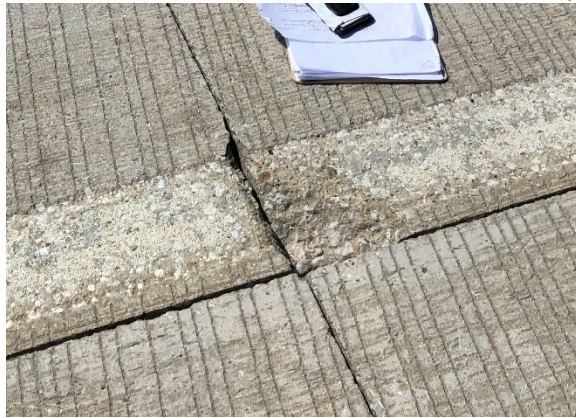
C. Grooving effect on leave joint corner spalling
