ENVIRONMENTAL GEOLOGY NOTES

*Bluff Erosion,
Recession Rates,
and
Volumetric Losses
on the Lake Michigan Shore in Illinois*

Richard C. Berg and Charles Collinson

ILLINOIS STATE GEOLOGICAL SURVEY

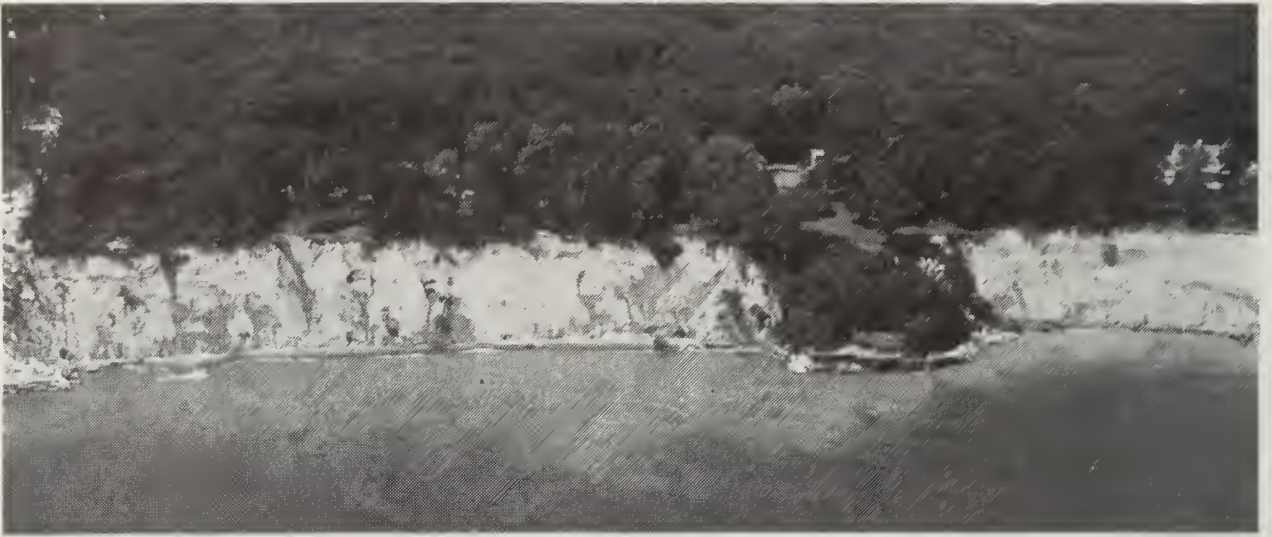
Fig. 11 - Bluff one-eighth of a mile south of Great Lakes Naval Training Center, August 1974, at a lake level near 580 feet. The bluff is more than 70 feet high. The lower part is of homogeneous gray glacial till. Most of the upper half of the bluff consists of weak till, silt, sand, and gravel. The beach house was built before 1947 and has been maintained ever since. Its location indicates the subsequent bluff recession (fig. 5). Numerous seeps can be seen along the entire reach. Fallen trees can be seen on the bluff face and on the narrow beach. More moisture is present below the mouths of truncated gullies than elsewhere. Rubble groins once present along this shore have been damaged and submerged. This location is shown by a vertical aerial view in figure 6.

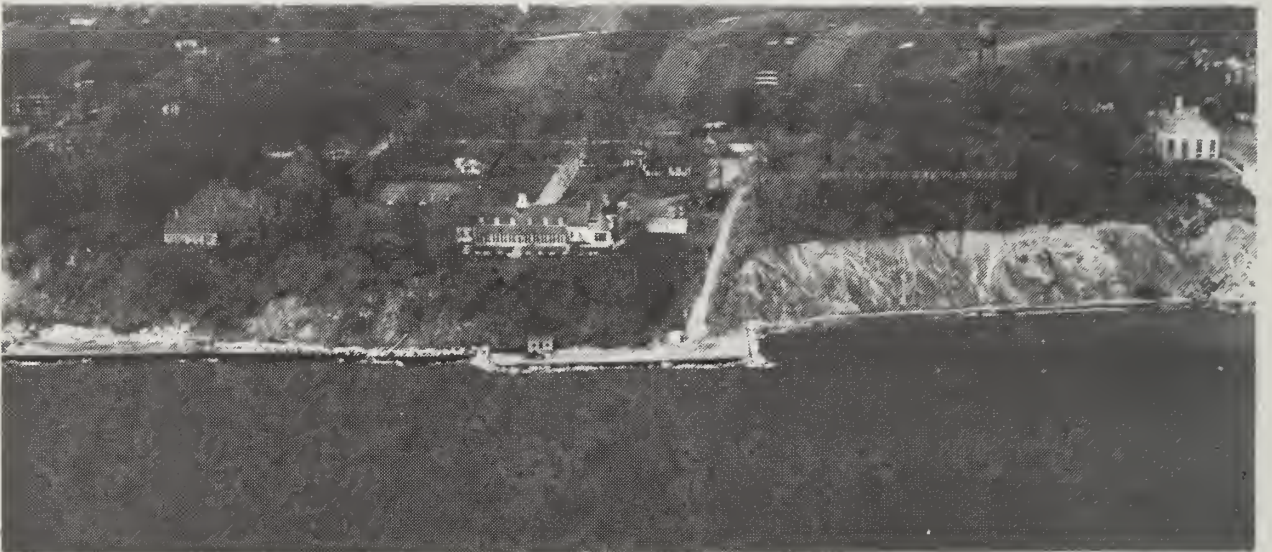
The seawalled area protecting the clubhouse of the Shore Acres Country Club, prior to its partial destruction over a period of years, was at one time nearly twice its present length. About 100 feet of the wall was breached in 1955. The breach remained until 1960, and a small erosional embayment formed behind it (fig. 6). By 1961, approximately 300 additional feet of wall was lost and the erosional embayment enlarged. The formerly protected bluff can now barely be distinguished from the bluff to the south that has been eroding for a longer time.

Fig. 12 - Shore Acres Country Club in Lake Bluff and the adjacent reach of shore northward. The northern part of the bulkhead shown here has been maintained for nearly 40 years. The eroding bluff adjacent on the north has receded nearly 90 feet since 1964, the highest bluff recession rate on the shore. The upper 40 feet of the bluff here is contorted glacial-fluvial sands, silts, and clays that create an unusually weak zone in the upper half of the bluff. The photo was taken in May 1975 when the lake level was near 580 IGLD. The dark areas indicate high moisture content. A vertical aerial view of this location is shown in figure 6.

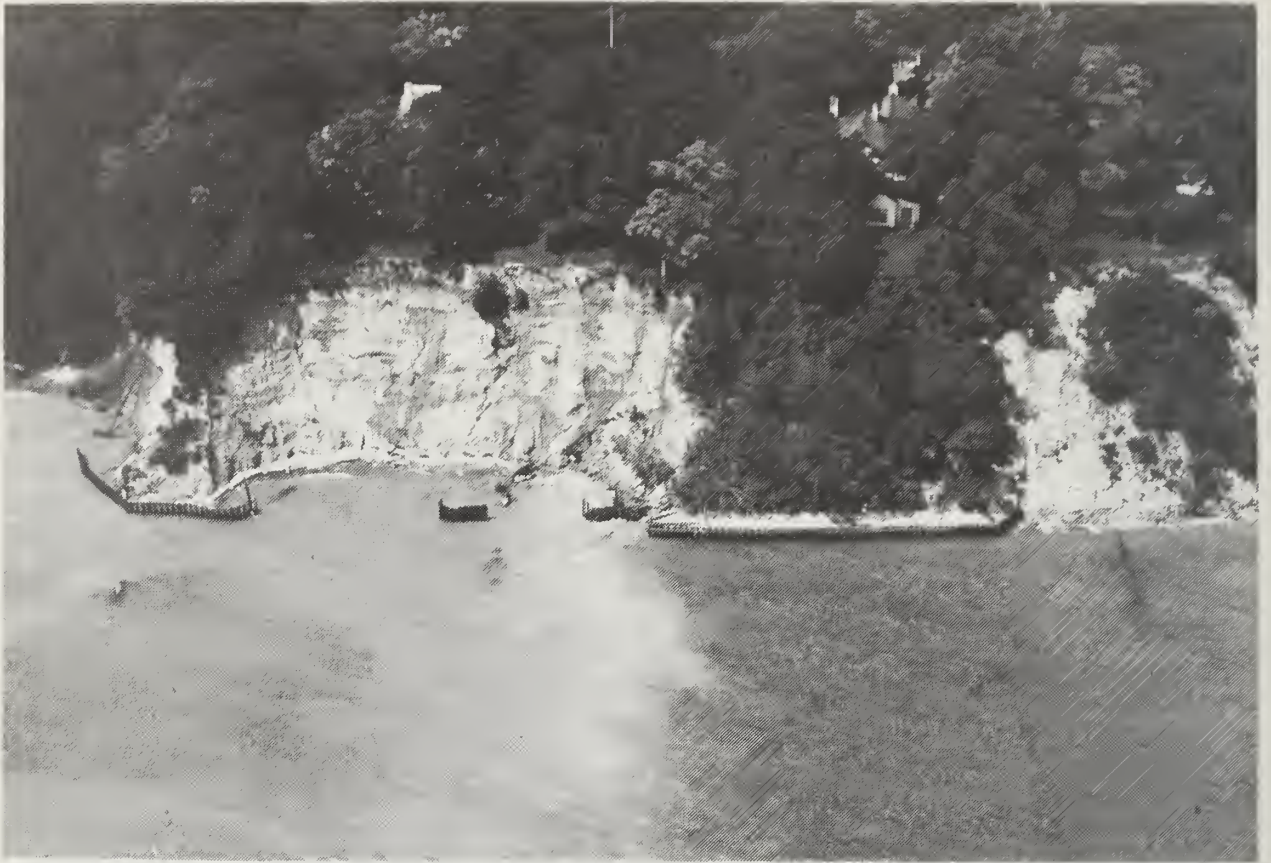
The third bluff area, north of the Lake Forest Waterworks, has not suffered as great a loss as the other two, but recession is now occurring behind the bulkhead at accelerating rates. The seawall is about 150 feet long and was constructed between 1947 and 1952. A gradual degradation of the bluff seems to have occurred since construction, partly because of the wall's limited extent. Since about 1973, the bluff has been eroding at accelerated rates because a small breach has been exploited by wave action.

1—Area 1100 feet north of the waterworks where a bulkhead has failed and a set of groins that normally protect the shore (shown here in April at low water) have been flanked, topped, and partly submerged by high water. Consequently, the reach from there northward to the Lake Bluff Sewage Disposal Plant has suffered severe erosion during the present high-water cycle.

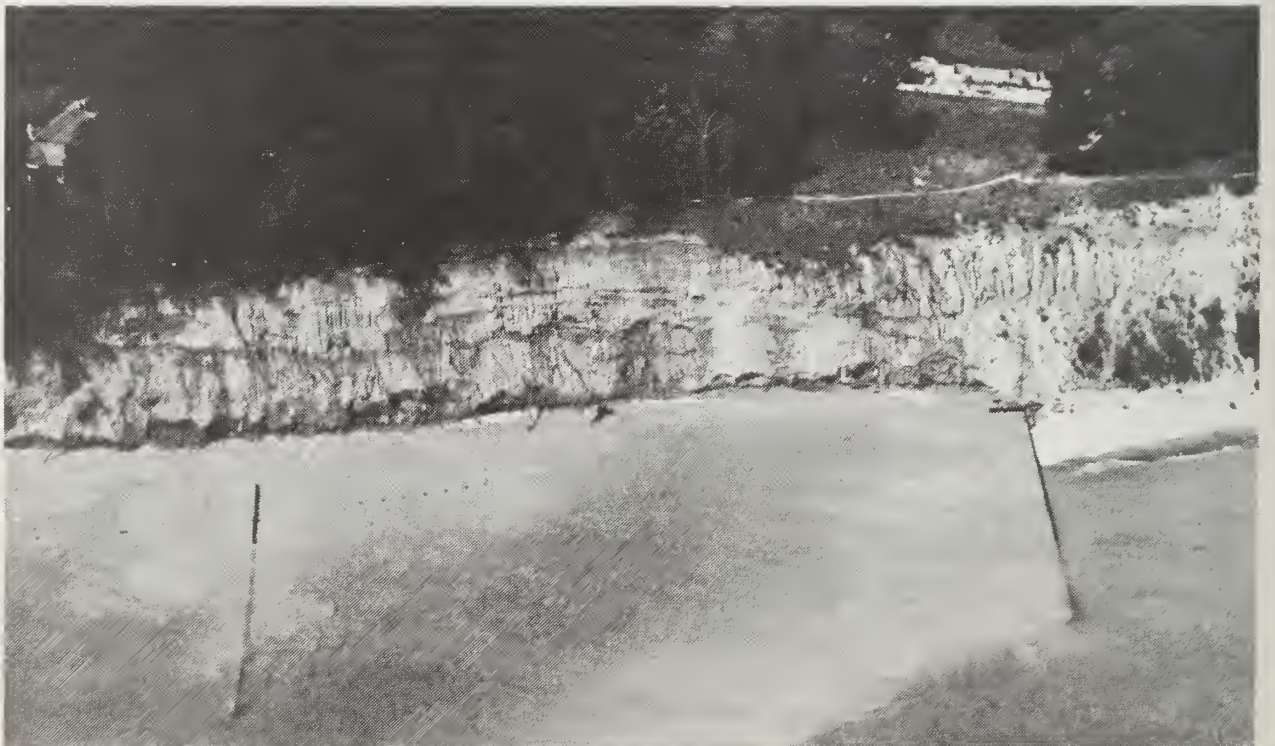
2 and 3—Shore in Lake Forest where groins and sheet-pile bulkheads have remained throughout high-water levels and have maintained a relatively stable and vegetated bluff.

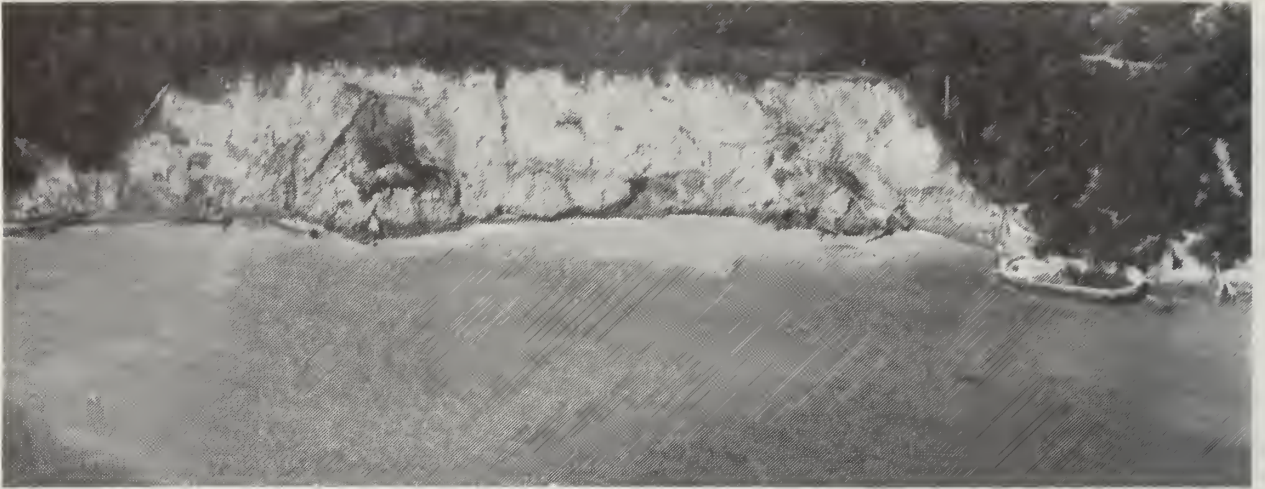
The second bluff area that has sustained significant erosion because of seawall failure is just south of the Lake Bluff Sewage Disposal Plant (fig.

Fig. 15 - The shore in Lake Bluff just south of the Lake Bluff Sewage Disposal Plant. The bulkhead shown here failed in 1969 or 1970. All recession behind the structure has occurred since that time. On the right, where the bulkhead has been maintained, the bluff has remained vegetated and stable. The houses on the top of the bluff are now less than 50 feet from the bluff edge. Note the submerged groins and debris. The photo was taken in August 1974 when the lake level was at 580.7 IGLD. The geologic section described is shown in figure 8; it is located a few hundred feet north of this area. Unstable sand, silt, clay, and brown silty till compose more than the upper half of the scarp. Homogeneous gray till composes approximately the lower half. Figure 7 shows a vertical view of this location.

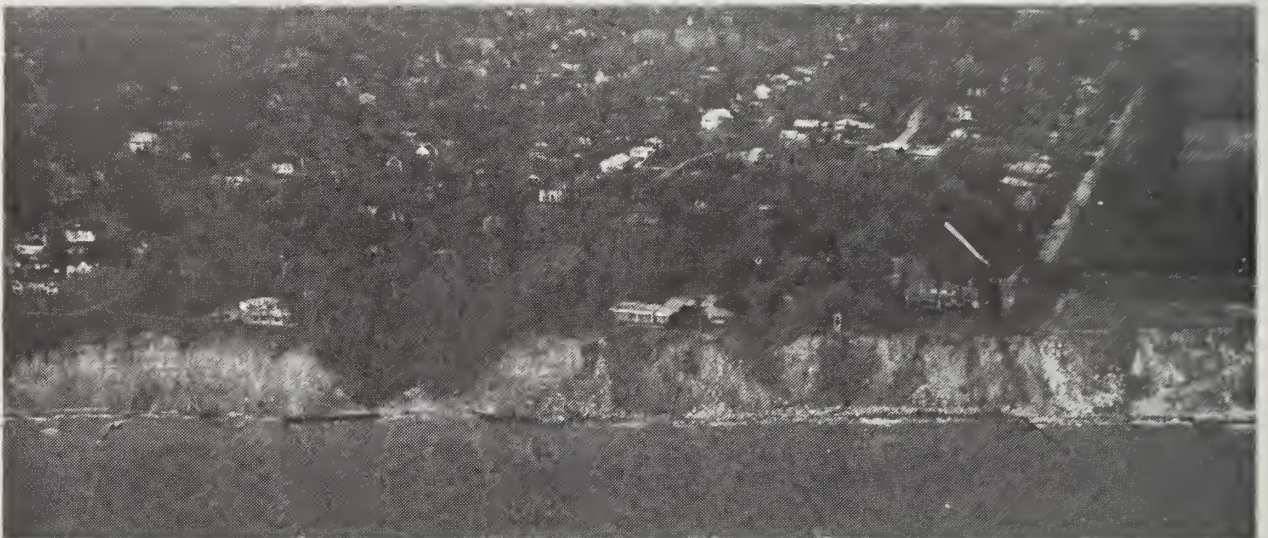
Fig. 16 - Seventy-foot bluff scarp in south Lake Bluff. The sharp, dark, irregular line halfway up the face is the contact between the lower gray, homogeneous, glacial till and the weak, irregularly layered, silty till, sand, silt, and clay sediments above. Dark streaks indicate surface seeps that were present during most months of 1974 and 1975. The vertical fluting of the bluff resulted when surface waters drained over the bluff face. The foot of the bluff is deeply undercut and shows fresh slumping. The photo was taken in August 1974 when the lake level was near 581 IGLD and the outer ends of groins were submerged, along with parts of other protective structures. The south groin has been entirely flanked and separated from the shore. The bluff has receded 39 feet since 1964 at this place (fig. 4, profile 2). Note the clouds of clay derived from the bluff that are suspended in the water. See figure 7 for a vertical aerial view at the location.

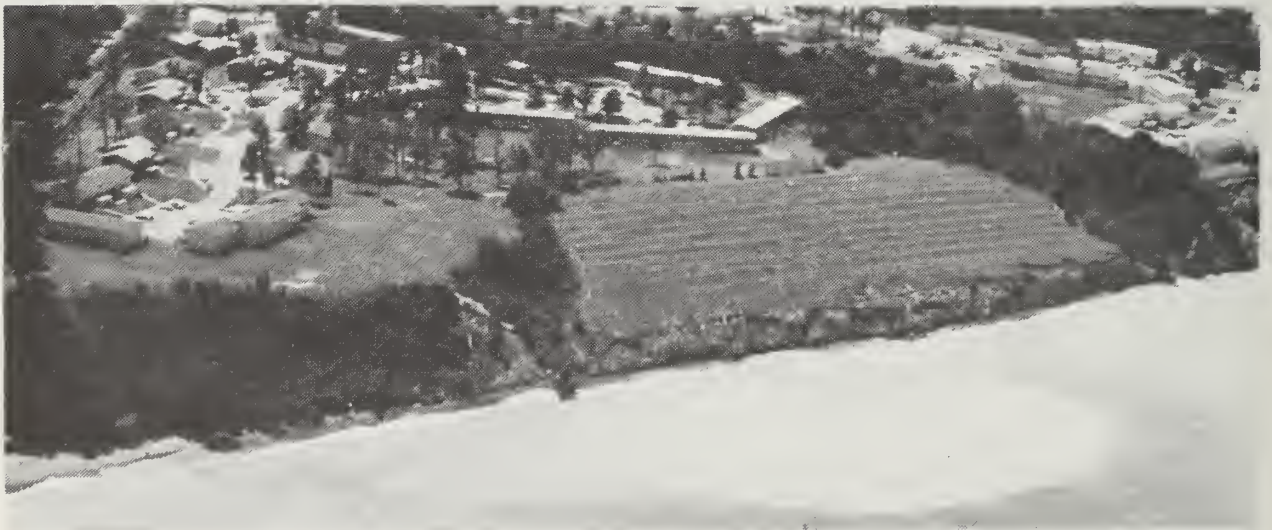
Fig. 18 - Bluff area between Center Avenue and Blodgett Avenue in Lake Bluff. The scarp has approached several houses. The bluff in the center has been stabilized by rubble dumped over the face as well as placed at the foot of the bluff. The groin at the south (left), replaced by a new one in 1975, has been damaged. The groins at the north end are essentially empty, although groins a little farther north are partially full. This reach was photographed in May 1975 when lake level was near 580 IGLD.
