The Storm of July 18-19, 1952 Rockford, Illinois and Vicinity

Bernt O. Larson, Homer W. Hiser, and Warren S. Daniels

A Cooperative Study of the
Illinois State Water Survey Division
and the
Water Resources Division, U. S. Geological Survey

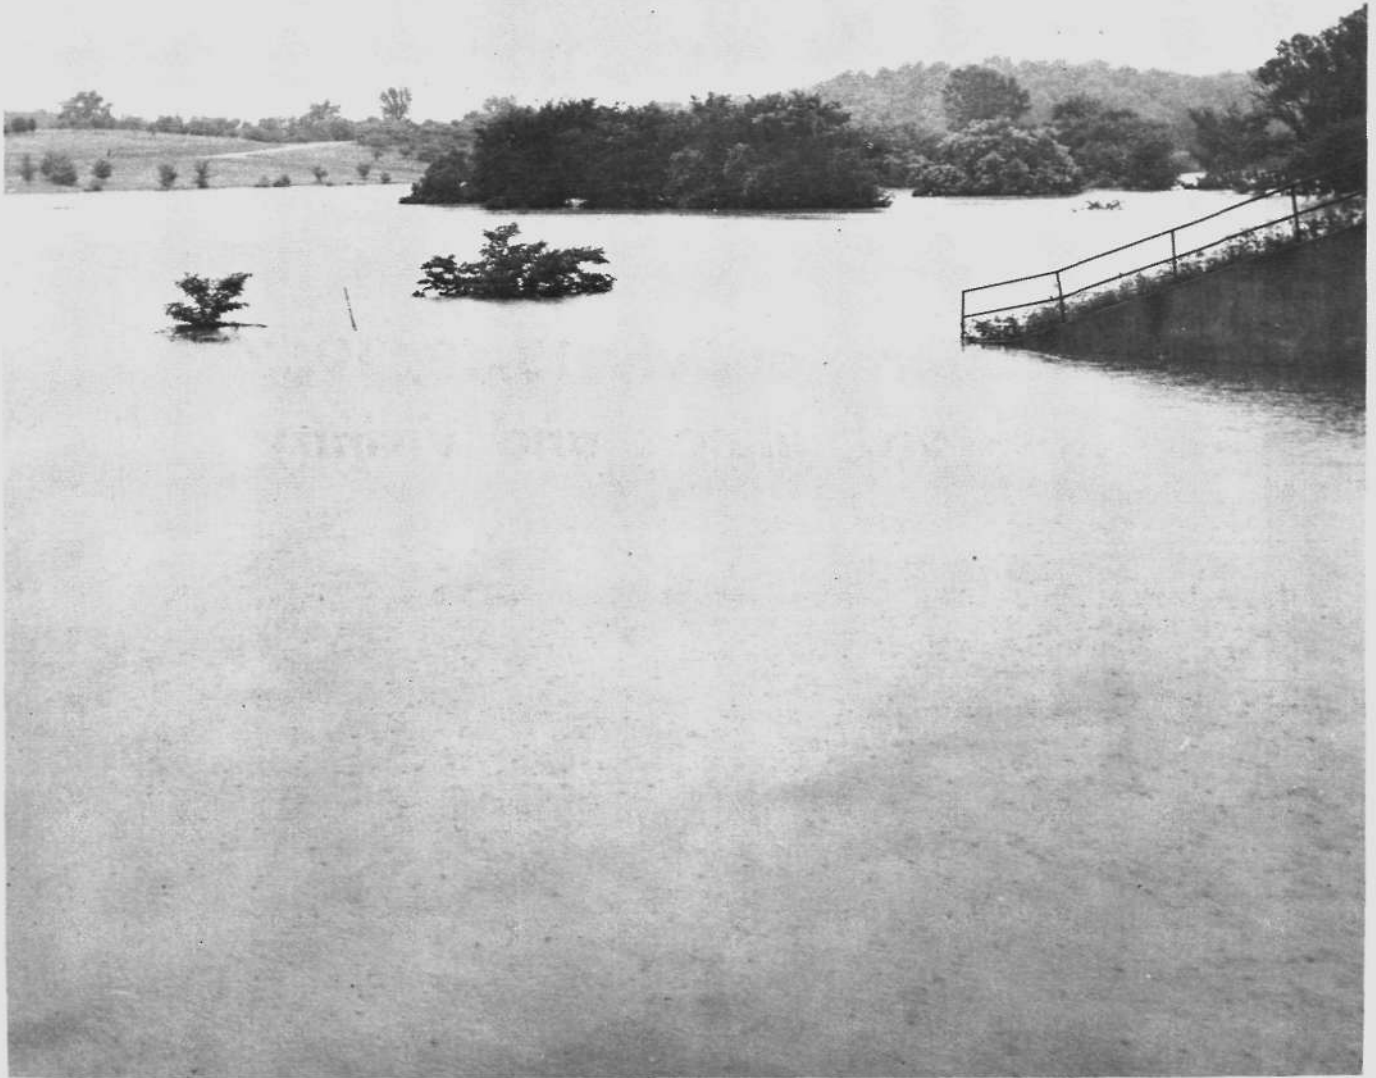
ALPINE DAM FLOOD CONTROL RESERVOIR ON KEITH CREEK FILLED FOR THE FIRST TIME SINCE ITS COMPLETION IN 1941. THIS PROJECT PREVENTED UNTOLD DAMAGE IN EAST ROCKFORD

The flood-control reservoir on Keith Creek above Alpine Dam was filled by the early A.M. storm of the 18th for the first time since its construction in 1941, and at the peak had 1 1/4 feet of water pouring over the spillway. Field examination at a former gaging station site on Keith Creek at Twentieth Street in Rockford showed that the channel, now a covered conduit, flowed full but did not cause any flooding at the approach to the conduit. Below the covered section, the creek flowed over the top of the flood wall on the right bank.

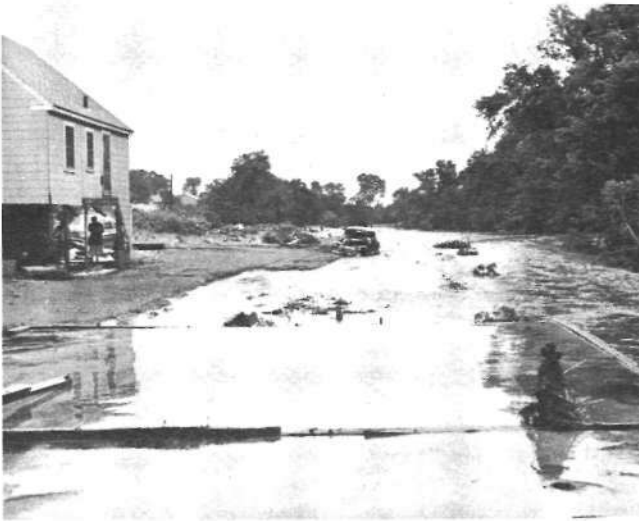
FIG. 1. PELLEY ROAD CREEK. IN FOREGROUND FOUNDATION OF HOME THAT WAS SWEEP AWAY

Engineers of the U. S. Geological Survey were able to find a suitable reach on Pelley Road Creek, near Riverside School on the south side of Rockford, for determining the peak discharge by the slope-area method. This creek caused the loss of two lives, swept away one house, damaged two others extensively, and washed out the bridge on State Highway 2 about four miles south of Rockford. The computed discharge has been carefully reviewed and is believed to be reliable. The discharge of 1230 second-feet per square mile is the greatest known rate in Illinois, exceeding all values determined for the floods of 1943 and the localized floods resulting from the storm of July 8, 1951 in north-central Illinois.

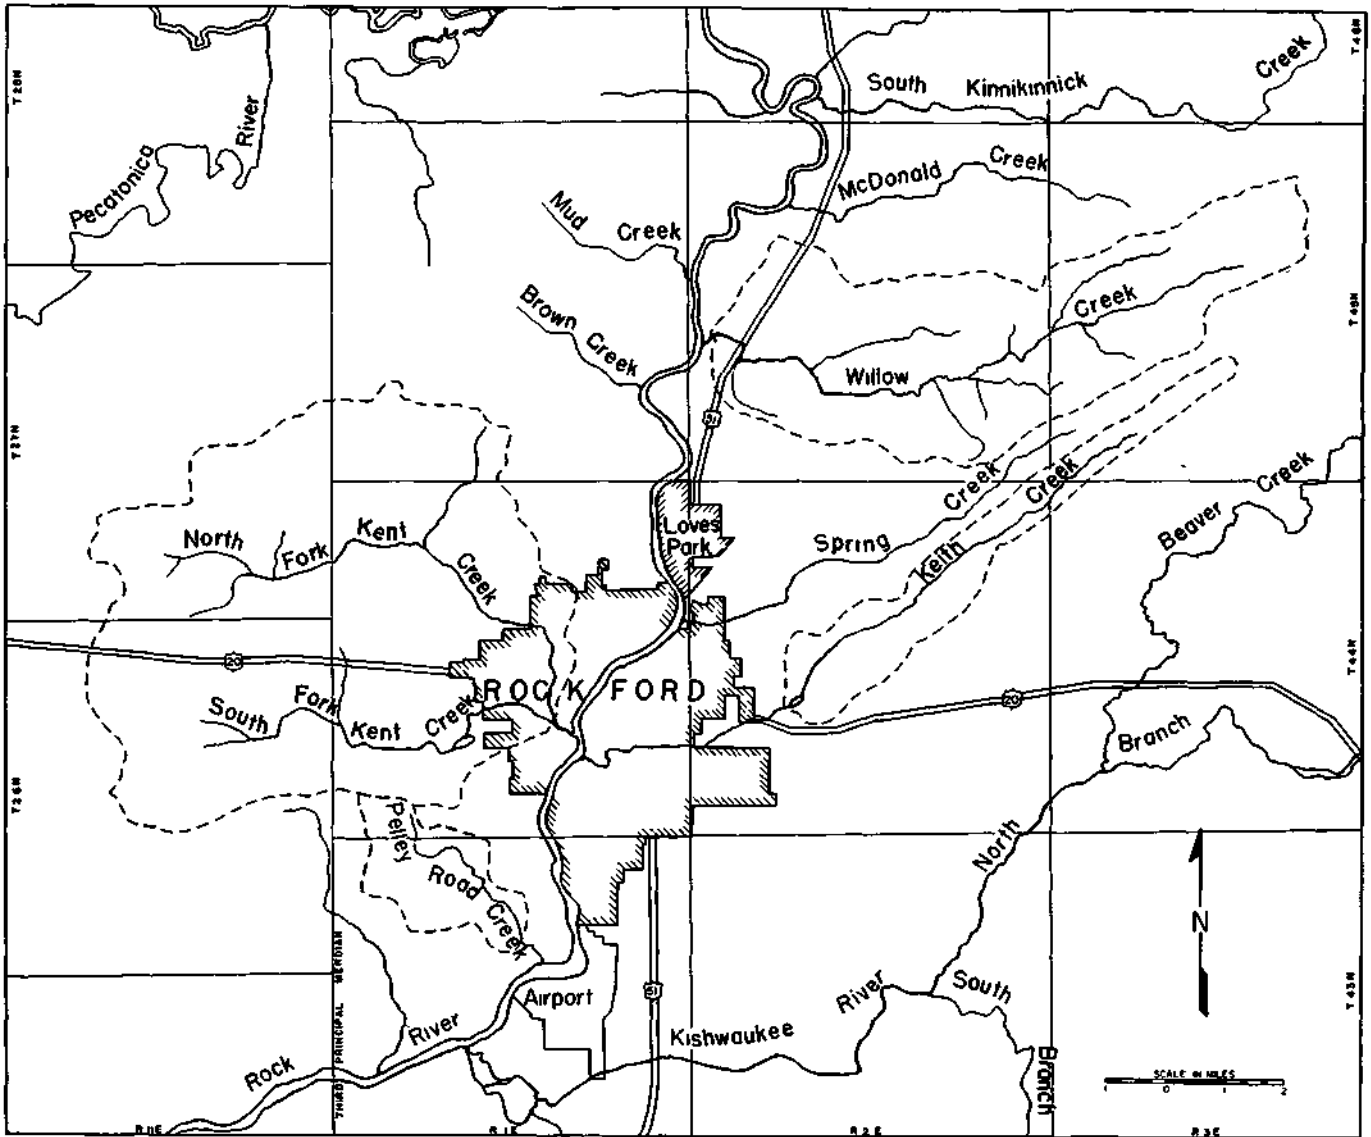
Figure 2 is a base map showing the general area of the storm and the names and locations of the streams referred to in the text of the report.

FIG. 2. BASE MAP OF ROCKFORD AND VICINITY

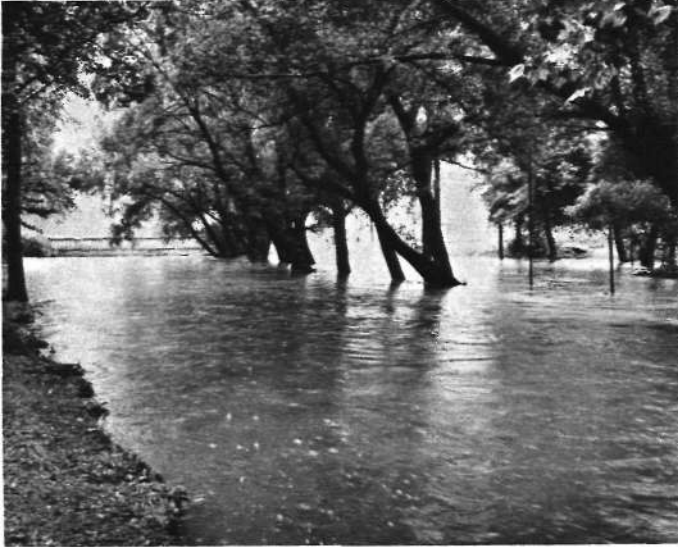
FIG. 3. JEFFERSON STREET BRIDGE AND FAIRGROUNDS PARK

The unusual nature, the high intensity and the resultant damage to property are reasons for making this storm a public record (Fig. 3 and Fig. 4).

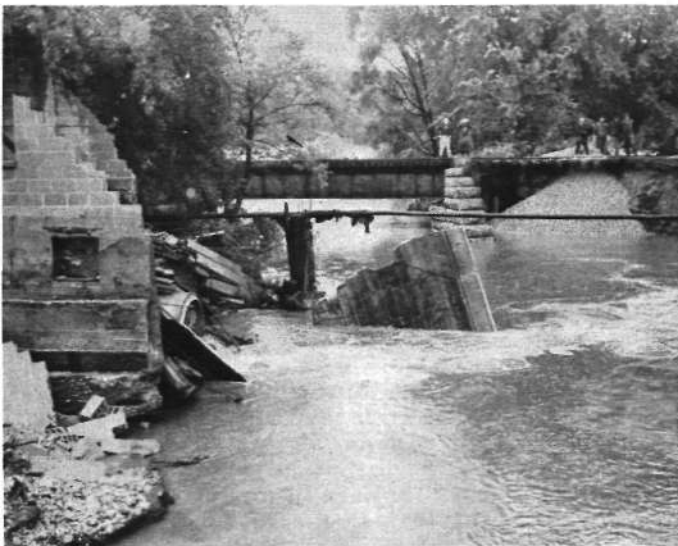
FIG. 4. DESTRUCTION OF CONCRETE BLOCK BUILDING ON SPRING CREEK AND UNDERCUT OF RAILROAD TRACK BED

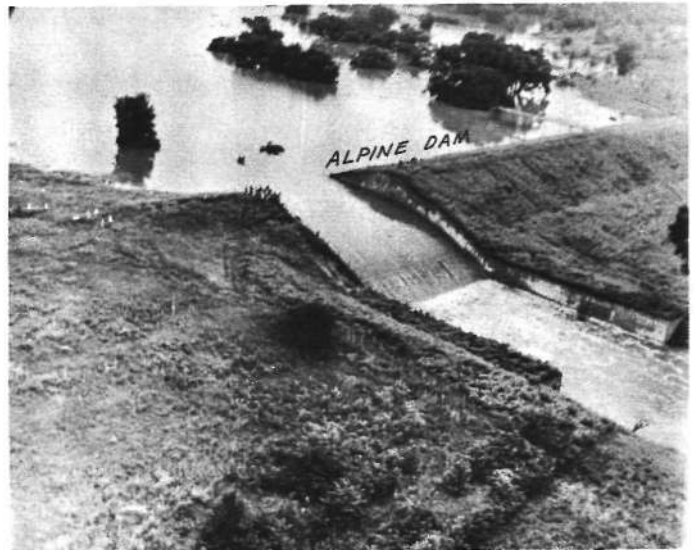
FIG. 12. VIEW OF ALPINE DAM AND FLOOD CONTROL RESERVOIR ON KEITH CREEK

The isohyetal pattern for the early storm of July 18 is shown in Figure 11. Note the two cells of concentration and the tight isohyetal gradient between the 12-inch and 6-inch lines over the Keith Creek watershed area and the 8-inch maximum over the Pelley Road Creek. The heaviest rates occurred between 0100 and 0400 C.S.T. It was this storm that produced the flash flood which caused the two deaths, destroyed several homes, and washed out the bridge on the Pelley Road Creek. The two cells on Keith Creek produced a runoff that was handled adequately by the Alpine Dam and flood-control reservoir southeast of Loves Park. This reservoir, built by the city of Rockford, was completed in 1941. This was the first storm to produce a discharge over the emergency spillway. Head over the spillway measured approximately 1 1/4 feet. The reservoir undoubtedly prevented extensive damage in southeast Rockford. See Figure 12.

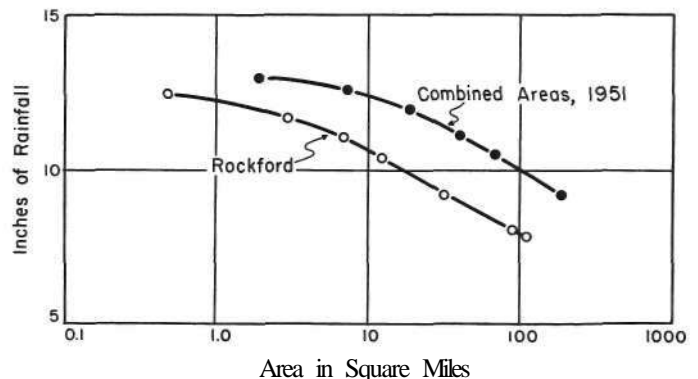
An area-depth curve for the 6-hour storm on July 18, was drawn for the storm area. Figure 14 shows a comparison between the area-depth curve for the Rockford area and the area-depth curve for the July 8, 1951 storm for the combined

FIG. 14. AREA-DEPTH CURVES

watersheds of the Vermilion and Mackinaw Basins.⁴ The two curves appear similar. That portion of the curve for the Rockford storm for points representing the two larger areas may be considered questionable since the positions of the 7 and 6-inch isohyets had to be closed without having a sufficient number of observations.

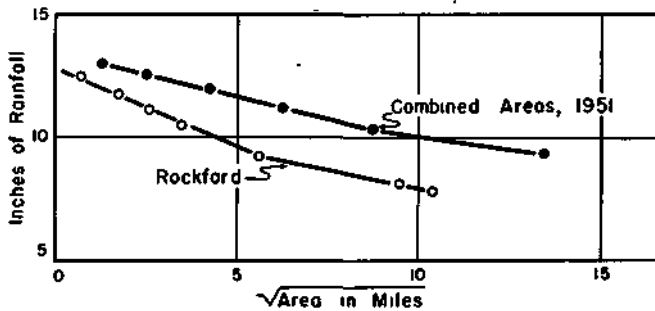
The same data were used to plot curves of the total rainfall vs. the square root of the area enclosed by the isohyet, after a method discussed by Huff and Stout.⁵ These curves, as reproduced

FIG. 15. AREA-DEPTH CURVES

in Figure 15, show a characteristic straight line plot except at the lower extremities. This portion of the curves may not be representative for the reason stated above.
