**Dewatering Well Assessment
for the Highway Drainage System
at Four Sites in the East St. Louis Area, Illinois**
Phase 6

Prepared for the
Illinois Department of Transportation

November 1992

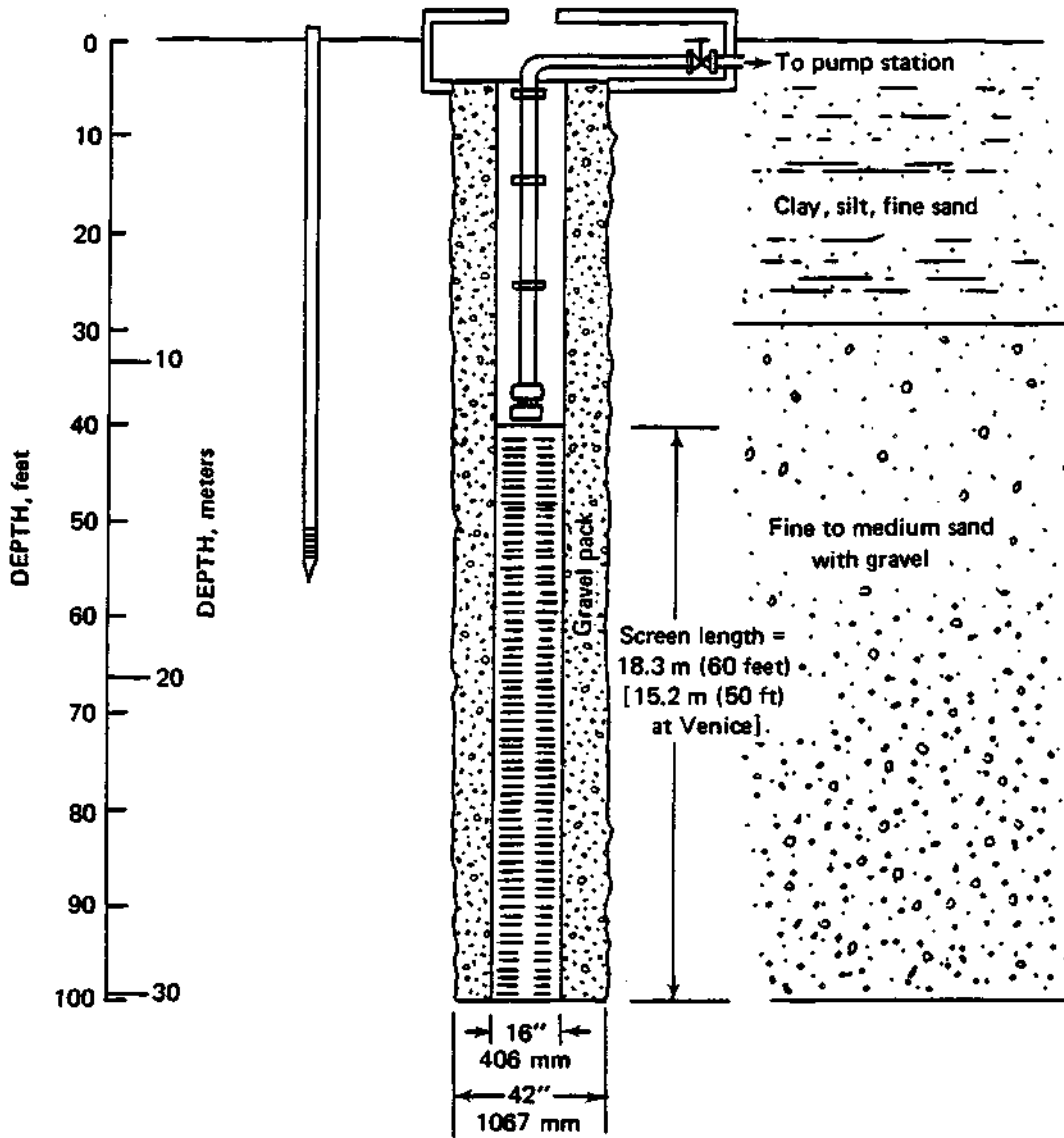
Figure 4. Typical features of a dewatering well

The wells are of similar construction, with 16-inch-diameter stainless steel casing and screen, and 6-inch-diameter stainless steel column pipe (figure 4). Each well is equipped with a 600-gpm submersible pump with bronze or stainless steel impellers, bowls, and jacket motors. The early experience with severe corrosion problems showed that corrosion-resistant materials are required to maximize service life. Five 8-inch recorder wells are available to monitor ground-water elevations near critical locations at the four sites. Each of the 48 wells has a 2-inch-diameter piezometer for monitoring individual well performance.

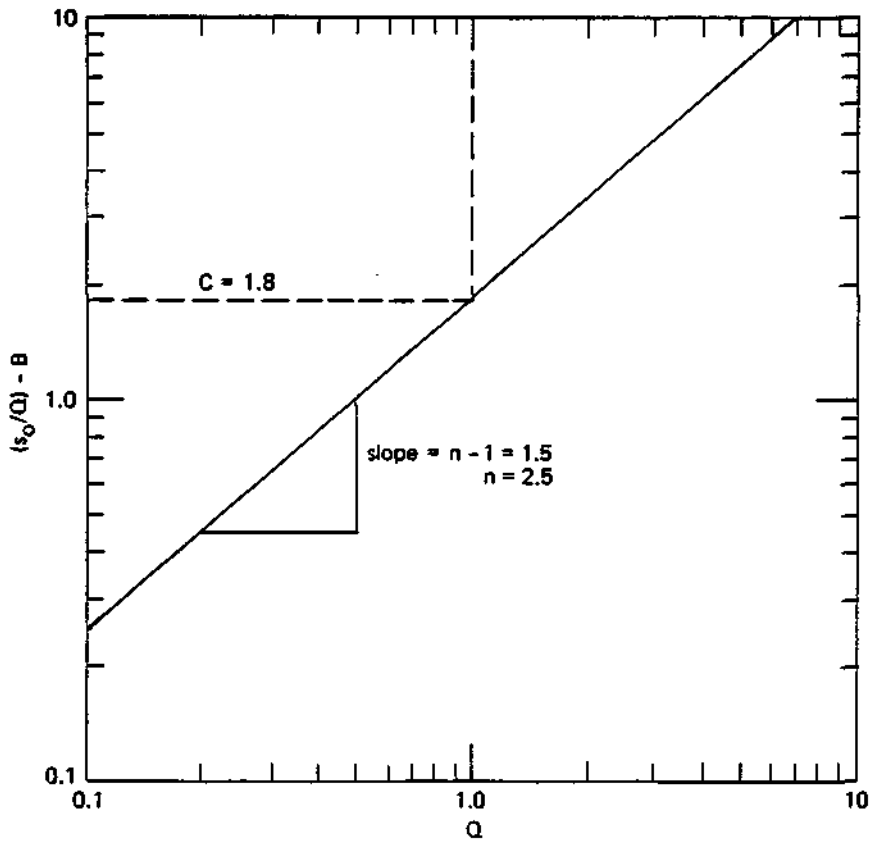
Figure 6. Graphical solution of Rorabaugh's equation for well-loss coefficient, C , and exponent, n

A plot of $(s_0/Q) - B$ versus Q can be made on logarithmic graph paper from step test data, replacing s with s_0 . Values of B are tested until the data fall on a straight line (figure 6). The slope of the line equals $n - 1$, from which n can be found. The value of C is determined from the y-intercept at $Q = 1$. In the example shown, the graphical procedure is facilitated if Q is plotted as cubic feet per second (cfs), and $(s_0/Q) - B$ is plotted as seconds per foot squared. It is also convenient (although not mandatory) to use these same units in the Jacob method.

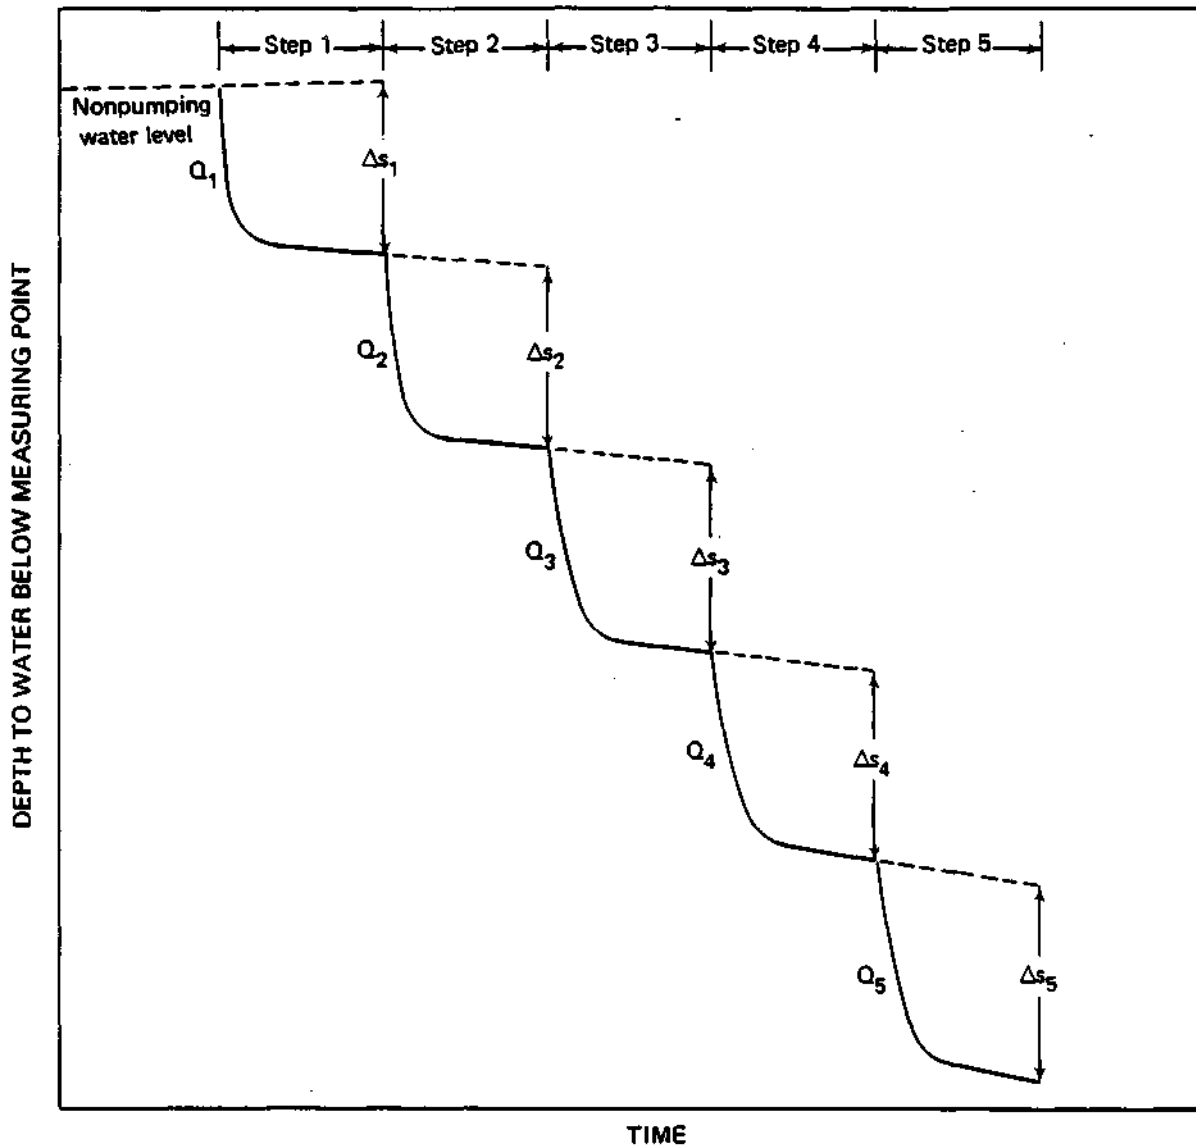
Figure 7. Relationship between time and water level during a five-step drawdown test

During each step pumpage is held constant. If data are collected manually, water-level measurements are made every minute for the first six minutes, every two minutes for the next ten minutes, and then every four to five minutes thereafter until the end of the step. For the step tests in this study, the Water Survey's Micro-computer Data Acquisition System (referred to as McDAS) was used to collect the data. It can be set to read the data either at a selected frequency or logarithmically as conditions dictate. The logarithmic rate was used for the step tests, in which the readings progress from several per second at the start of the step to readings every two to three minutes at the end of each step. In this investigation, water levels were measured for 30 minutes per step. At the end of each 30-minute interval, the pumping rate was immediately changed, the water-level measurements reverted to the initial frequency again, and so on until a wide range of pumping rates within the capacity of the pump was tested.

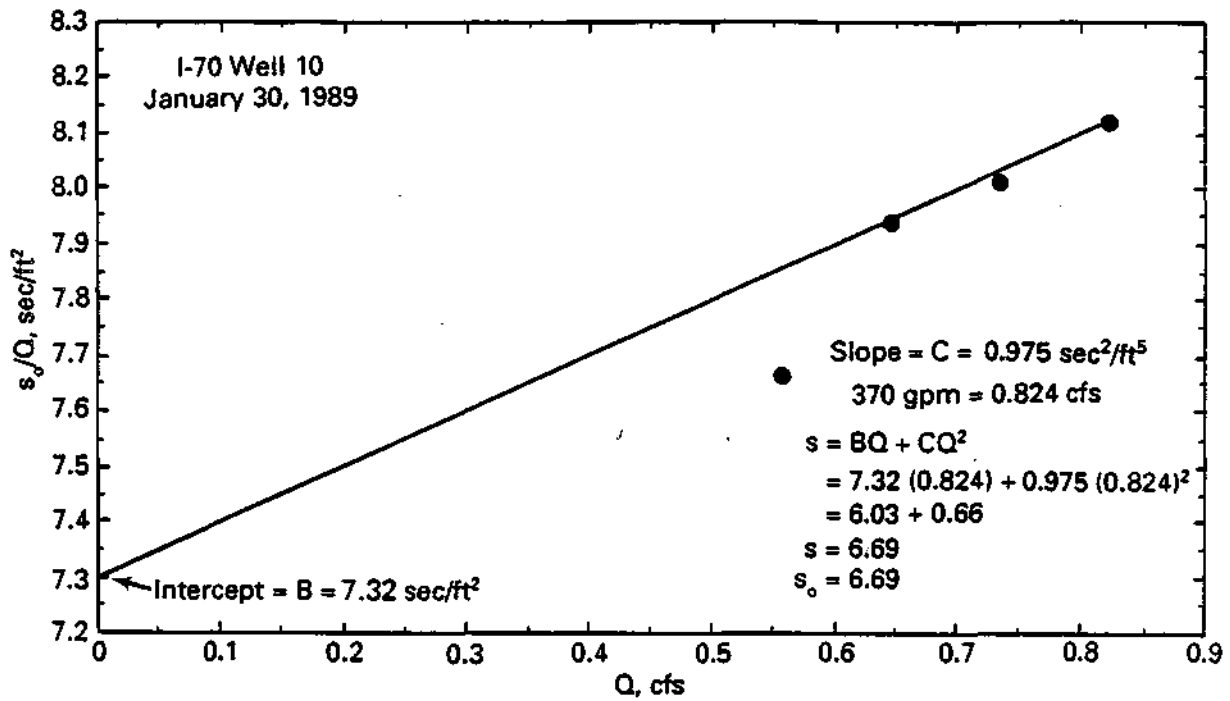
Figure 8. Graphical analysis, I-70 Well 10

To verify the C value, a plot of s_o versus Q is used (figure 9). When $C = 0$, equation 2 becomes $s = BQ$ (the theoretical drawdown due to laminar formation losses), which would plot as a straight line through the origin. If $C \neq 0$, then the non-linear CQ^2 term will cause the line to curve upward increasingly as Q increases. The amount of displacement from the straight line is the amount of well loss at each pumping rate. In our case, $C \neq 0$. Using $s = CQ^2 + BQ$, and substituting s_o for s , we should be able to subtract the CQ^2 from each value of observed drawdown, leaving the value of BQ . If our evaluation of C is correct, the BQ values should plot on a straight line through the origin. Each of these lines is plotted in figure 9. One is labeled s_o , and the other is labeled $s_o - CQ^2 = BQ$. As can be seen, the BQ line is a straight line through the origin, which verifies that $C = 0.975$, obtained from figure 8, is a good estimate for C .

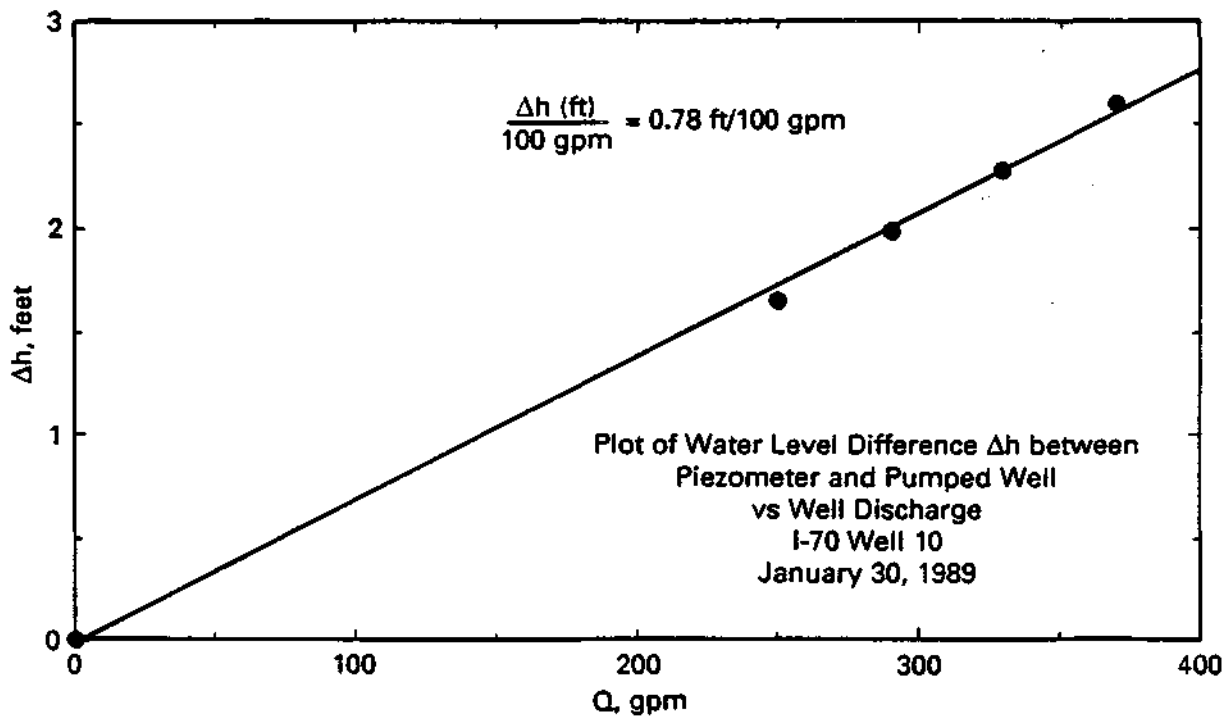
Figure 10. Water-level difference versus discharge, I-70 Well 10

Figure 10 shows h values at I-70 Well 10 for each step during the test. The projected h for I-70 Well 10 pumping 600 gpm is 4.34 ft or 0.78 ft per 100 gpm, which also suggests that the well is in fair condition. The apparently linear relationship implies that turbulent losses in the vicinity of the well are small and that most of this head difference is the result of laminar losses. This was corroborated by a plot of the drawdowns at the piezometer versus pumpage, which also showed a linear relationship.

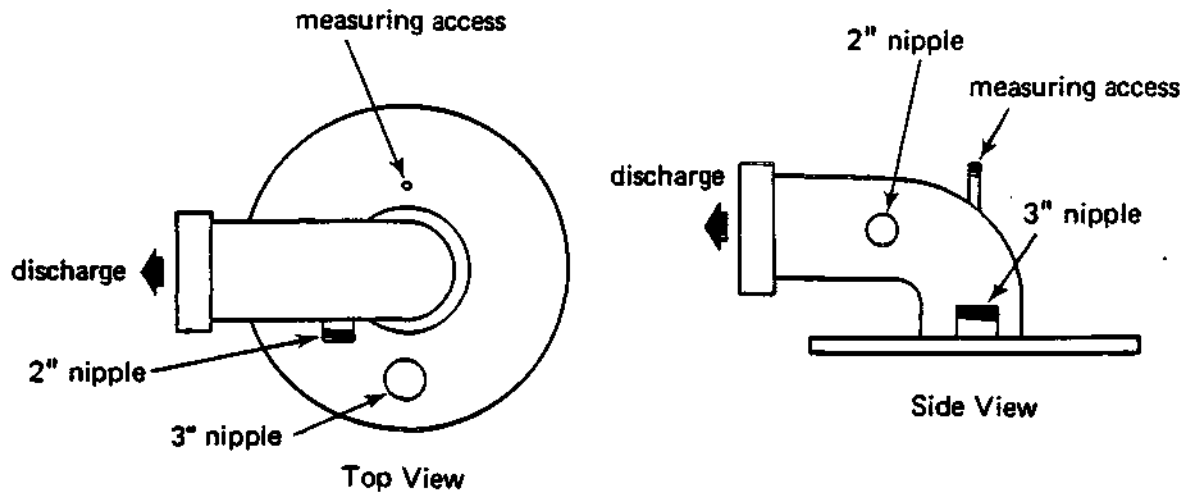
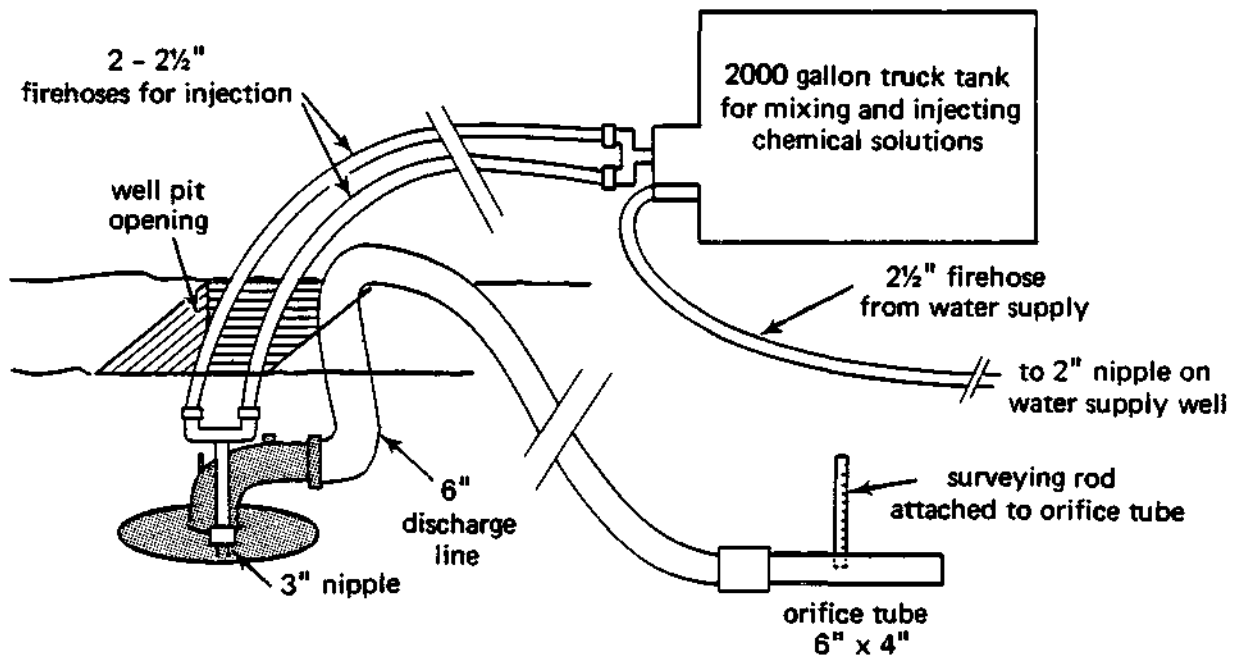
WELL COVERPLATE MODIFICATIONS

CHEMICAL INJECTION ASSEMBLY

Figure 11. Injection assembly and discharge apparatus

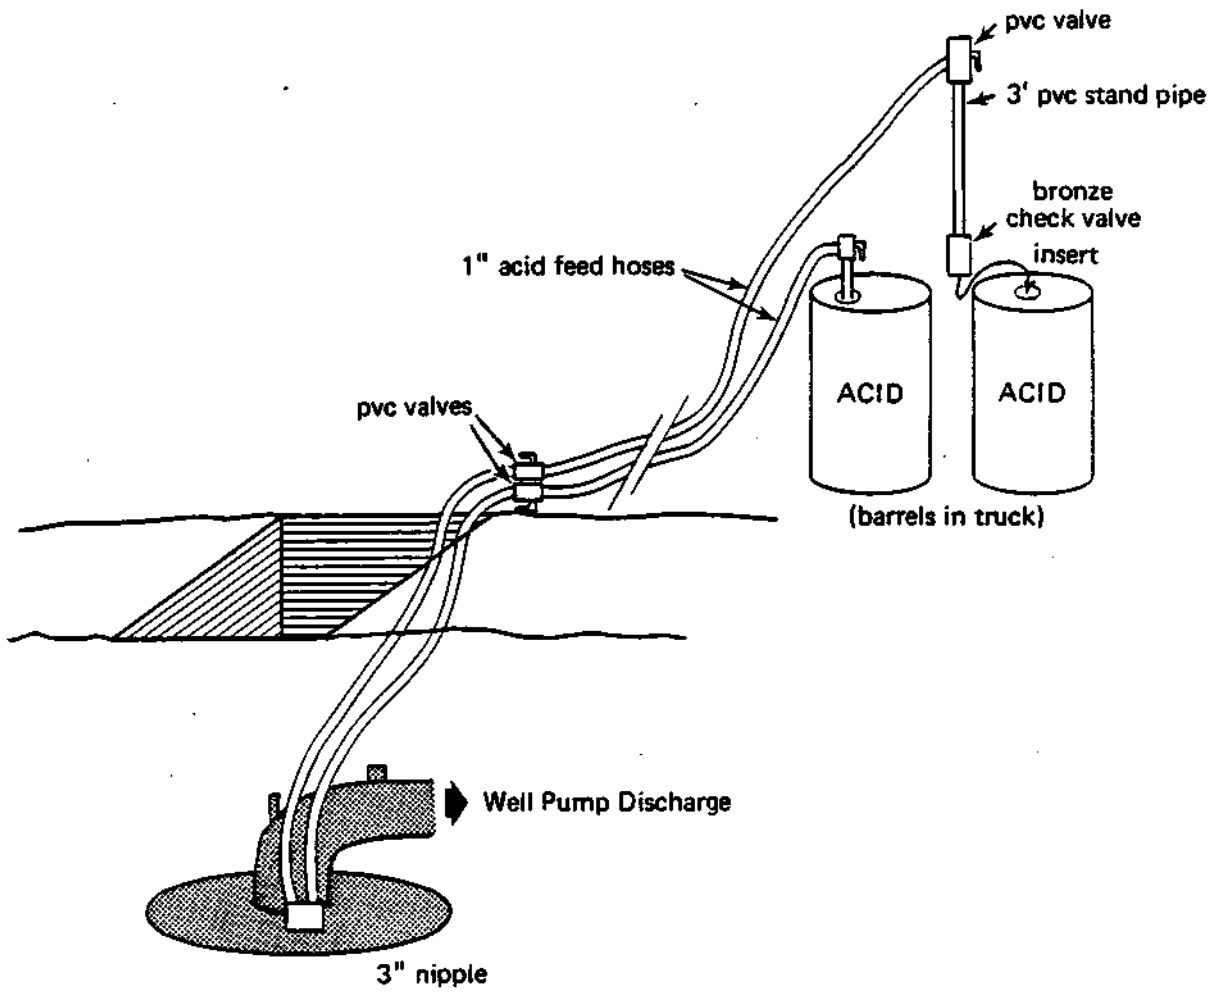
Figure 12. Acidization assembly

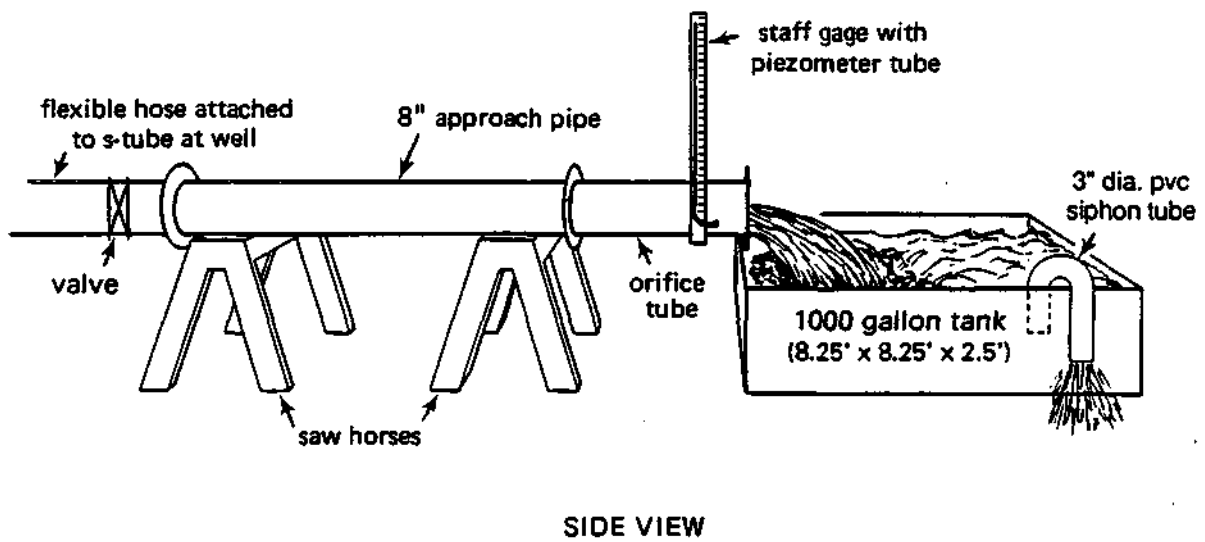
Figure 13. Sand pumpage test setup

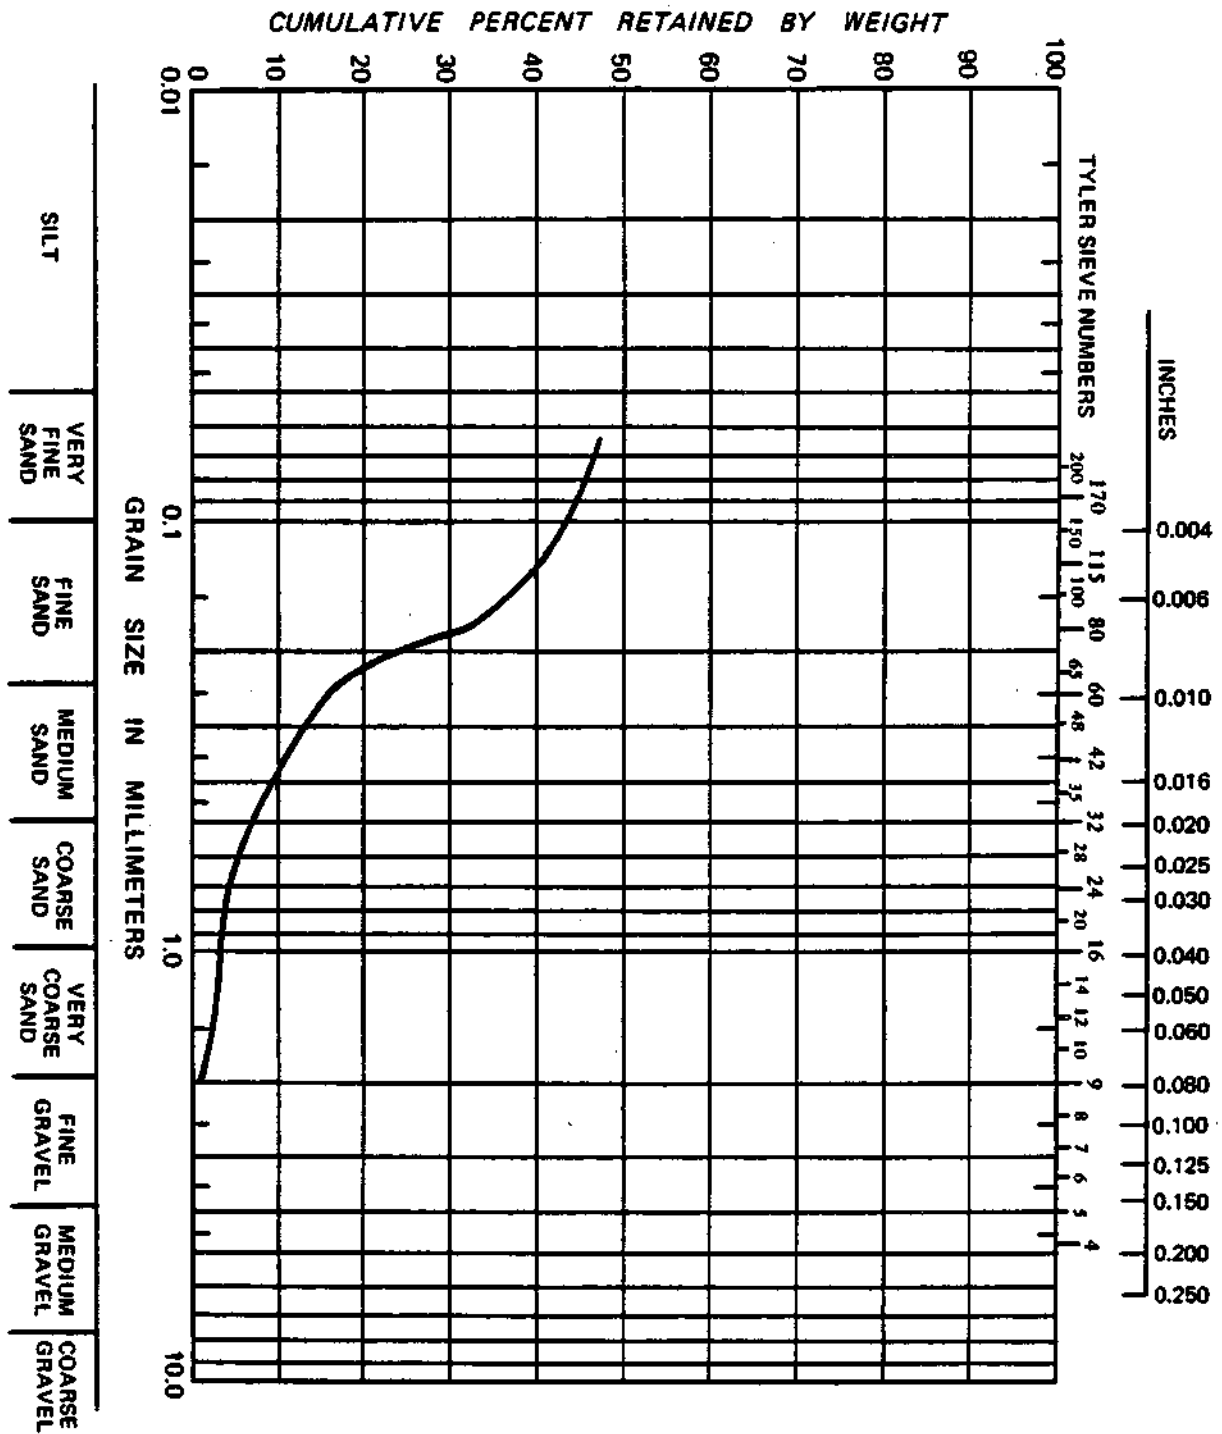
Figure 14. Sieve analysis for sand pumped from I-70 Well 11

Of the nine wells investigated, only I-70 Well 11 yielded enough sand in the tank during the step tests to allow collection of a sample for sieve analysis. A handful of material accumulated in the tank during the test, and it visually consisted of about 50% sand and 50% encrustation chips. The sieve analysis data for this sample with the chips removed are plotted in figure 14 and appear in Appendix E. The sand is similar to that from most of the other sand-producing wells that have been investigated, with the major fraction of the sand being very fine. Based on the gravel pack originally recommended for use in the I-70 wells (see Phase 4 report), the sand could easily migrate through the gravel pack to the well screen and into the well. Review of the sieve data suggests that zones of fine material in the upper aquifer, above about elevation 340 to 350 feet msl, may be the source of the sand. At these elevations, the top 10 to 20 feet of well screen and an even longer interval of the gravel pack would be opposite this suspect source material. It is also conceivable (but unlikely) that the sand is piping through a small hole in the well casing or screen.

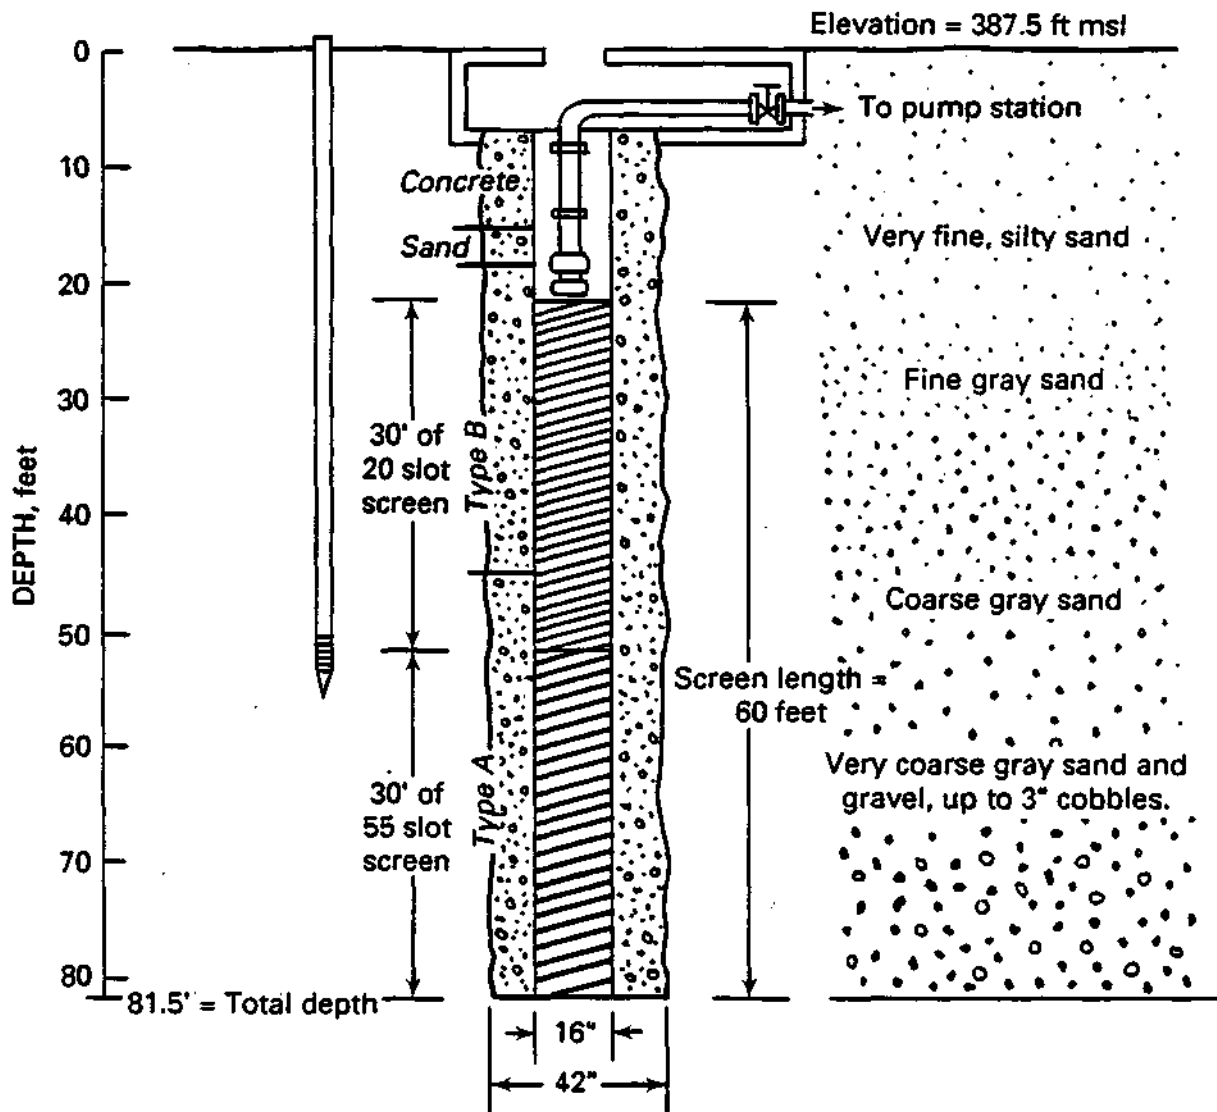
Figure 15. I-70 Well 8A construction features

Two noteworthy potential problems arose at I-70 Well 8A during construction. First, large cobbles encountered near the bottom of the bore hole (figure 15) severely restricted additional penetration by the

drag bit, and eventually, drilling was terminated with the total depth about 4 feet short of the target elevation. This caused the screened interval and gravel packs to be shifted up 4 feet higher than specified. Secondly, the bore hole wall apparently caved in during the placement of the upper Type B gravel pack. Measurements indicated that about 84 feet of native material may have filled in the bore hole from 18½ to 27 feet below land surface and is now against the well screen. The cave-in occurred in the time between the placement of two loads of Type B gravel pack. Collectively these actions result in a significant risk for sand pumpage from Well 8A.

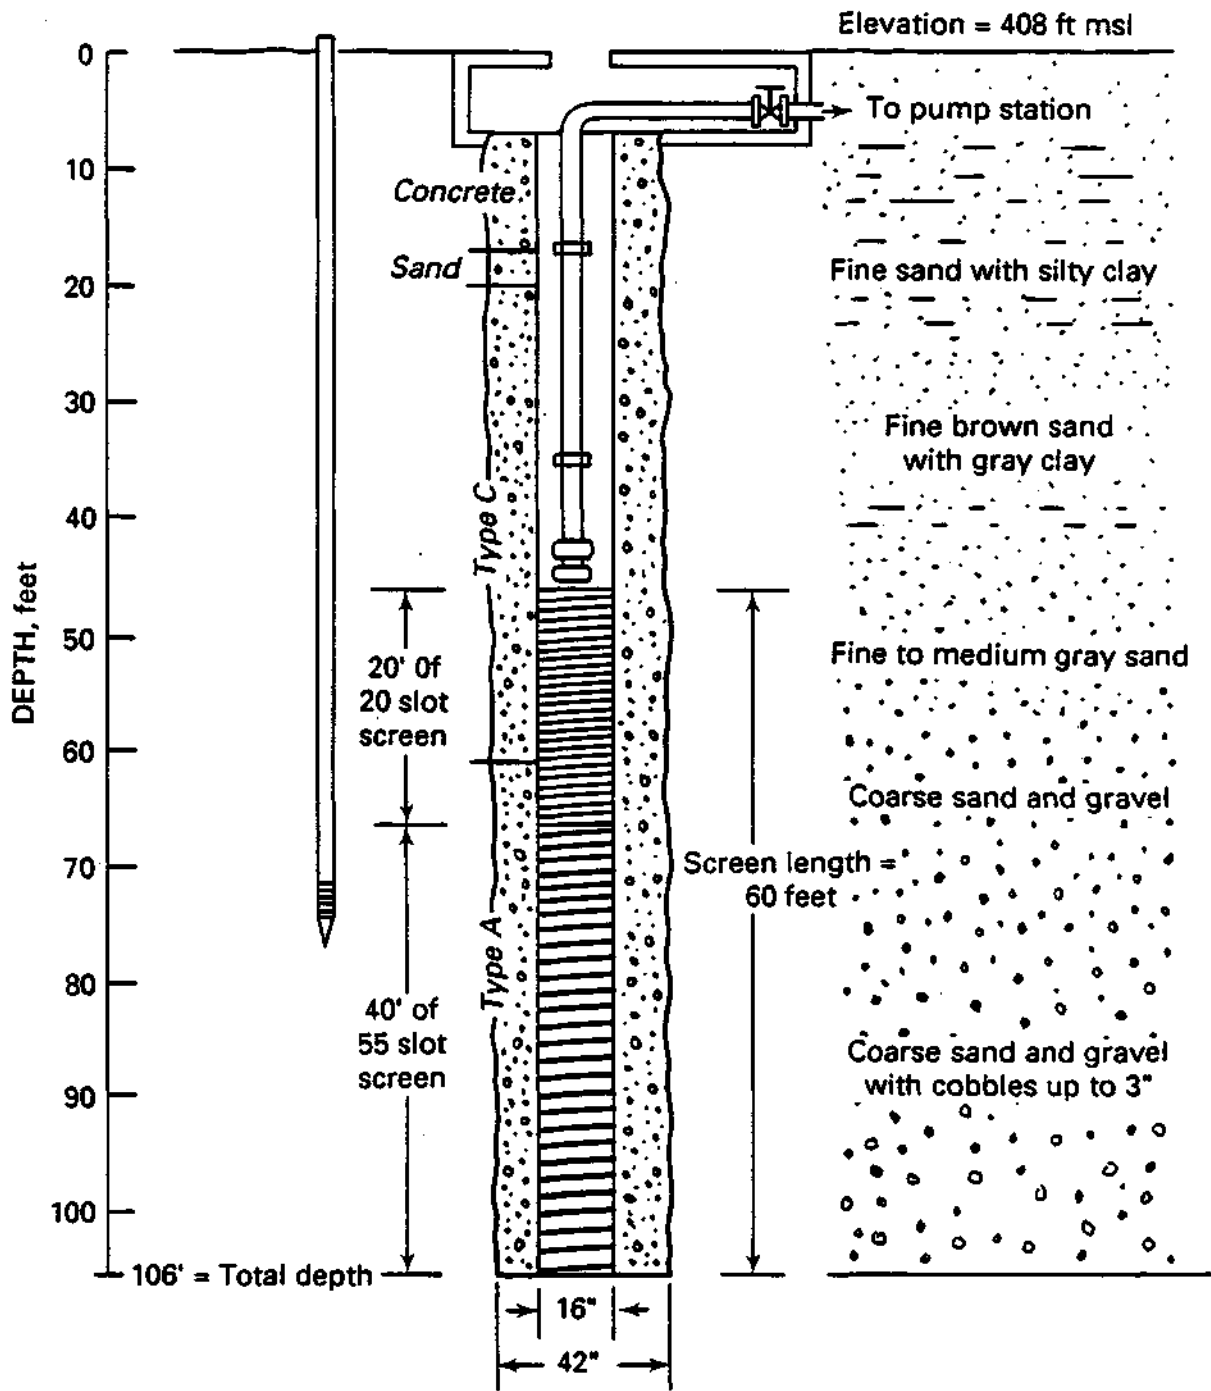
Figure 16. I-70 Well 9A construction features
