Illinois Center for Transportation Series No. 18-005

# **BEHAVIOR OF EPOXY-COATED TEXTURED REINFORCEMENT BARS**

Research Report No. FWHA-ICT-18-004

**ICT PROJECT R27-SP35**

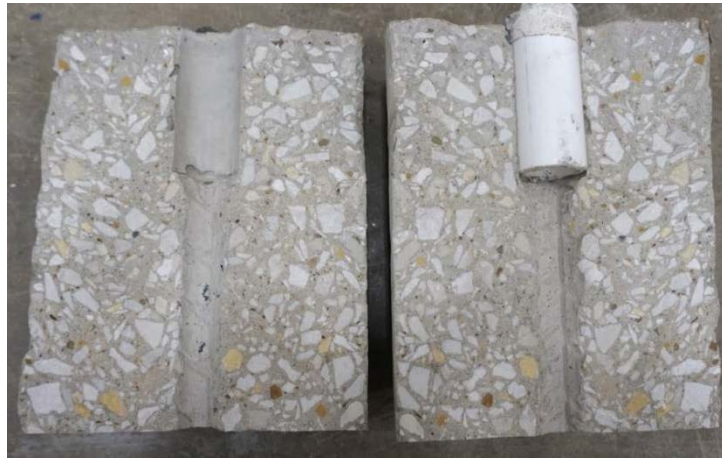
**Figure 2-5. Pull-out testing of No. 8 bars that resulted in splitting failure; (a) Force-slip results, and (b) Failed concrete.**

No. 8 bar specimens were tested with an embedded length of 5 in. The testing of No.8 bars did not go as expected—as specimens failed prematurely due to concrete splitting, regardless of the bar type. Since splitting failures are not very meaningful to this study, the embedded length of an epoxy-coated specimen was reduced to determine if failure due to slippage could be induced. This was done by sawing 0.5 in. off the end of the specimen. An epoxy-coated bar was chosen because it is the most liable to slip. However, the shortened specimen also failed due to splitting. Results from these tests are shown in Figure 2-5.

The bond stress developed at failure was approximately 2.65 ksi, 2.90 ksi, and 2.75 ksi for the uncoated, epoxy-coated, and textured epoxy-coated bars respectively. These values are marginally higher than the average peak bond stresses obtained by the No. 5 bars, which attained peak pull-out force at slip ranging between approximately 0.02 in. and 0.04 in. The bond stress and bending of the bond-slip curve both suggest that the bars were close to peak strength and pulling out. The failure occurred at almost identical levels of pull-out force in all three specimens, which suggests that the diameter of the concrete simply was not sufficient enough to provide adequate splitting resistance. Since the failure occurred with relatively minimal bar slip, there were no signs of distress in the concrete at the reinforcing bar interface. In Figure 2-5 (b), imprints of the ribs are clearly visible in the concrete but no crushing or cracking is evident between the ribs.

Despite the premature failure, the initial force-slip behavior of the No. 8 bars was similar to that of the No. 5 bars. The initial force-slip behavior of the textured epoxy-coated bar was very similar to that of the uncoated bar, but diverged as the force increased. The slip resistance of the epoxy-coated bar was considerably lower than the uncoated or textured epoxy-coated bar. Since little to no damage is done to the concrete at relatively low levels of slip, it is likely that slip occurring prior to the peak pull-out force can be elastically restored. This is also true for the No. 5 bars.
