Case Studies Using Quality Control for Performance and Pay for Performance Specifications: Field Observations

Research Report No. FHWA-ICT-20-006

Evaluation of Data Trends and Variability in the Quality for Performance (QCP) and Pay for Performance (PFP) Programs

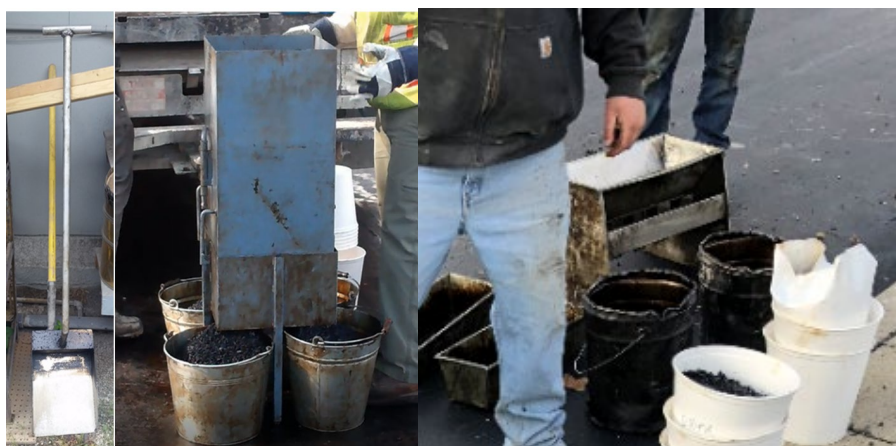
Figure 27. Photo. Aluminum sampling shovel, Gilson SP-55 Quartermaster, and Humboldt Riffle.

The contractor had four QC personnel during the construction project in charge of all QC tasks. Two contractors were sampling in the field, one was responsible for density cores, and the fourth performed laboratory tests in the plant. Eight metal buckets of mix samples were obtained from the mat using an aluminum sampling shovel, as specified in Appendix E.4 of IDOT's *Manual of Test Procedures for Materials* (IDOT, 2018a) and shown in Figure 27. The samples were blended twice using a Gilson SP-55 Quartermaster Asphalt Sample Divider to split the samples into metal buckets on site, which is not an IDOT-approved splitter (Figure 27).

The contractor used a Humboldt splitter to reduce the sample size to the G_{mm} and G_{mb} test size. The practice is known as “pre-splitting” in District 1. Samples that were pre-split in the field to the G_{mm} and G_{mb} size took approximately 45 min to obtain, split, and store. However, because of cold weather, IDOT samples were stored in paper buckets after quartermaster splitting because the temperature was too low to complete the pre-split. The paper buckets were placed in canvas bags and secured by the resident engineer.

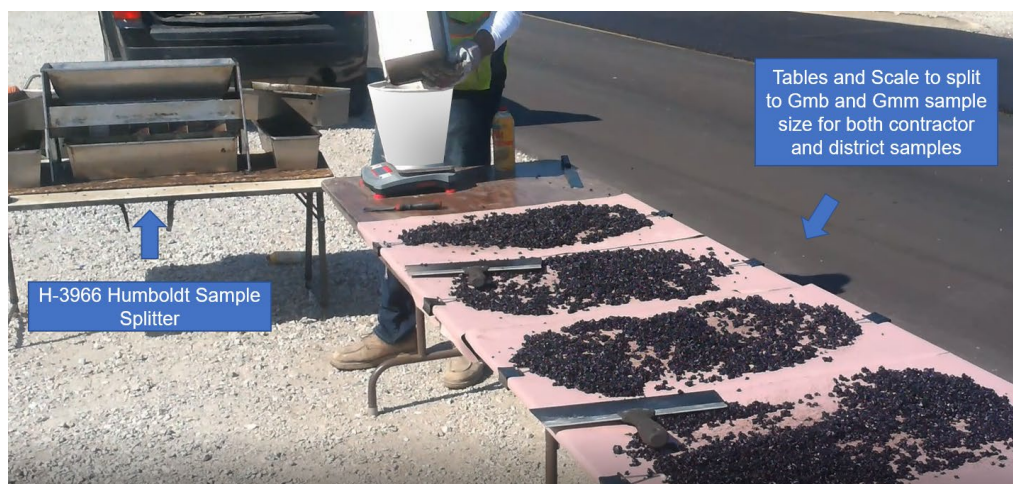
Figure 47. Photo. Pre-splitting set-up.

After the discussion, the contractor collected the samples by shoveling the mat. Then, the samples were blended and split in the field to the G_{mb} and G_{mm} test sizes (pre-splitting). The company (representing the district) set up tables with the scales shown in Figure 47. There was no need to split the sample in the district's lab, which reduced reheating time.

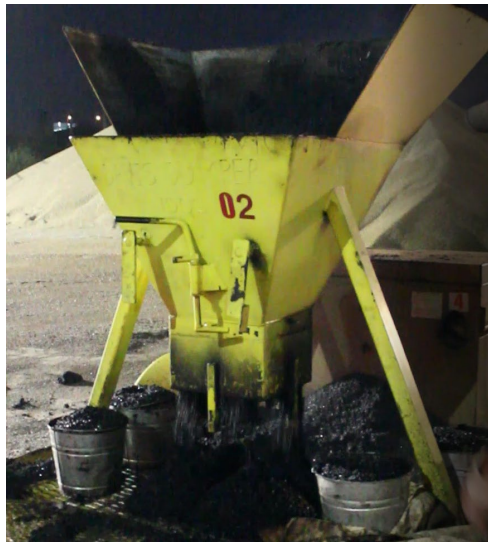
Figure 59. Photo. MTD quartermaster.

The hauling time was 10 to 15 min. The mix samples were obtained from the MTD at the jobsite. At the time of sampling, the paver loading conveyor was rotated toward the shoulder of the road where there was a pick-up truck with a quartermaster (Figure 59). The paver loading conveyor dropped mix into the quartermaster until it was completely full. Afterwards, the truck returned to the asphalt plant, 15 min away, with the resident engineer witnessing sampling. At the plant, the material was pre-blended once, split using a quartermaster, reblended two more times using a conventional splitter, and then stored in canvas bags. The process took around 30 min after the sample was obtained from the MTD.

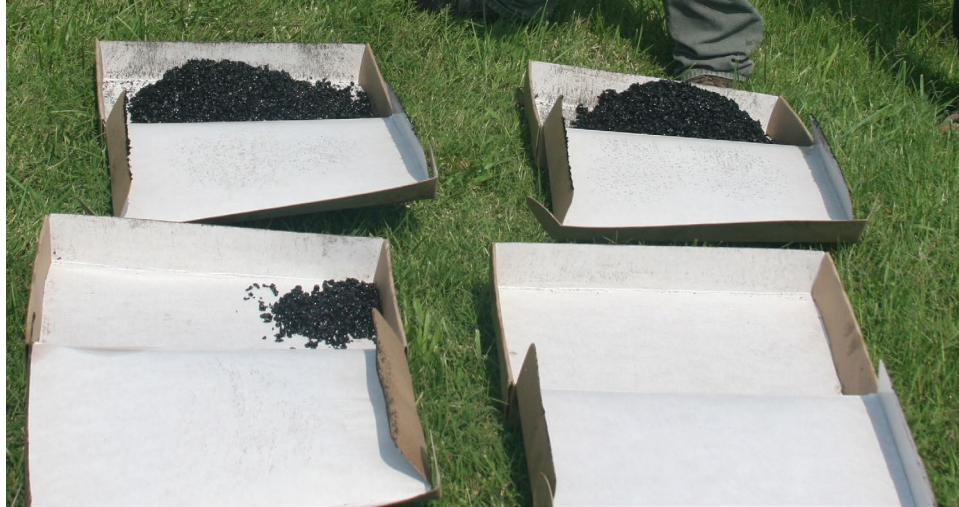
Figure 66. Photo. Rectangular boxes used to store and secure district and contractor samples.

The mix was hauled for 40 min to the jobsite and delivered to an MTD. The plate method was used to obtain mix samples in the field following IDOT specifications (IDOT, 2018a). Two personnel oversaw sampling, one of whom had 25 years of experience. The mix was transferred to a pick-up truck and prepared with an extended table and conventional splitter. The sample was blended and split in accordance with the requirements. Finally, district and contractor samples were stored in cardboard boxes and secured by district personnel (Figure 66). The contractor had been able to achieve comparable results with the district. Samples were stored overnight and reheated the next day using a Despatch oven.
