Bond Characteristics and Experimental Behavior of Textured Epoxy-coated Rebars Used in Concrete Bridge Decks

Research Report No. FHWA-ICT-22-001

ICT PROJECT R27-197

Characterization of the Bond Strength of Textured Epoxy-Coated (TEC) Reinforcement Bars (Phase 2)

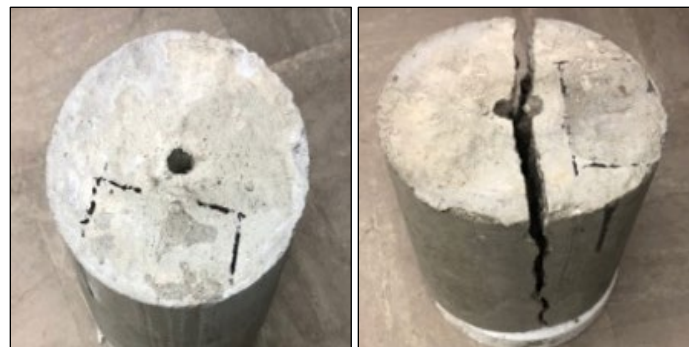
A. Pull-out failure. B. Splitting failure.

Figure 7. Photo. Failure modes exhibited by the pull-out specimens.

For the direct pull-out test, there are two possible failure modes: splitting and pull-out. However, the probability of experiencing one or the other failure mode in practical field conditions is based on factors such as concrete strength, concrete cover, bar spacing, or degree of confinement. For instance, for high-strength concrete or concrete with a small cover, splitting failures are more likely to happen (Lundgren, 2005). After running tests for Batches 1 and 2, most failures were found to occur due to the splitting of the specimens. To ensure that both failure modes were well represented in the data, Batch 3 specimens were confined prior to testing using carbon fiber–reinforced polymer (CFRP) sheets. The CFRP sheet had a ply thickness of 0.049 in. (1.25 mm), an ultimate elongation of 0.98%, a tensile modulus of 13,000 ksi (89,630 MPa), and a tensile strength of 135 ksi (930 MPa). The specimens were confined with two layers of CFRP sheets, applied using the wet-layup method, on a height of 4 in. (101.6 mm) starting from the bonded region. In Batch 4, both failure modes were well represented in the results. Figure 7 presents an example of both failure types observed in the tests.

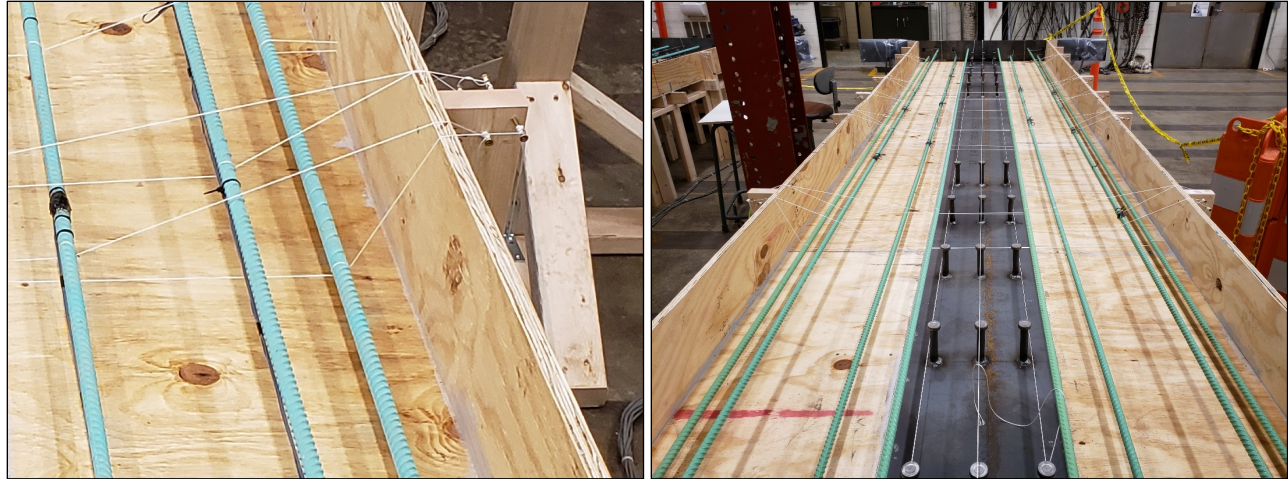
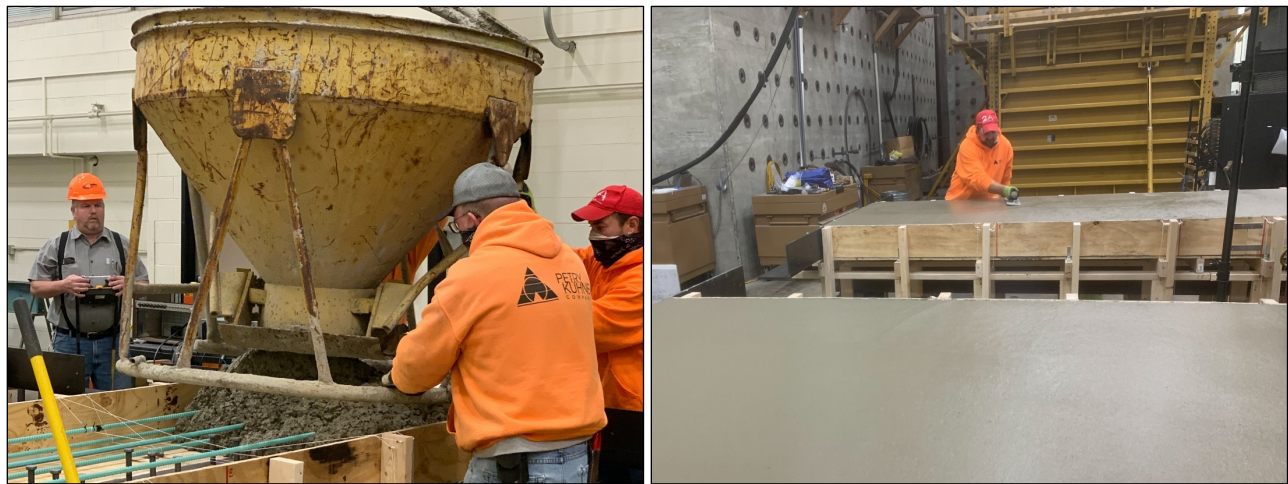
A. Wrapping nylon thread around rebars and end screw. B. Rebars after being straightened.

C. Releasing concrete mixture from metal container over specimens. D. Finishing specimens' surface.

Before casting, the appearance of the reinforcement was clean and free of harmful foreign materials, as stipulated in Section 26.6.1.2 of ACI 318-19. Also, the coating did not present signs of damage or surface imperfections. Both specimens were cast in a single activity, using the same batch of class BS concrete described before. The truck mixer discharged the fresh concrete into a metal container that was dragged with the laboratory moving bridge crane over the specimens to be released, as shown in Figure 18-C. However, before starting to fill the container, a preliminary slump test was made to check the initial workability of the mixture. The result was satisfactory, falling within the limits for this type of concrete. Once the mixture was released over the specimens' formworks, it was consolidated with mechanical vibrators. The surface was leveled with a straight metal screed that was ridden along the top edges of the forms, and two hours after the concrete was cast, the surface received a typical troweled finishing, as shown in Figure 18-D.

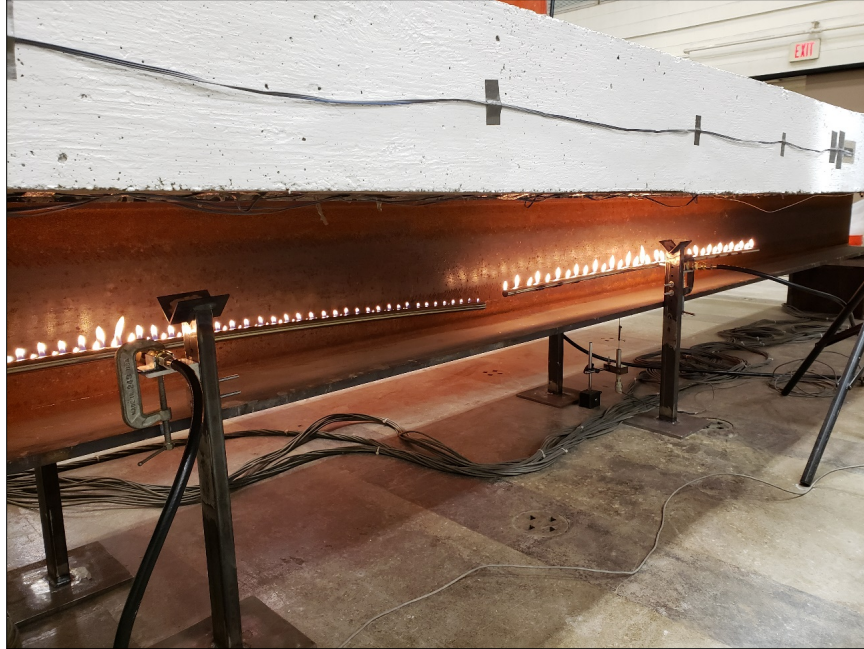
Figure 30. Photo. On-site temperature effect simulation test.

The temperature difference was simulated by applying a thermal load on the half of the steel girder adjacent to the roller support. It was important to apply it in a way that prevented extreme upwards or downwards deflections of the specimens that could create additional forces acting on the concrete deck. For example, had the heat been concentrated only on the lower region of the steel girder cross-section, the element would have exhibited a concave-upward shape as the thermal expansion came into effect. Based on this premise, the test was accomplished using four 60 in. long (1.50 m) T-shaped stainless-steel burners placed on both sides of the girder web, supported on custom-made metal stands. They were grouped in two pairs. In every pair, each of these elements was connected to one propane tank through a 12 ft long (3.66 m) hose and split tee adaptor. This distribution was beneficial to convey the heat and produce mostly longitudinal strains, avoiding the undesired effects of significant deflected shapes explained above. A cross-section of the arrangement is shown in Figure 29-A, and a lateral elevation is shown in Figure 29-B. The burners were then kindled and heated the W-shape section until its upper part reached 150°F (65.6°C), which could represent the temperature of a member receiving intense sunlight in the summer season. During the heating process, which took approximately 6 hours, the amount of gas was regulated by the valves located at the tanks, so that small-sized flames emanated from the burners. Once the heating time was completed, the propane tank valve was closed, and the specimens were allowed to cool down.

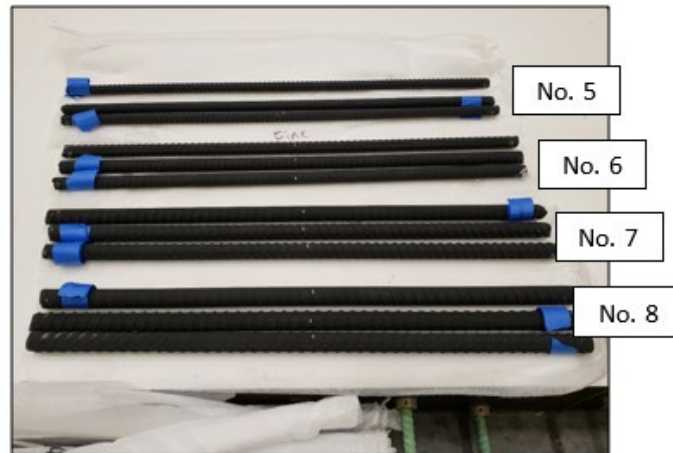
Figure 45. Photo. “As-delivered” reinforcement for the empirical roughness test.
