SPATIAL PATTERNS AND DRIVERS OF FLOODPLAIN CHANGE IN THE SQUAMISH
RIVER, A DYNAMIC GRAVEL BED RIVER

THESIS

Submitted in partial fulfillment of the requirements
for the degree of Master of Science in Geography
in the Graduate College of the
University of Illinois Urbana-Champaign, 2023

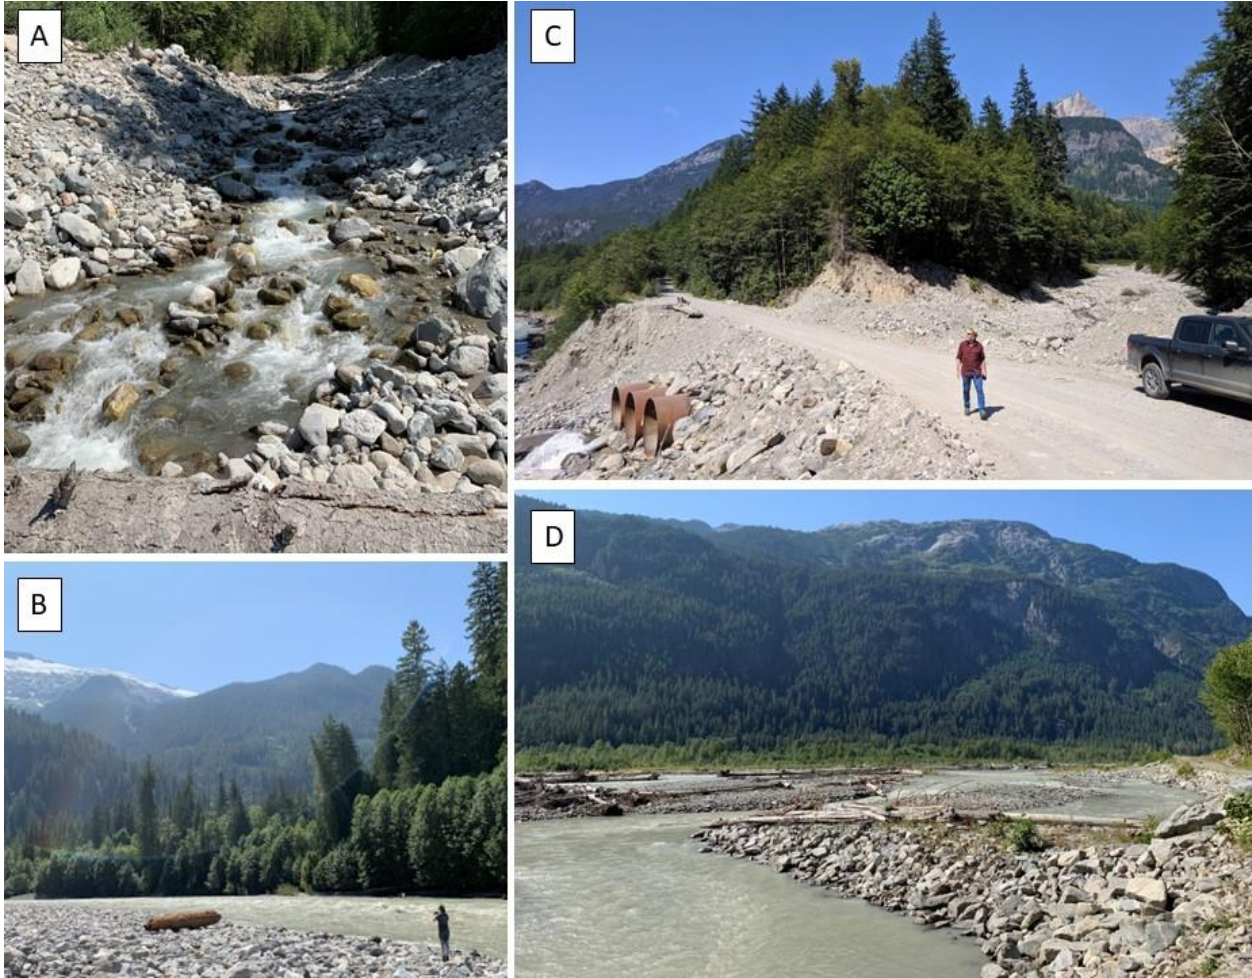
Figure 19: A: Terminal Creek B: Standing on debris deposited by Turbid Creek, Icecap Peak in background, Sarah in foreground for scale C: Flow off Turbid Creek, Mount Cayley in background, Jim/truck for scale D: Squamish confluence with Shovelnose Creek. Note the widening valley floor.

This reach was determined to receive a moderate level of sediment from the reach above, but a high level of sediment from its tributaries. The high lateral inputs from out-of-channel sources are associated with landslides and debris flows from Mount Cayley coming down Terminal, Turbid and Shovelnose Creeks. Small volcanic landslides are generally triggered by runoff mobilizing stored debris that accumulated during summer dry spells. Larger flows can occur after deep-seated slope failures, triggered by earthquakes, intensive precipitation, rapid snowmelt, or a combination thereof (Friele, 2013). For example, between 1963 and 2017, there have been 27 recorded landslide events from Turbid Creek, ranging from 10,000 to 500,000 m³, including four events in both 2012 and 2016 and one in 2015. This is an average of one event every 2-3 years. These are typically triggered by precipitation events greater than 50mm in 24

hours and greater than 5 mm in an hour (NHC, 2018). Turbid Creek is a transport-limited system, which means that landslide events will occur any time conditions allow, as volcanic debris supply is nearly limitless. It provides the most sediment of any tributary upstream of the Cheakamus. (Jakob, 1996; NHC, 2018).

Across the valley, Endurance Creek is also subject to landslides, despite not belonging to the same Garibaldi volcanic group. Instead, it consists of Jurassic granodiorite basement rock (Jakob, 1996). It experienced landslide events in 1909, 1920, 1934, 1962, 1980, 1984, 1991 and 2003, typically in the range of $10^3\text{-}10^4 \text{ m}^3$ in volume. Endurance Creek is also a weathering-limited basin (NHC, 2018; Jakob, 1996).

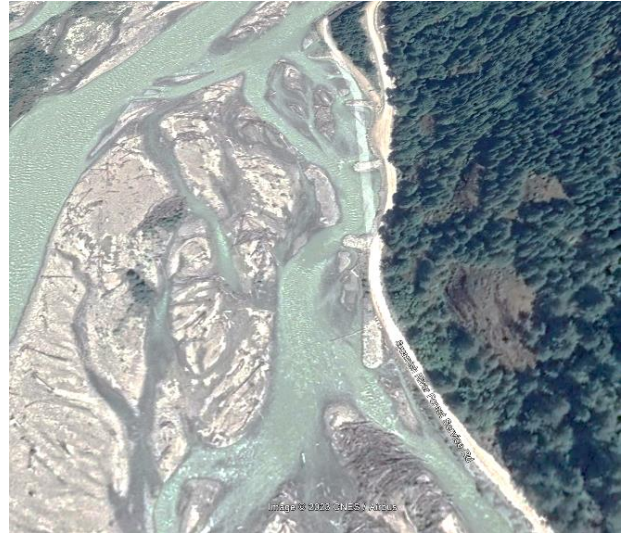
Figure 22: Erosion control measures along the eastern side of the Braided Reach to protect the Squamish Valley Forest Road from Google Earth, 2023
