STRENGTH OF PRESTRESSED CONCRETE BEAMS WITH WEB REINFORCEMENT

A Thesis

Issued as a Part
of the
SEVENTH PROGRESS REPORT
of the
INVESTIGATION OF PRESTRESSED CONCRETE
FOR HIGHWAY BRIDGES

MAY 1958
UNIVERSITY OF ILLINOIS
URBANA, ILLINOIS

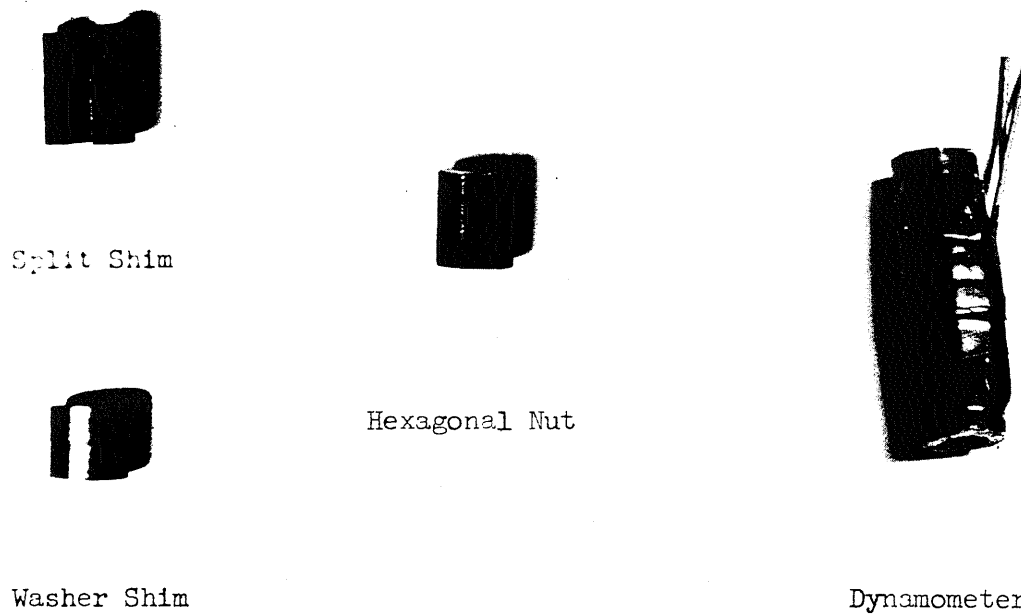
Split Shim

Hexagonal Nut

Dynamometer

FIG. 14 SHIMS, NUT, AND DYNAMOMETER

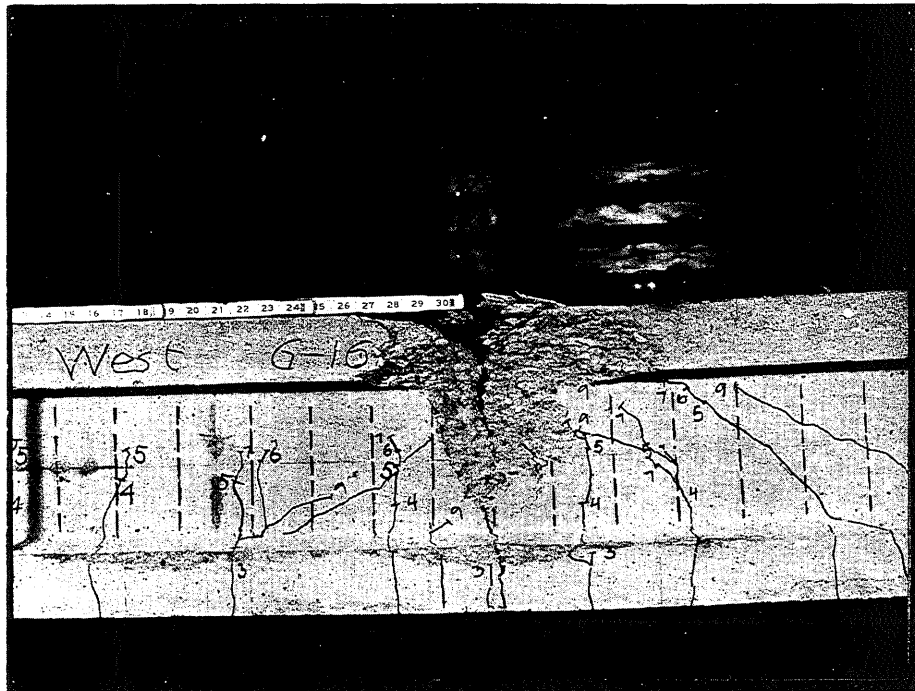
FIG. 38 FLEXURAL FAILURE IN A BEAM WITH EIGHT WIRES

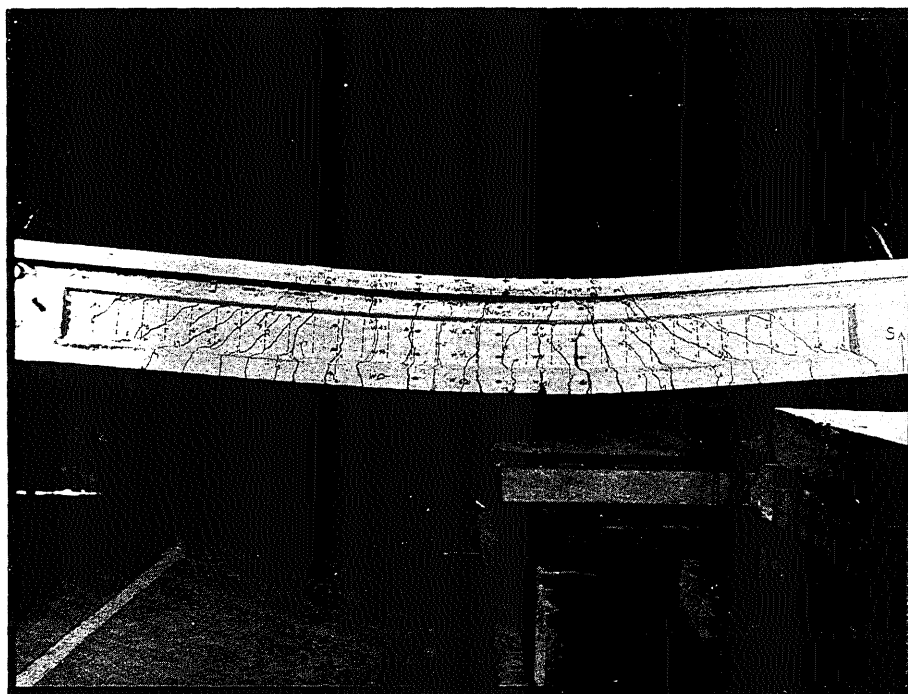
FIG. 44 FLEXURAL FAILURE OF A GREATLY UNDER-REINFORCED BEAM
