EVALUATING PAVEMENT MARKINGS ON PORTLAND CEMENT CONCRETE (PCC) AND VARIOUS ASPHALT SURFACES

Results of Year 1, 2, 3, and 4 Data Collection

Research Report FHWA-ICT-13-033

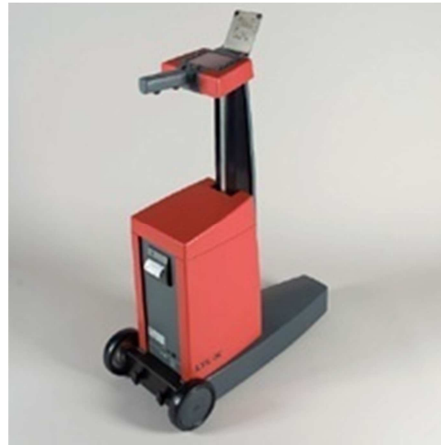
During field investigations, retroreflectivity measurements were collected with a hand-held 30-meter geometry retroreflectometer, a Delta LTL-X, shown in Figure 2.

Figure 2. Delta LTL-X Retroreflectometer.

Retroreflectivity testing was performed in accordance with ASTM E 1710-05, “Standard Test Method for Measurement of Retroreflective Pavement Marking Materials with CEN- Prescribed Geometry Using a Portable Retroreflectometer.”

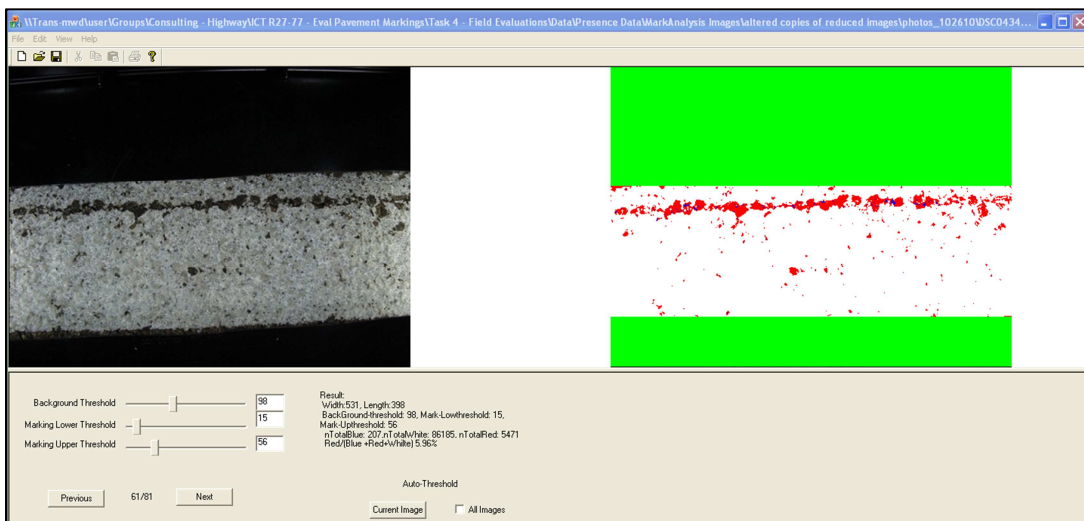
Figure 3. Image analysis program.

Presence, the second metric for evaluating pavement marking performance, is an indication of a marking’s durability, which represents a marking’s ability to remain bonded to the pavement and in place. ARA developed a binary image analysis program specifically for measuring a marking’s presence. Photos of the markings are taken under standardized lighting conditions and are then processed with the image analysis software. Results from the software report presence as the percentage of material missing from the pavement marking. Figure 3 is an example of a pavement marking photo viewed in the analysis program.

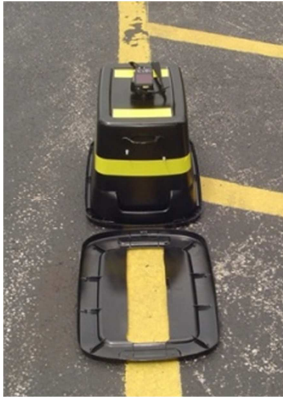
To standardize the lighting for each pavement marking photo, ARA devised a simple box that blocks all outside light and illuminates markings with lights mounted inside the box. The camera mounts on top of the box. Figure 4 shows a camera box placed over a pavement marking and Figure 5 shows the interior of the box.

Figure 4. Camera box.

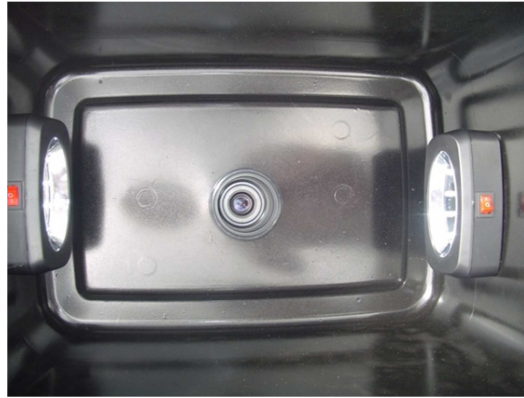
Figure 5. Camera box interior.

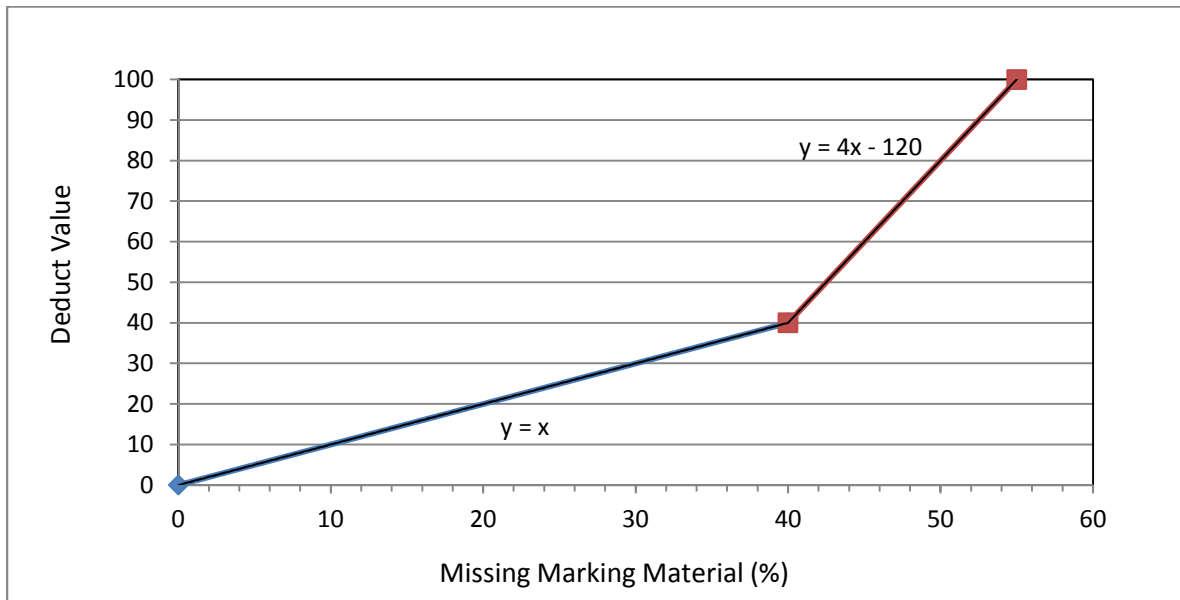
The deduct curve for presence was developed based on experienced analysis of presence data and observed increases in the rate of bond deterioration. The presence deduct curve is shown in Figure 7.

Figure 7. Deduct curve for presence (percentage missing).

The shape of the presence deduct curve is opposite to the shape of the retroreflectivity deduct curve because as the percentage missing increases, the deduct values for the condition

index should increase. When a marking is 100% present, the deduct value should be zero, so the y-intercept was set to zero. Based on expert opinion of presence data analyzed to-date and on observation of presence deterioration, the curve's initial slope is gradual up to 40% missing. However, the slope increases beyond 40% missing because deterioration is more rapid past this point. All presence values at or above 55% missing will have a deduct value of 100. Markings with 55% or more missing material were considered to provide minimal value to the traveling public.

Presence deducts, as presented here, are only applicable to solid line markings. Structured markings, which begin with coverage values close to 55% missing, would obviously fail quickly. If the PMI were to be standardized for all markings, including structured markings, then a standard method for taking photos from an angle representing a driver's perspective should be developed.

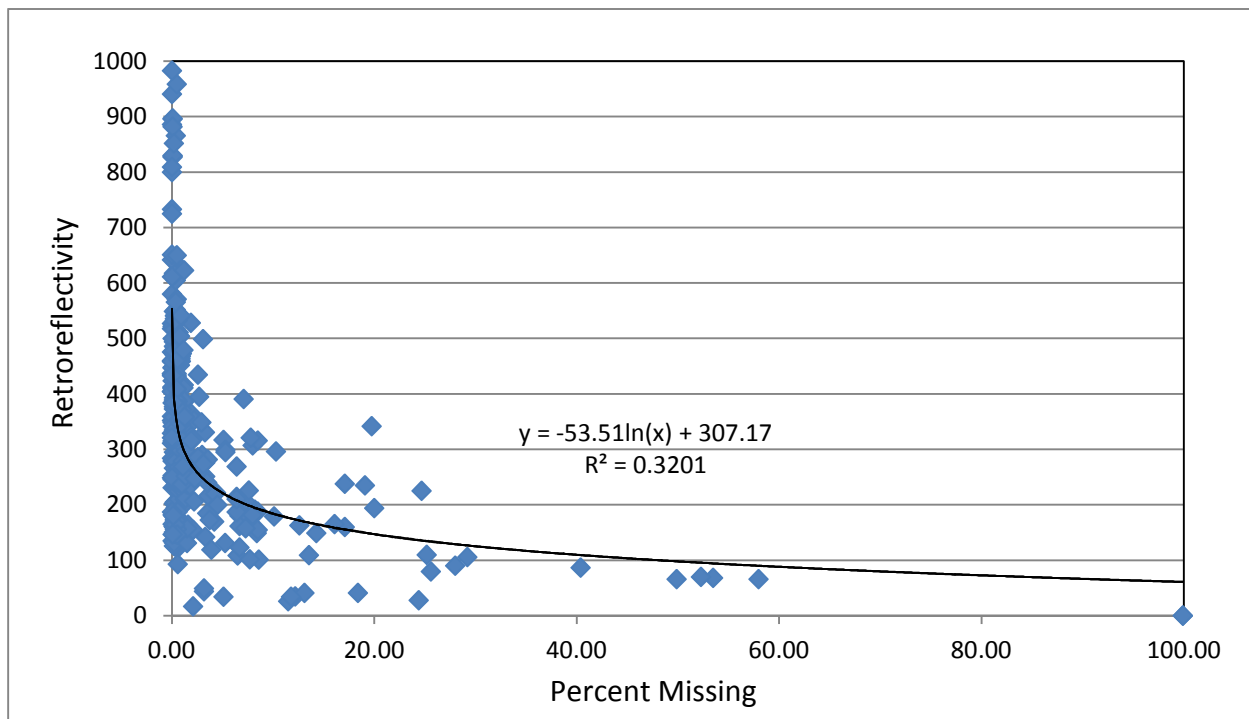
Although a marking's presence is not dependent on retroreflectivity, retroreflectivity is partially dependent on a marking's ability to remain bonded to a pavement surface. A marking can be 100% present and have little or no retroreflectivity if there is no reflective media on it. However, if a marking material becomes de-bonded, then there is less surface area returning light back to the driver's eyes. Retroreflectivity also depends on other variables such as bead embedment, bead condition and retention, and type of reflective media. Figure 8 clearly shows the relationship between retroreflectivity and presence and represents most of the retroreflectivity and presence data that ARA has collected to-date. The data is collected from a variety of marking types and ages, and each point typically represents an average of 20 readings; the graph supports the points selected in the presence deduct curve.

Figure 8. Relationship between retroreflectivity and presence.

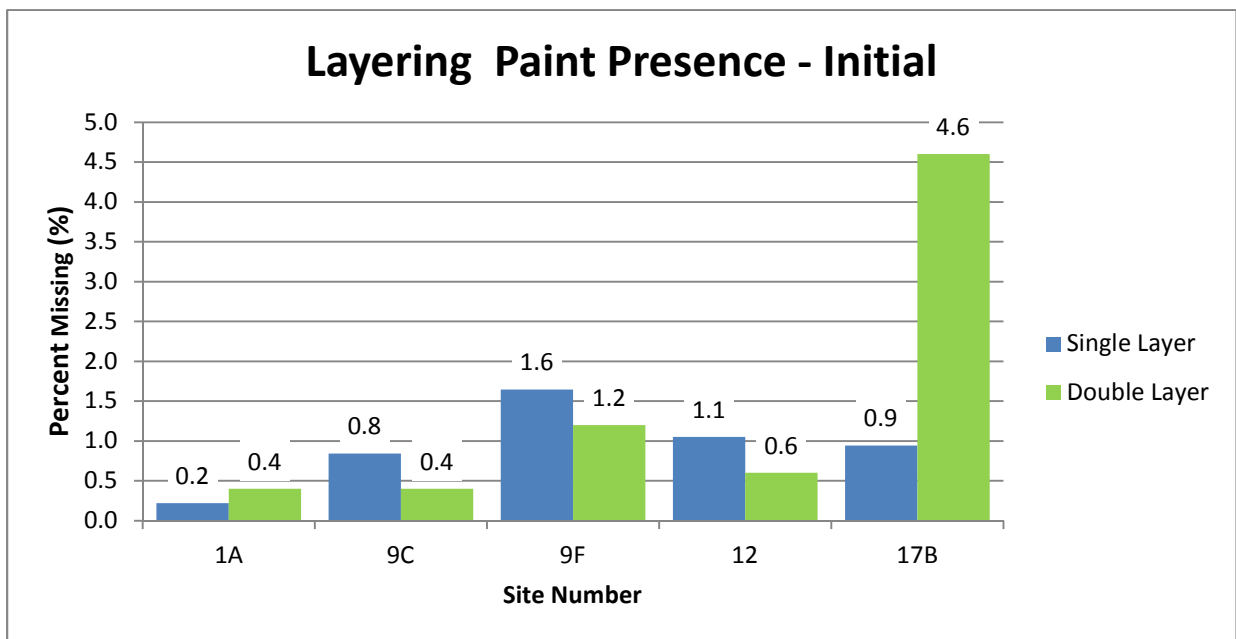
Figure 23 compares the initial presence values of single and double-layered paint. Three out of five sites had a better presence (lower percentage missing) with a second coat. Paint-17B, however, had a much higher percentage missing than the other double-layer sites. This was due to poor restriping because the new layer was consistently less than 4" wide. Figure 24 compares the presence values after one winter. All five sites had a significantly lower percentage missing with a double layer of material. Again, the mild winter likely influenced the data of the double-layer paint.

Figure 23. Initial paint presence for single and double layers.

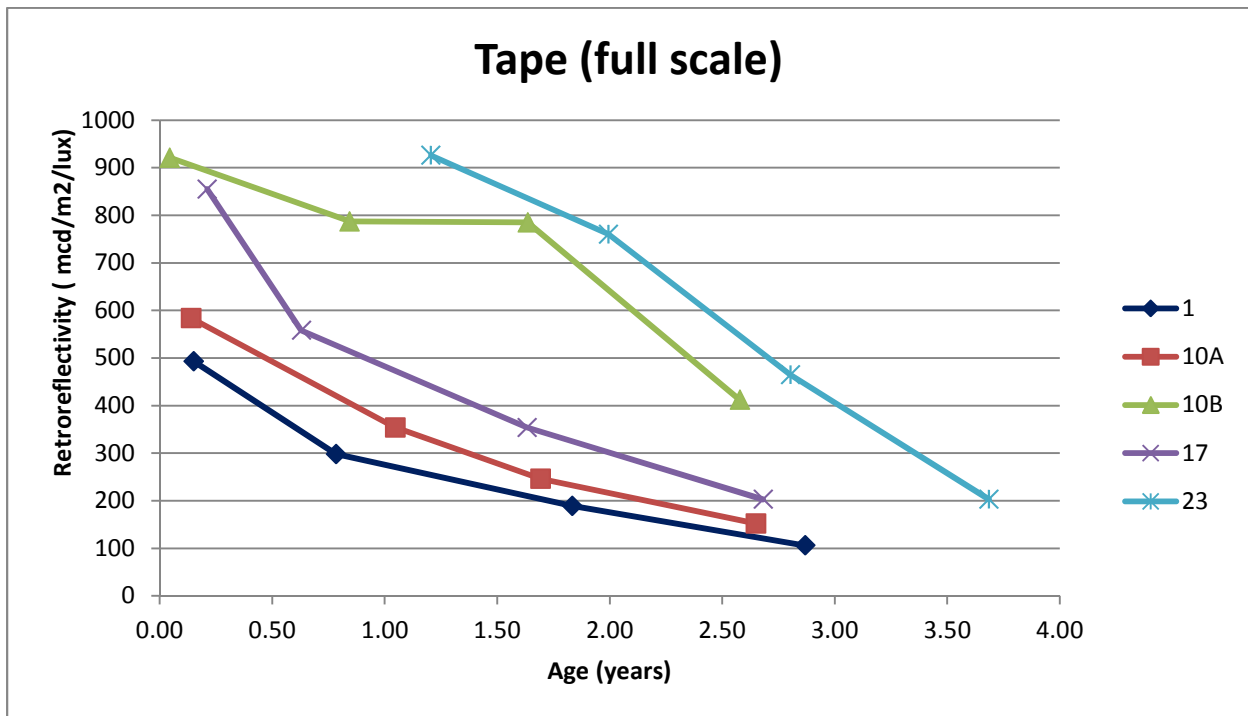
Unlike the other tapes, Tape-10B showed almost no change in retroreflectivity from 2011 to 2012. It was protected from damage because it is inlaid. Inlay tapes are typically 50% embedded in the pavement while the HMA is still malleable. The average retroreflectivity of this site fell sharply in 2013 to 412 mcd/m²/lux. The sites with the lowest retroreflectivity were Tape-1 and Tape-10A at 106 and 152 mcd/m²/lux, respectively. Tape-10A is the only site located on a local road rather than a major highway. Tape-1 differs from the others because it (1) has a different raised surface pattern, as shown in Figure 35, (2) experiences a considerably higher ADT, and (3) is surface-applied. Tape-1 is the only tape placed entirely on the surface of the pavement.

Figure 34. Tape retroreflectivity.

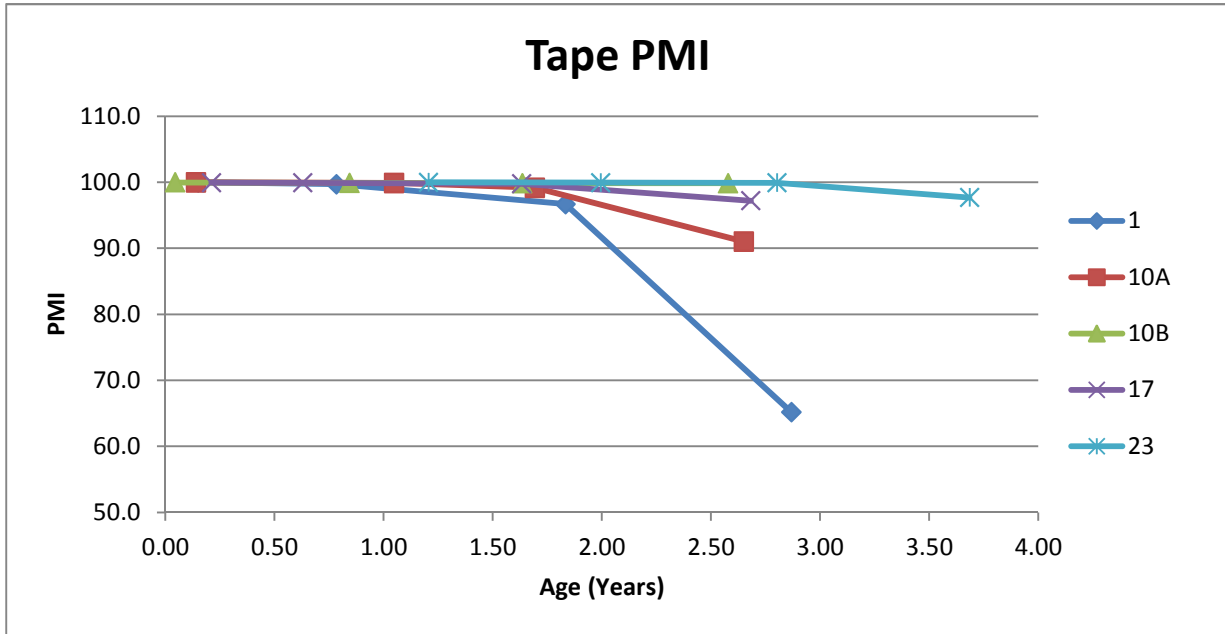
Figure 36. Tape Pavement Marking Index.

As expected, all tape sites showed very little deterioration of presence. The PMI values shown in Figure 36 reflect that the retroreflectivity for Tape-1 is very near failure and that Tape-10A seems to be following suit.

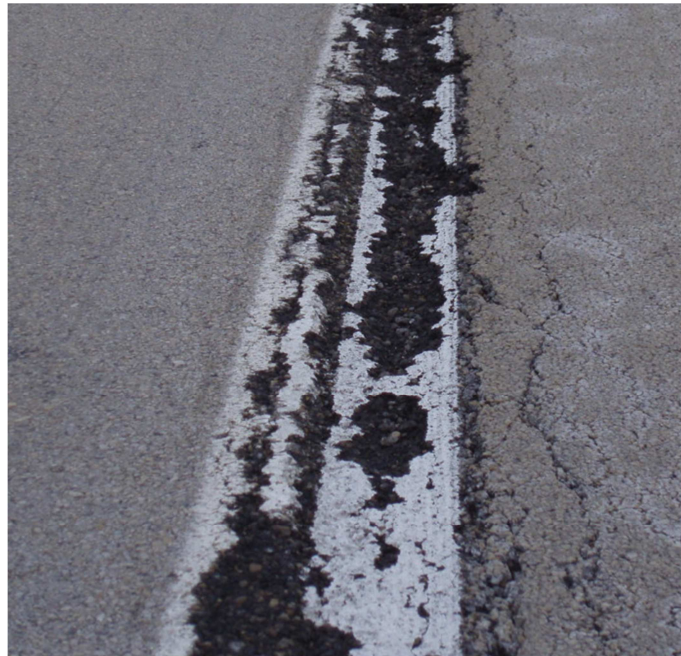
In early March 2011, it was noticed that several sections of the northbound lanes at the Poly-6 site had significantly deteriorated. This HMA surface was 8 years old when the markings were placed in the fall of 2010, and the pavement was already exhibiting some distress at the longitudinal joints. Figure 45 shows an example of marking and pavement deterioration. Polyurea might have accelerated pavement deterioration; however, some sections of longitudinal joints that did not have markings exhibited similar deterioration. The loss of pavement and marking material was so great that repairs had to be made and the site was restriped. This site was the only recessed polyurea and was not tested after 2011.

Figure 45. March 2011 photo of Poly-6 site (northbound right edge line).

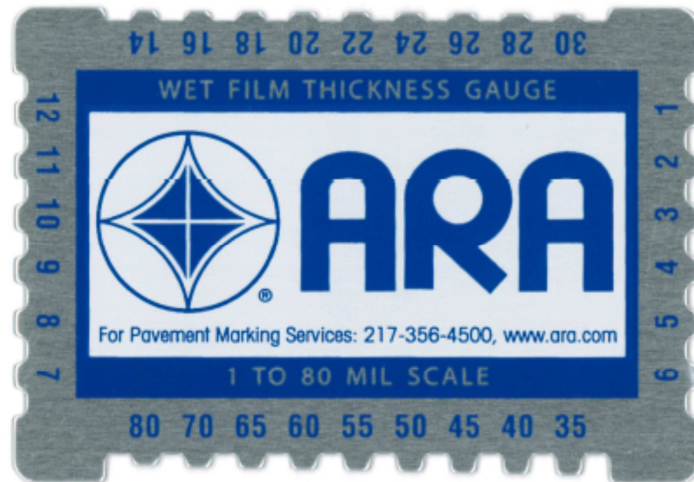
Markings with a required wet film thickness of 80 mils or less should be measured with a wet film thickness gauge. Figure 2 is an example of a wet film thickness gauge. To measure wet film thickness, press the edge of the gauge vertically into the wet material. Withdraw the gauge and note the deepest tooth with material on it and the next higher tooth that is not coated with material. The wet film thickness lies between these two readings. For materials thicker than 80 mils, place a metal plate or duct tape down in advance of the striping operation. Collect the sample after striping, and when the material has cooled, remove pieces of the sample and measure the thickness with a needle-point micrometer.

Figure 2. Wet film thickness gauge.

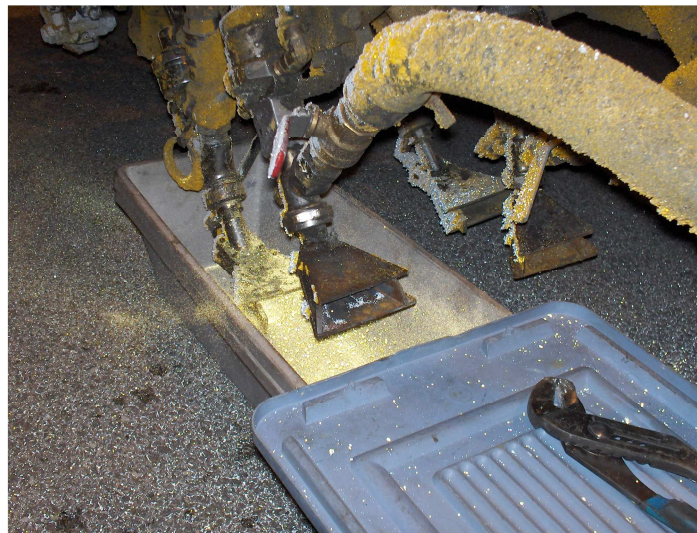
Most glass bead application rates are given in pounds of beads per gallon of the specified marking material. To ensure that beads are applied at the specified rate, the bead guns must be calibrated prior to marking installation. Verifying that the calibration is performed is an inspector's best opportunity to ensure that rates will be met. To calibrate bead guns, the desired travel speed must first be known. Then, while the striping truck is stationary, beads are sprayed into a container for a pre-determined amount of time, usually a few seconds. Figure 3 is a photo of this step.

Figure 3. Glass bead calibration.

The beads are then poured into a graduated cylinder, and the volume of beads is read. The volume of beads should correspond with the required application rate for a given travel speed. For example, to place 10 pounds of Type I glass beads per gallon of material while traveling 4 miles per hour, the volume of beads collected during a 15-second spray should be 1,200

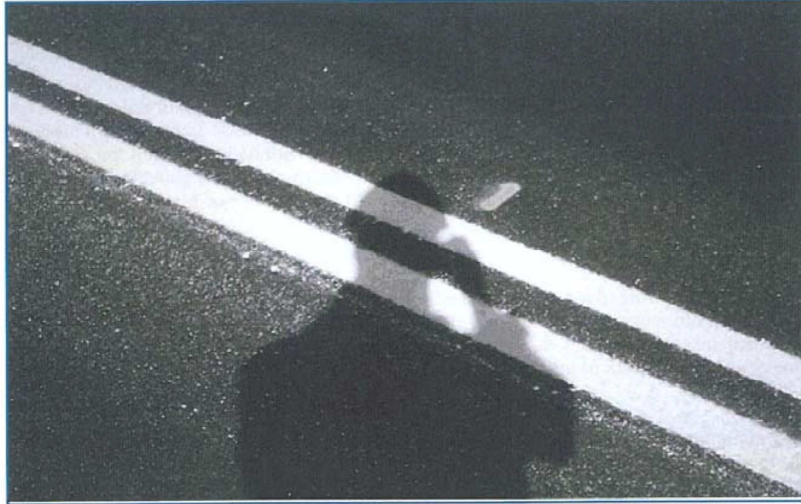
Figure 4 shows a demonstration of this test method.

Figure 4. Demonstration of sun over shoulder test method.
