EMBRITTLLEMENT IN BOILERS

A REPORT OF AN INVESTIGATION

FREDERICK G. STRAUB

BULLETIN No. 216

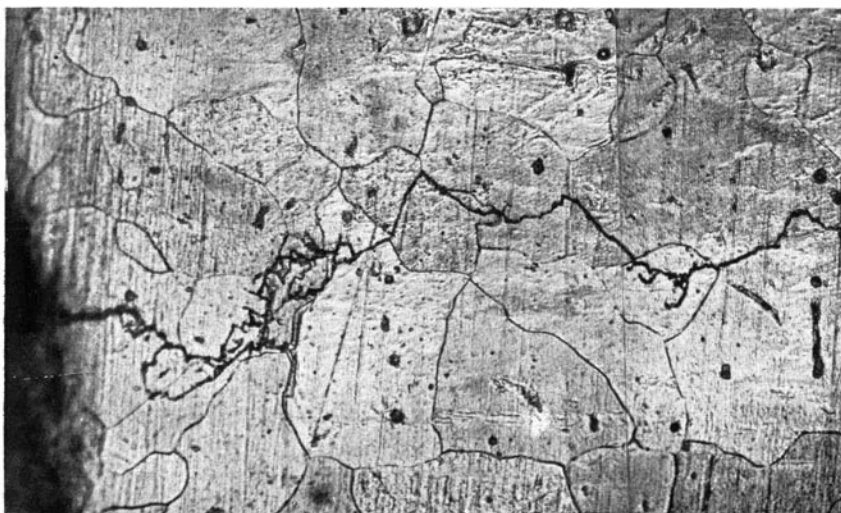
FIG. 10. MICROGRAPHS OF FATIGUE CRACKS IN ARMCO IRON

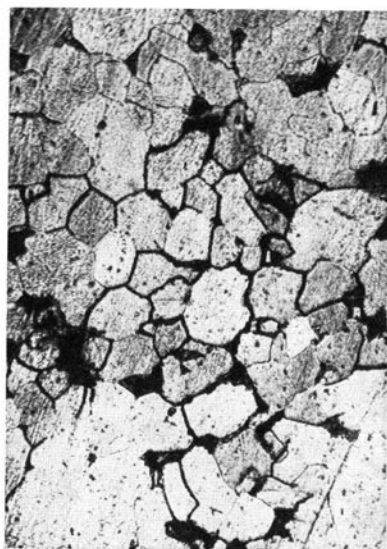
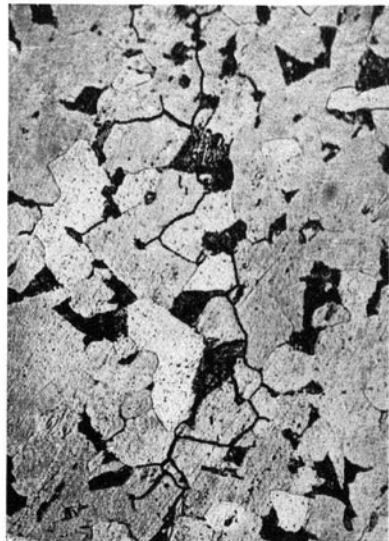
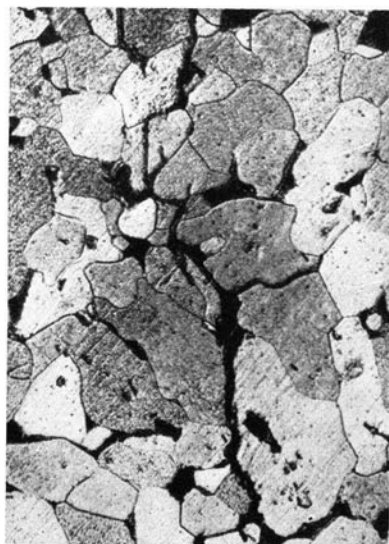
Unetched

Etched, 2 Per Cent Nital

Rivet Head—Same Specimen, x 250

Boiler Plate, Etched, 2 Per Cent Nital, x 250

FIG. 11. MICROGRAPHS OF EMBRITTLMENT CRACKS FROM BOILERS

Figure 17 shows a cracked drum head from another plant. Tubes often crack in a manner shown in Fig. 18. Figure 11 shows micrographic studies of embrittlement cracks in these same plates or tubes or corresponding ones which have failed in service.

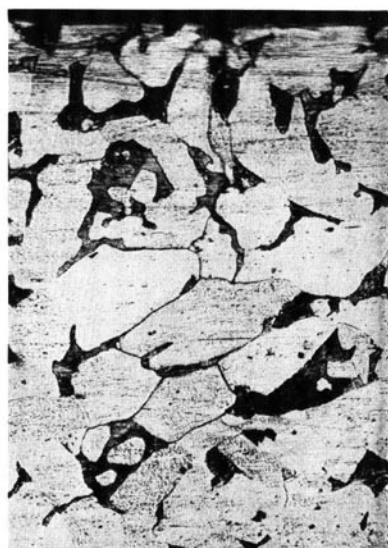
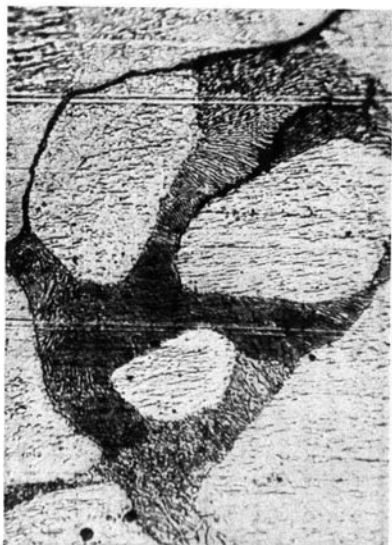
Unetched, x 150

Etched, 2 Per Cent Nital, x 150

Etched, 2 Per Cent Nital, x 900

FIG. 20. MICROGRAPHS OF FLANGE STEEL EMBRITTLED IN TESTS
All from the same specimen.

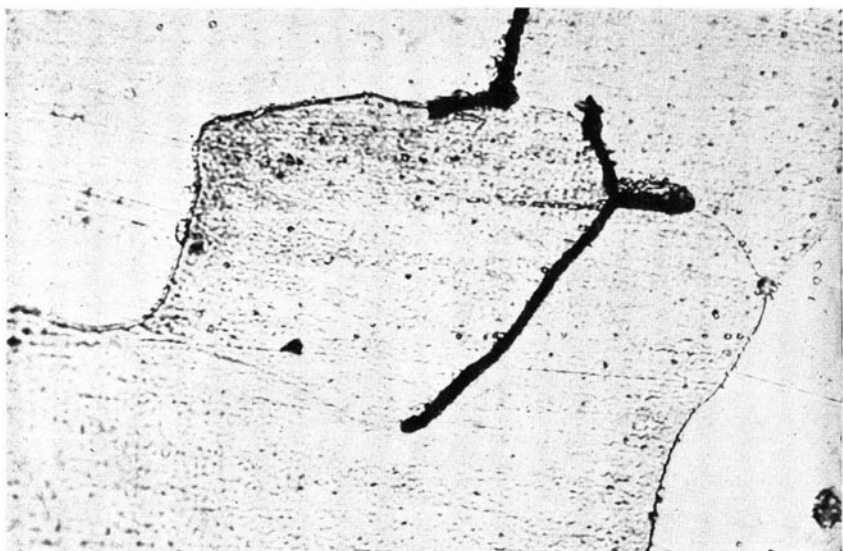
Magnetic Iron, Etched, 2 Per Cent Nital, x 3000

FIG. 22. MICROGRAPH OF EMBRITTLEMENT CRACKS

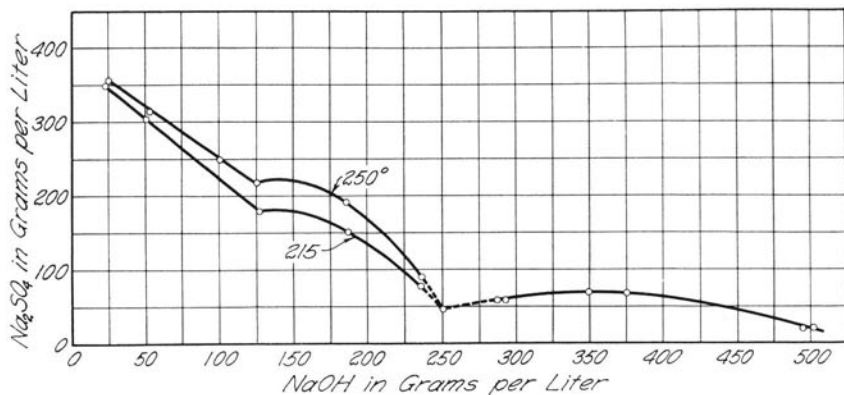
FIG. 38. SOLUBILITY AT 215 AND 250 DEG. C. OF SODIUM SULPHATE IN SODIUM HYDROXIDE SOLUTIONS

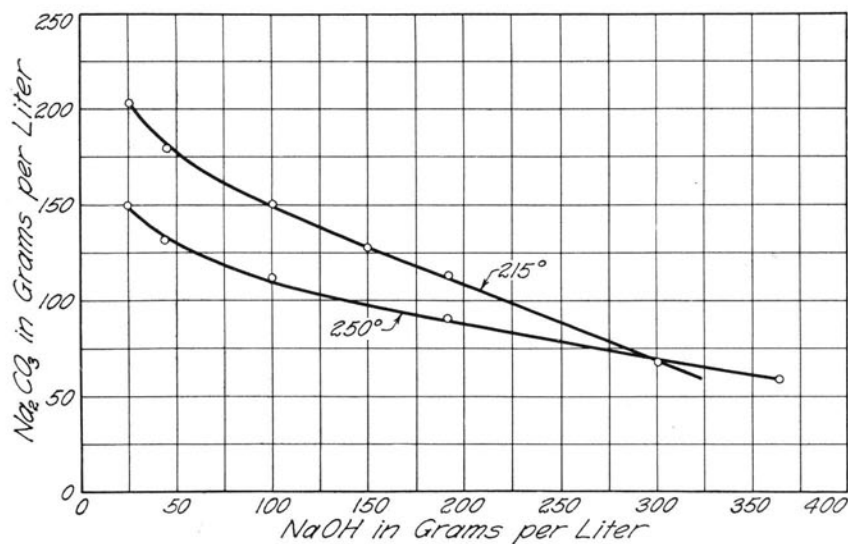
FIG. 39. SOLUBILITY AT 215 AND 250 DEG. C. OF SODIUM CARBONATE IN SODIUM HYDROXIDE SOLUTIONS
