# UNIVERSITY OF ILLINOIS BULLETIN

## REINFORCED CONCRETE WALL FOOTINGS AND COLUMN FOOTINGS

ARTHUR N. TALBOT

BULLETIN NO. 67

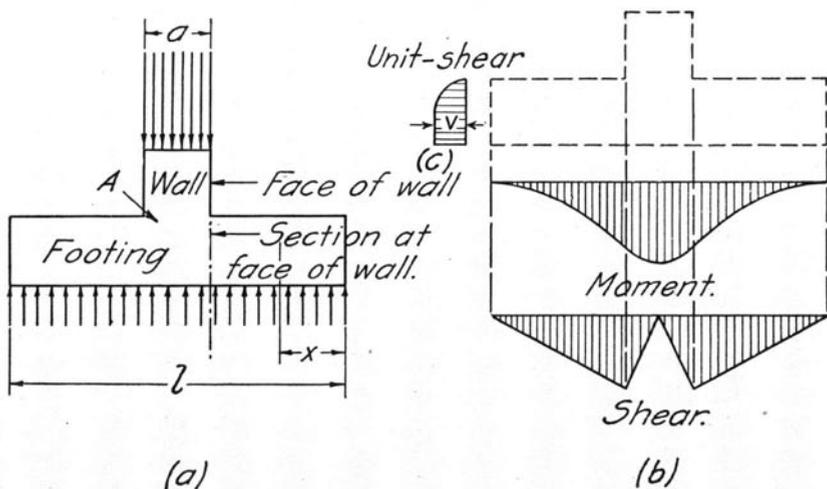
FIG. 1. (a) DISTRIBUTION OF LOAD AND PRESSURE IN WALL FOOTING. (b) MOMENT CURVE AND SHEAR CURVE. (c) DISTRIBUTION OF SHEARING STRESS OVER VERTICAL SECTION

Fig. 1 (b) shows also the variation in the external vertical shear  $V$  over the length of the footing for uniform loading. The theory of beams gives a distribution of the intensity of the vertical shearing stresses throughout the vertical section which is represented in Fig. 1 (c) and is more fully discussed in Bulletin No. 29, page 9. Due to a concentration of pressure near the face of the footing, as at A, Fig. 1 (a), and to the transmission of pressure diagonally therefrom in

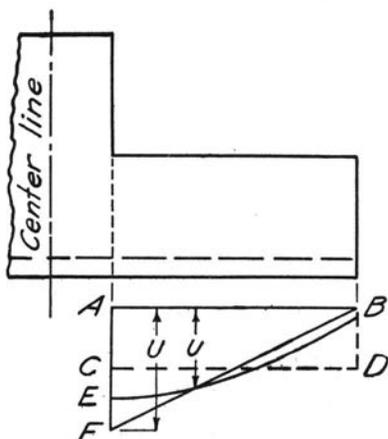
FIG. 2. DISTRIBUTION OF BOND STRESS ALONG THE REINFORCEMENT IN A WALL FOOTING

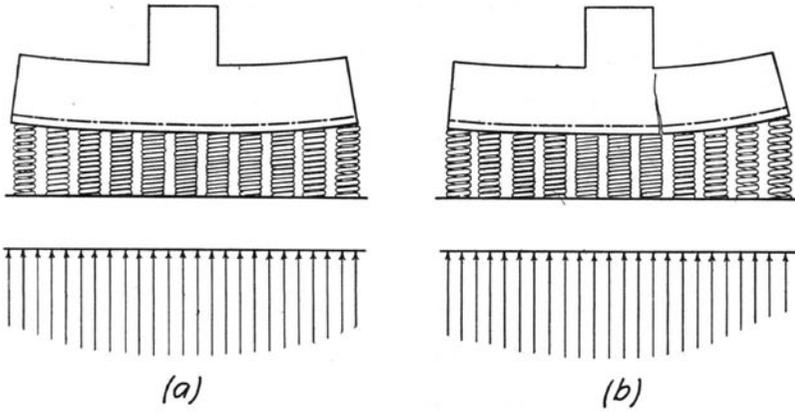
FIG. 3. EFFECT OF DEFLECTION OF WALL FOOTING UPON DISTRIBUTION OF LOAD BY SPRINGS

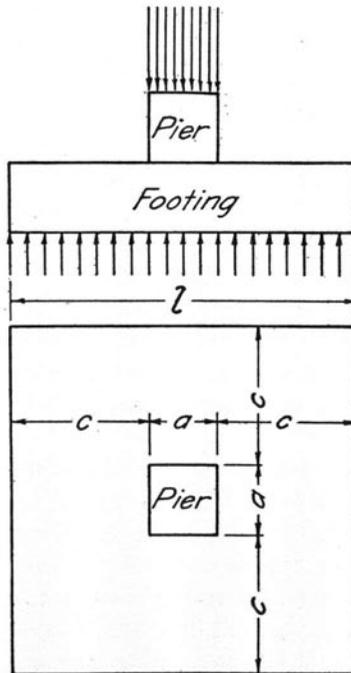
FIG. 4. DISTRIBUTION OF LOAD AND PRESSURE IN COLUMN FOOTING

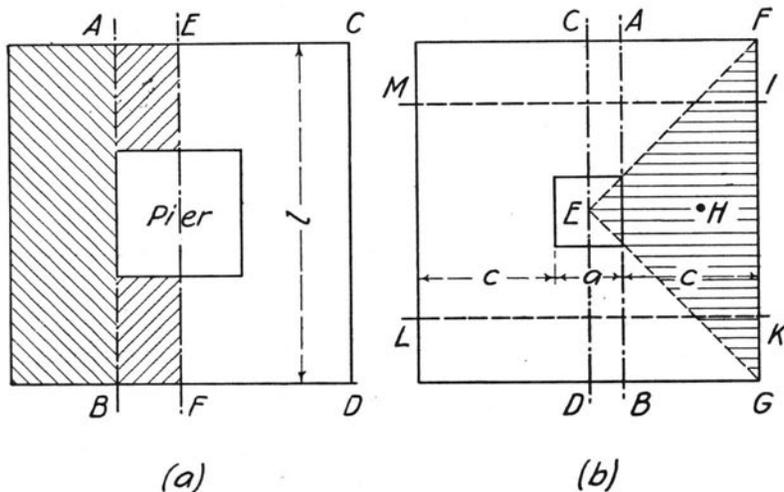
FIG. 5. LOADED AREAS ASSUMED IN DESIGNING COLUMN FOOTINGS

Various methods of calculating the strength of column footings have been proposed. In some cases the offsets have been considered as cantilever beams having the full width of the footing and the full load on this area is considered to be taken by this beam, the critical section being at AB, Fig. 5 (a). Although the load at the corners is counted twice,

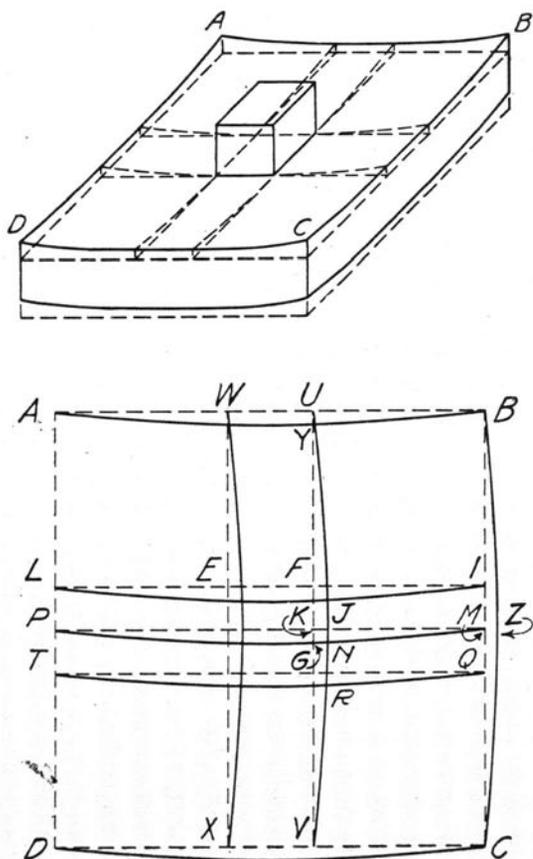
FIG. 6. FORM TAKEN BY COLUMN FOOTINGS UNDER LOAD

Fig. 6 represents in a general way the form which the footing under load may be expected to take along various sections. The full lines in the lower figure represent the deflections or flexure curves of vertical sections taken along the dotted lines. The vertical rise at a corner B

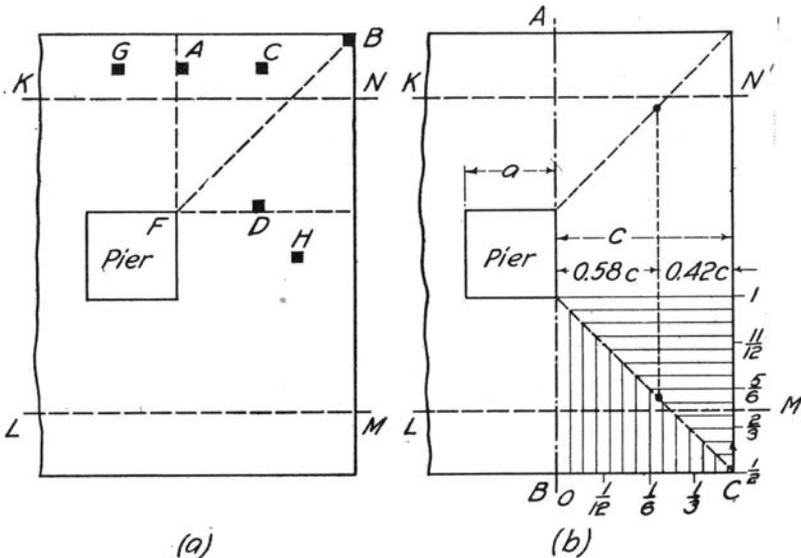
FIG. 7. DIAGRAM SHOWING ASSUMED DISTRIBUTION OF LOAD IN PRODUCING BENDING MOMENT

After making a study of the flexure curves obtained on a number of the column footings tested, the fractions given on the diagram in Fig. 7 (b) were taken as roughly representing the proportion of the unit-load at the points indicated which acts upon the east-and-west beam to produce bending moment and curvature. For the variation of the proportions along the lines of the diagram between the limits noted a curvilinear relation was assumed, and a process of approximate integration was applied to the load division problem. Of the part above the diagonal line, approximately two-thirds of the load or pressure upon the triangle was found to go to produce bending moment in the east-and-west beam, and of the part below the diagonal line approximately one-third, the remainder in both cases going to produce bending moment in the beam in the north-and-south direction; and of course altogether one-half of the load on the corner square must be considered to produce bending moment on each beam. By the calculation, under the assumed division of load, the center of pressure of the various parts of the load tributary to the north-and-south beam from a corner square was found to be  $0.58c$  from a line through the face of the pier. That is to say, this analysis results in considering that the pressure on the corner square affects the bending moment of the north-and-south beam the same as if one-half of the load of this corner square were placed at a point distant  $0.58$  of the width of the square from a line through the face of the pier, see Fig. 7 (b). As the method of assuming the division of load will not warrant refinement of calculation it seems well to adopt the more convenient and more conservative value of  $0.6c$  for the position of the center of pressure, and this value will be used in the calculations in this bulletin. It may be added, also, that other methods of attacking the problem locate the center of pressure not far from the position here chosen.

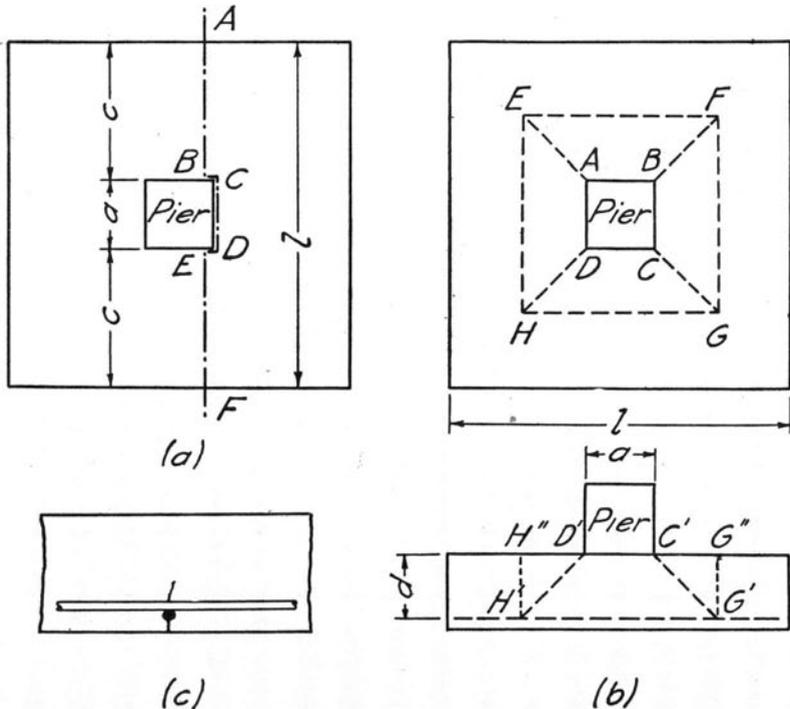
FIG. 8. CRITICAL OR DANGEROUS SECTION FOR RESISTING MOMENT AND POSITION OF SECTION FOR CALCULATING VERTICAL SHEARING STRESSES

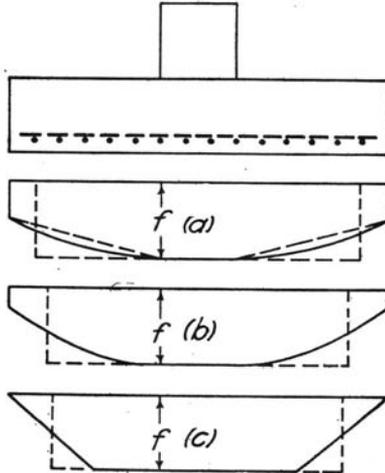
FIG. 9. VARIATION OF STRESS AMONG REINFORCING BARS

of the section. The range in stresses may be illustrated by Fig. 9, where the stress in the reinforcing bars at right angles to the section considered is represented by the ordinates in the diagram. The stress of the bars lying under the pier may be considered to be uniform and

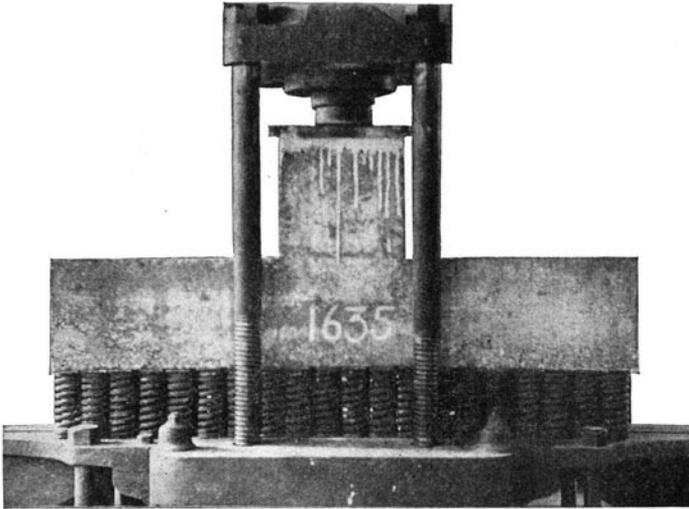
FIG. 10. VIEW OF WALL FOOTING IN TESTING MACHINE

As the load was applied by the testing machine, the springs compressed and the ends of the footing deflected somewhat. Vertical measurements were taken from the bed of the machine to marks on

both sides of the footing at five points along its length. These measurements were taken at a load of 2 000 lb., and at the various loads applied thereafter. A careful watch was made for cracks and their appearance and growth was recorded. After failure the footing was broken up and examined. Measurement of slip of bar and of deformations in the bar were made in some cases, as is described elsewhere.

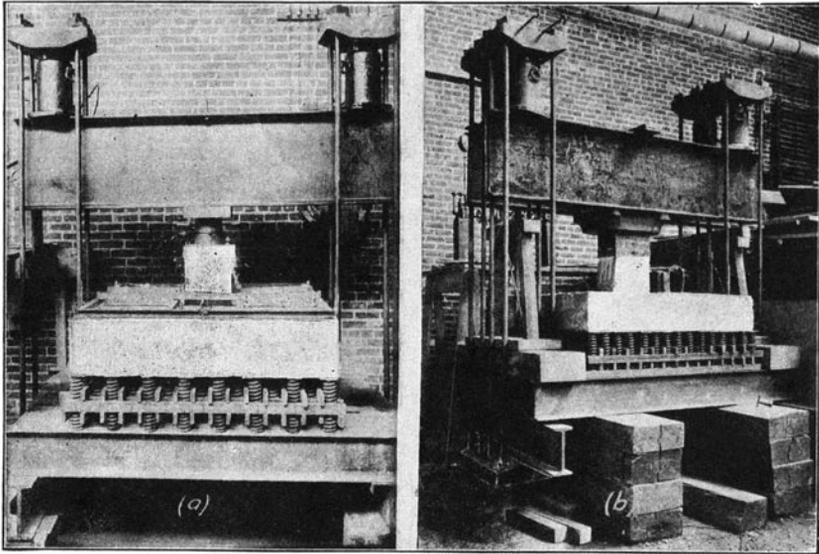
FIG. 11. TESTING MACHINES FOR COLUMN FOOTINGS

13. *Testing Column Footings.*—The column footings were tested in a machine built especially for the purpose. Fig. 11 (a) gives a view of the apparatus which was used in the tests in 1910, 1911, and 1912. A bed was formed by placing 10-in. I-beams side by side, the edges of the flanges touching. On this rested a bed of car springs on which the test footing was placed. Transversely under the bed of I-beams and near their ends were two 12-in. x 55-lb. I-beams 6 ft. long which took the load from above. Under these I-beams were two cast-iron blocks through which eight rods passed to similar cast-iron blocks on the upper part of the machine. The two hydraulic jacks by which the load was applied were placed between these blocks and a 24-in. I-beam. This I-beam transmitted the load through blocks to the top

of the pier. One of these blocks was an adjustable spherical bearing block. The lower or base block was bedded to the top of the pier with plaster of paris. The whole of the machine rested on a timber foundation. The pumps which operated the hydraulic jacks were placed on a platform near by, a gage being connected with each pump.

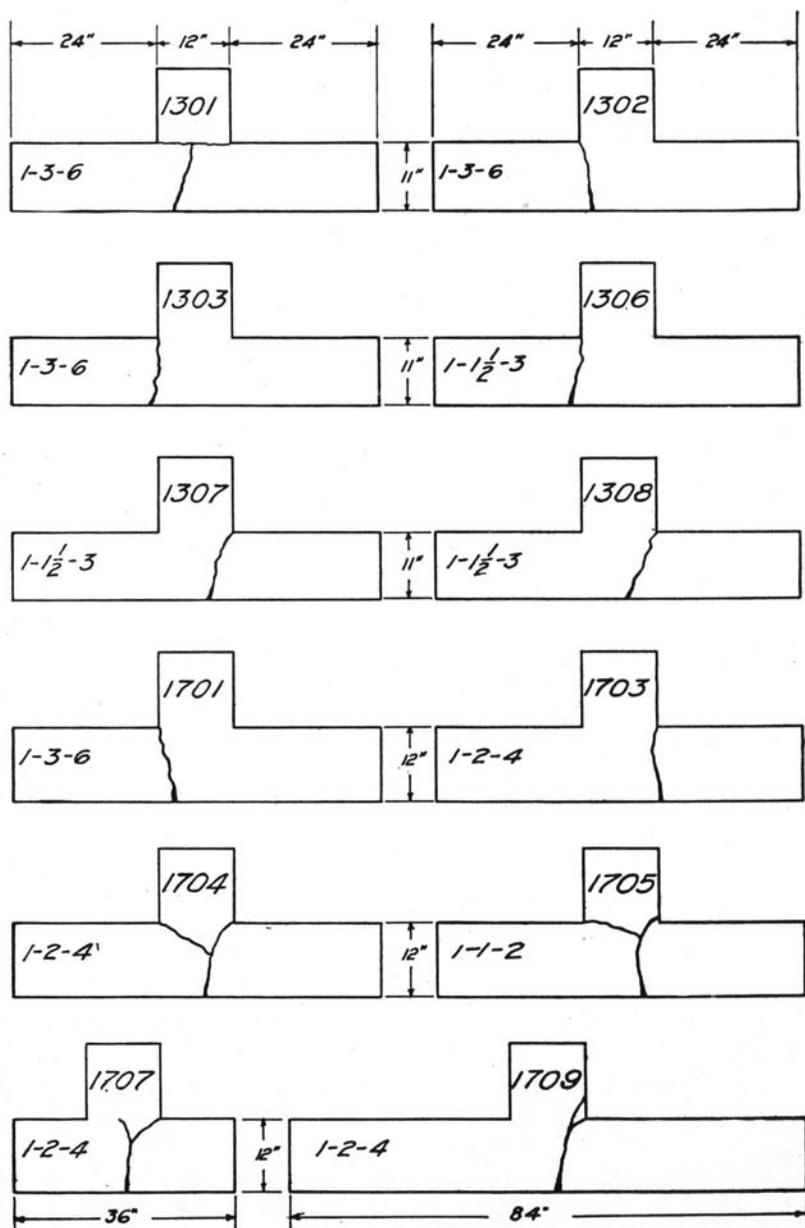
FIG. 12. UNREINFORCED CONCRETE WALL FOOTINGS

15. *Unreinforced Concrete Wall Footings.*—In the unreinforced concrete footings failure occurred very suddenly, no cracks being observed until the instant of failure. The failure crack (see Fig. 12) formed most frequently from a point almost directly under the edge of the wall and passed vertically upward to the face of the wall. In No. 1301, in which the wall had become separated from the footing before the test, the crack formed from a point under the middle of the footing and at failure the wall separated from the footing. Even with this form of failure, the footing developed a higher strength than its companion test pieces. In No. 1308 the crack formed from a point below the middle of the wall and extended to the edge of the wall; but its strength was less than that of its companion test pieces. The cubes from the mix from which this footing was made (see Table 4) gave a lower strength than did those of the companion cubes. It is considered that the critical section is at the edge of the pier and the calculations in Table 7 are made on this basis.

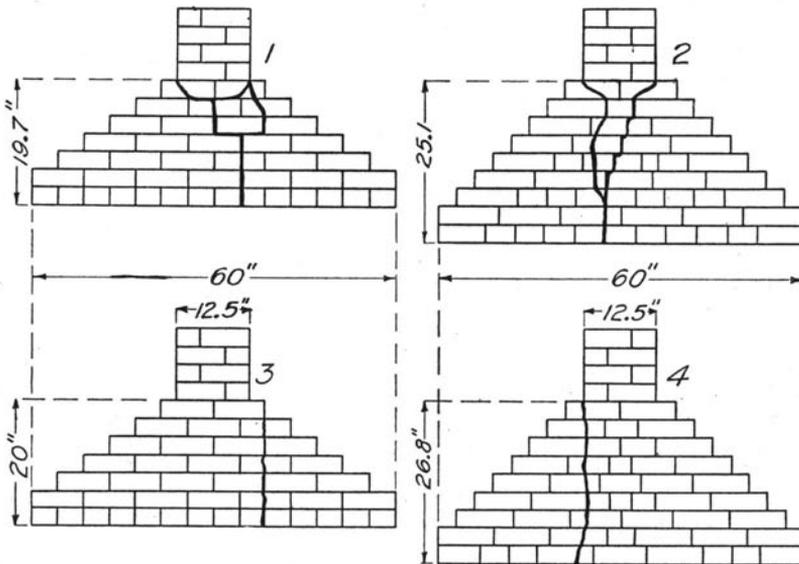
FIG. 13. BRICK WALL FOOTINGS

footings are shown in Fig. 13. All the footings were well laid up in 1-3 portland cement mortar, joints being broken in workmanlike manner, and the workmanship was the same as that described in Bulletin No. 27 for the brick columns. Two grades of brick were used, shale build-

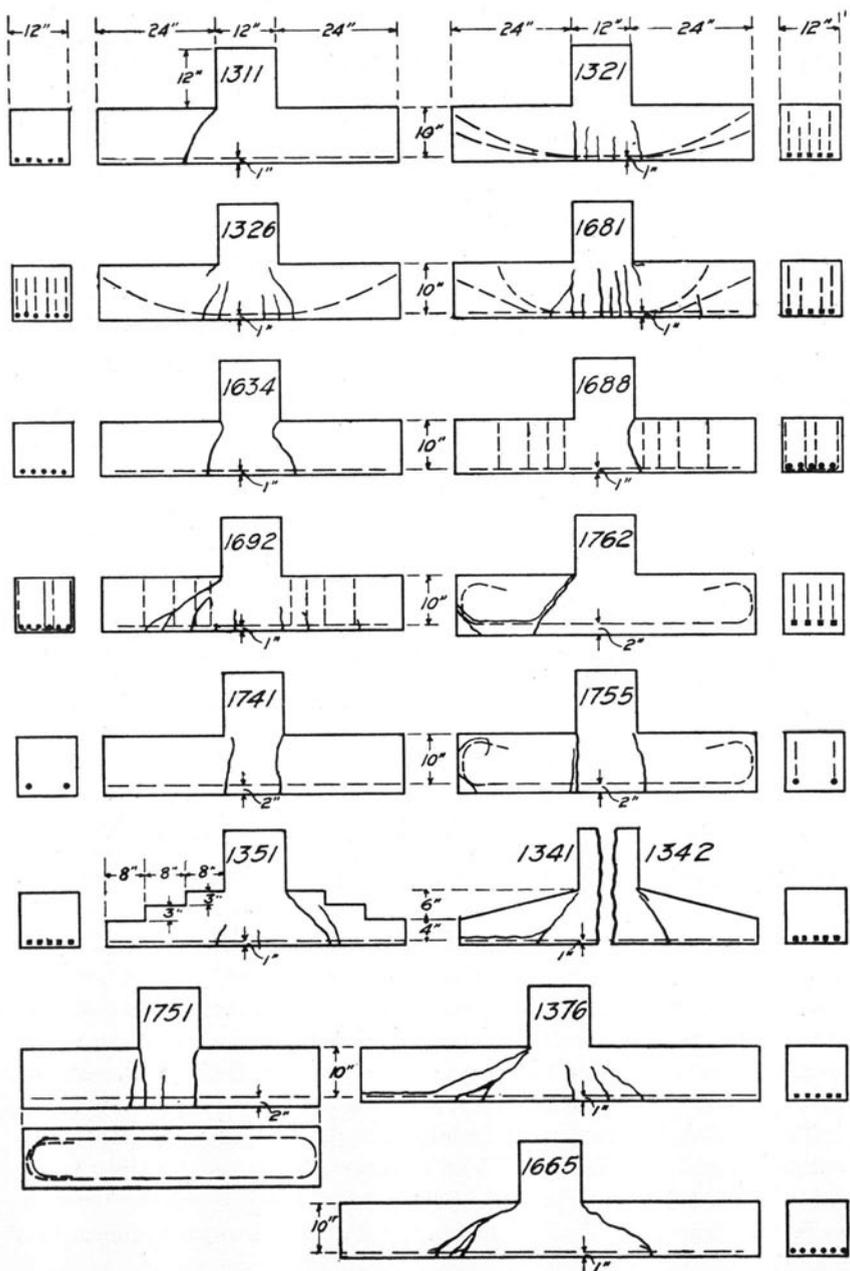
FIG. 14. REINFORCED CONCRETE WALL FOOTINGS

described in Tables 9 to 11, and the position of the bars is shown in Fig. 14. Except where otherwise noted, the wall and footing were poured at the same time. In the footings made in 1909 and 1911 four  $\frac{1}{4}$ -in. bars were placed vertically in the corners of the wall, extending down into the footing, to prevent displacement of the wall in handling.

The following are brief notes of the tests. The location of the cracks is shown in Figs. 14 and 19. Heavy lines indicate the crack

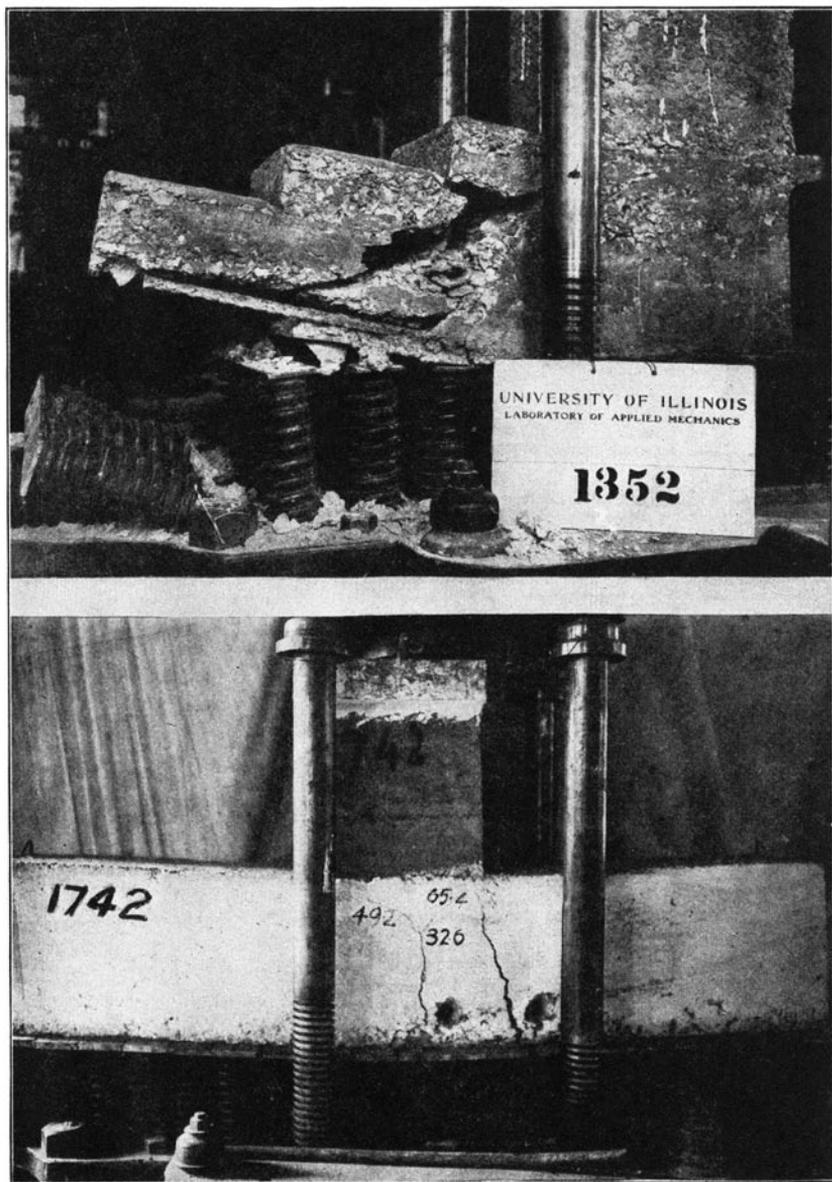
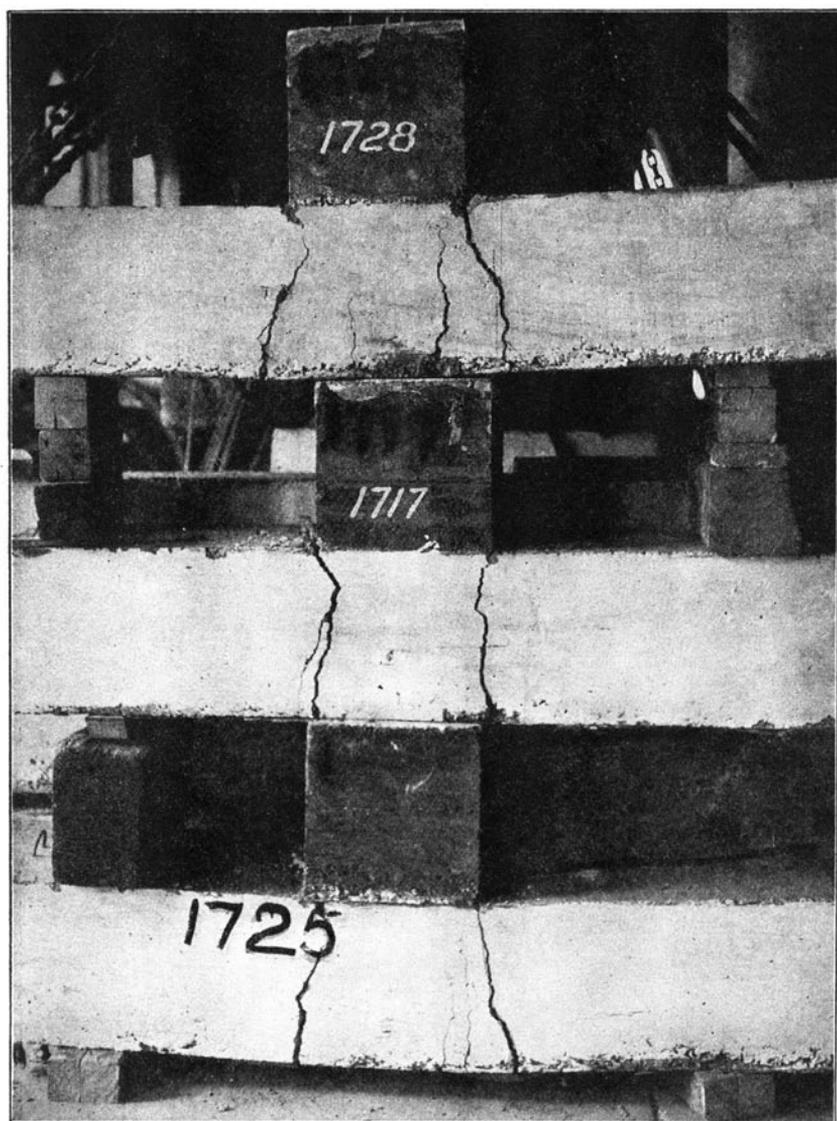
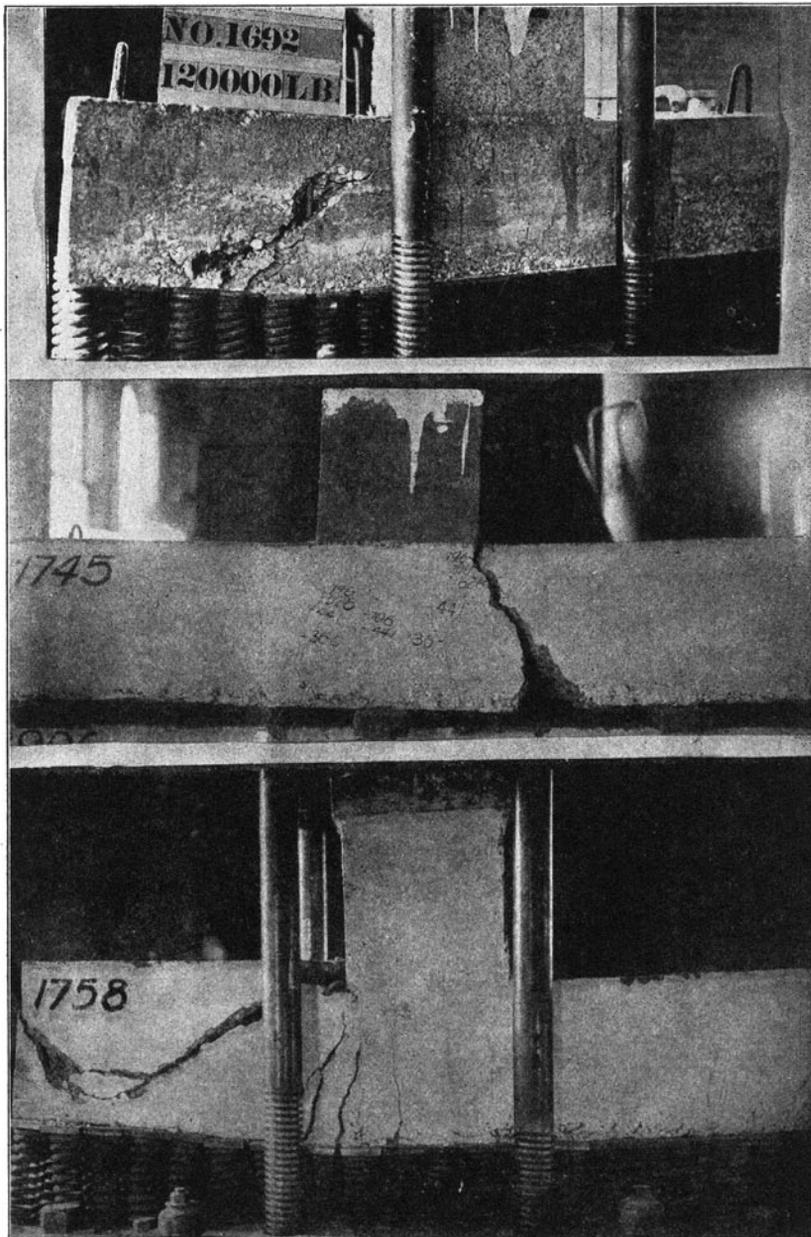
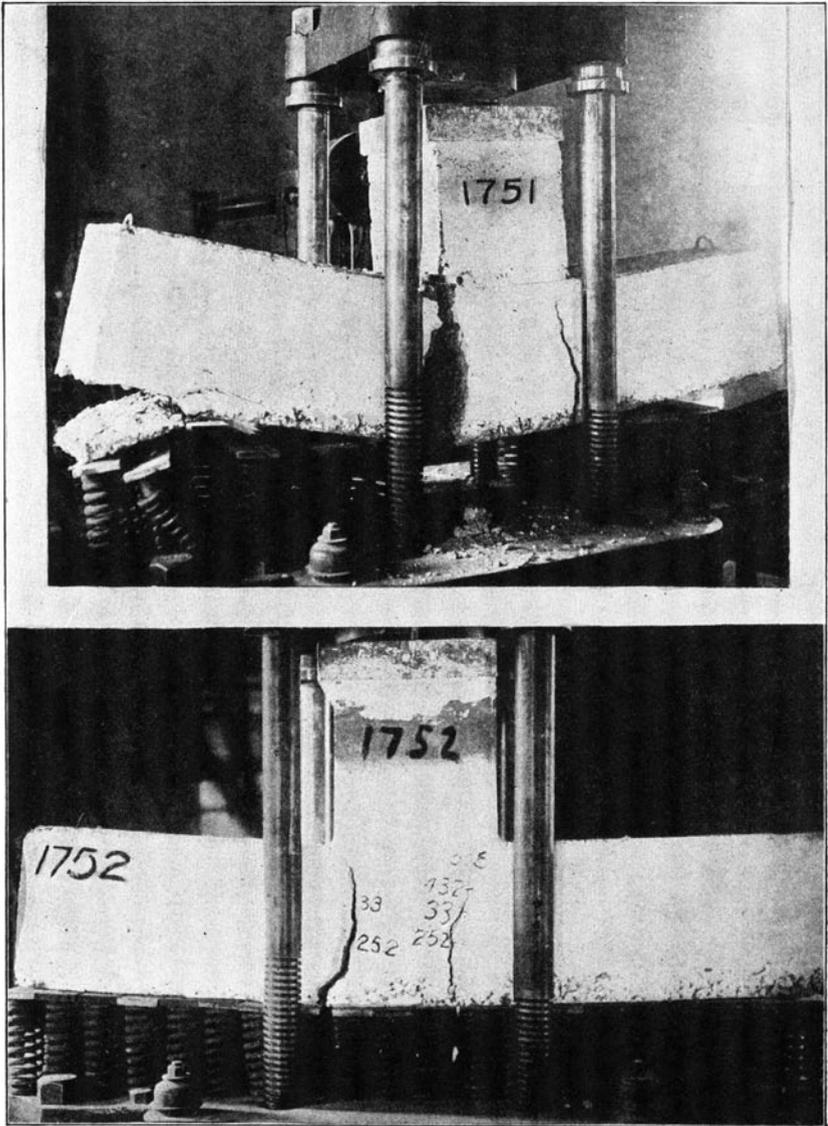
FIG. 15. VIEWS OF REINFORCED CONCRETE WALL FOOTINGS AFTER TEST

FIG. 16. VIEWS OF REINFORCED CONCRETE WALL FOOTINGS AFTER TEST

FIG. 17. VIEWS OF REINFORCED CONCRETE WALL FOOTINGS AFTER TEST

FIG. 18. VIEWS OF REINFORCED CONCRETE WALL FOOTINGS AFTER TEST

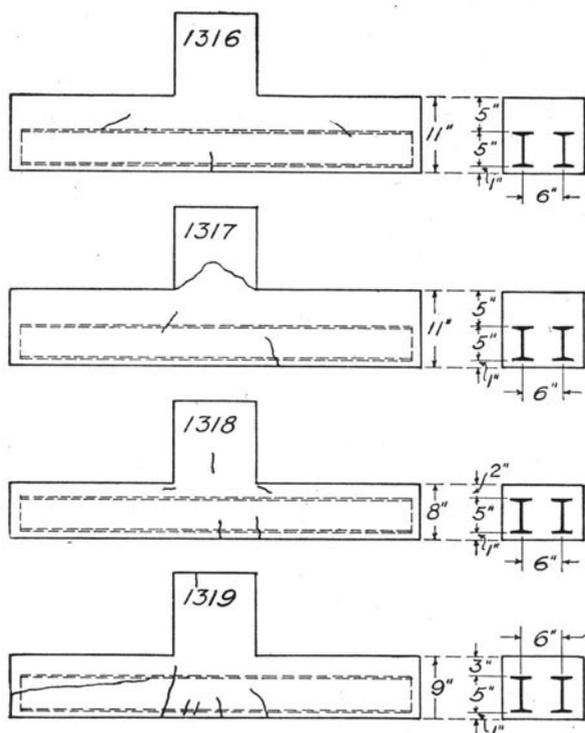
FIG. 19. WALL FOOTINGS REINFORCED WITH I-BEAMS

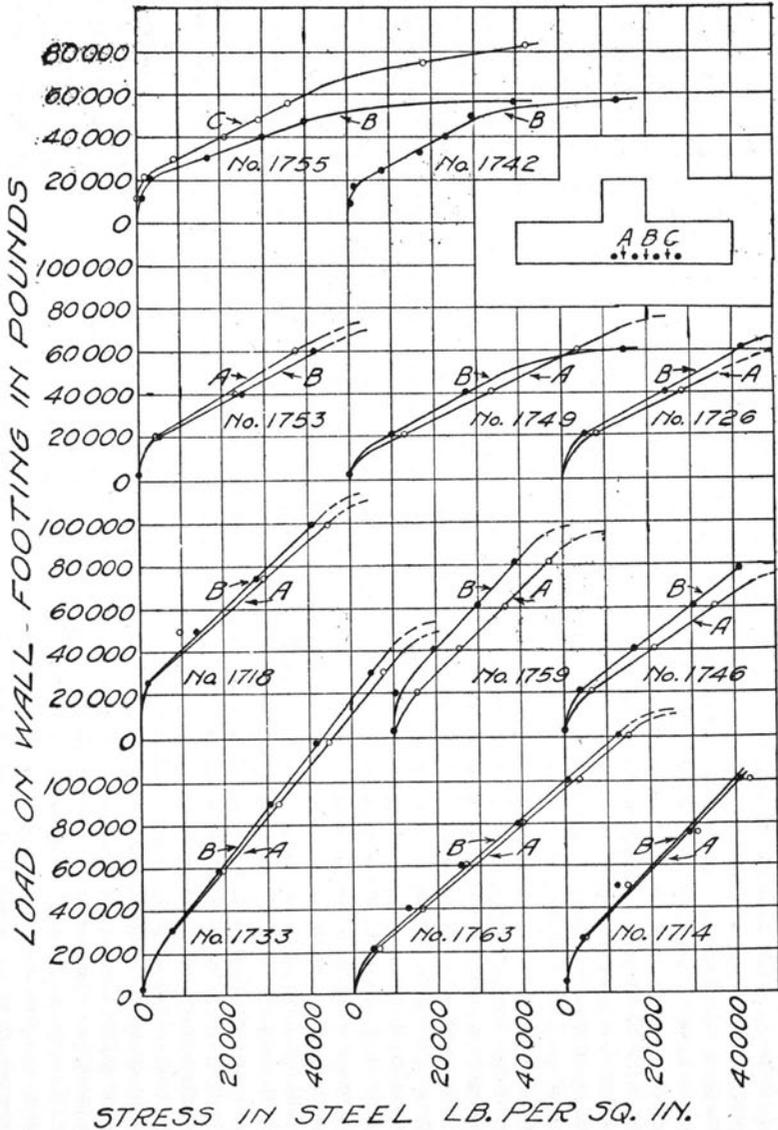
FIG. 20. DIAGRAM OF OBSERVED STRESSES IN REINFORCING BARS

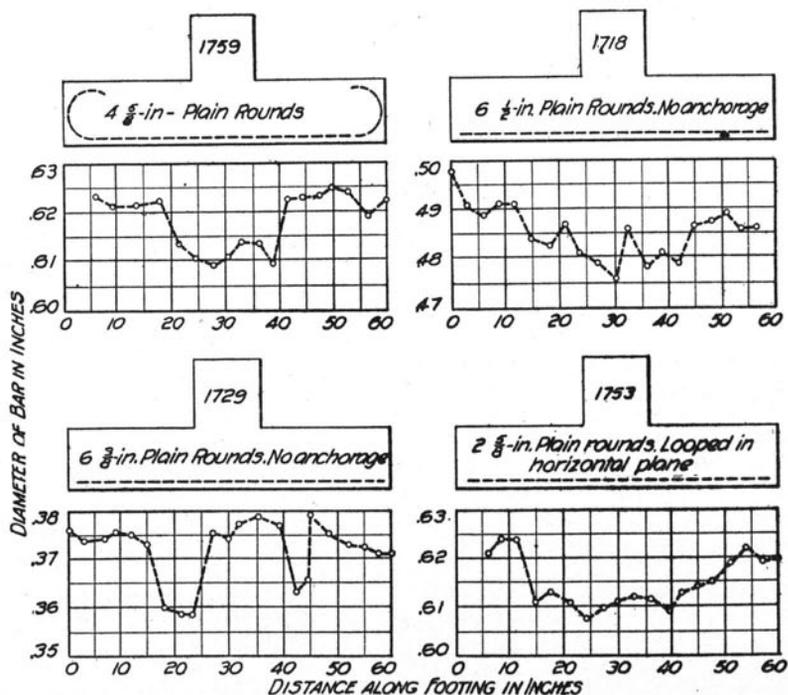
FIG. 21. DIAGRAM SHOWING DIAMETER ALONG BARS AFTER TEST OF FOOTING

bars examined and calipered. In Fig. 21 the diameter of bars at various sections along their length is plotted. Although there is always considerable variation in the original diameters of such bars, these measurements were useful in helping to determine the method of failure.

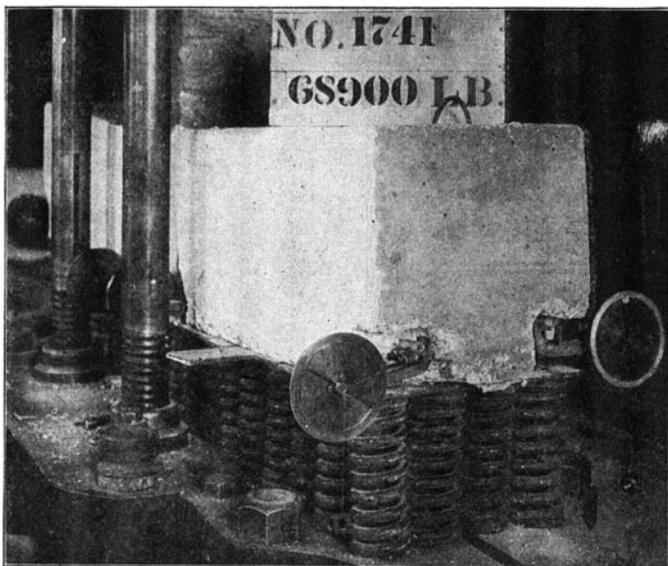
FIG. 22. INSTRUMENTS IN PLACE TO MEASURE SLIP OF BARS

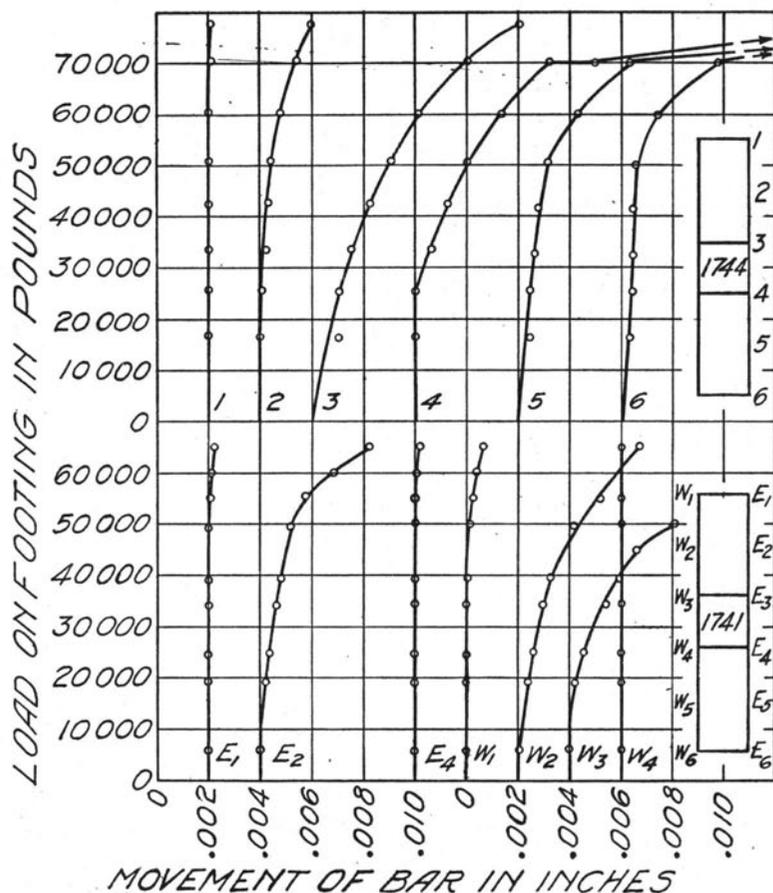
FIG. 23. DIAGRAM SHOWING SLIP OF BARS

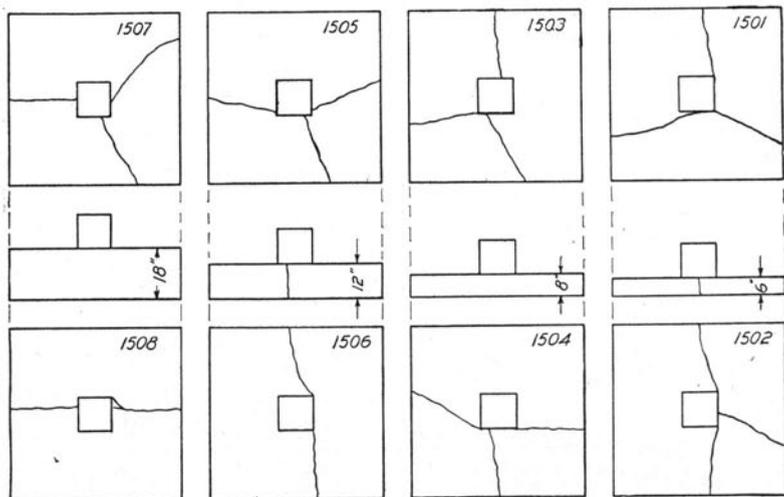
FIG. 24. UNREINFORCED CONCRETE COLUMN FOOTINGS

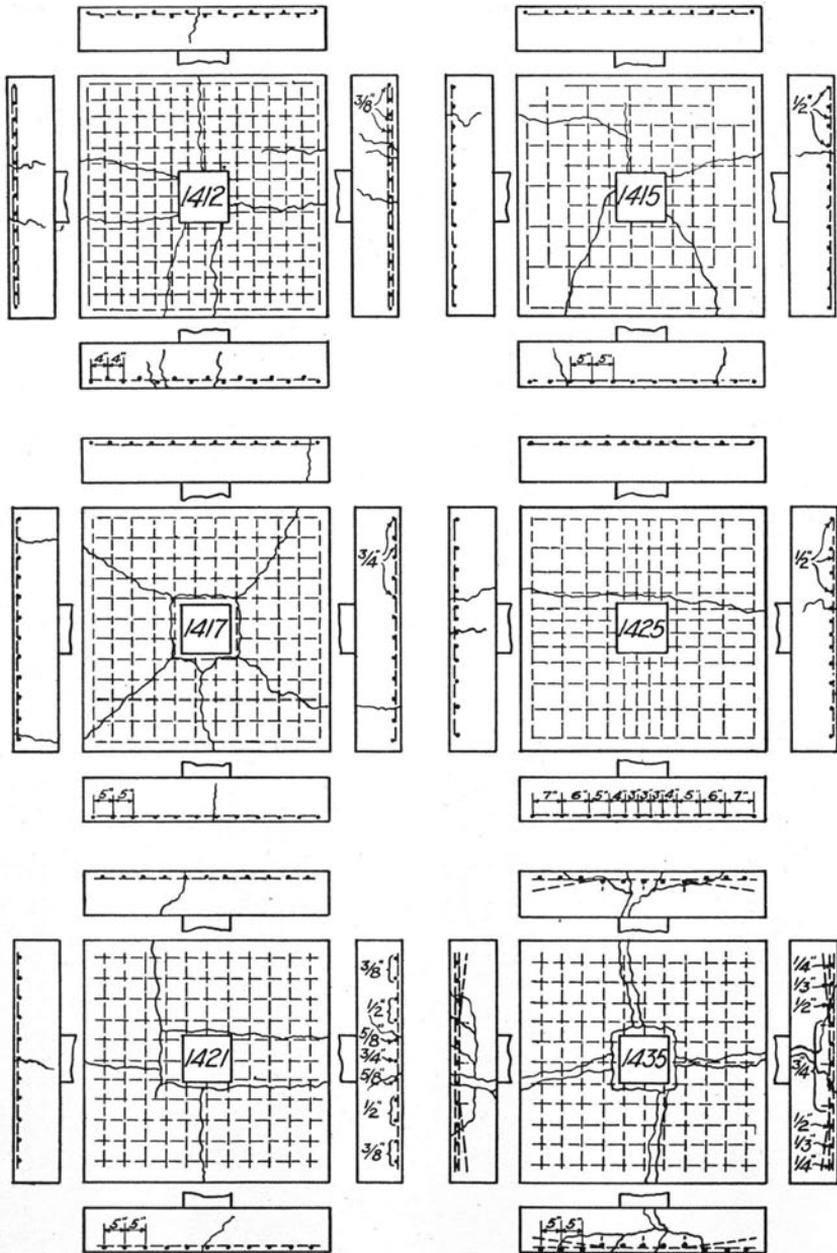
The Drawings of No. 1412, 1415 and 1421 show the Cracks as they appeared on the Bottom Surface of the Footing.

FIG. 25. REINFORCED CONCRETE COLUMN FOOTINGS

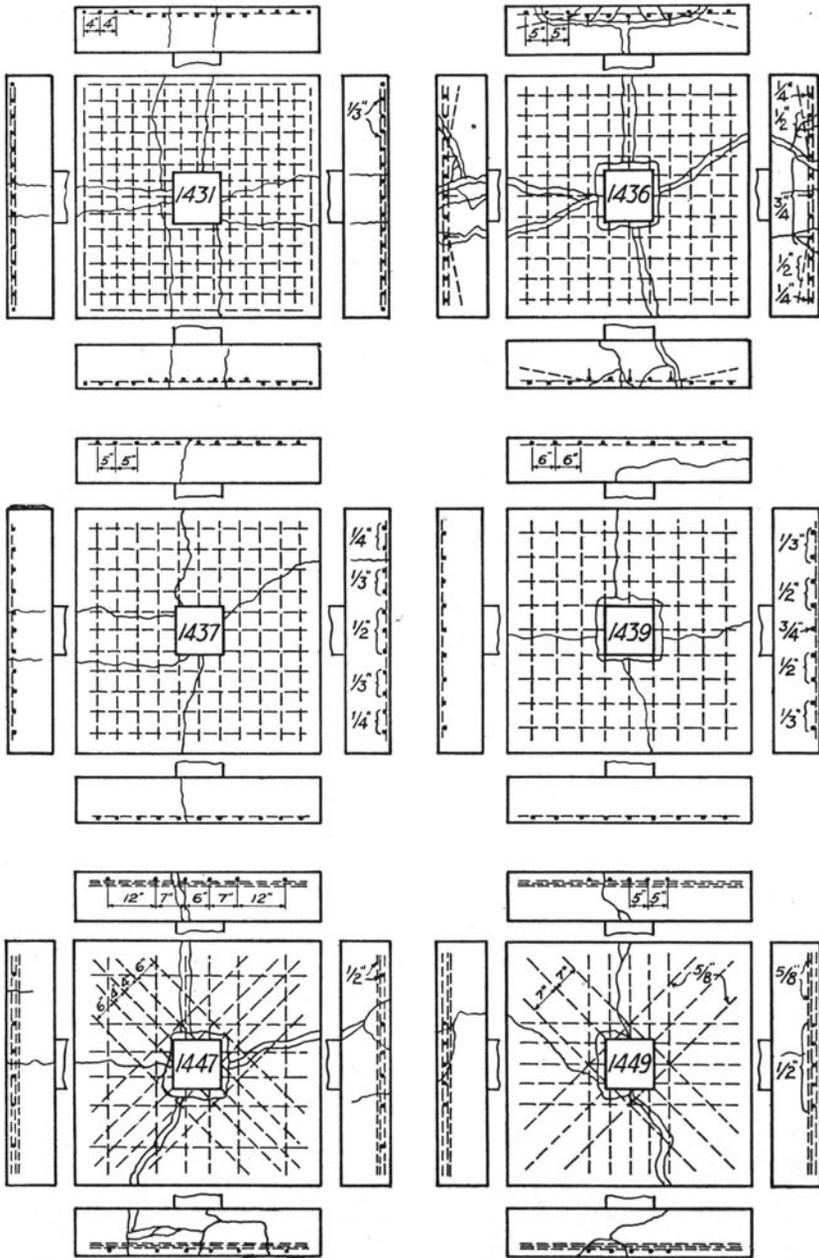
The Drawings of No. 1431 and 1437 show the Cracks as they appeared on the Bottom Surface of the Footing.

FIG. 26. REINFORCED CONCRETE COLUMN FOOTINGS

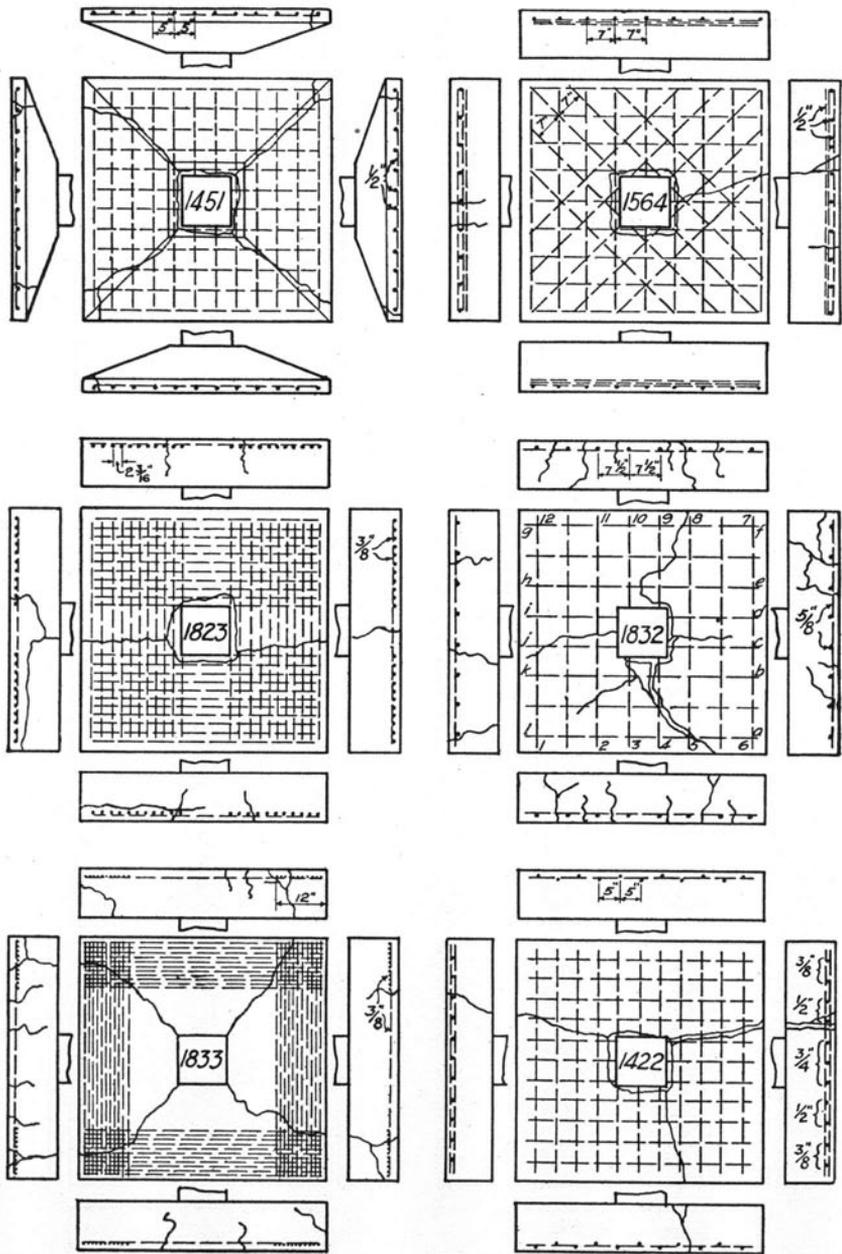
FIG. 27. REINFORCED CONCRETE COLUMN FOOTINGS

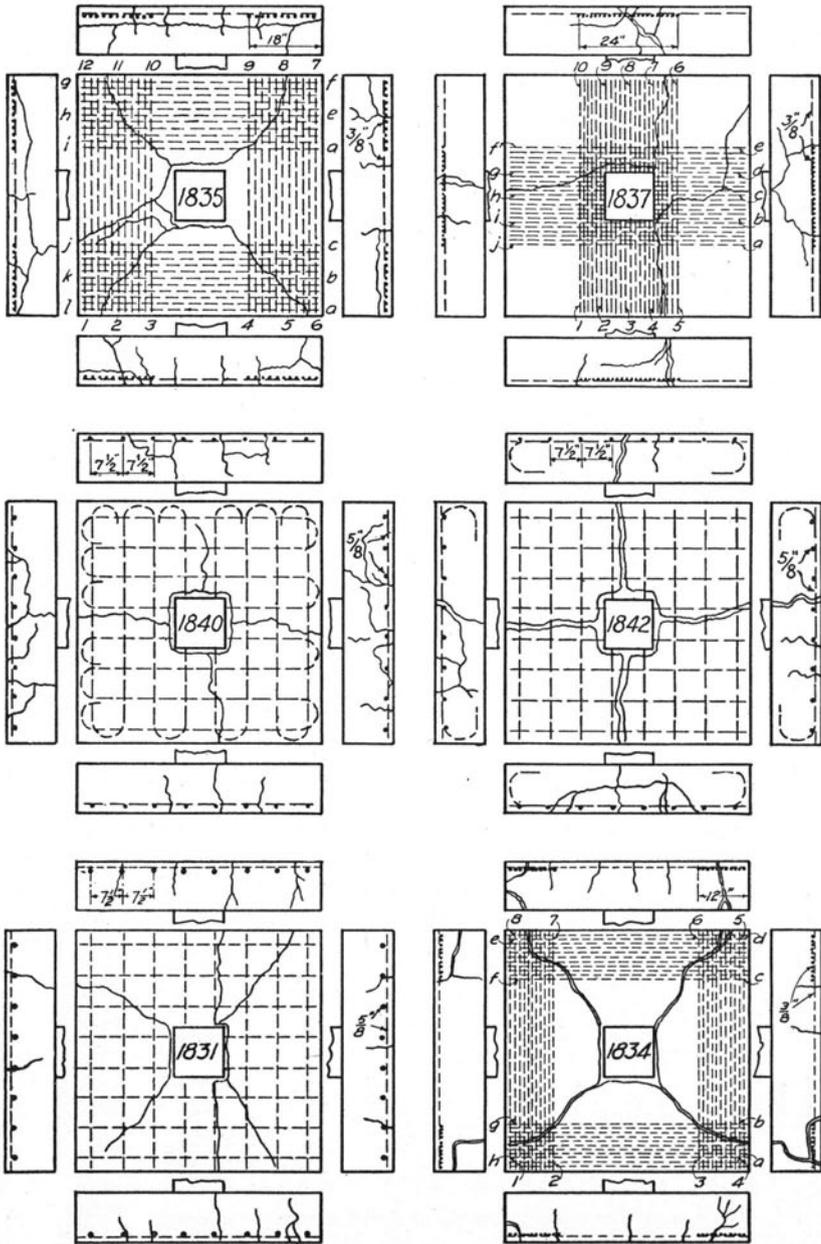
FIG. 28. REINFORCED CONCRETE COLUMN FOOTINGS

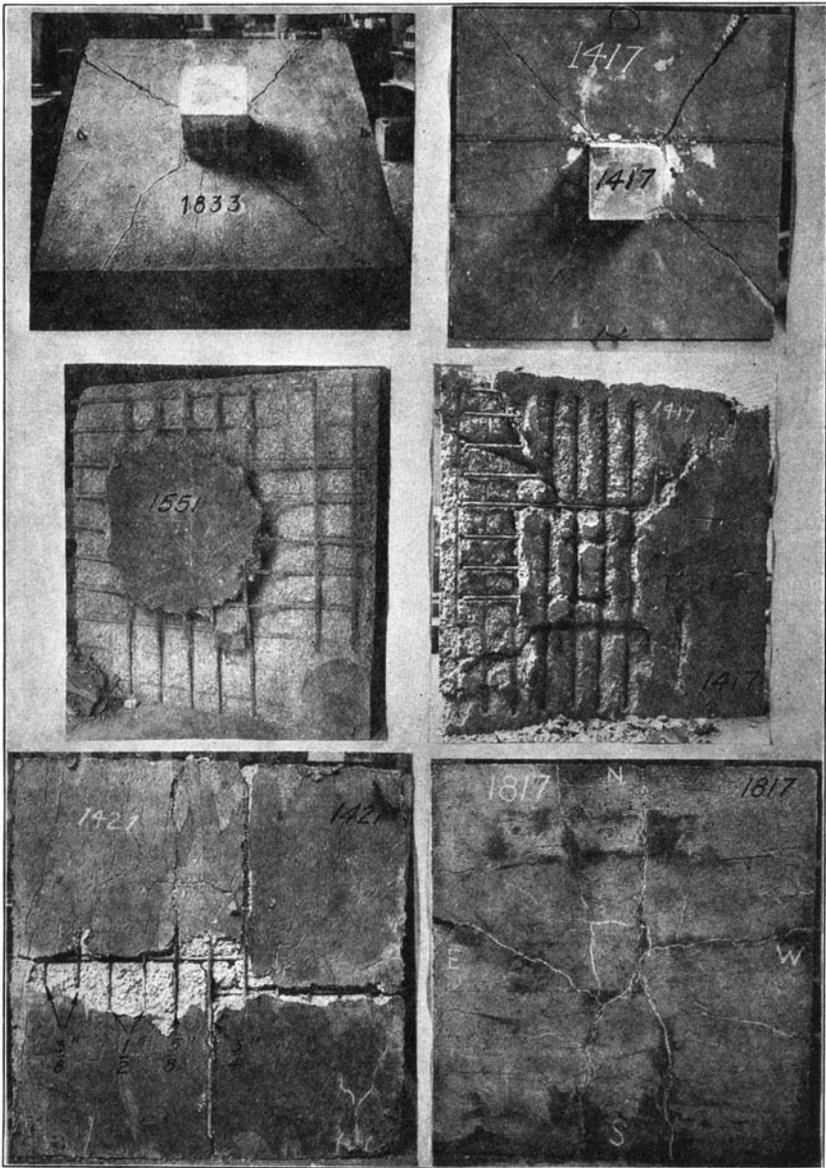
FIG. 30. VIEWS SHOWING COLUMN FOOTINGS AFTER FAILURE

No. 1551. (See Fig. 30.) Ten-inch depth. Reinforced with round corrugated bars. Tension cracks formed at 102 000 lb. Instru-

ments removed at 102 000 lb. At 218 000 lb. tension cracks formed at middle of third lateral face. At 225 000 lb. failure by diagonal tension, as shown in Fig. 30, the reinforcing bars stripping off.

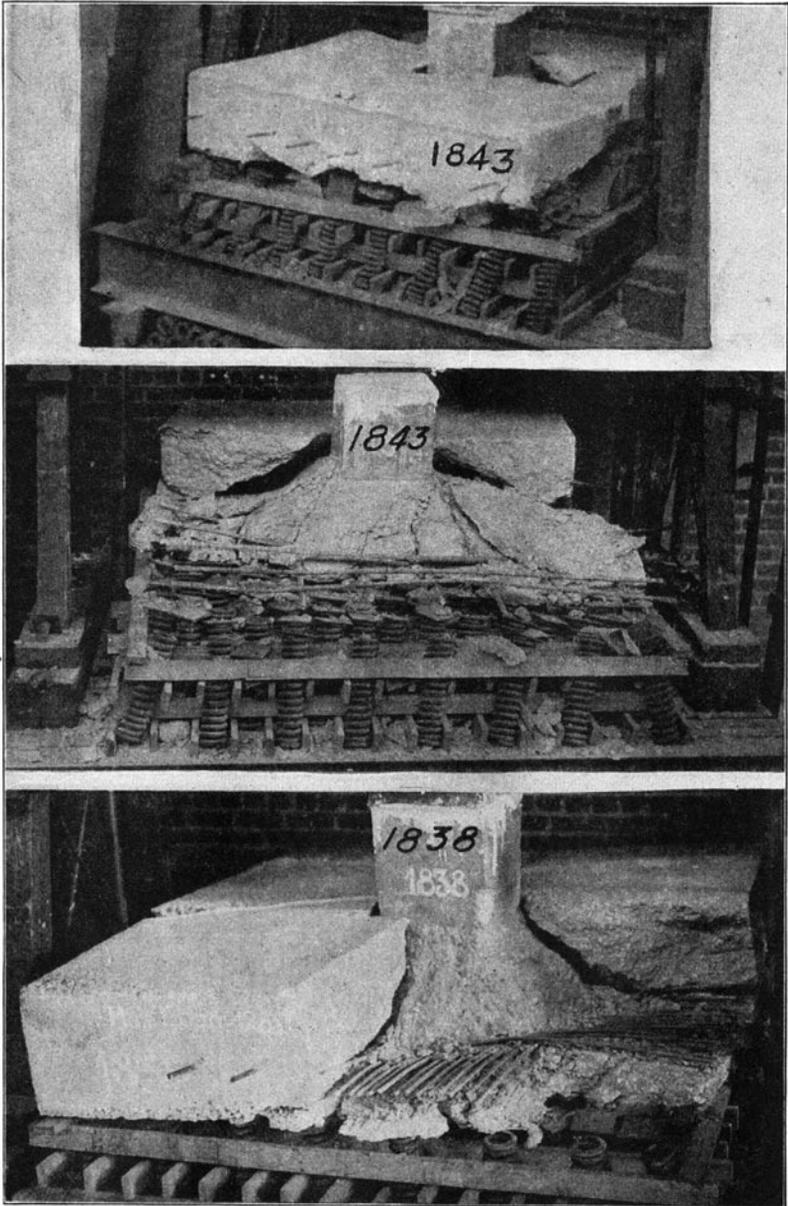
FIG. 31. VIEWS SHOWING COLUMN FOOTINGS AFTER FAILURE
