# UNIVERSITY OF ILLINOIS BULLETIN

## REINFORCED CONCRETE WALL FOOTINGS AND COLUMN FOOTINGS

ARTHUR N. TALBOT

BULLETIN NO. 67

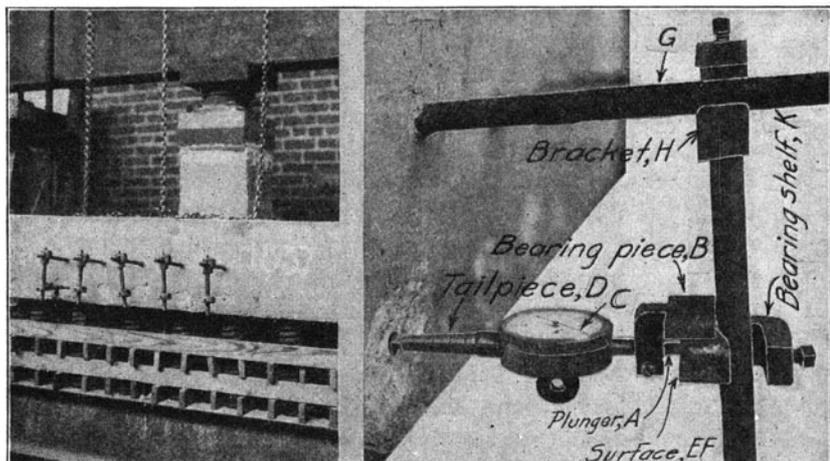
FIG. 32. APPARATUS FOR DETERMINING END SLIP OF BARS

In order to determine definitely when first slip occurs at the end of the bars and whether bond is likely to be a primary cause of failure, a device was used in some of the 1912 tests by means of which an end movement of the bar as small as 0.0001 in. was measured with considerable certainty. This movement was determined by measuring the change in distance between the end of the reinforcing bar and a point in line with its axis and about  $5\frac{1}{2}$  in. from the face of the footing. The apparatus is shown in Fig. 32. The measuring instrument consists of an Ames gage micrometer equipped with a pointed tail piece D and a bearing piece B. Movement of the pointer C indicates change in distance between the point of the tail piece and the end of the micrometer plunger A. In operation the point of the tail piece is inserted in a small hole drilled in the end of the reinforcing bar, and the end of the plunger is brought to bear at a definite point upon the surface EF which has a fixed position relative to the face of the footing. The position of the surface EF is maintained by means of the auxiliary rod G, the cast-iron bracket H, and the bearing shelf K. The auxiliary rod G is embedded a short distance in the concrete at the time of pouring the concrete and the other parts are put in place at the time of the test. In order that the end of the plunger shall always have contact with the same point of the surface EF, two conical contact points attached to the under side of the bearing piece serve to insure that the bearing of the plunger of the micrometer shall always be in

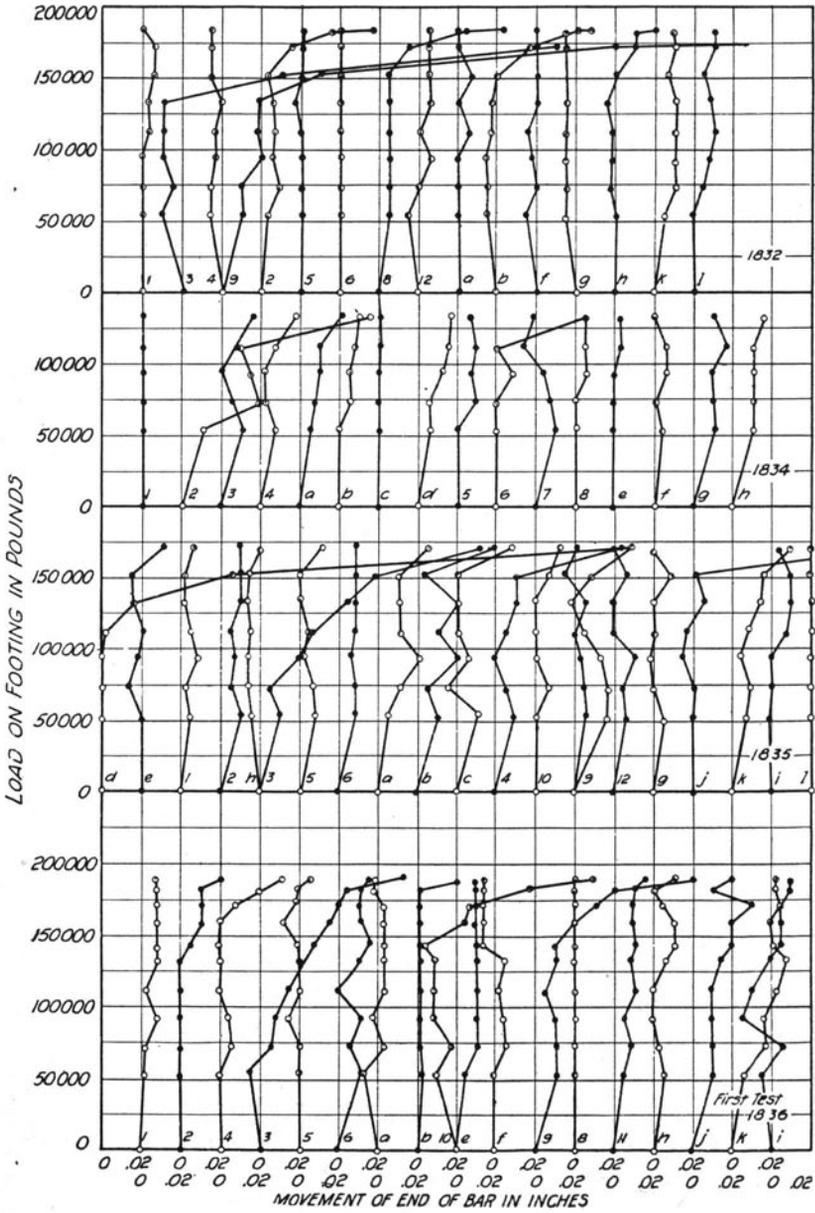
FIG. 33. DIAGRAM SHOWING END SLIP OF BARS

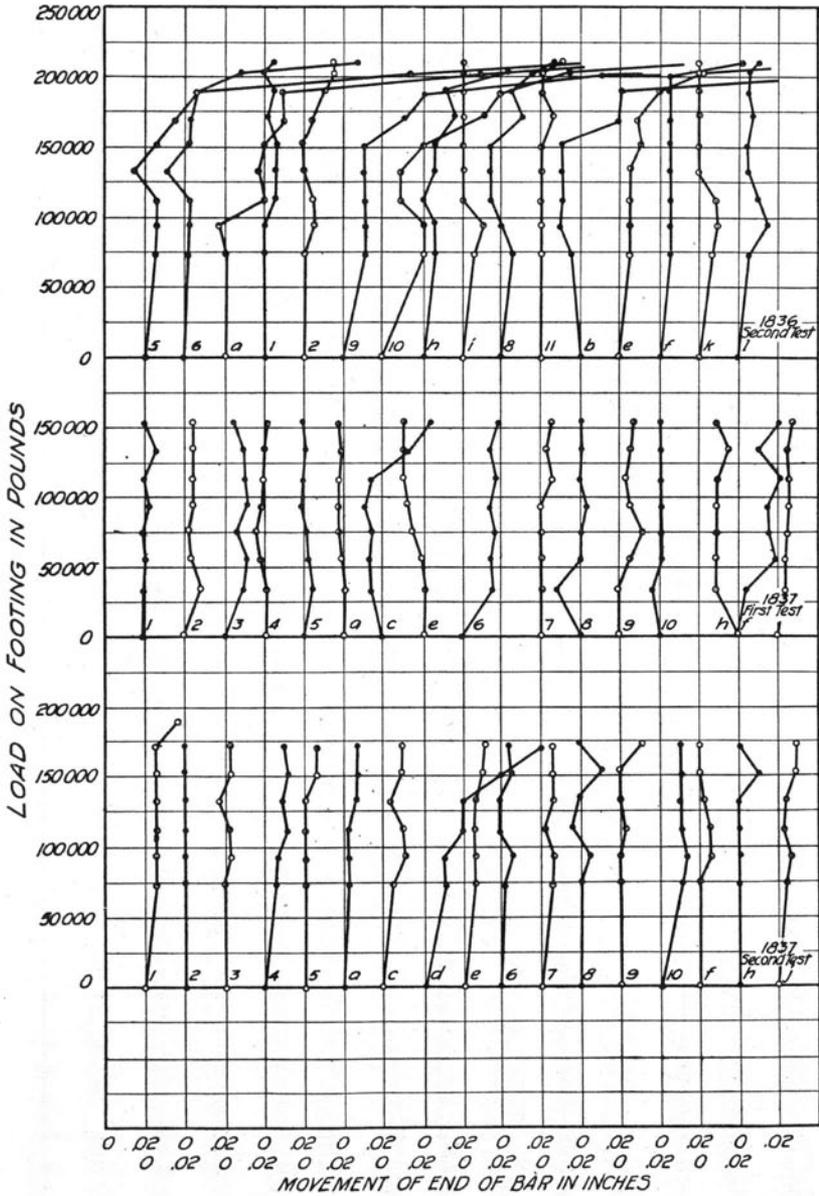
FIG. 34. DIAGRAM SHOWING END SLIP OF BARS
