Destructive Testing of IDOT Bridge Structure Number 020-3087

Research Report No. FHWA-ICT-20-008

Destructive Testing of IDOT Structure Number 020-3087

August 2020

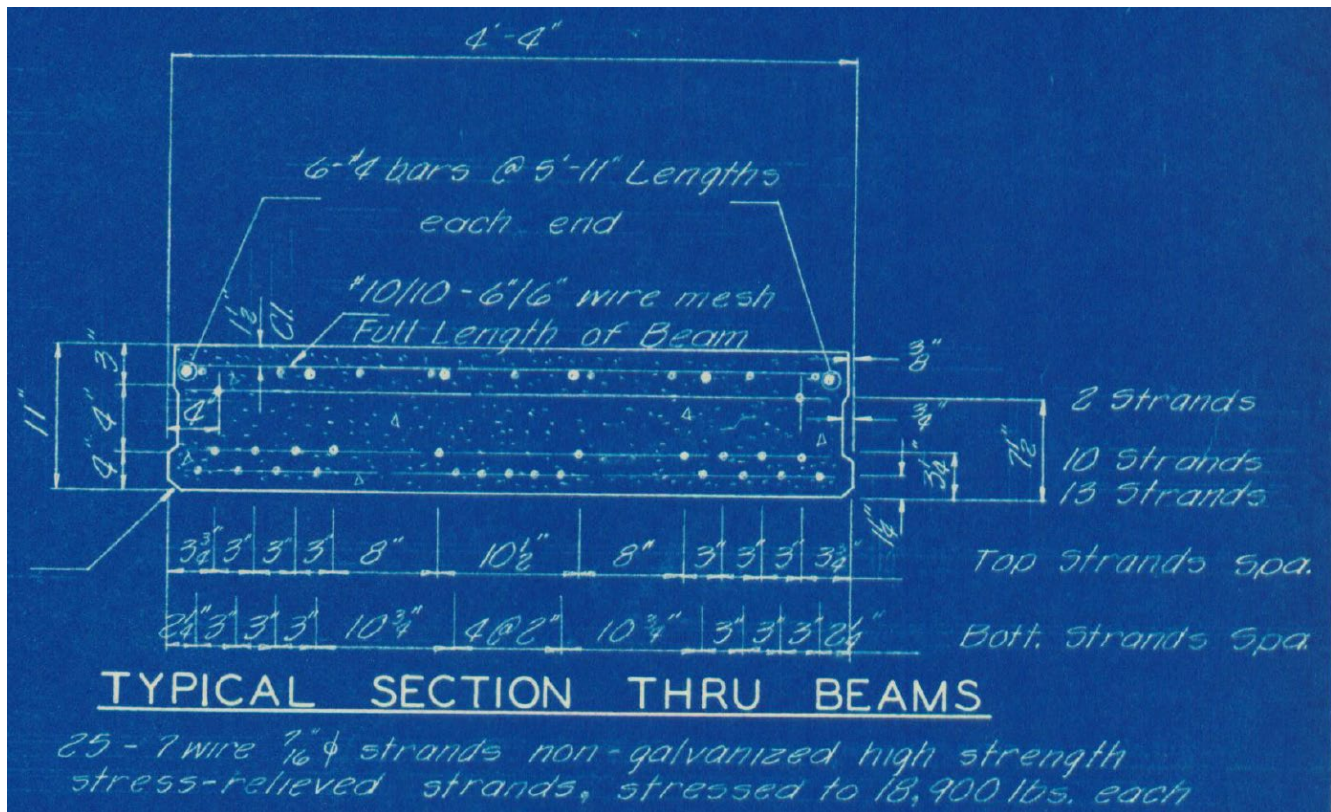
Figure 4. Photo. Cross-section of PPC deck beam per original design drawings.

The design drawings indicate 25-7 wire high-strength, stress-relieved strands that are non-galvanized, stressed to 18,900 lbs each. This corresponds to 0.108 in² cross-sectional area stressed to 70% of its ultimate strength of 250 ksi per appendix A-5 in Nawy (2009).

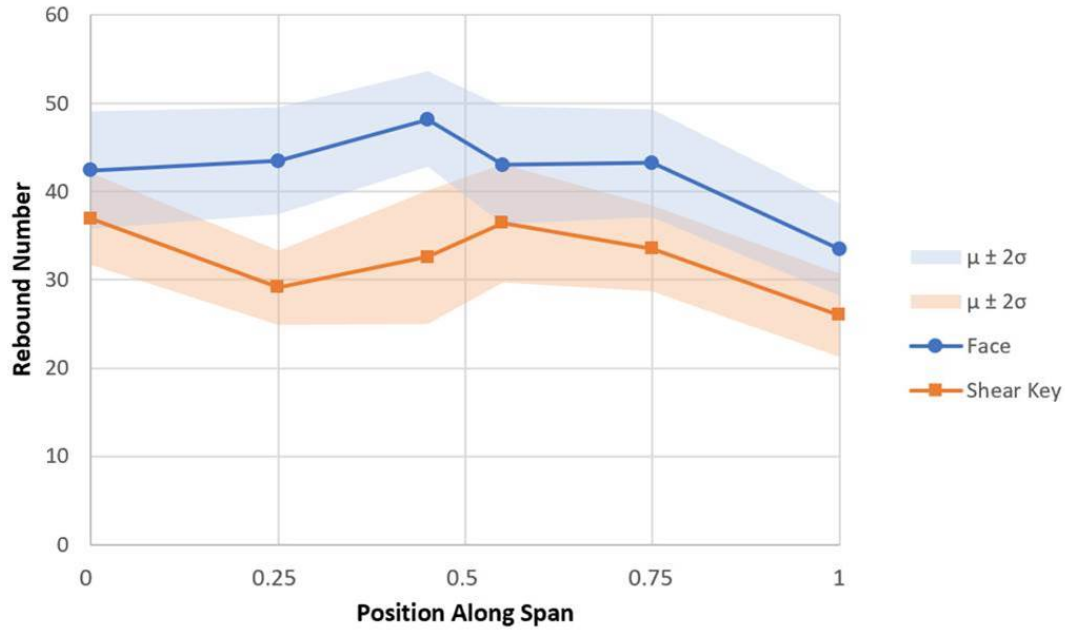
The rebound hammer test results were used to determine that the concrete quality was not significantly different at the beam ends, compared to the midspan location. This result justified the decision to support the beam near its ends.

Figure 6. Graph. Rebound number along the length of the beam.

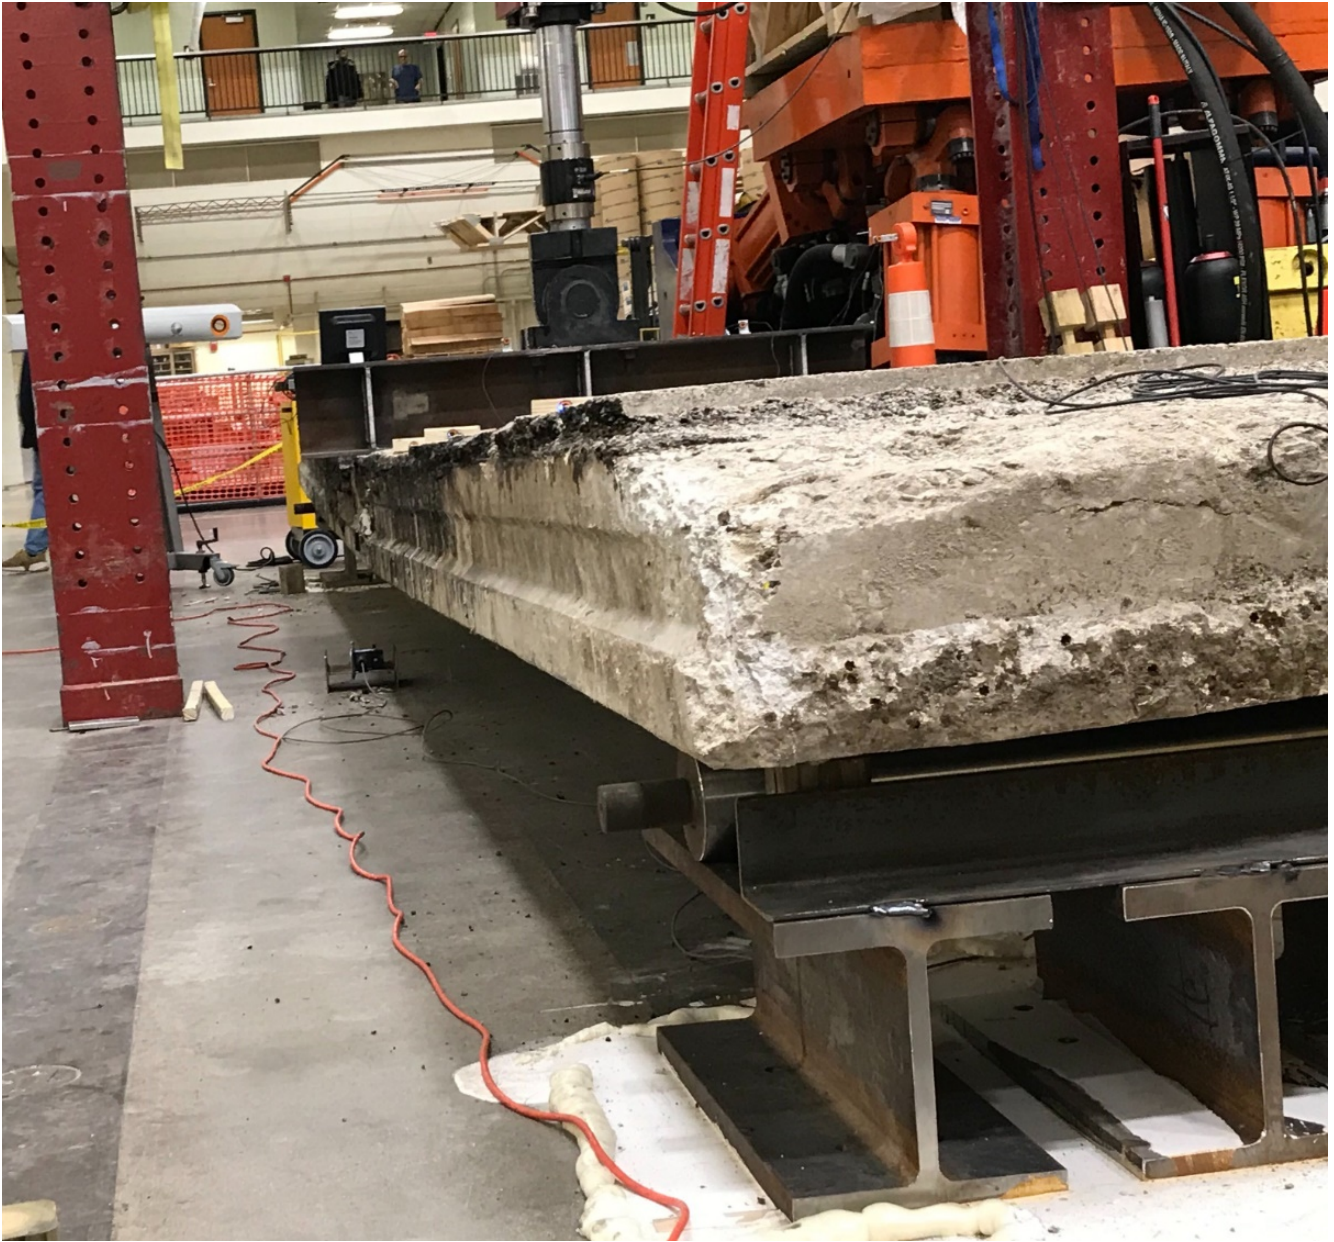
Figure 9. Photo. Test specimen during the three-point bending test.

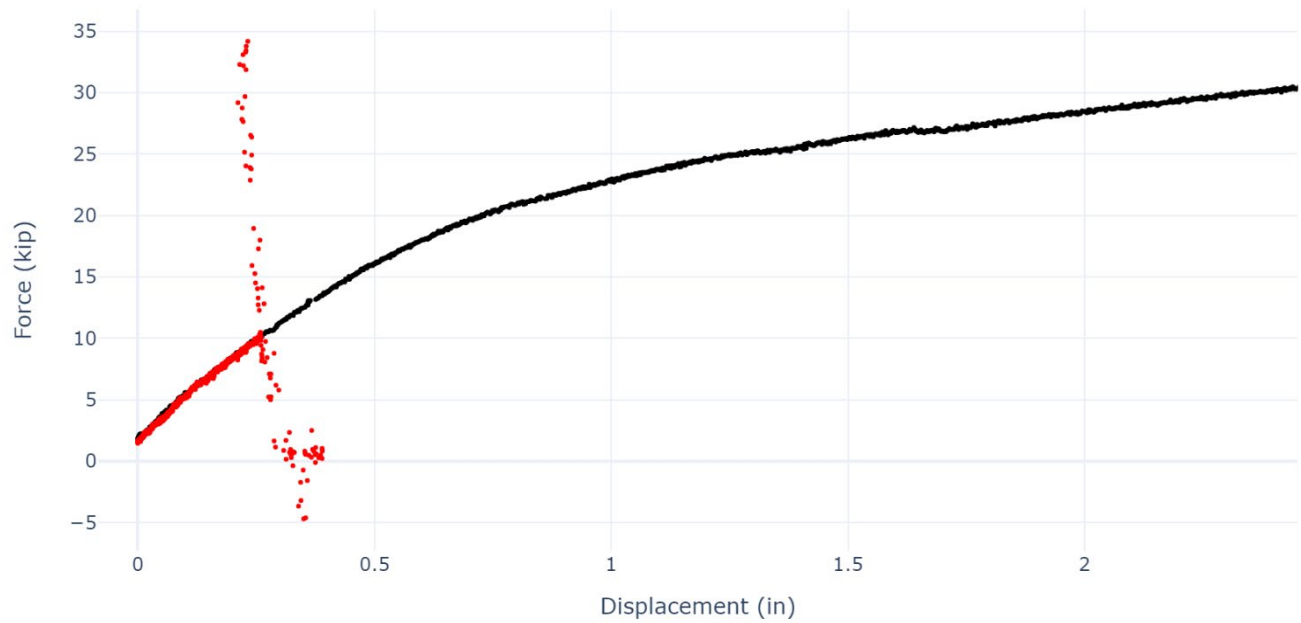
The test was carried out using displacement-controlled loading at a rate of 1/4 inch per minute. The three-point bending test results are shown in Figures 12 and 13. The initial loading showed an instability in the load application, which resulted in large jumps of applied force in very short time increments. This test was immediately halted and the actuator tuning corrected. As seen in Figure 12, the restarted test showed nearly identical results in the low displacement range compared to the initial test. This result indicates that the instability in the initial test likely did not damage the specimen, as there was no change in initial stiffness. The complete load vs displacement plot is shown in Figure 13. A peak load of 33.1 kips was reached at a displacement of 3.5 in, after which a steep drop in applied load is seen. This drop is the result of crushing the concrete on the surface of the beam. The post-peak plateau sustained around 21 kips of loading for an additional inch of displacement before the cracks propagated completely through the depth of the beam, causing collapse. The noncontact displacement measurements closely match the string potentiometer measurements. The peak load of 33.1 kips corresponds to a moment of 227.5 kip-ft.

Figure 12. Graph. Force vs displacement plot of the initial loading (in red) and the corrected loading (in black)

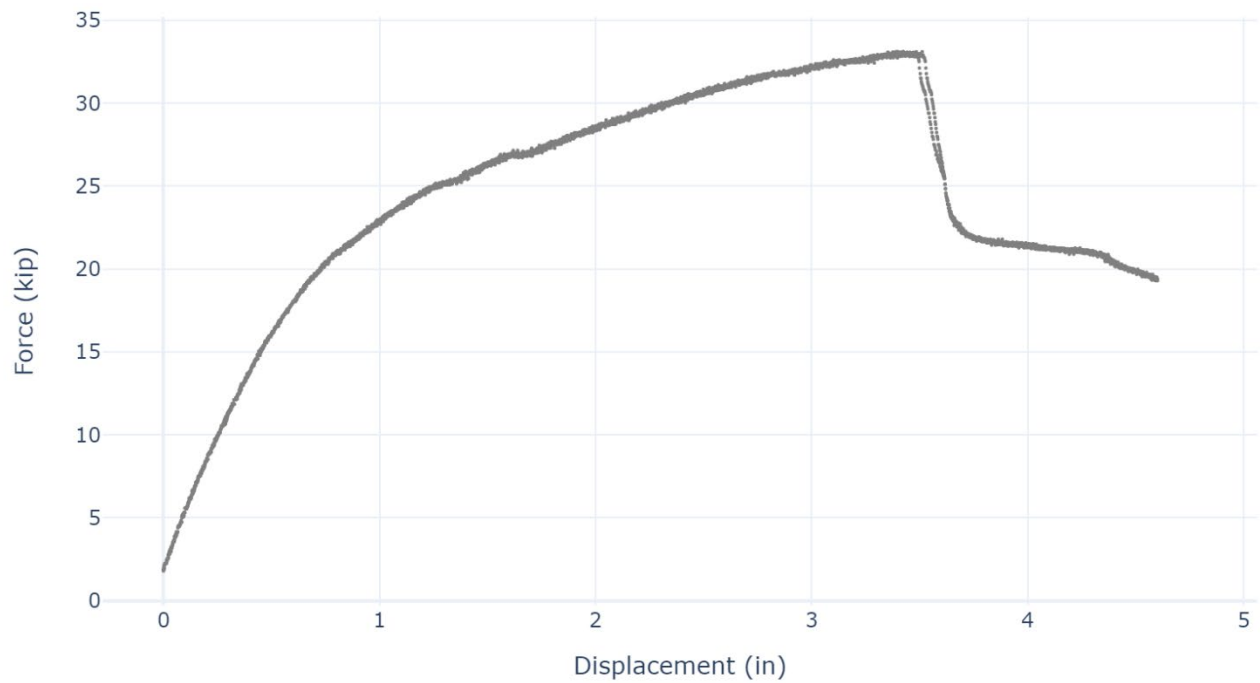
Figure 13. Graph. Force vs displacement plot of the complete load test showing displacement data from both string potentiometers.

The three-point bending test successfully loaded the member to a flexural failure that consisted of concrete crushing at the top surface. The load-displacement behavior of the three-point bending test resulted in an ultimate strength well below a moment capacity computed using nominal material strengths. When the laboratory reopens following the COVID-19–related closures, concrete core samples will be taken from the undamaged portion of the deck and tested to determine the actual concrete strength of the beam.
