Evaluation of Premature Cracking in Urban Concrete Pavement

Research Report No. FHWA-ICT-21-001

A report of the findings of
ICT PROJECT R27-193-4
Premature Cracking Mechanism for
Jointed Plain Concrete Pavement

January 2021

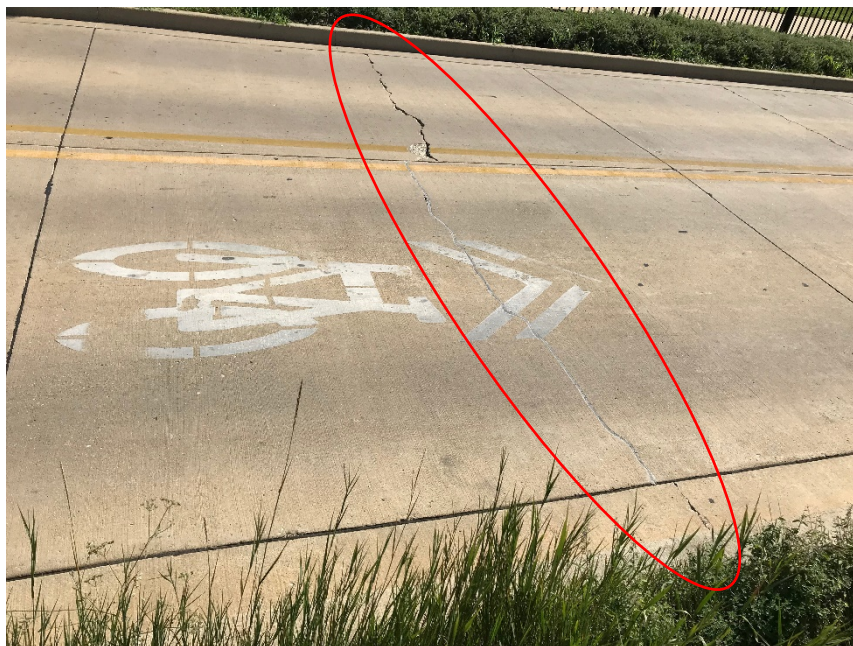
The University of Illinois at Urbana-Champaign conducted a research investigation on the potential mechanisms causing premature cracking distresses in urban jointed plain concrete pavements (JPCP) in the state of Illinois. Premature transverse cracking has been periodically observed in relatively new urban concrete pavements. Figure S1 illustrates an example of a premature transverse crack in Champaign, Illinois.

Figure S1. Photo. Urban concrete pavement section with a transverse crack.

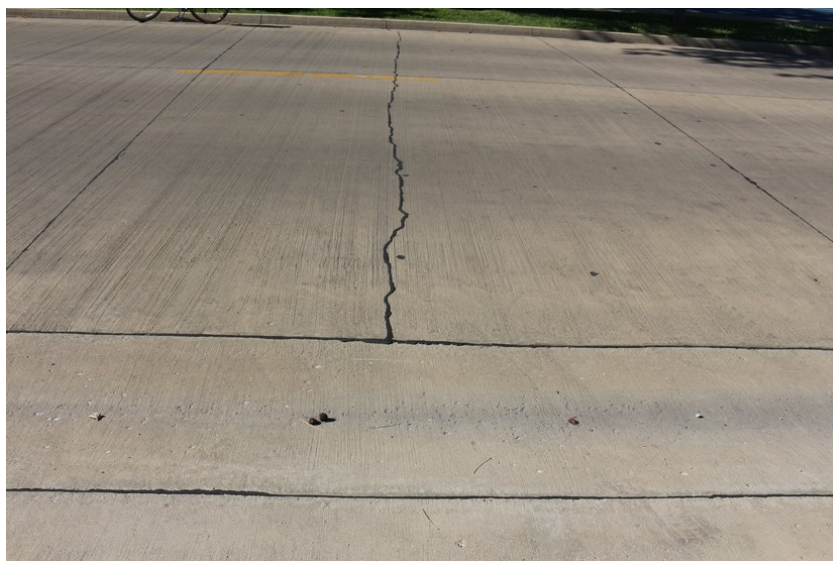
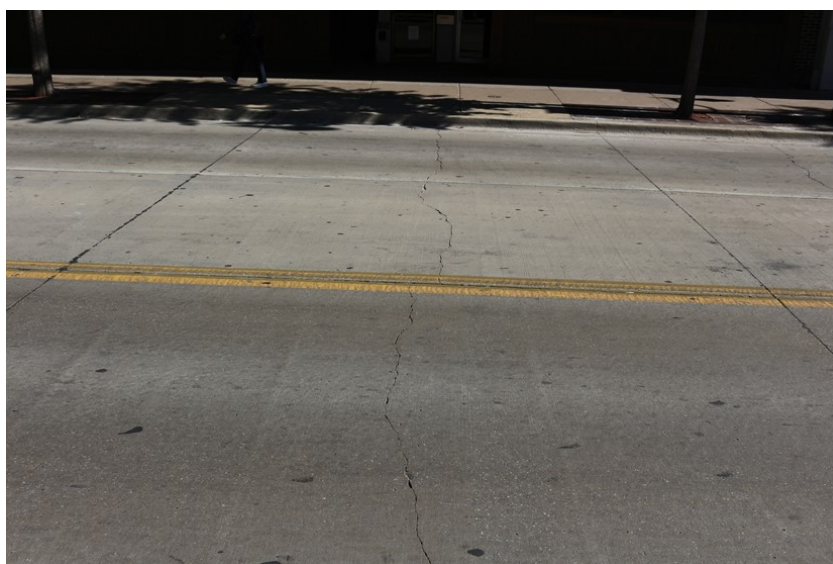
Over the past 15 years, premature cracks have been occasionally observed on jointed plain concrete pavements (JPCP) in Illinois. Premature cracking was first observed in Champaign-Urbana on urban JPCP sections designed with a curb and gutter (C&G). The design life for a JPCP section in Illinois is 20 years, with an even longer expected service life. Some of these observed sections had developed mid-panel transverse cracks within the first few years after construction. Figure 1 shows several urban streets in Champaign, Illinois, that exhibited mid-panel transverse cracking within several years after construction (Figure 1).

Figure 1. Photo. Premature transverse cracking on (a) East Armory Avenue and (b) Green Street in Champaign, Illinois.

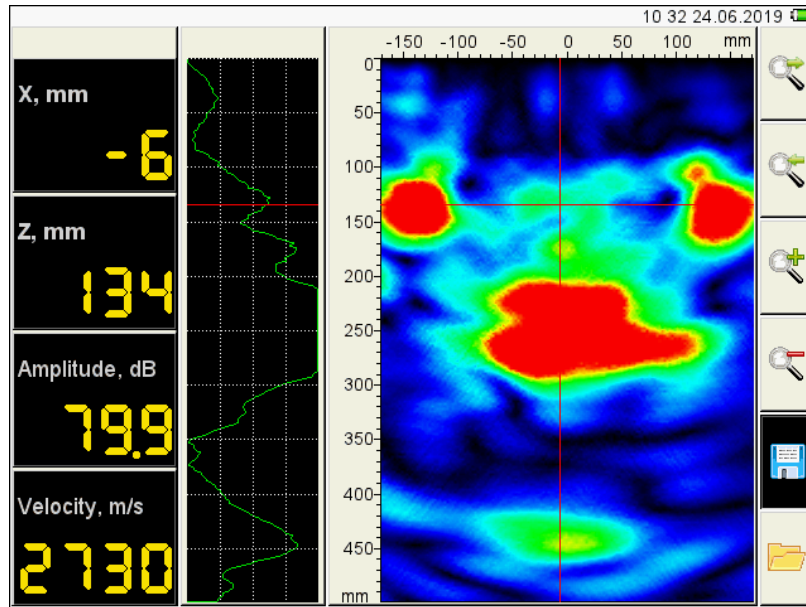
Figure 10. Photo. Ultrasonic MIRA example image for IL 59.

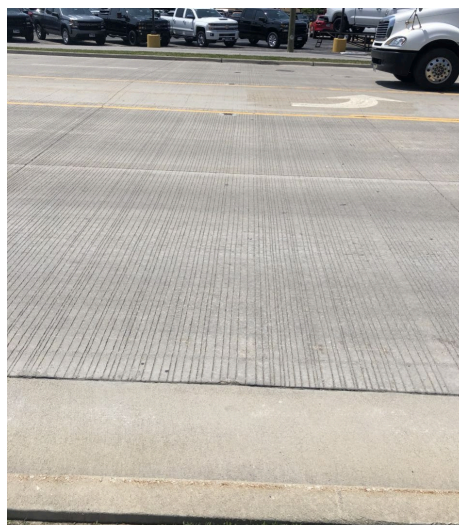
The most recent sections constructed on IL 59 (see Figure 11) were well constructed JPCP and do not exhibit any distress. Figure 12-A presents a picture of another section constructed around 2002. This section was 17 years old at the time of the survey and has some mid-panel transverse cracks. Figure 12-B illustrates the 1998 section, which has a significant amount of cracking distress. It is unknown when the distress initiated and developed.

Figure 11. Photo. IL 59 section constructed approximately in 2010 (no distress).

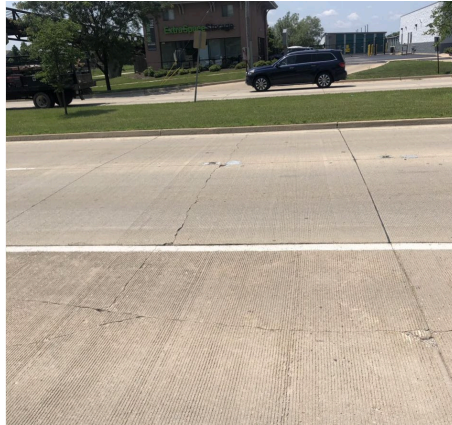
(B) IL 59 section constructed in 1998 (significant cracking).

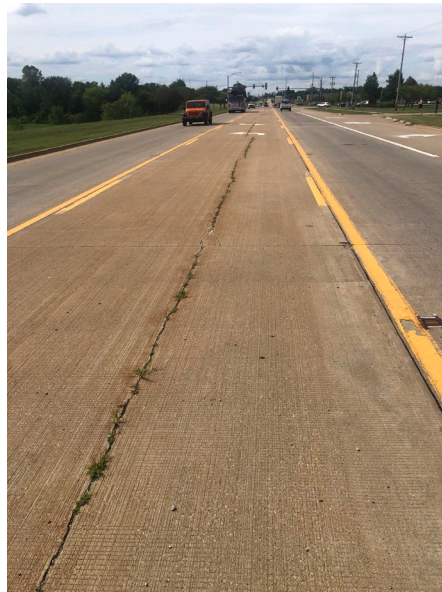
US 20 is a principal arterial highway that connects cities and towns across the United States. In 2002, a section of the highway near Galena underwent a full reconstruction. The constructed pavement consists of a JPCP with curb and gutter. The surveyed pavement section had one lane in each direction along with a two-way left turn lane. This section shows significant distress and deterioration. Figures 13 and 14 show longitudinal cracking and joint deterioration within the section.

Figure 13. Photo. US 20 longitudinal cracking in a two-way left turn lane.

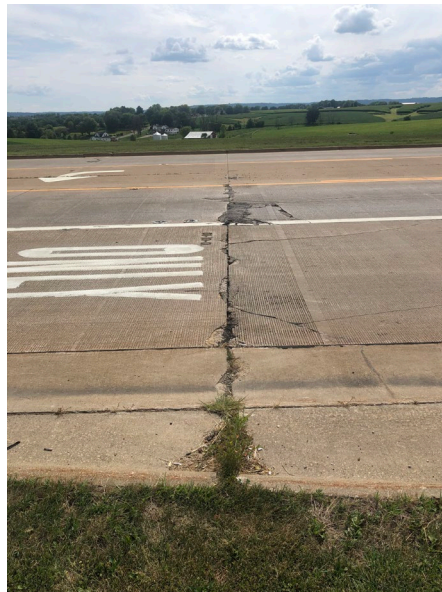
Figure 14. Photo. Transverse construction joint deterioration on US 20.

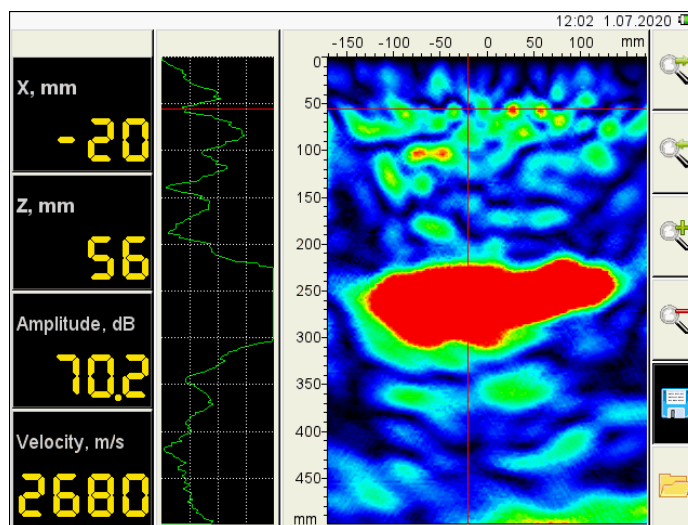
Table 7 presents the ultrasonic evaluation results for slab thickness and joint reinforcement. The evaluation also showed near-surface reflections at about 50 mm (2 in.) below the surface (see Figure 15). These reflections could represent potential voids or poor consolidation within the top portion of the concrete, but coring would need to be taken to verify the image results.

Figure 15. Photo. Ultrasonic MIRA example image for US 20.

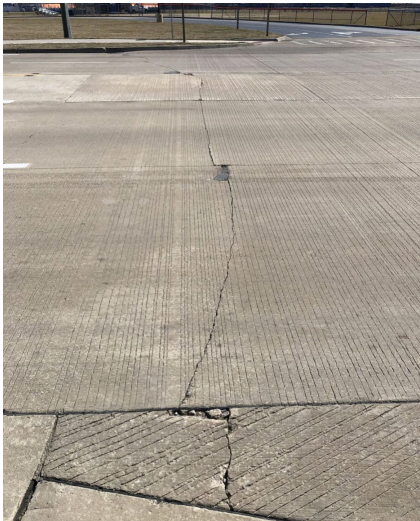
IL 71 showed a mid-panel transverse crack, as seen in Figure 16, spanning the entire width of the pavement cross-section near the entrance to Oswego High School. The results of the ultrasonic evaluation are presented in Figure 17 and Table 9. The ultrasonic evaluation did not show anomalies in the dowel or tie bar construction and design. A plausible deterioration mechanism is an over-restriction caused by the intersection panels.

Figure 16. Photo. IL 71 transverse cracking distress.

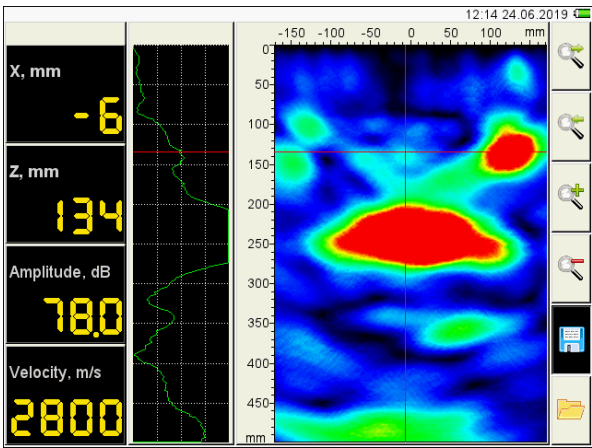
Figure 17. Photo. IL 71 MIRA ultrasound evaluation.

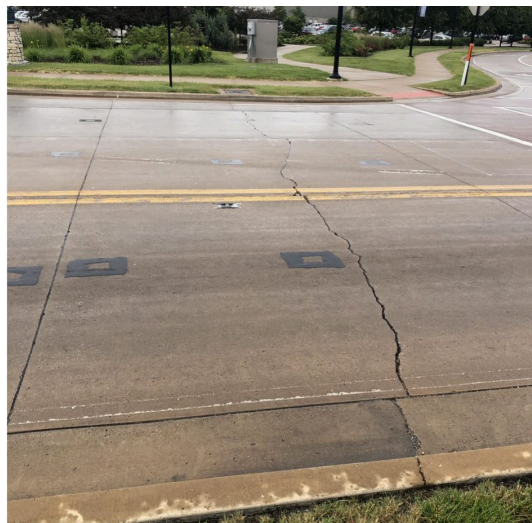
The distress in MacArthur Highway consisted of a transverse crack spanning the entire width of the pavement section (Figure 18). The crack is extremely wide and is located by a utility manhole (seen in Figure 18 on the opposite side of the road). This is likely the cause of the premature distress.

Figure 18. Photo. MacArthur Highway transverse distress near utility duct.

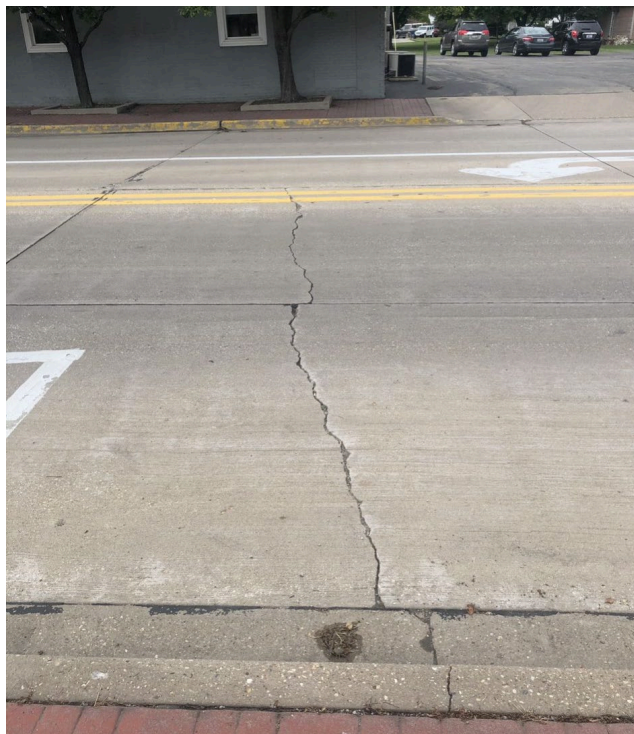
The distresses observed in Jefferson Avenue consisted of mid-panel transverse cracks (Figure 19). Table 11 presents the results of the ultrasonic evaluation. The observed transverse cracks are likely related to the excessive slab length of 20 ft for the given slab thickness of 9 in.

Figure 19. Photo. Transverse crack on Jefferson Avenue near Jackson Street.

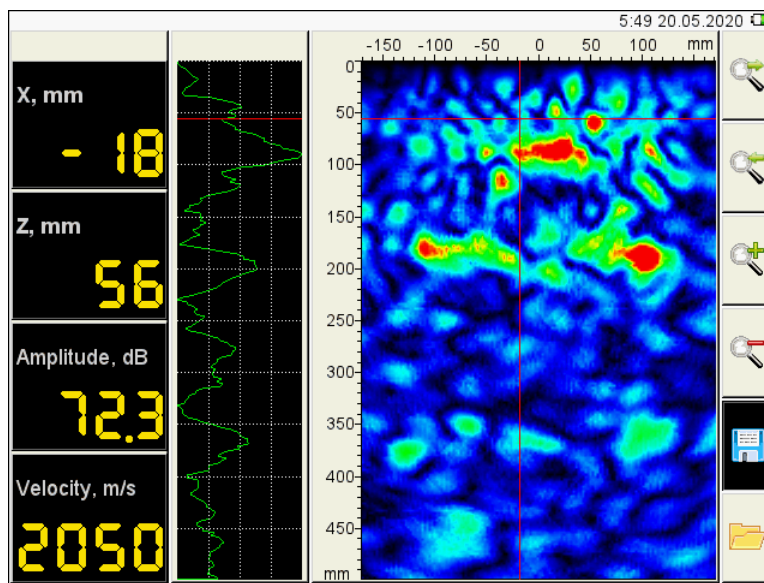
Healey Street is a road that runs parallel to Green Street but is located one block north. Healey Street is a local street and has only car traffic. This recently reconstructed urban JPCP section is showing premature transverse cracks in about 30% of the slab panels (see Figure 21). The images from the ultrasonic evaluation showed significant distortion near the surface of the concrete (Figure 22). This may be related to poor consolidation of the concrete and may have contributed to premature cracking with another mechanism.

Figure 22. Photo. Healey Street ultrasonic image.

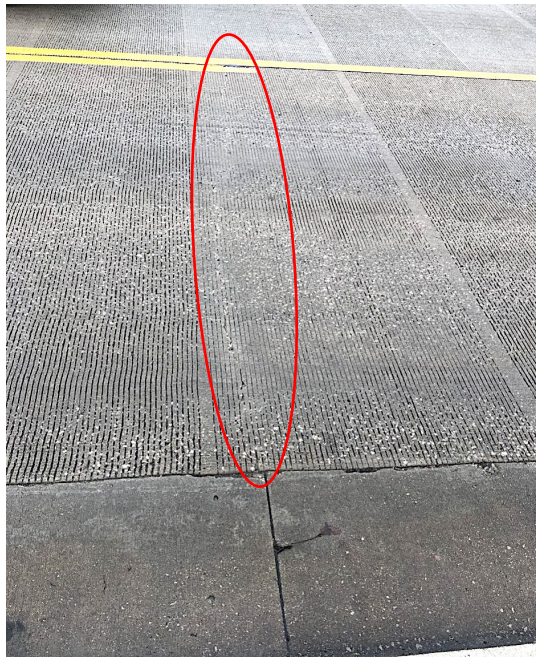
Harrison Street is composed of long JPCP panels (up to ~45 ft) that are showing significant premature cracking distress and deterioration. Almost all the panels (98%) are showing a type of distress in the form of either a transverse crack (Figure 23) or joint deterioration (Figure 24). Excessive panel length with an 8 in. thickness is the main factor contributing to the transverse cracks. In addition, large joint spacing can cause large changes in magnitude of joint width and can lead to joint damage and deterioration.

Figure 23. Photo. Harrison Street transverse crack.

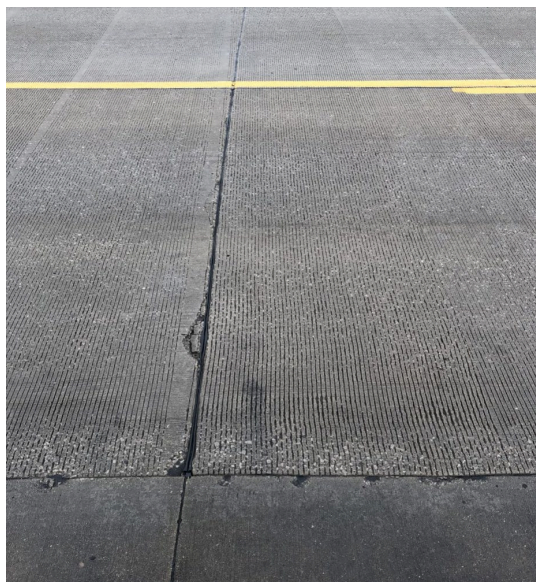
Figure 24. Photo. Harrison Street transverse joint deterioration.

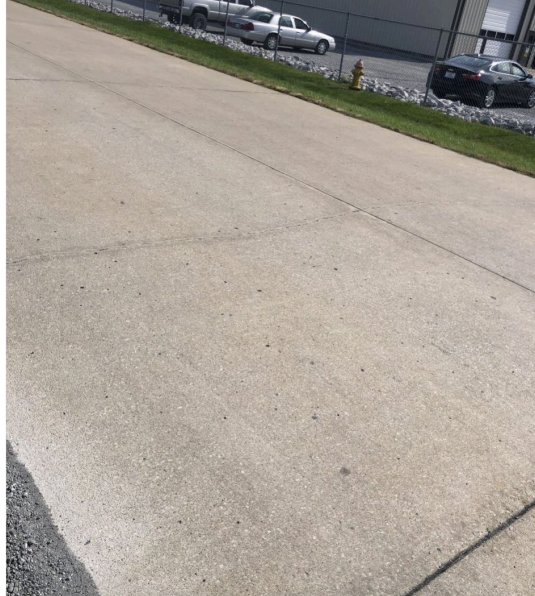
Similar to Harrison Street, Central Street is composed of very long JPCP slab panels (~30 ft) that are exhibiting premature transverse cracks. These mid-panel cracks are likely due to excessive panel length relative to this slab's thickness (see Figure 25).

Figure 25. Photo. Mid-panel transverse crack on Central Street (East St. Louis, IL).

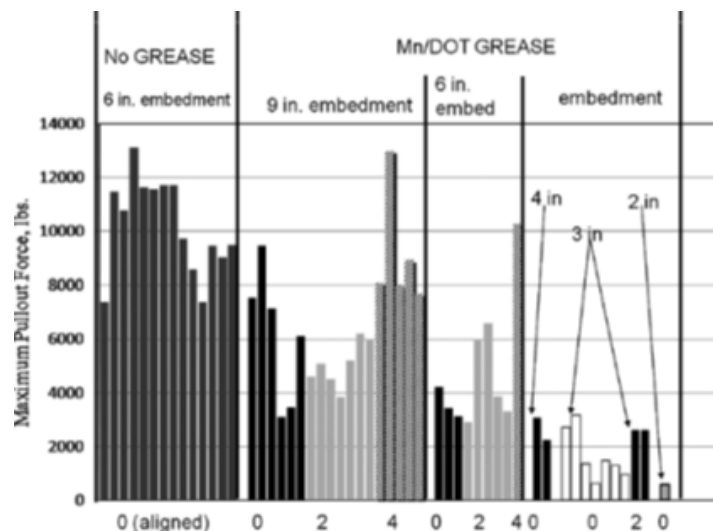
Figure 31. Graph. Distribution of maximum pullout forces for greased and ungreased dowels.

Khazanovich et al. (2009) performed laboratory pullout testing to examine the effect of lubricating or greasing dowels in addition to various degrees of dowel misalignment. The pullout testing examined 1.5 in. diameter dowels with a standard embedment depth of 6 in. As shown in Figure 31, an average pullout force of 11.6 kips is required for a 6 in. embedment without lubrication versus a required average pullout force of 3.5 kips for a 6 in. embedment with lubrication. The research demonstrated that the pullout force required for dowels moving relative to the concrete could be 3 to 4 times higher without lubricating dowels. This increased resistance to pullout may result in premature cracking.

These values per dowel are close to the results obtained by Khazanovich et al. (2009) for ungreaed dowel bars (see Figure 31), which found the mean pullout force for ungreaed dowels of 11.6 kips with 6 in. embedment. If dowel embedment is greater, for example, 9 in. (half of a standard dowel length of 18 in. in Illinois), then the pullout force could be 50% higher for ungreaed dowels, e.g., 17.4 kips. In addition, any skew or tilt of the dowel will further increase the pullout force between 10%–20%. With these additional factors (skew/tilt and 9 in. embedment), a single dowel pullout force may require 20 kips, which is over 50% greater than the restraining force to create a transverse crack in the slab. This analysis suggests it is likely that some premature cracking is directly a result of lack of dowel lubrication and subsequent transverse joint restraint. For thicker slabs, e.g., 10 in., the force to crack the concrete is proportional to the thickness, and therefore it is more difficult for thicker sections. Some recent visual surveys of urban concrete construction by the lead author did not see evidence of dowel lubrication, and, thus, in some projects it appears dowel lubrication is not consistently occurring.

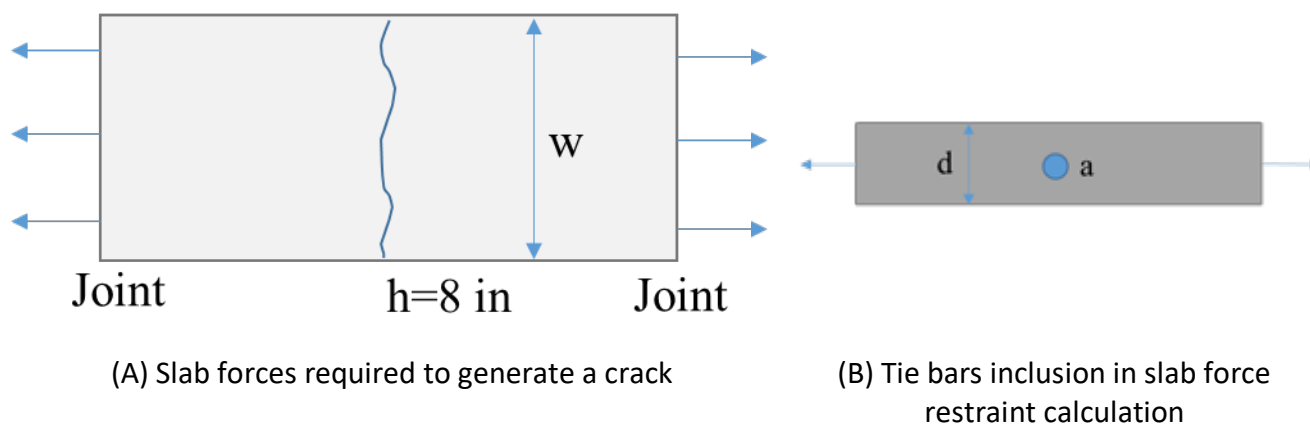
Figure 32. Schematic. Transverse joint restraint forces.

width (w) \times thickness (h) \times concrete tensile strength (f_t). This required force is the same force needed to restrain the transverse joints, i.e., lockup the joints from misalignment or nonlubricated dowels, or both. Examining a 15 ft \times 11 ft \times 8 in. thick slab with a concrete tensile strength of 400 psi results in a required force (P) of approximately 422.4 kips in order to crack the concrete (Figure 32-A) and restrain the joint from moving.

In addition to the concrete tensile strength, tie bars can add to longitudinal restraint as well as act as initiators of edge cracks, e.g., plate with a hole. Tie bars are located along the perimeter of the slab and act as a hole (stress concentration) within the concrete slab. The diameter of the tie bar is represented as the hole in Figure 32-B relative to the concrete slab thickness. The ratio between the diameter of the tie bars and the thickness of the pavement is used to determine the stress concentration factor which is approximately 3.0 for small a/d . For a small a/d (< 0.10), a stress concentration factor of 3.0 results in a slab transverse cracking force (P) of 141 kips. If this force is distributed over the 11 dowels at a transverse joint, the restraining force per dowel (locked-up joint) is 12.8 kips. Therefore, a doweled joint must resist more than 141 kips to generate a tensile crack in the slab or 12.8 kip dowel force if there are no other restraining elements.

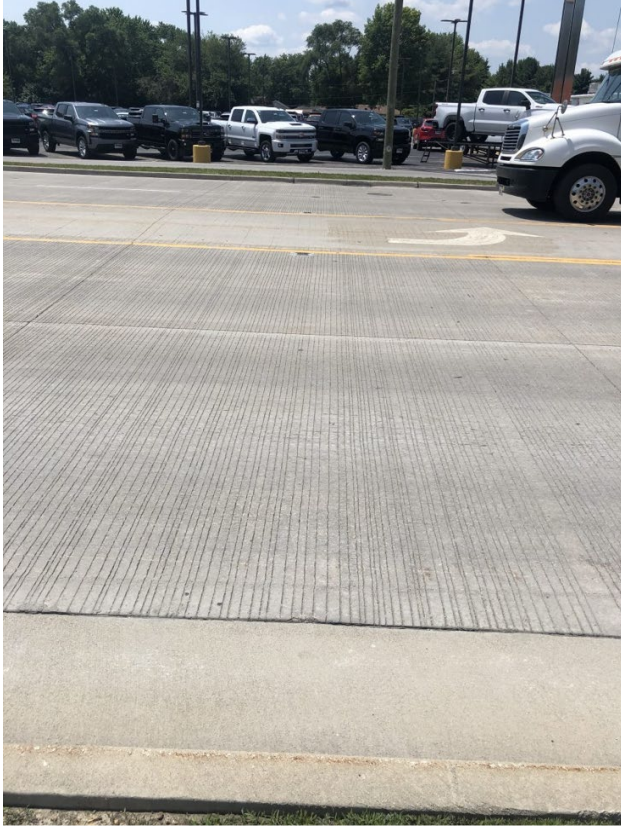
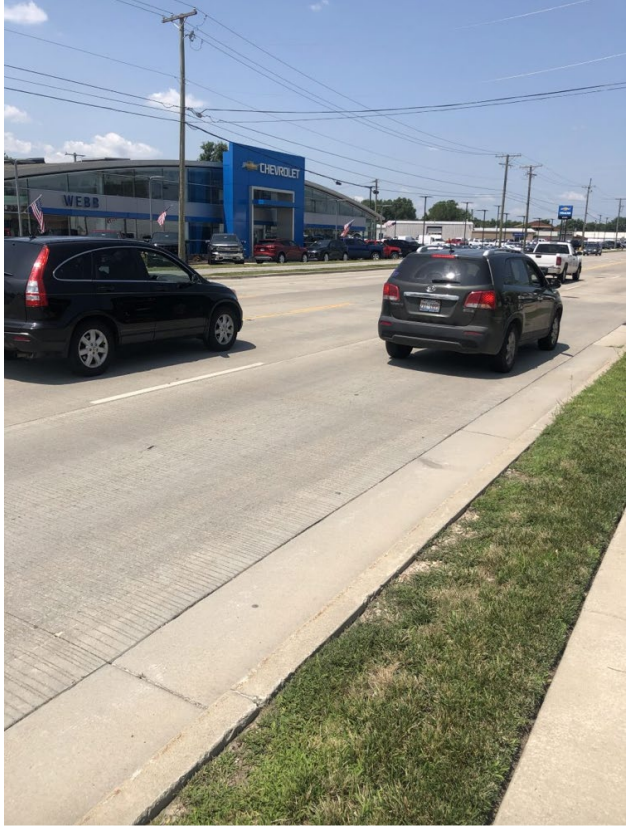
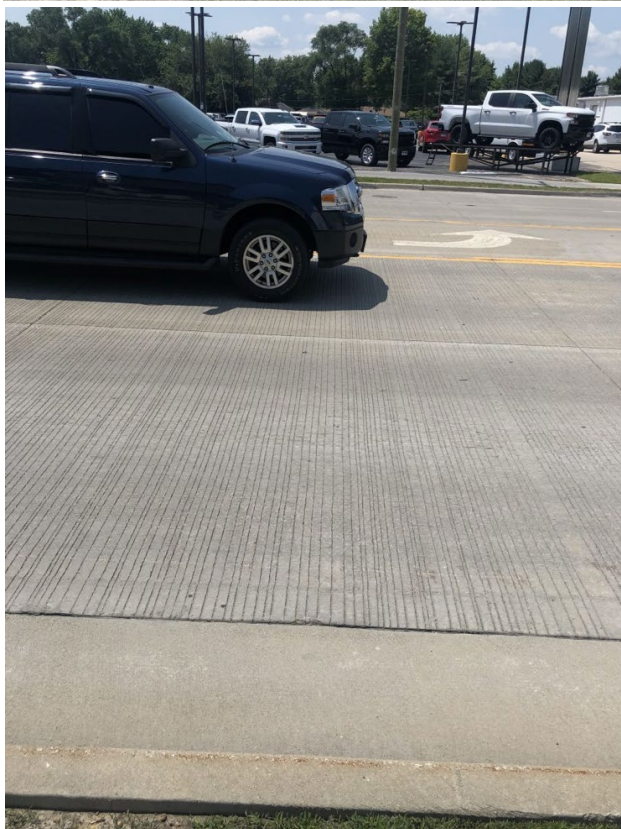
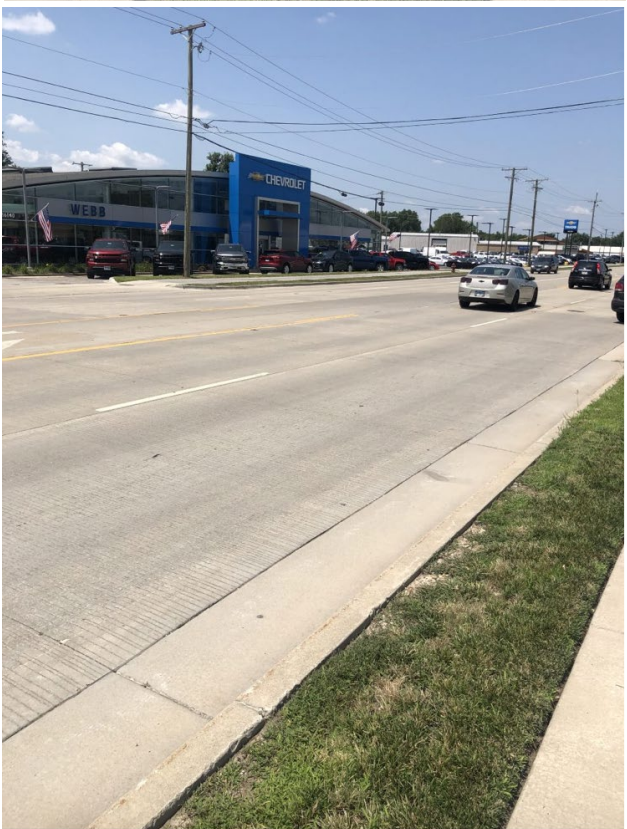
Figure 34. Photos. IL 30 with SS 55.

Thickness (in.)	Panel Length (ft)	Panel Width (ft)	Dowel Bar Spacing (in.)	Tie Bar Spacing (in.)	Lane Configuration	Visual Distress	Additional Observations
10	15	11	12	27	Two lanes per direction + central lane	No distress observed	Construction date ~2015

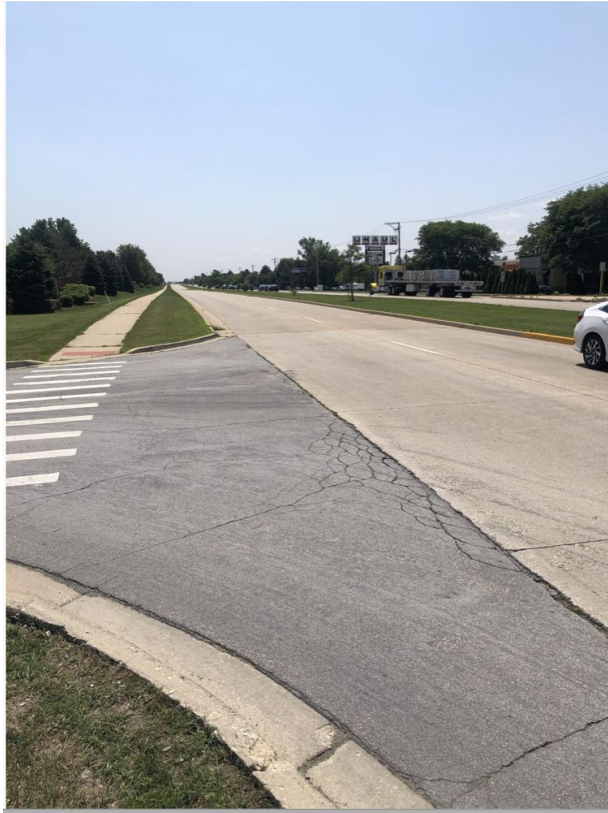
Figure 36. Photo. IL 59 from IL 30 to IL 80.

Thickness (in.)	Panel Length (ft)	Panel Width (ft)	Dowel Bar Spacing (in.)	Tie Bar Spacing (in.)	Lane Configuration	Visual Distress	Additional Observations
10	15	11	12	27	Two lanes per direction + central lane	About 3% of the panels showed deterioration in the form of cracks and joint spalling.	Construction date ~2002

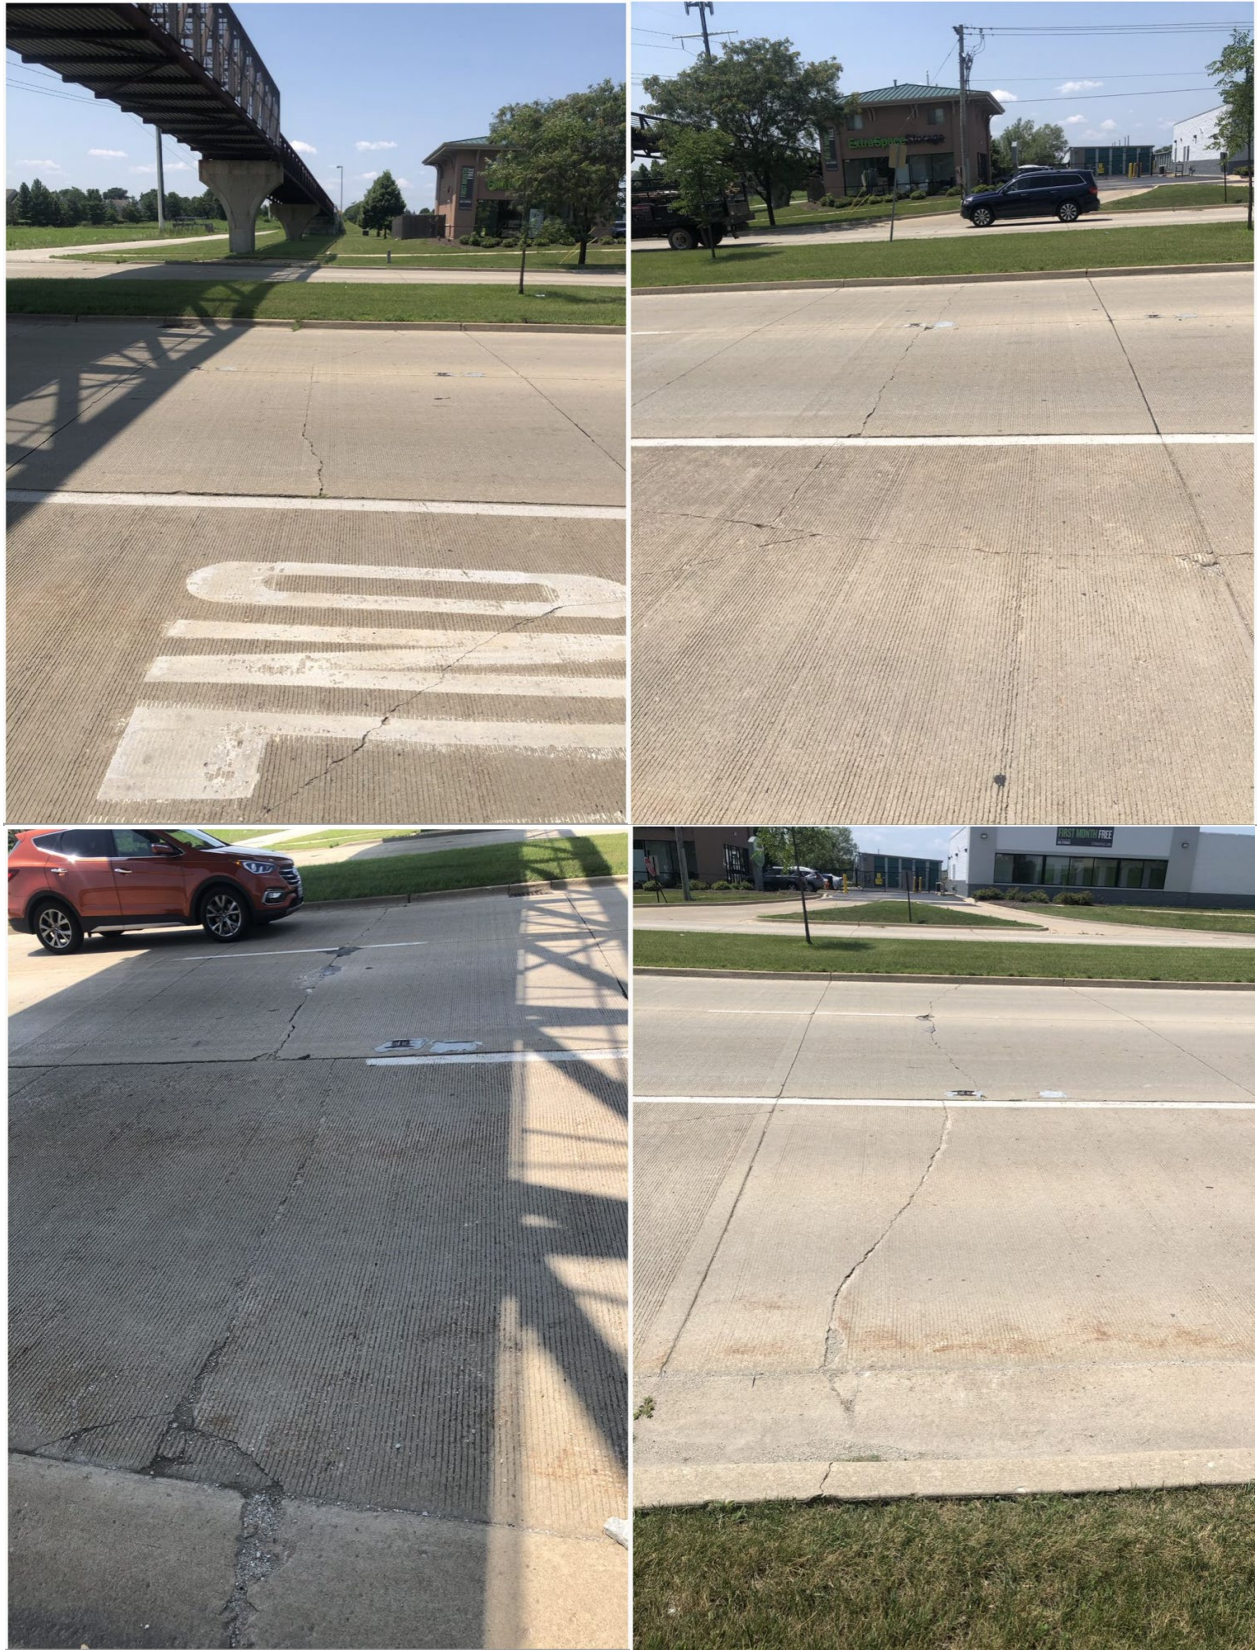
Figure 37. Photos. IL 59 from 103rd to 95th Streets.

Thickness (in.)	Panel Length (ft)	Panel Width (ft)	Dowel Bar Spacing (in.)	Tie Bar Spacing (in.)	Lane Configuration	Visual Distress	Additional Observations
10	15	11	12	27	Two lanes per direction + central lane	More than 50% of the panels showed deterioration in the form of cracks and joint spalling.	Construction date ~1998

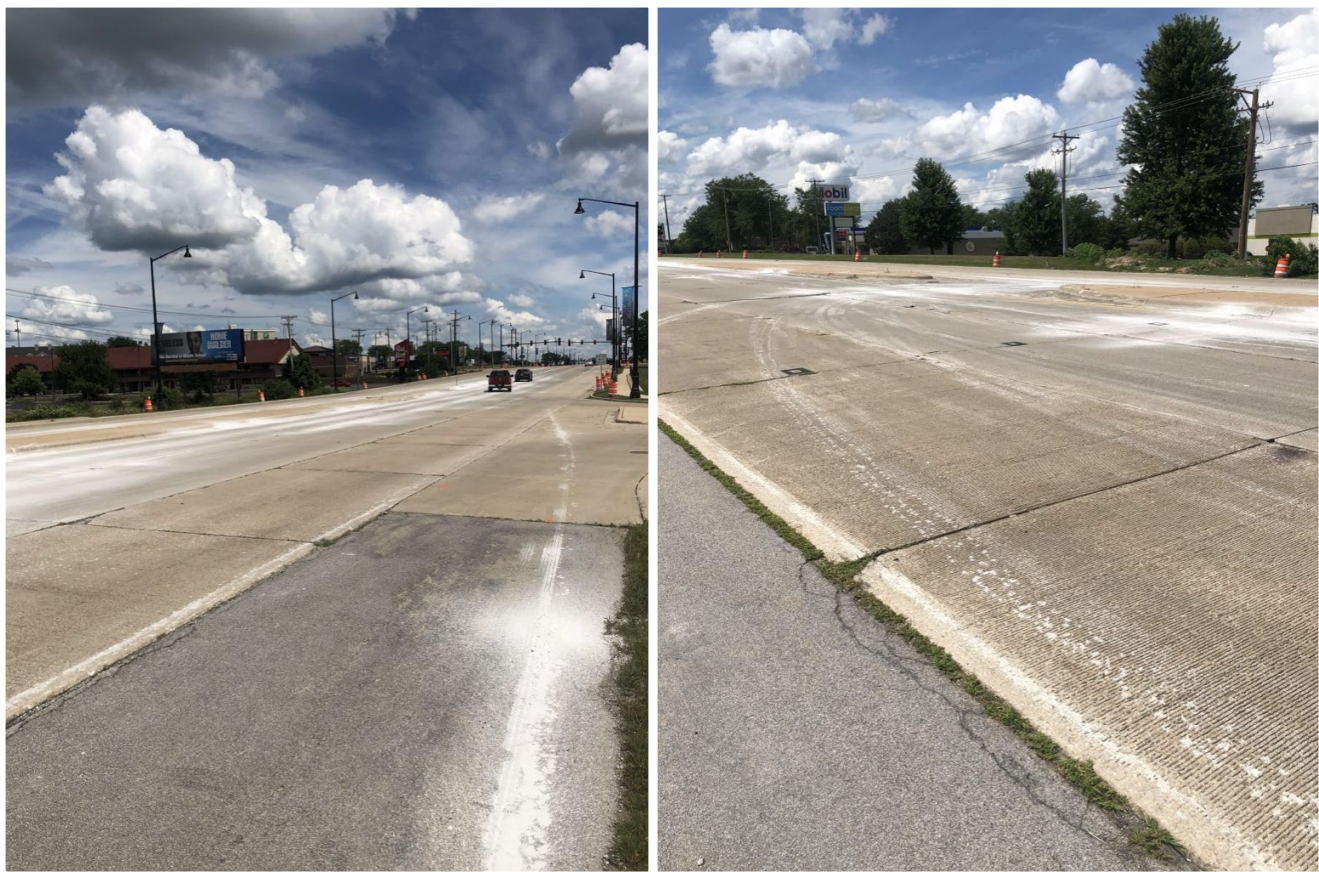
Figure 45. Photos. State Street with Bell School Road.

Thickness (in.)	Panel Length (ft)	Panel Width (ft)	Dowel Bar Spacing (in.)	Tie Bar Spacing (in.)	Lane Configuration	Visual Distress	Additional Observations
Not evaluated due to heavy traffic	42	15	Not evaluated due to heavy traffic	Not evaluated due to heavy traffic	3 lanes per direction	Severe longitudinal and transverse cracks. (>50%)	Construction date ~2000s Some panels were renewed.

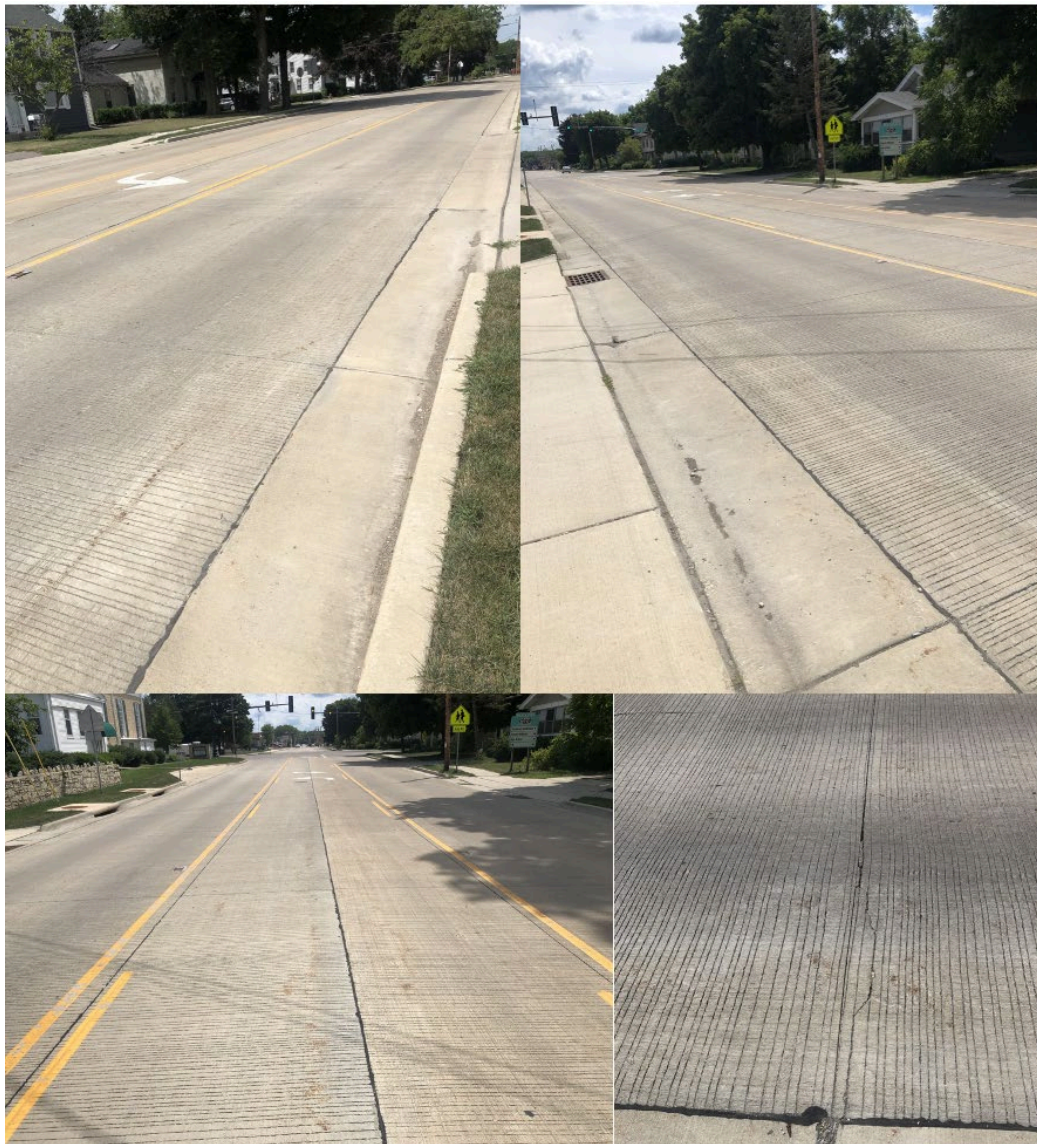
Figure 46. Photos. Union Street with Blackhawk Boulevard.

Thickness (in.)	Panel Length (ft)	Panel Width (ft)	Dowel Bar Spacing (in.)	Tie Bar Spacing (in.)	Lane Configuration	Visual Distress	Additional Observations
10	15	13	12	24	One lane per direction + center turning lane	Minimal joint deterioration (<2%)	Construction date ~2010s

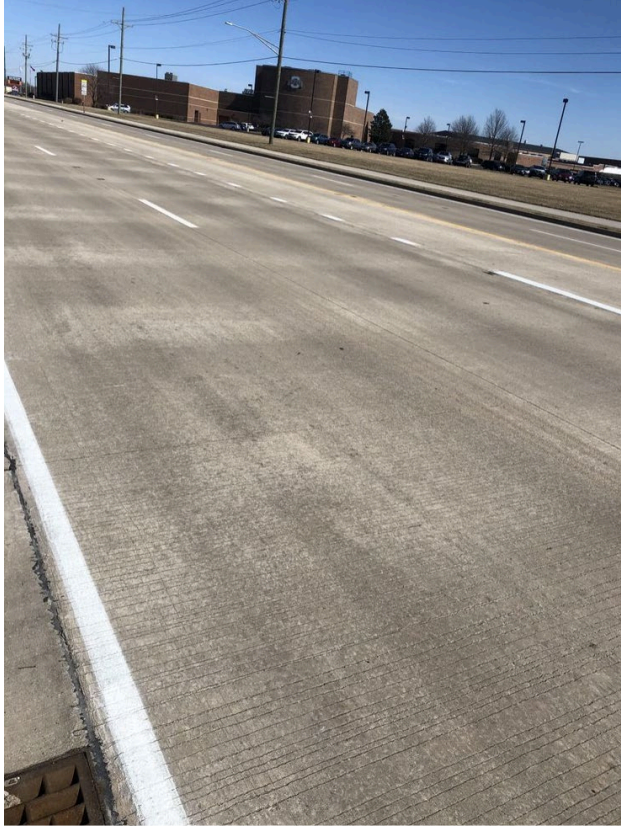
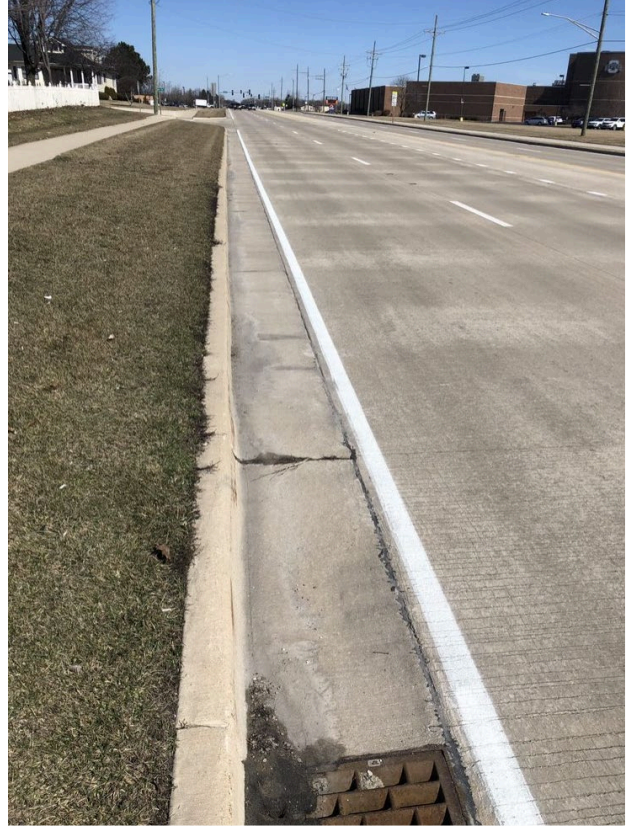
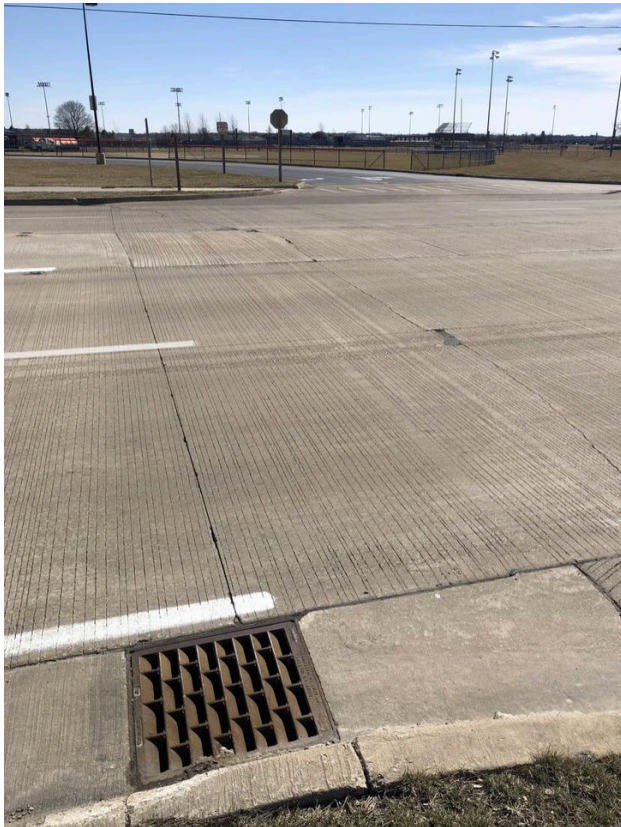
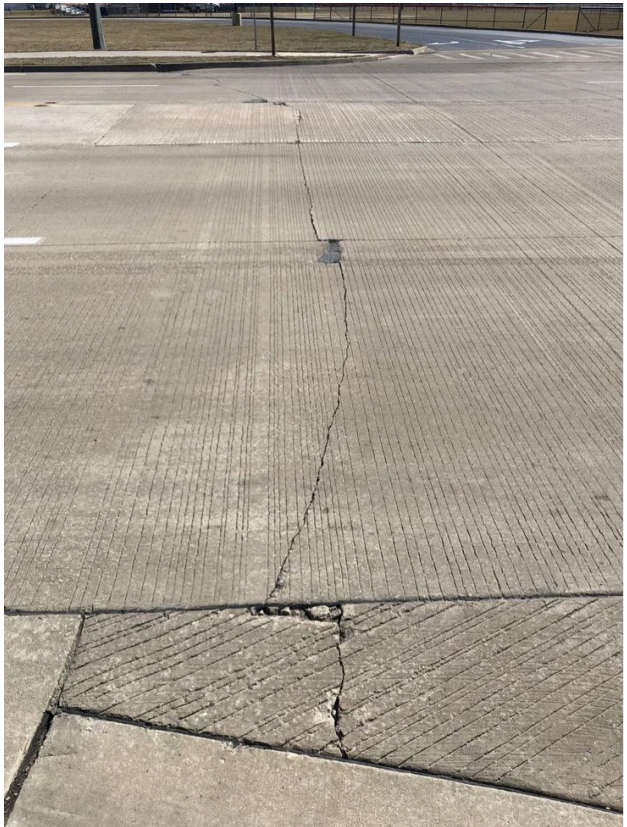
Figure 52. Photos. IL 71 with Franklin Street.

Thickness (in.)	Panel Length (ft)	Panel Width (ft)	Dowel Bar Spacing (in.)	Tie Bar Spacing (in.)	Lane Configuration	Visual Distress	Additional Observations
10	15	12	12	24	2 lanes per direction + central turning lane	One full lane width transverse crack located at the intersection with a school entrance.	Construction date ~2010s

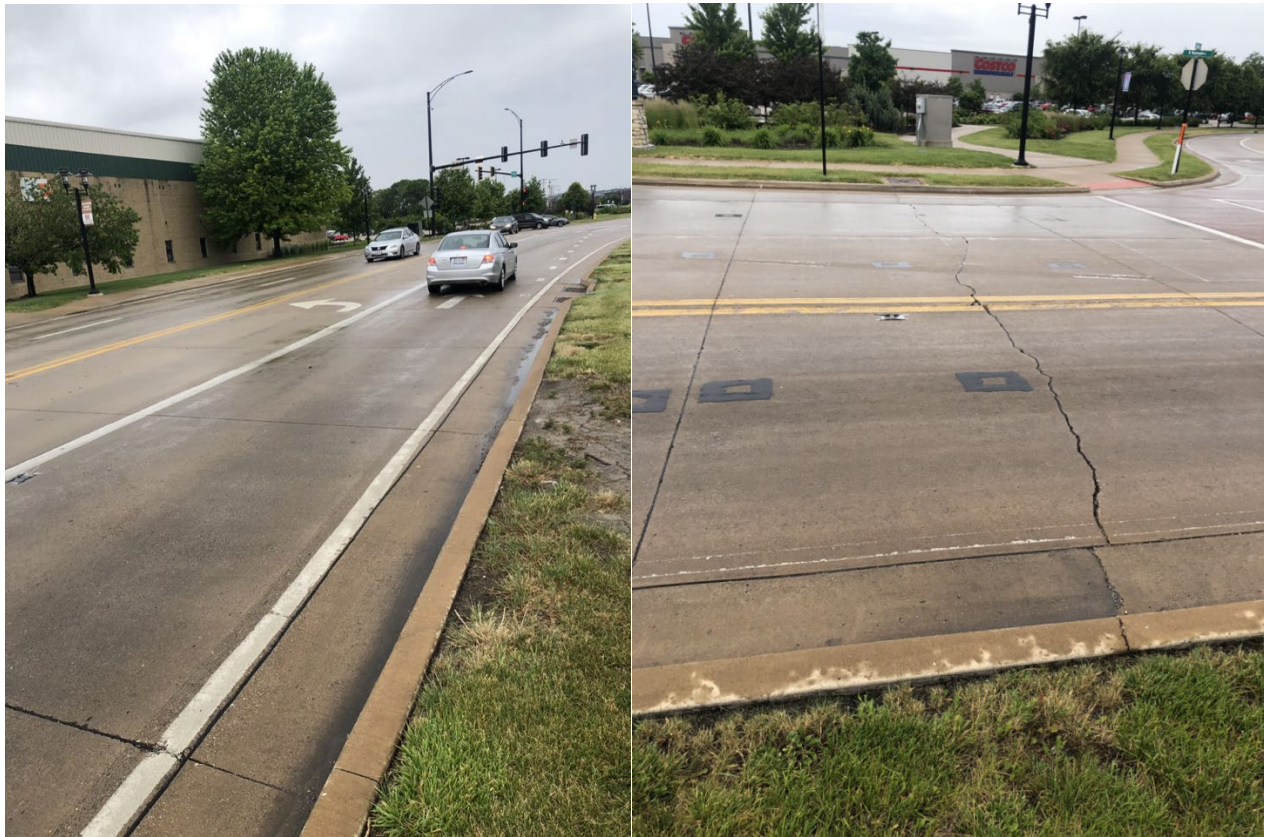
Figure 57. Photos. MacArthur Highway with Richland Street.

Thickness (in.)	Panel Length (ft)	Panel Width (ft)	Dowel Bar Spacing (in.)	Tie Bar Spacing (in.)	Lane Configuration	Visual Distress	Additional Observations
Not evaluated due to heavy traffic	12	12	Not evaluated due to heavy traffic	Not evaluated due to heavy traffic	2 lanes per direction + central lane	Minimum transverse cracking around drainage area (<2%)	Construction date ~2011

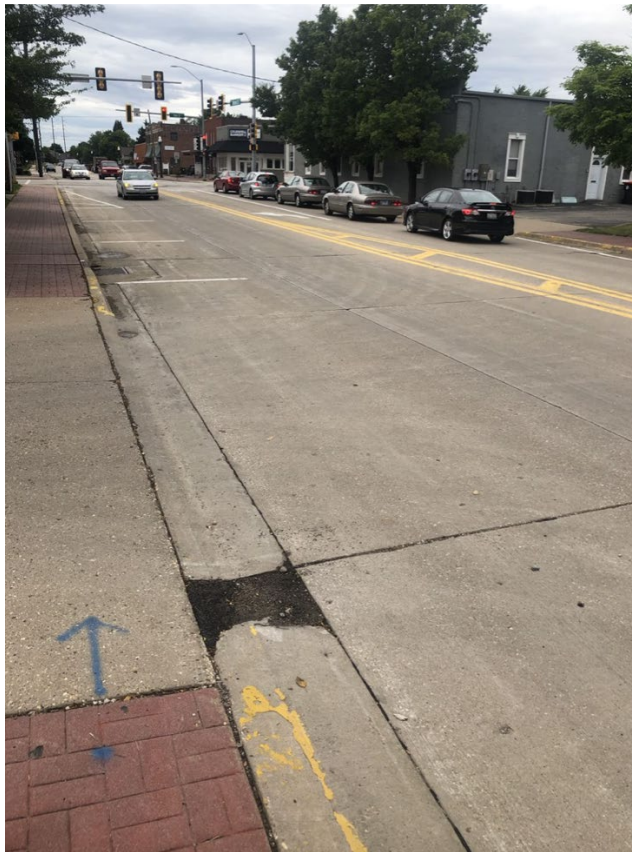
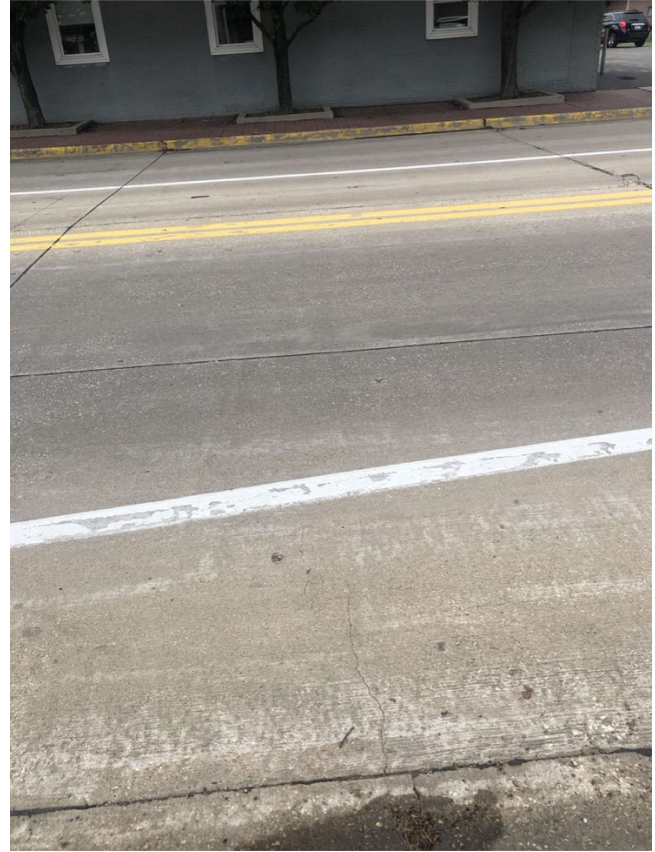
Figure 60. Photos. Jefferson Street with Jackson Street.

Thickness (in.)	Panel Length (ft)	Panel Width (ft)	Dowel Bar Spacing (in.)	Tie Bar Spacing (in.)	Lane Configuration	Visual Distress	Additional Observations
9	20	9	Dowels present*	45	2 lanes per direction	Minimum transverse cracks (<30%)	Construction date ~2016 * It has dowel bars, but no measurements due to heavy traffic.

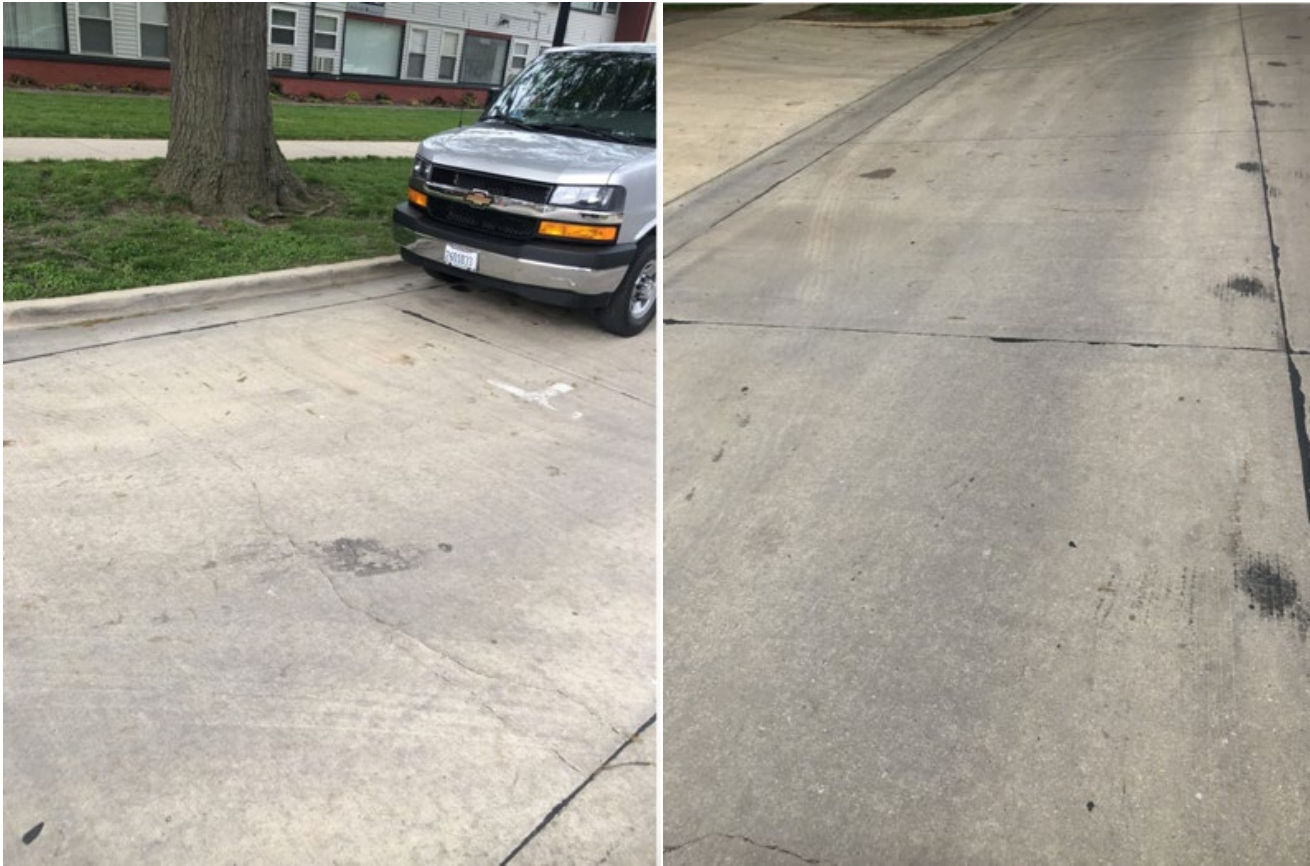
Figure 65. Photos. Healey Street from Fourth Street to Fifth Street.

Thickness (in.)	Panel Length (ft)	Panel Width (ft)	Dowel Bar Spacing (in.)	Tie Bar Spacing (in.)	Lane Configuration	Visual Distress	Additional Observations
8	12.5	12	24	26	1 lane per direction	mid-panel transverse cracks (>50%)	<i>Construction date ~2015</i>
