Evaluation of Premature Cracking in Urban Concrete Pavement

Research Report No. FHWA-ICT-21-001

A report of the findings of
ICT PROJECT R27-193-4
Premature Cracking Mechanism for
Jointed Plain Concrete Pavement

January 2021

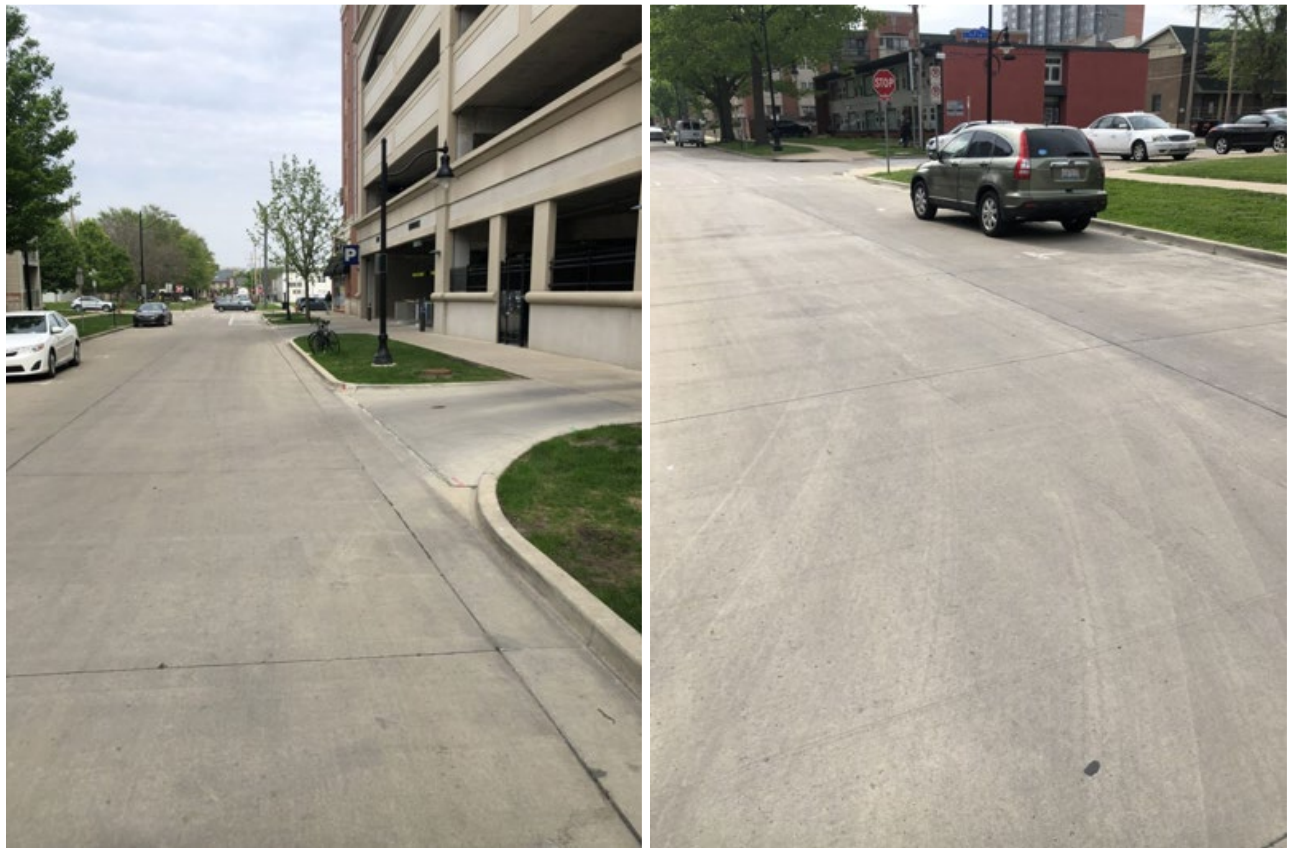
Figure 67. Photos. Healey Street from Fifth Street to Sixth Street.

Thickness (in.)	Panel Length (ft)	Panel Width (ft)	Dowel Bar Spacing (in.)	Tie Bar Spacing (in.)	Lane Configuration	Visual Distress	Additional Observations
8	12.5	12	16	26	1 lane per direction	mid-panel transverse cracks (>30%)	<i>Construction date ~2015</i>

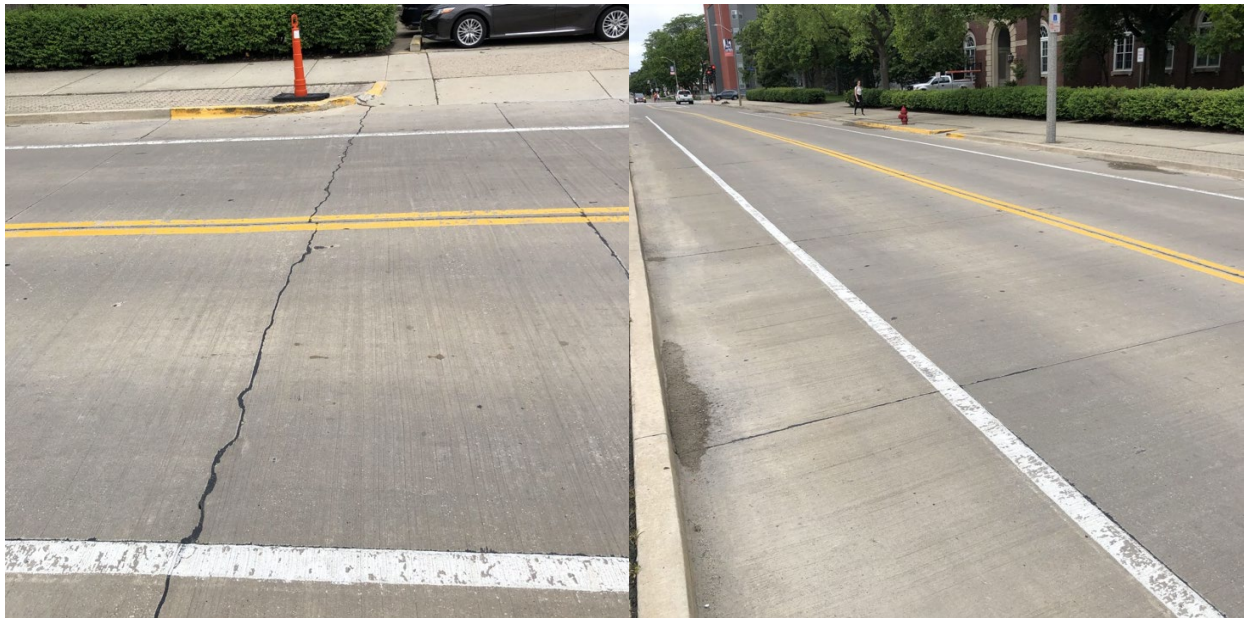
Figure 68. Photos. Gregory Drive from Fourth Street to Sixth Street.

Thickness (in.)	Panel Length (ft)	Panel Width (ft)	Dowel Bar Spacing (in.)	Tie Bar Spacing (in.)	Lane Configuration	Visual Distress	Additional Observations
8	15	10.5	23	39	1 lane per direction + 1 bicycle lane per side	mid-panel transverse cracks (>50%)	<i>Construction date ~2013</i>

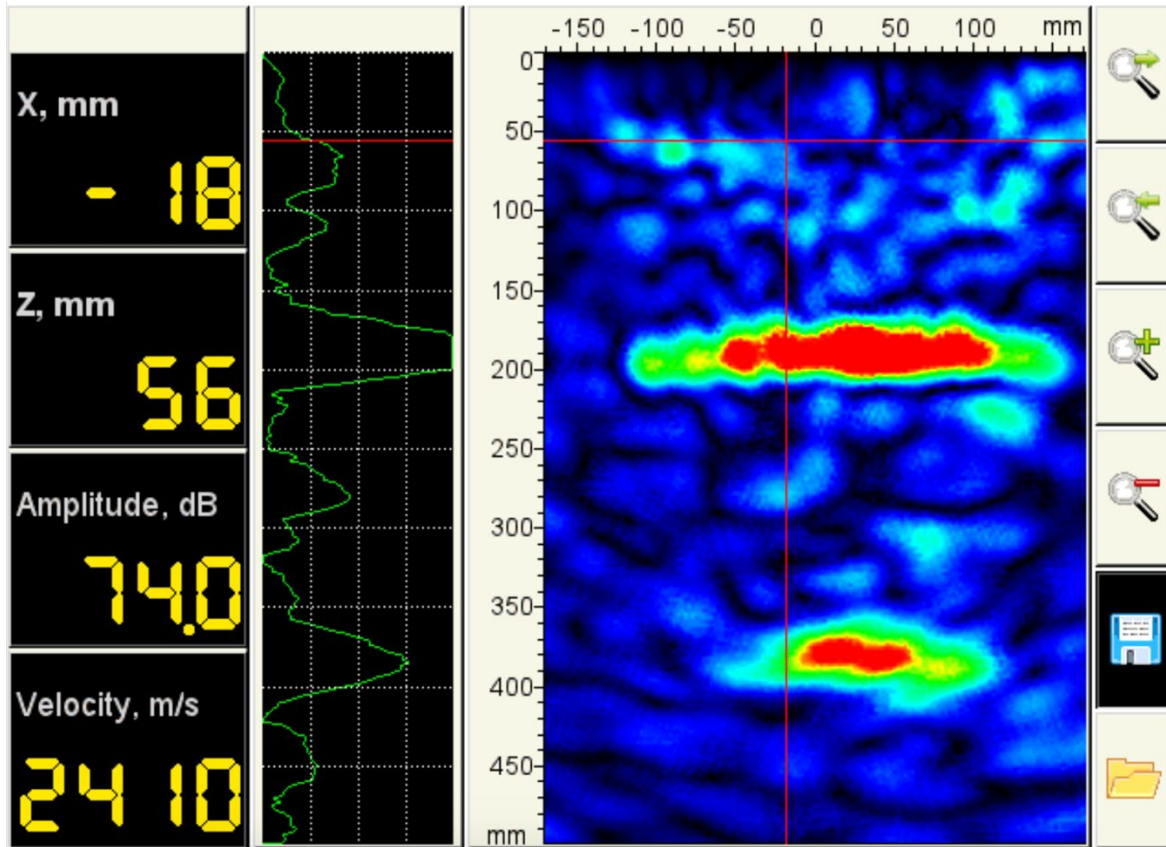
Figure 69. Photos. Ultrasound images of Gregory Drive from First Street to Fourth Street.

Thickness (in.)	Panel Length (ft)	Panel Width (ft)	Dowel Bar Spacing (in.)	Tie Bar Spacing (in.)	Lane Configuration	Visual Distress	Additional Observations
7–8*	15	10.5	Not observed	36	1 lane per direction + 1 bicycle lane per side	Mid-panel transverse cracks (>50%)	Construction date ~2013 <i>*Thickness was variable between slabs</i>

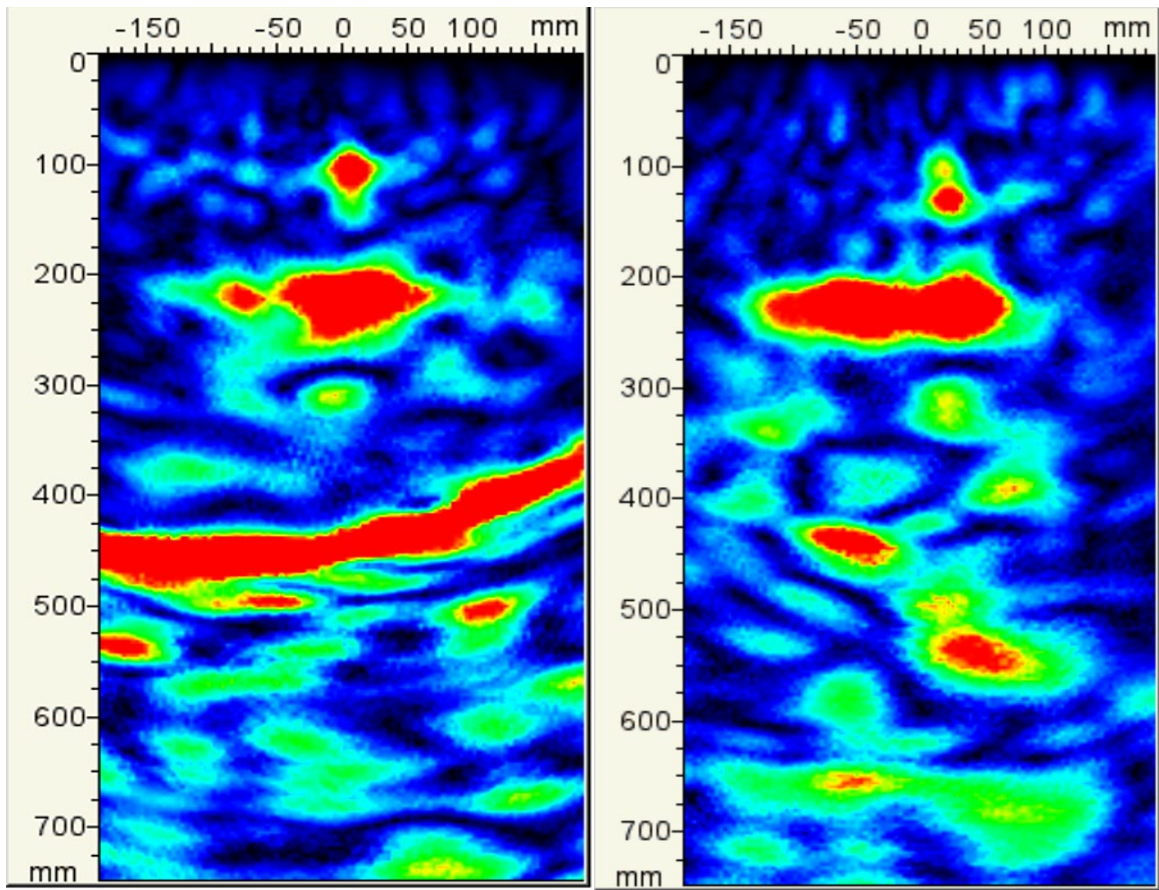
Figure 71. Photos. Ultrasound images of Gregory Drive from Oak Street to First Street.

Thickness (in.)	Panel Length (ft)	Panel Width (ft)	Dowel Bar Spacing (in.)	Tie Bar Spacing (in.)	Lane Configuration	Visual Distress	Additional Observations
8	18	15	12	24	2 lane per side +	Mid-panel transverse cracks (>50%)	<i>Construction date ~2013</i>

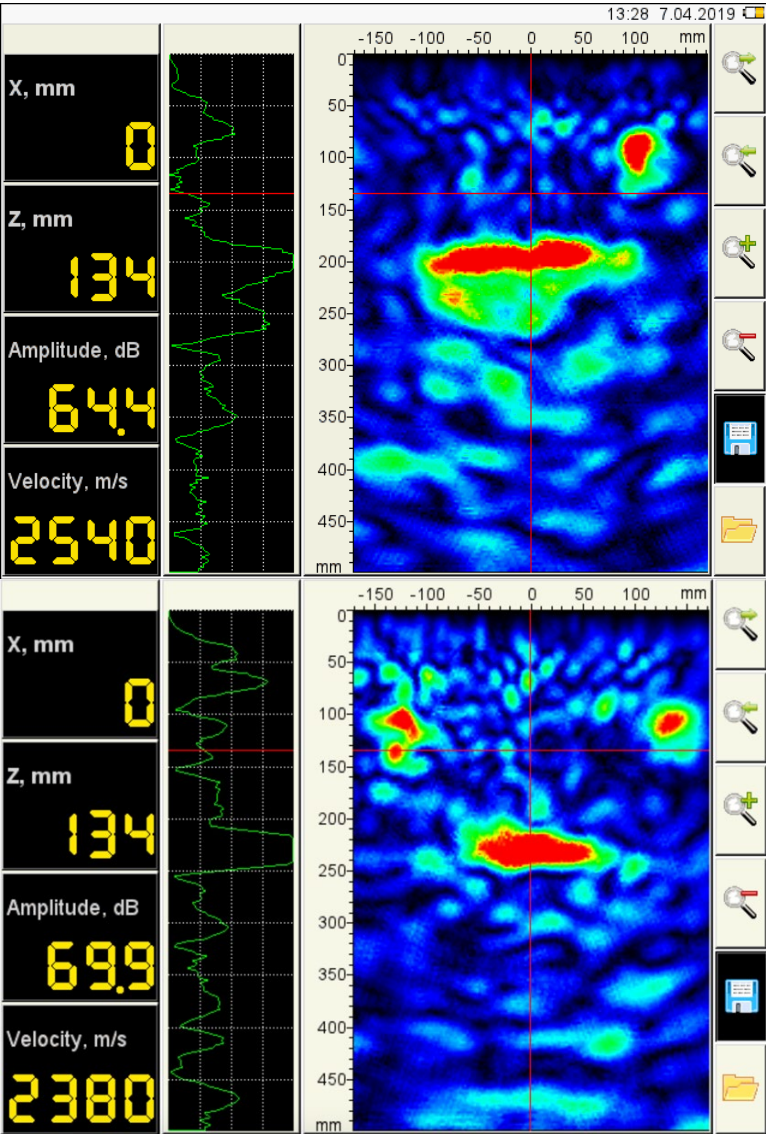
Figure 74. Photos. Ultrasound images of John Street from Prospect Avenue to New Street.

Thickness (in.)	Panel Length (ft)	Panel Width (ft)	Dowel Bar Spacing (in.)	Tie Bar Spacing (in.)	Lane Configuration	Visual Distress	Additional Observations
8	13*	13	12	24	1 lane per direction.	Transverse Cracking (>30%)	<i>*The section showed variability in the panel length, long panels (20 ft) showed premature distress.</i>

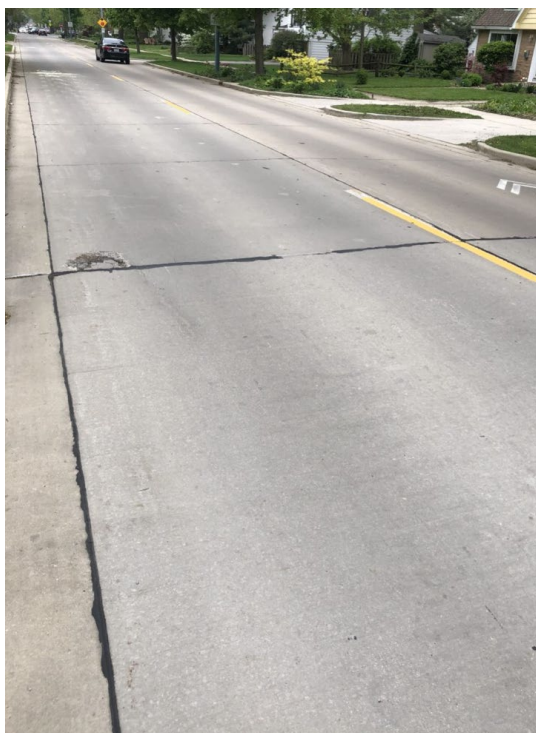
Figure 76. Photo. John Street from Neil Street to Elm Street.

Thickness (in.)	Panel Length (ft)	Panel Width (ft)	Dowel Bar Spacing (in.)	Tie Bar Spacing (in.)	Lane Configuration	Visual Distress	Additional Observations
8.5	Variable (10–15)	7.5	12	24	1 lane per direction	Transverse cracking (>30%) and minimum joint deterioration	Construction date ~2008

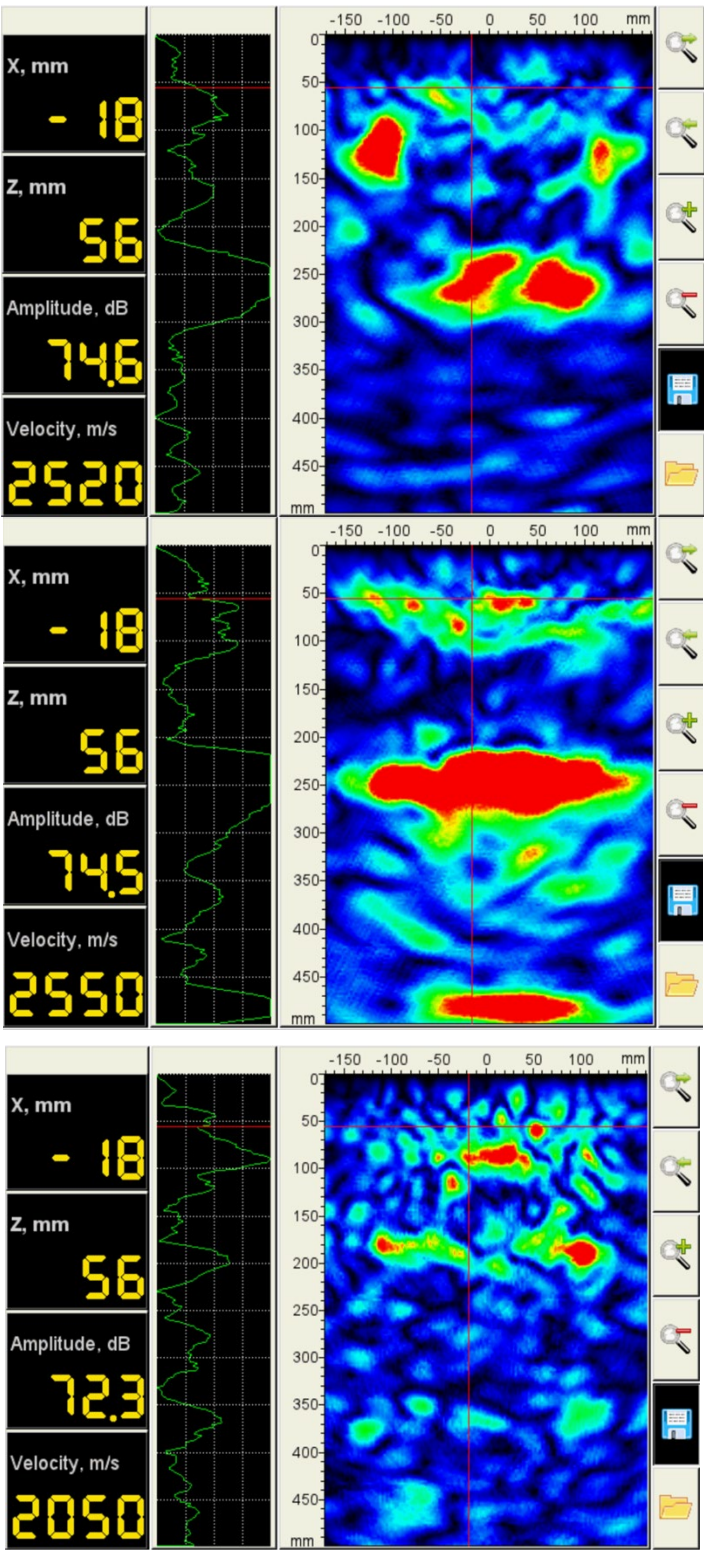
Figure 77. Photos. Ultrasound images of Green Street from First Street to Wright Street.

Thickness (in.)	Panel Length (ft)	Panel Width (ft)	Dowel Bar Spacing (in.)	Tie Bar Spacing (in.)	Lane Configuration	Visual Distress	Additional Observations
8-10*	15	11	12	24	1 lane per direction + central lane	Transverse Cracking (>50%)	Construction date ~2011 <i>*Slab thickness varies from 8" to 10".</i>

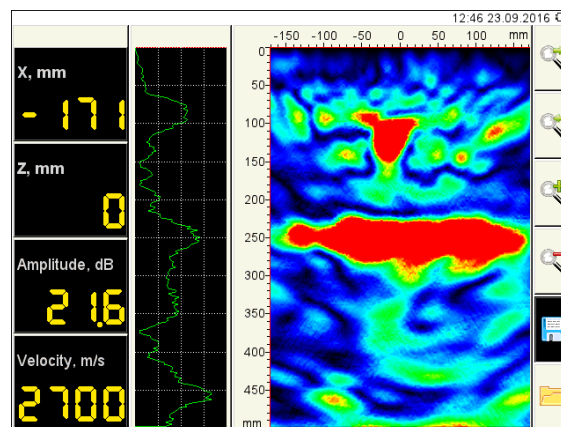
Figure 79. Photo. Ultrasound image of Stadium Drive.

Thickness (in.)	Panel Length (ft)	Panel Width (ft)	Dowel Bar Spacing (in.)	Tie Bar Spacing (in.)	Lane Configuration	Visual Distress	Additional Observations
10	15	9	Not observed	24	2 lanes per direction + 1 bicycle lane	Transverse Cracking (>50%)	<i>Construction date ~2016</i>

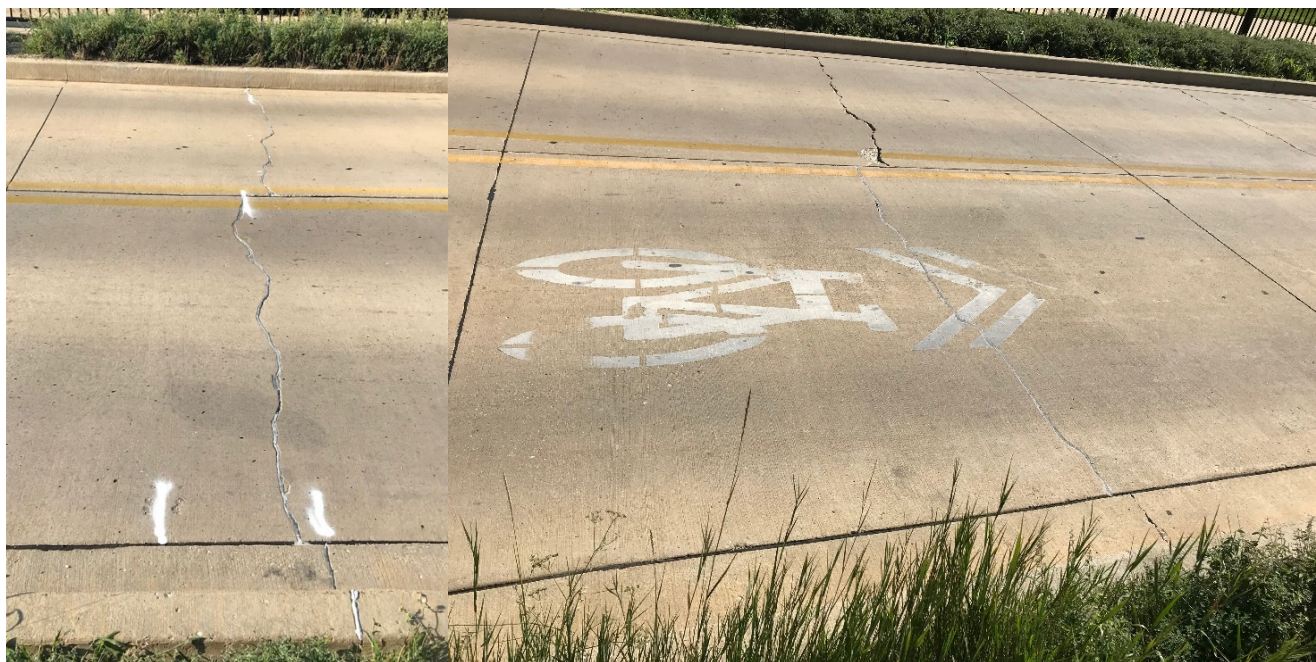
Figure 84. Photos. Logan Street.

Thickness (in.)	Panel Length (ft)	Panel Width (ft)	Dowel Bar Spacing (in.)	Tie Bar Spacing (in.)	Lane Configuration	Visual Distress	Additional Observations
8	15	11	12	23	1 lane per direction	Transverse Cracking (>50%)	<i>Construction date ~2010</i>

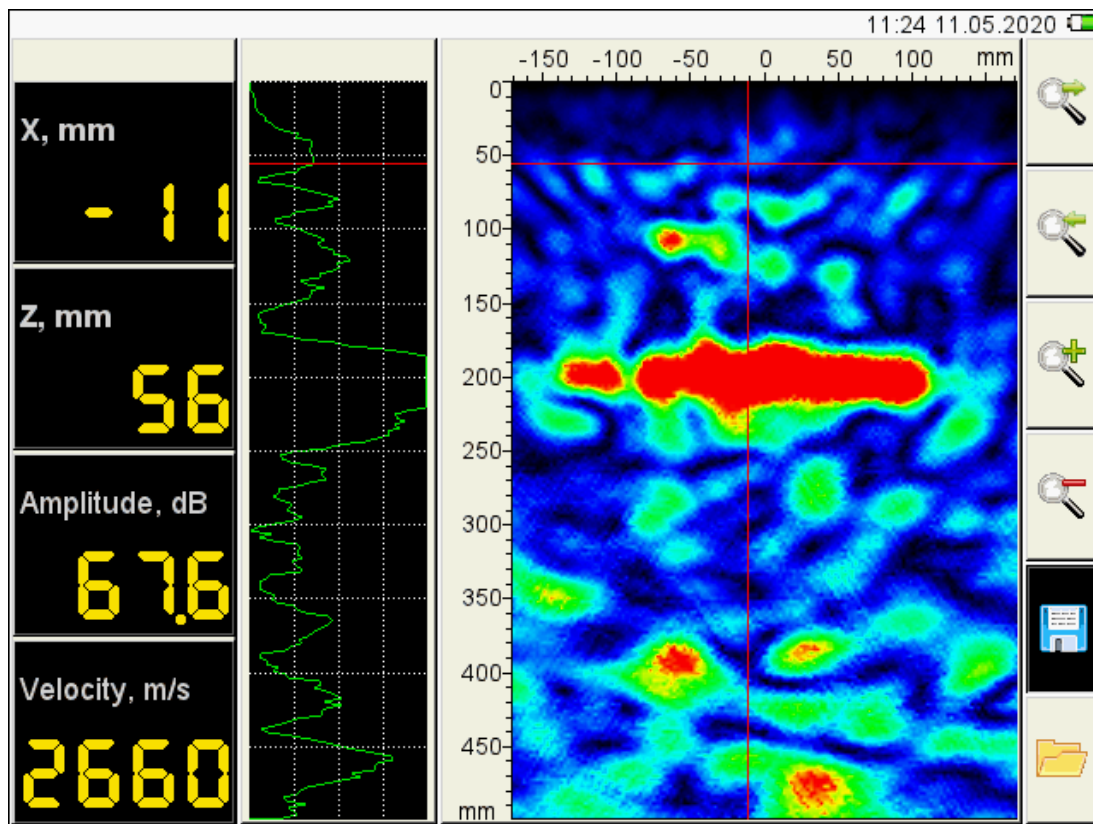
Figure 85. Photos. Ultrasound images of Curtis Road from Prospect Avenue to Duncan Road.

Thickness (in.)	Panel Length (ft)	Panel Width (ft)	Dowel Bar Spacing (in.)	Tie Bar Spacing (in.)	Lane Configuration	Visual Distress	Additional Observations
8	15	12	12	36	2 lanes per direction	Transverse cracking (>30%)	<i>Construction date ~2010</i>

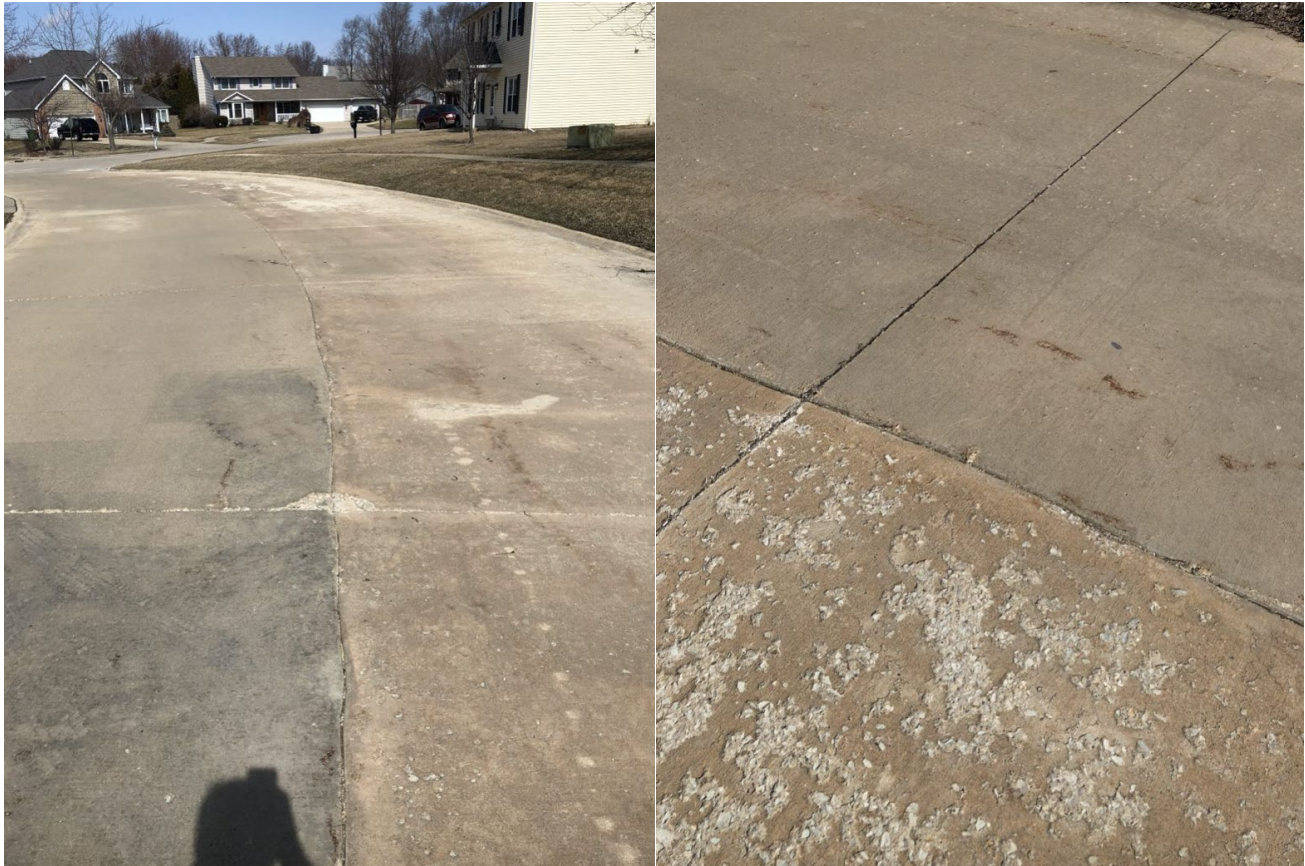
Figure 92. Photos. Sprucer Drive.

Thickness (in.)	Panel Length (ft)	Panel Width (ft)	Dowel Bar Spacing (in.)	Tie Bar Spacing (in.)	Lane Configuration	Visual Distress	Additional Observations
7	15	13	24	Not observed	1 lane per direction	Joint spalling and slab scaling	<i>Construction date not available.</i>

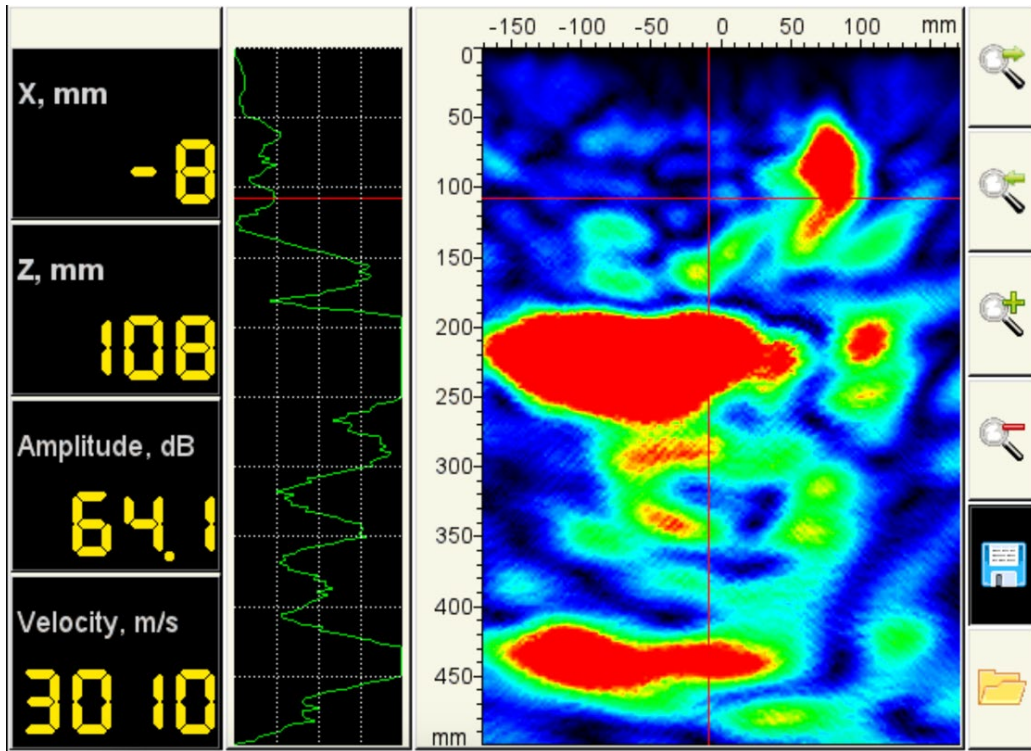
Figure 93. Photos. Ultrasound images of Lake of the Woods Road.

Thickness (in.)	Panel Length (ft)	Panel Width (ft)	Dowel Bar Spacing (in.)	Tie Bar Spacing (in.)	Lane Configuration	Visual Distress	Additional Observations
9	12	13	30	22	1 lane per direction + central lane	Transverse cracking (<30%)	<i>Construction date ~ 2014.</i>

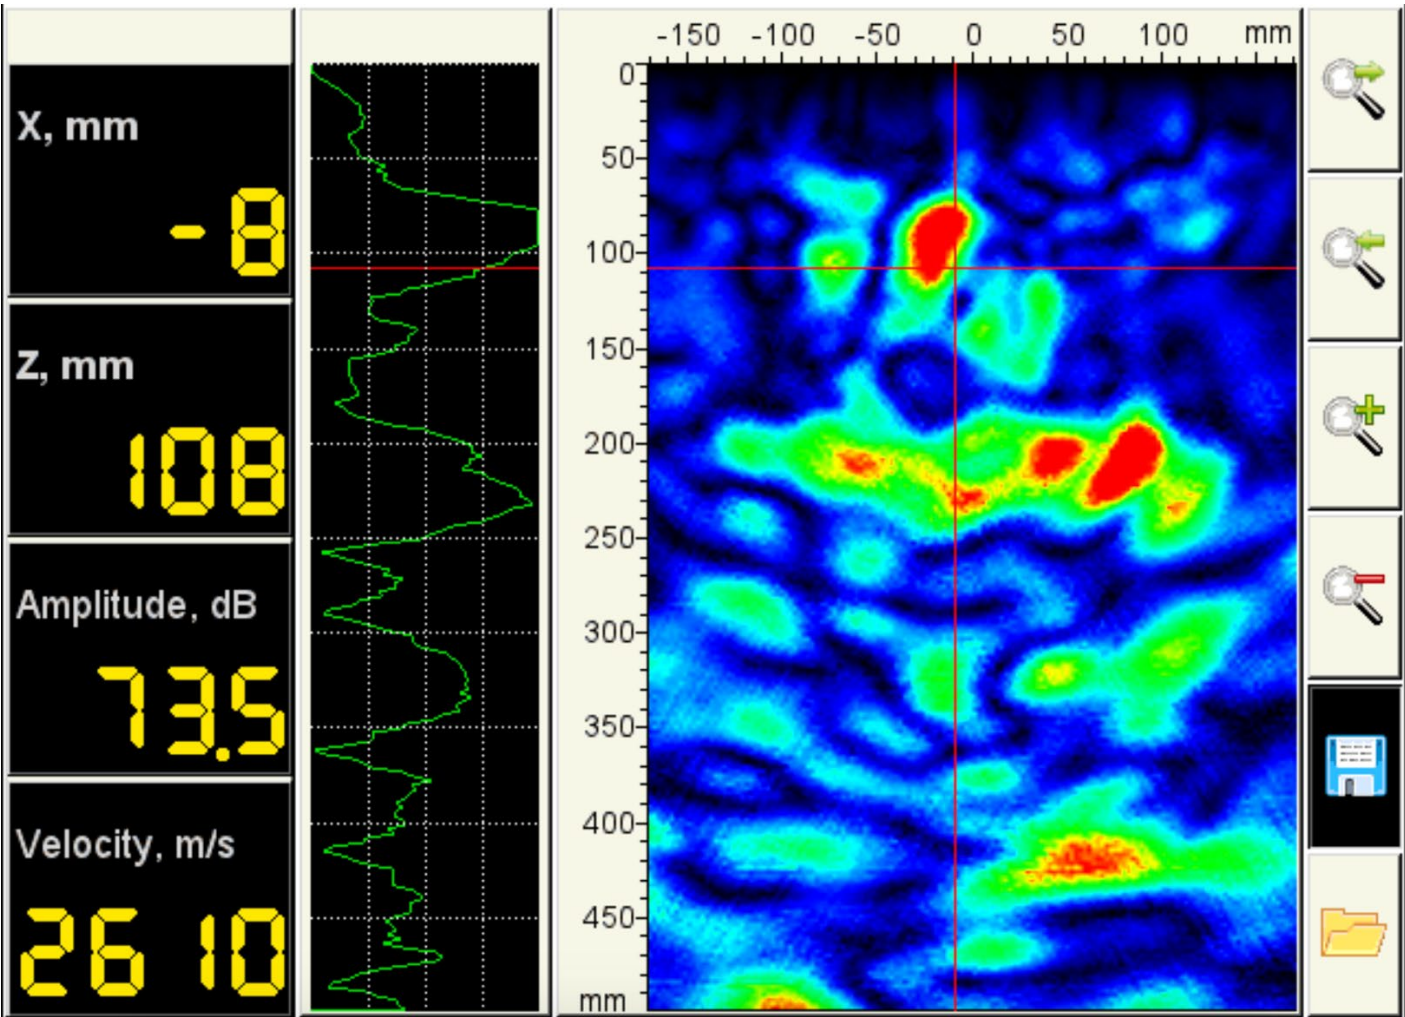
Figure 95. Photos. Ultrasound images of Veterans Parkway.

Thickness (in.)	Panel Length (ft)	Panel Width (ft)	Dowel Bar Spacing (in.)	Tie Bar Spacing (in.)	Lane Configuration	Visual Distress	Additional Observations
8	15	13	26	Not observed	1 lane per direction + central lane	Minimum surface cracks parallel to joint	<i>Construction date ~2014</i>

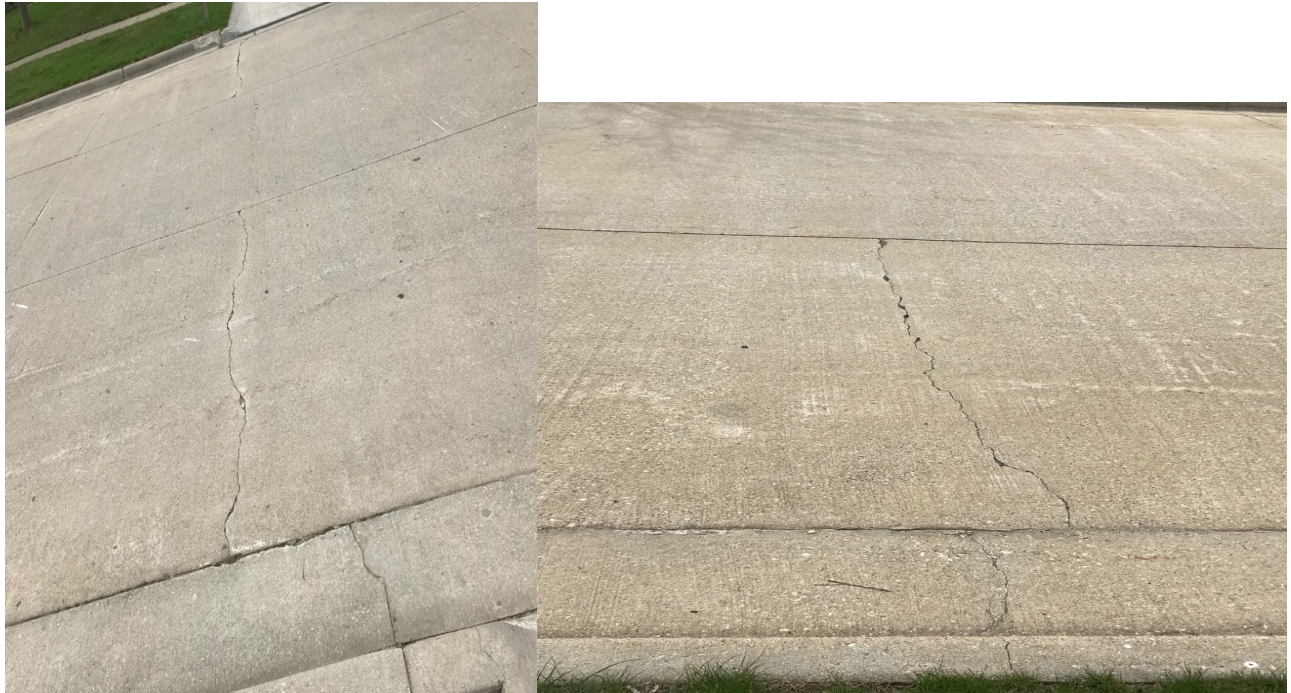
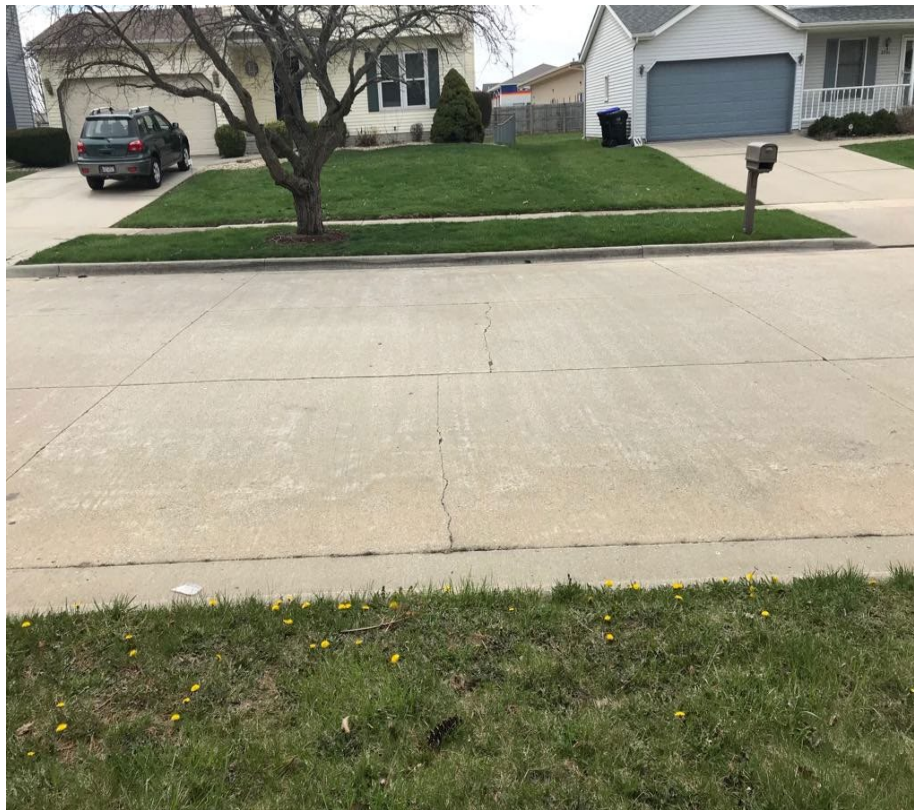
Figure 100. Photos. Providence Drive.

Thickness (in.)	Panel Length (ft)	Panel Width (ft)	Dowel Bar Spacing (in.)	Tie Bar Spacing (in.)	Lane Configuration	Visual Distress	Additional Observations
Not evaluated	20	9	Not evaluated	Not evaluated	1 lane per direction + central lane	Medium transverse cracking (>30%)	Construction date ~ 2000s

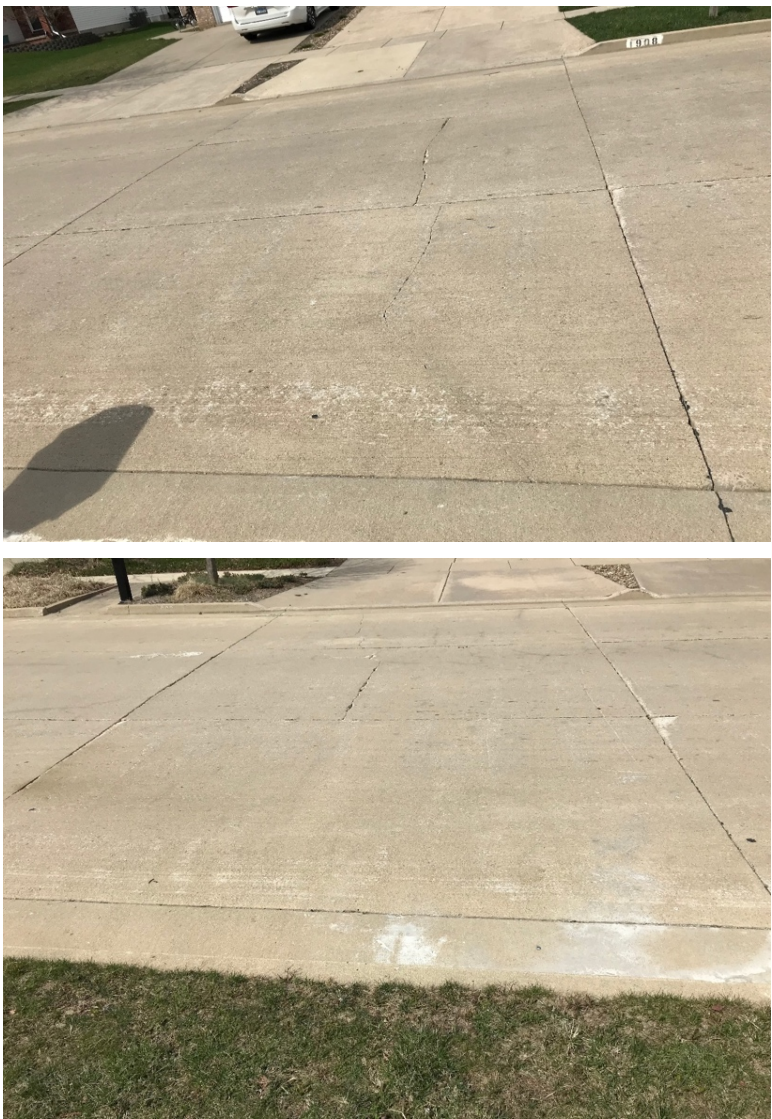
Figure 101. Photos. Vladimir Drive.

Thickness (in.)	Panel Length (ft)	Panel Width (ft)	Dowel Bar Spacing (in.)	Tie Bar Spacing (in.)	Lane Configuration	Visual Distress	Additional Observations
Not evaluated	15	9	Not evaluated	Not evaluated	1 lane per direction + central lane	Transverse cracking (>30%)	<i>Construction date ~2000s</i>

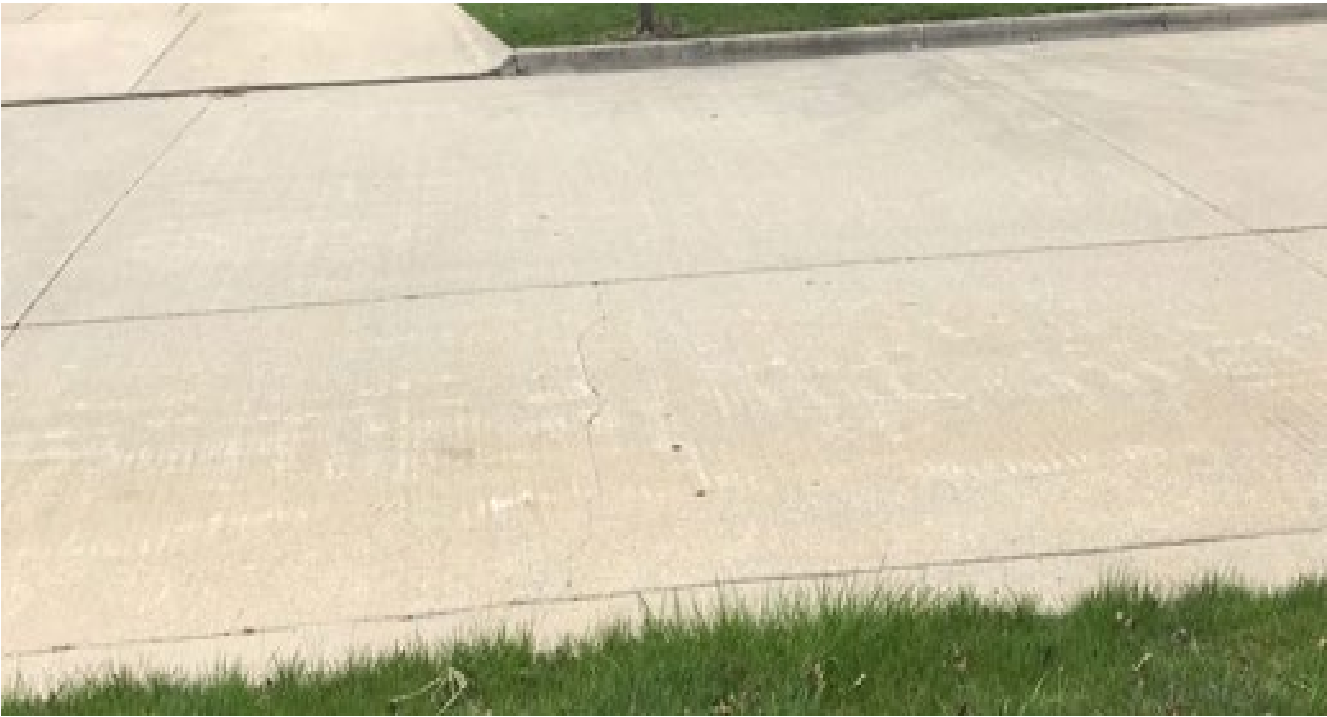
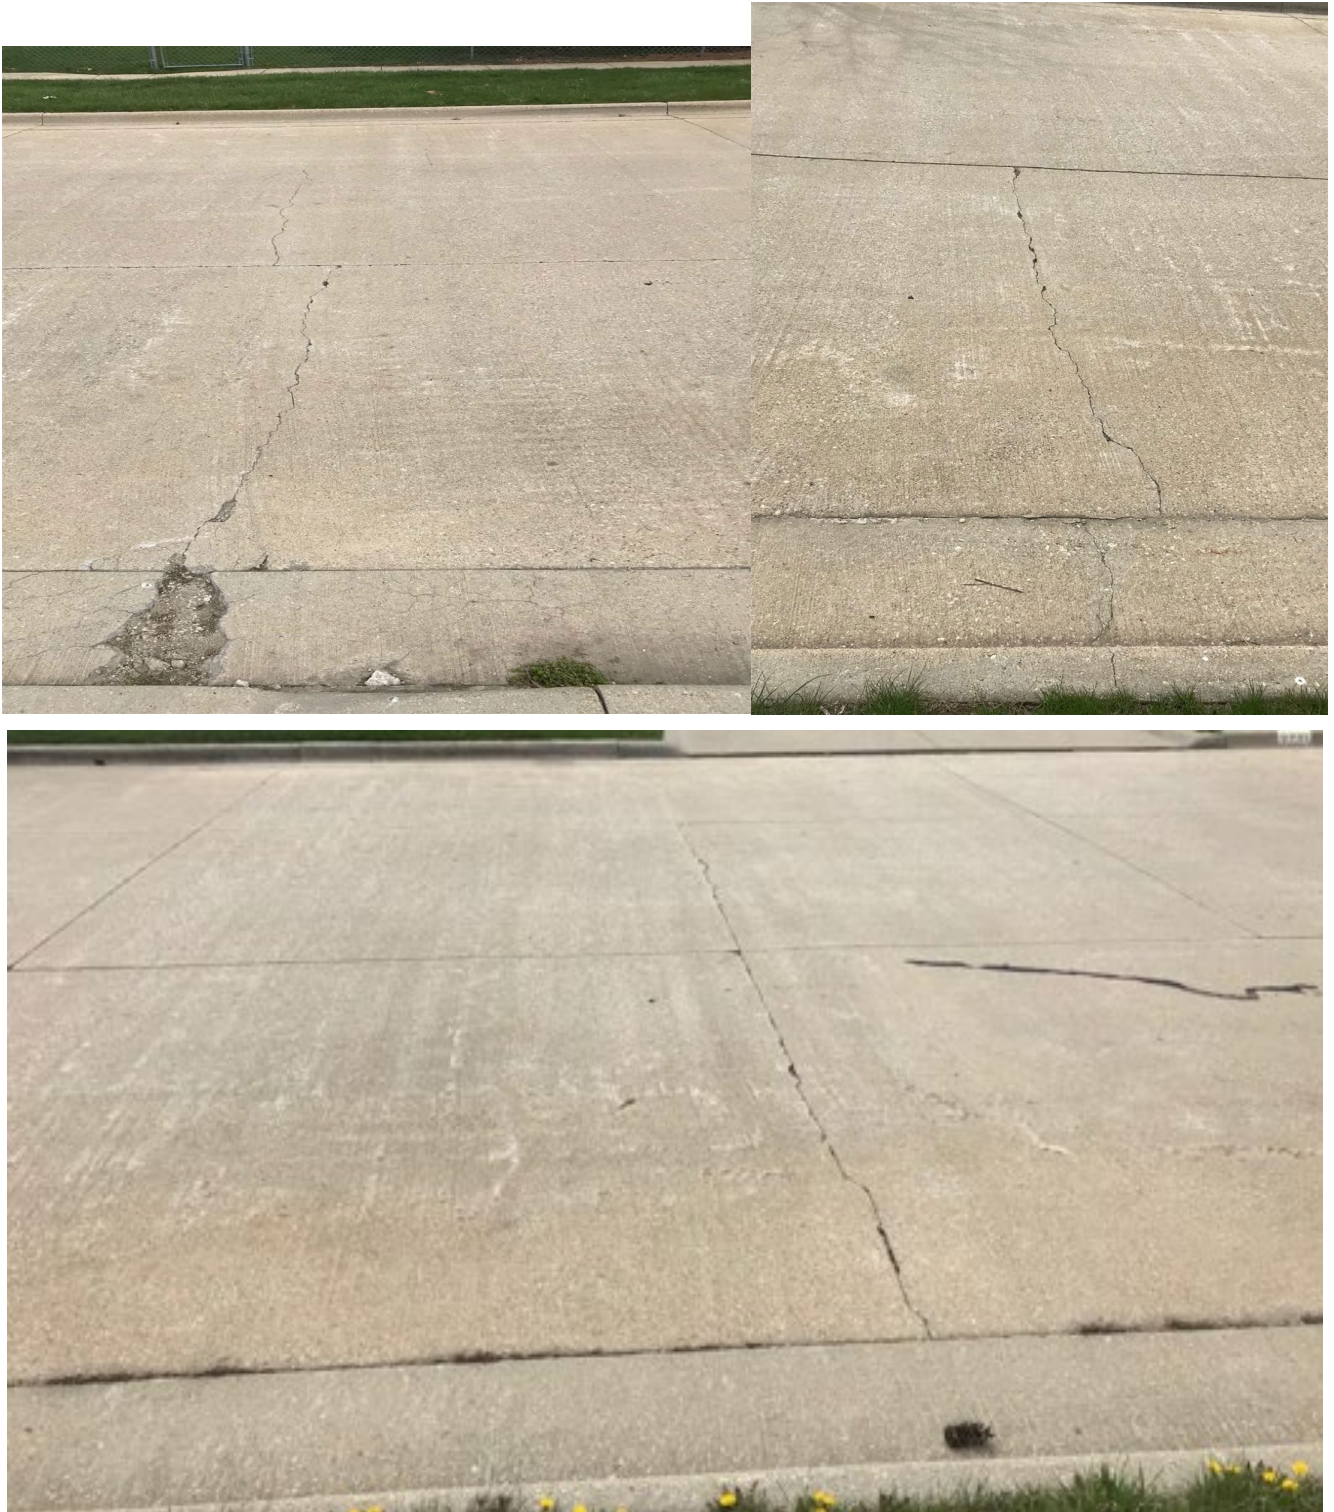
Figure 102. Photos. Slaydon Drive.

Thickness (in.)	Panel Length (ft)	Panel Width (ft)	Dowel Bar Spacing (in.)	Tie Bar Spacing (in.)	Lane Configuration	Visual Distress	Additional Observations
Not evaluated	20	9	Not evaluated	Not evaluated	1 lane per direction + central lane	Transverse cracking (>50%)	Construction date ~2000s

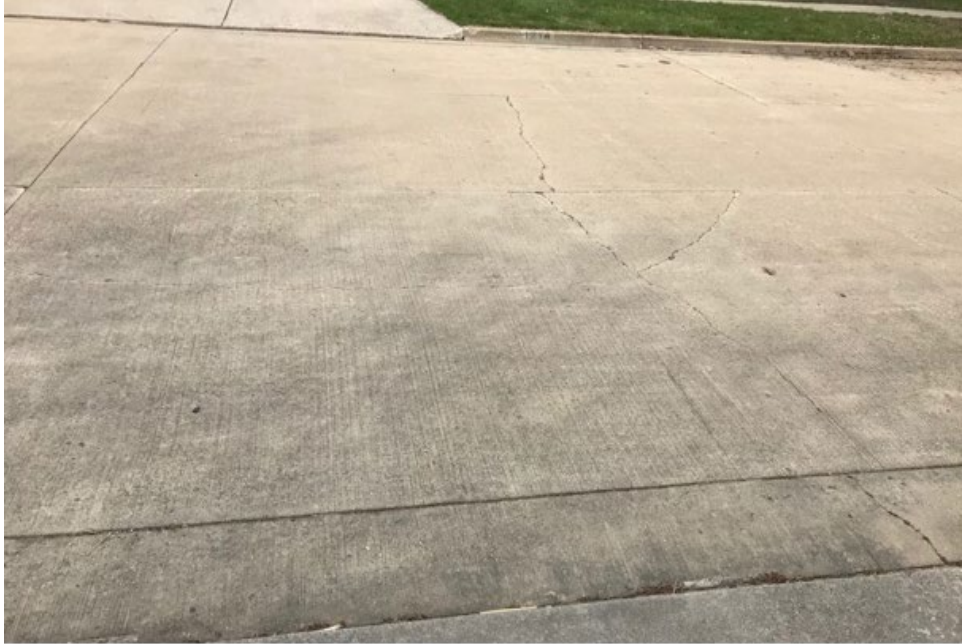
Figure 103. Photos. Challis Drive.

Thickness (in.)	Panel Length (ft)	Panel Width (ft)	Dowel Bar Spacing (in.)	Tie Bar Spacing (in.)	Lane Configuration	Visual Distress	Additional Observations
Not evaluated	20	9	Not evaluated	Not evaluated	1 lane per direction + central lane	Transverse cracking (>30%)	<i>Construction date ~2000s</i>

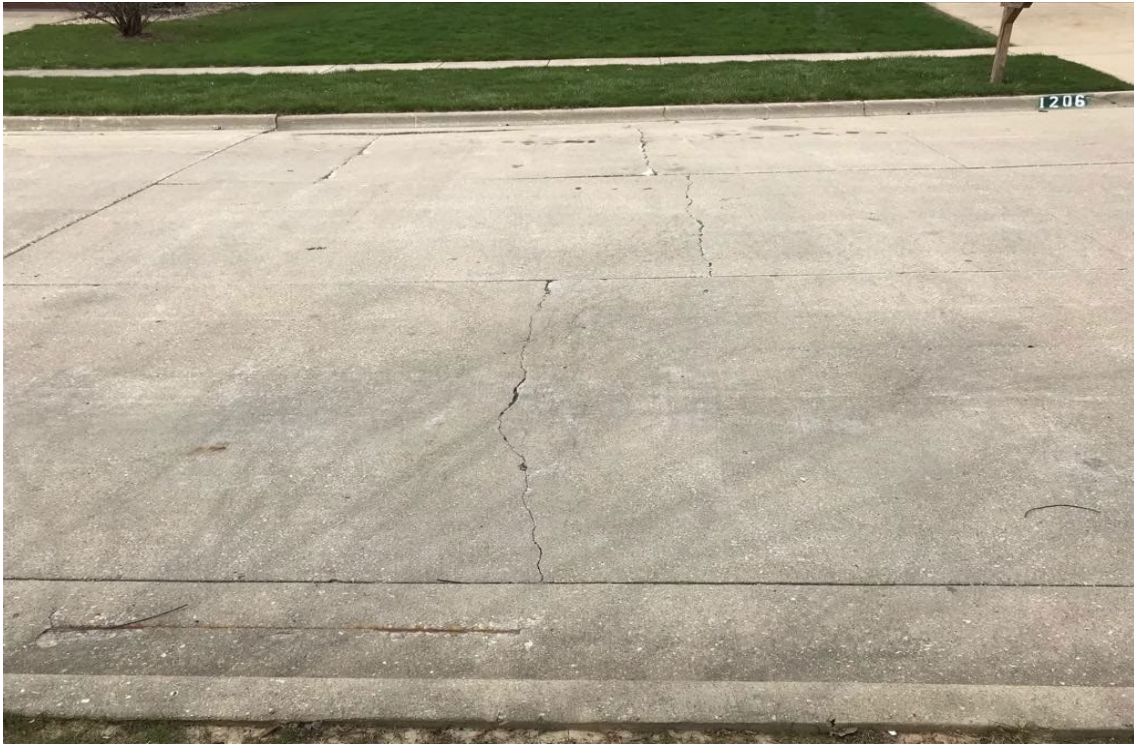
Figure 104. Photos. Bancroft Drive.

Thickness (in.)	Panel Length (ft)	Panel Width (ft)	Dowel Bar Spacing (in.)	Tie Bar Spacing (in.)	Lane Configuration	Visual Distress	Additional Observations
Not evaluated	20	9	Not evaluated	Not evaluated	1 lane per direction + central lane	Medium transverse cracking (>50%)	<i>Construction date ~2000s</i>

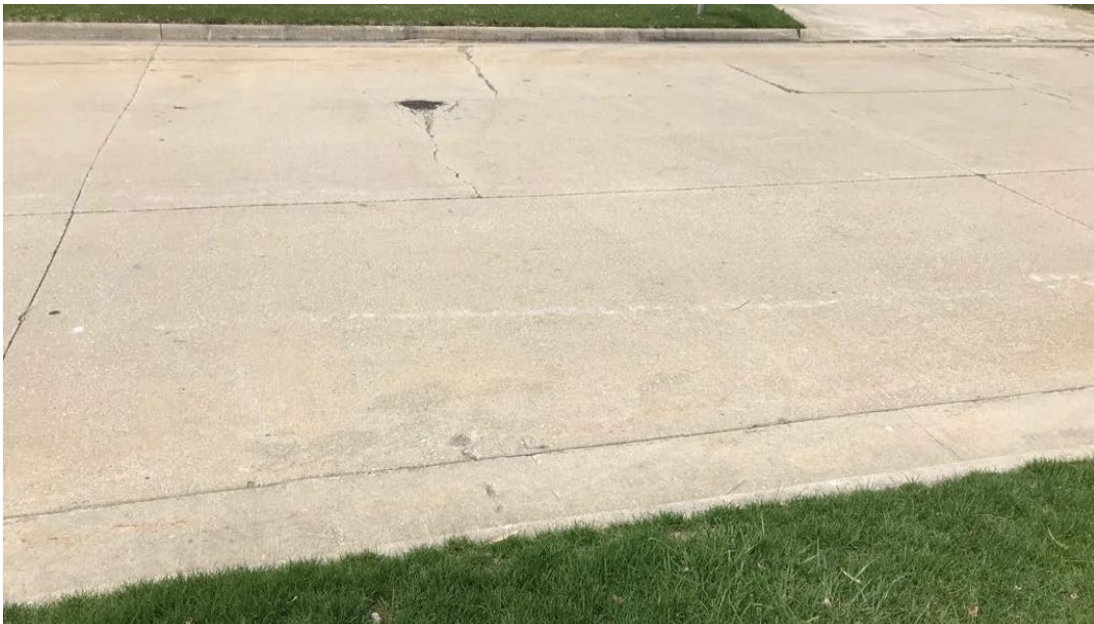
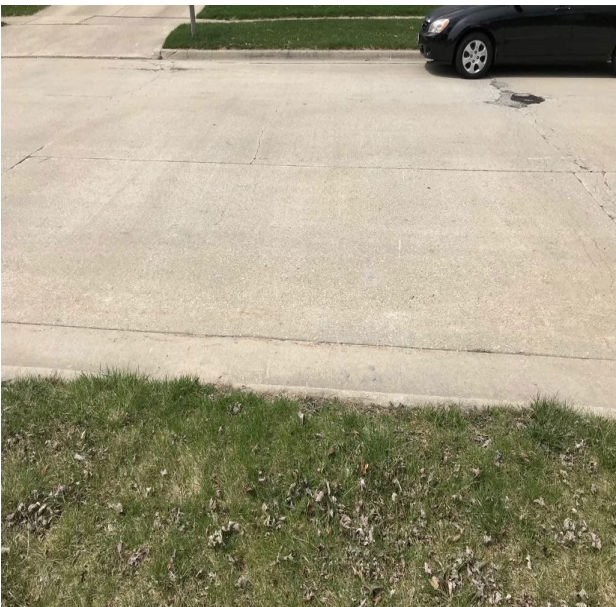
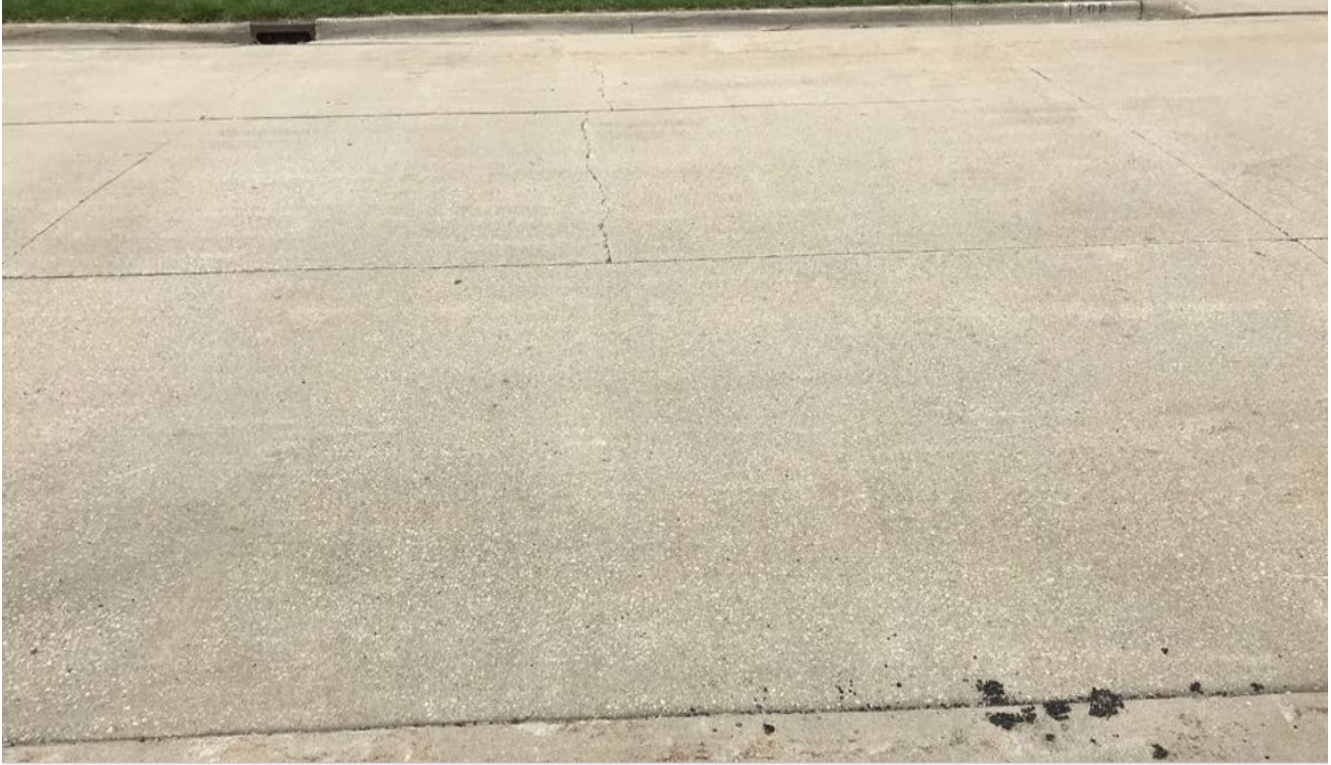
Figure 105. Photos. Cadwell Drive.

Thickness (in.)	Panel Length (ft)	Panel Width (ft)	Dowel Bar Spacing (in.)	Tie Bar Spacing (in.)	Lane Configuration	Visual Distress	Additional Observations
Not evaluated	20	9	Not evaluated	Not evaluated	1 lane per direction + central lane	Transverse cracking (>30%)	Construction date ~2000s
