Evaluation of Premature Cracking in Urban Concrete Pavement

Research Report No. FHWA-ICT-21-001

A report of the findings of
ICT PROJECT R27-193-4
Premature Cracking Mechanism for
Jointed Plain Concrete Pavement

January 2021

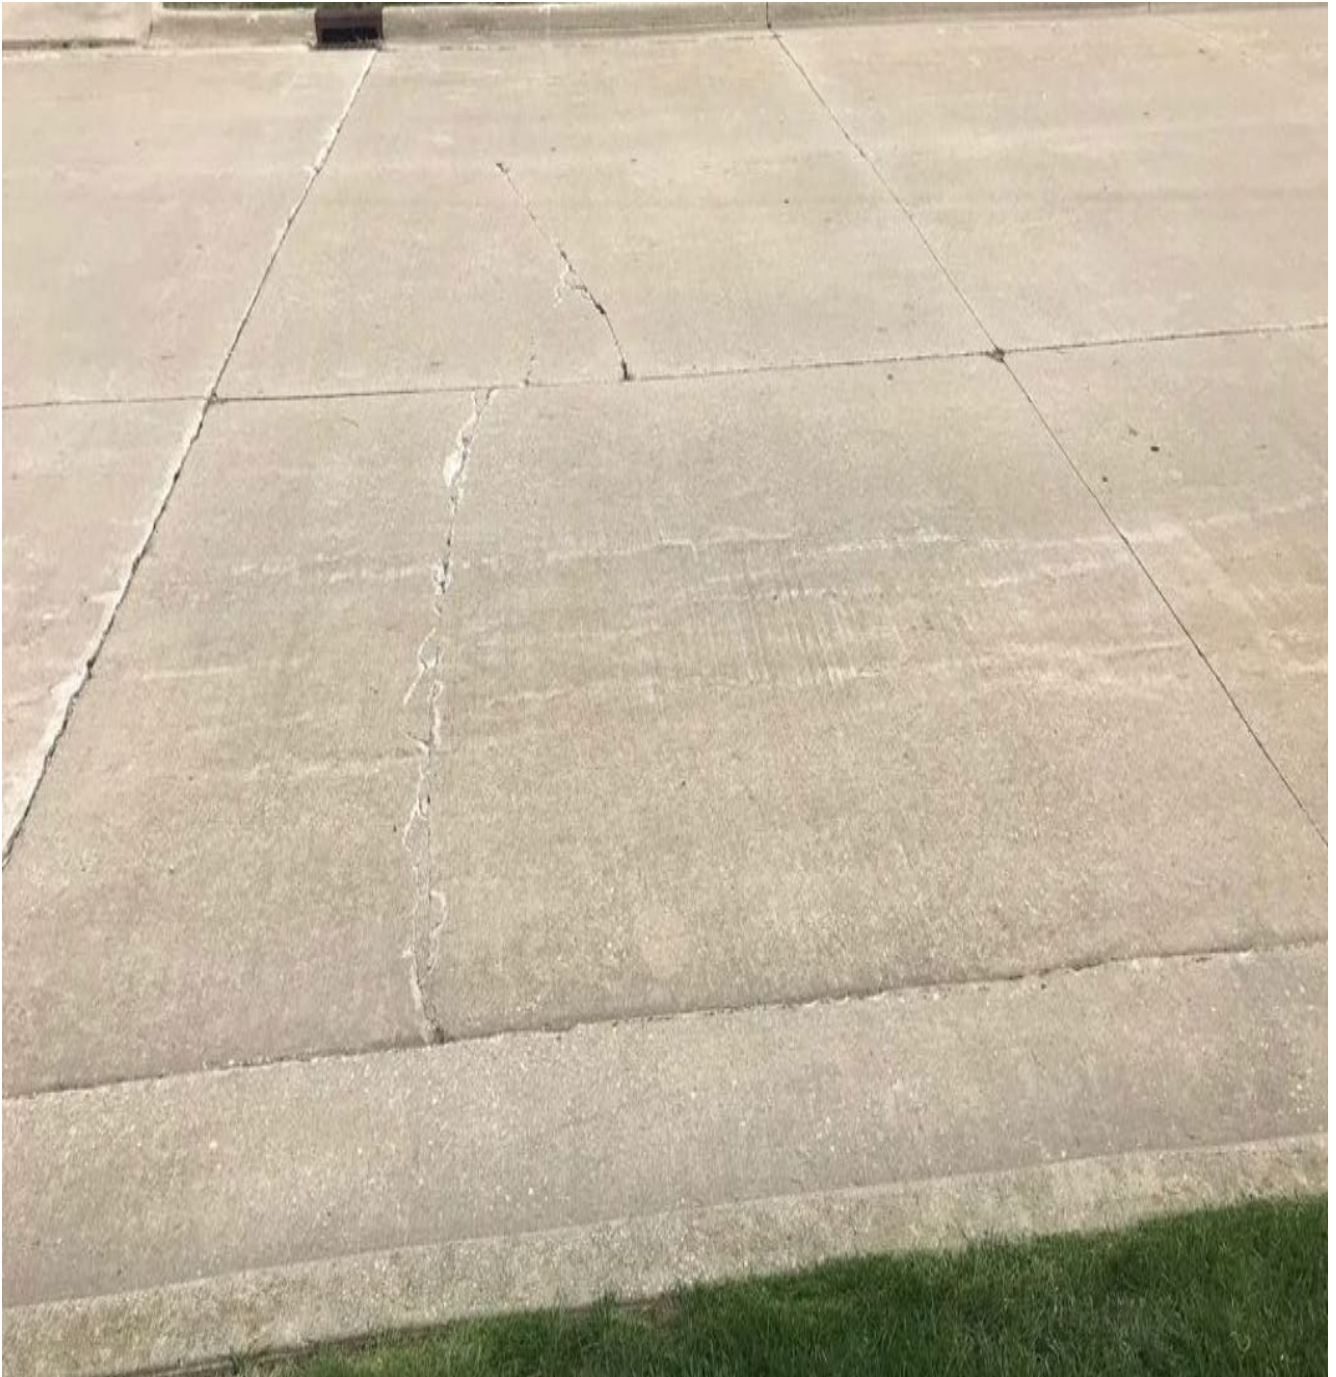
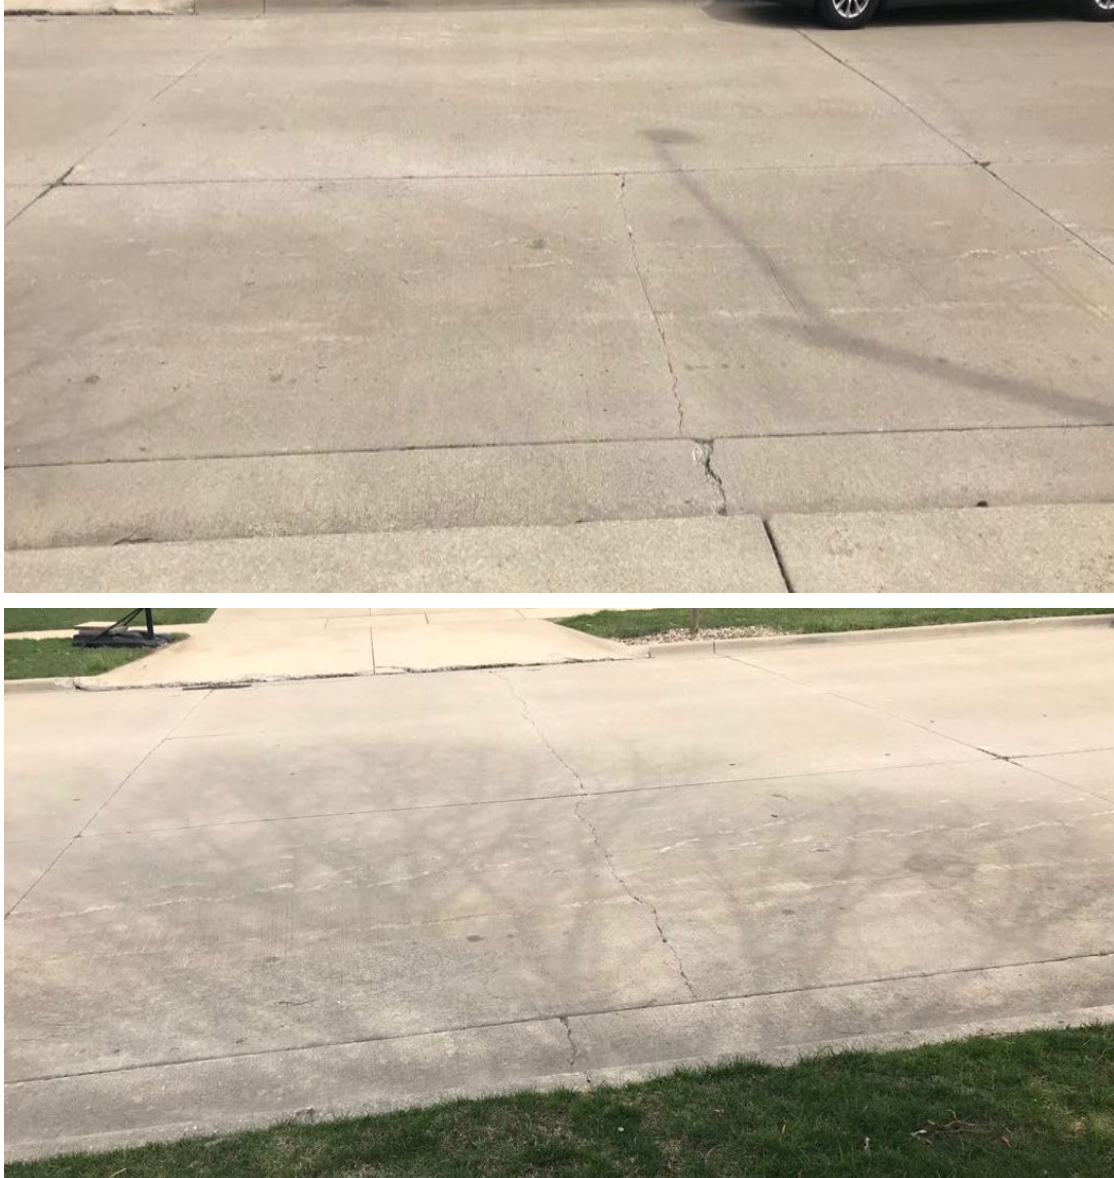
Figure 106. Photos. Newcastle Drive.

Thickness (in.)	Panel Length (ft)	Panel Width (ft)	Dowel Bar Spacing (in.)	Tie Bar Spacing (in.)	Lane Configuration	Visual Distress	Additional Observations
Not evaluated	20	9	Not evaluated	Not evaluated	1 lane per side + central lane	Transverse cracking (>30%)	<i>Construction date ~2000s</i>

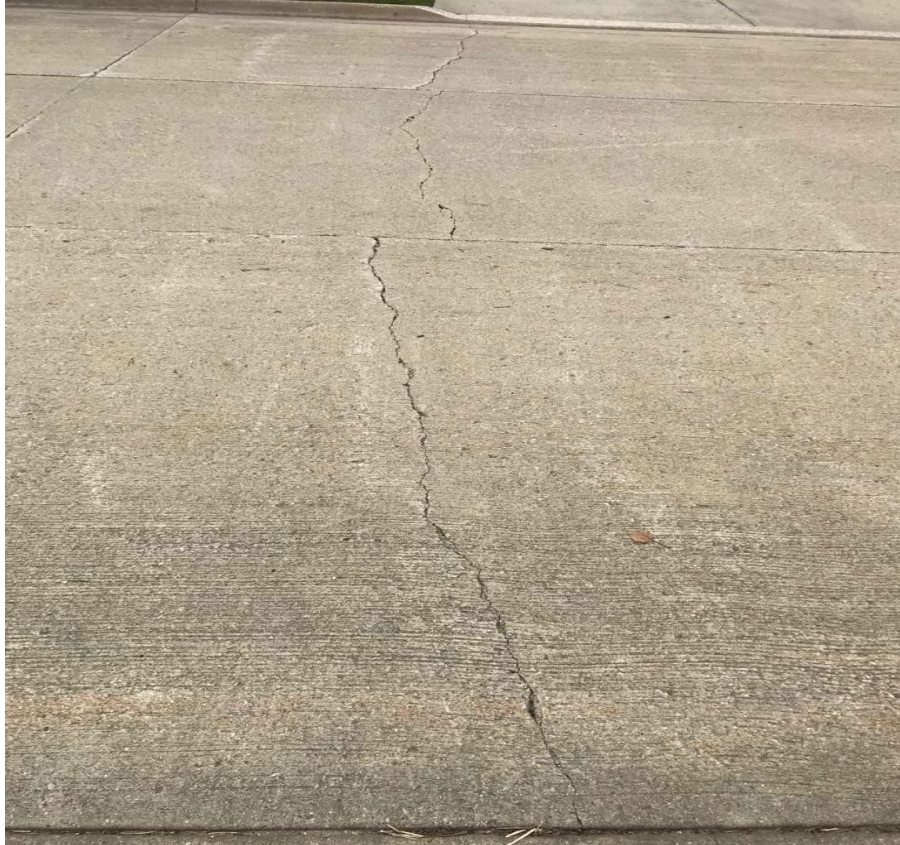
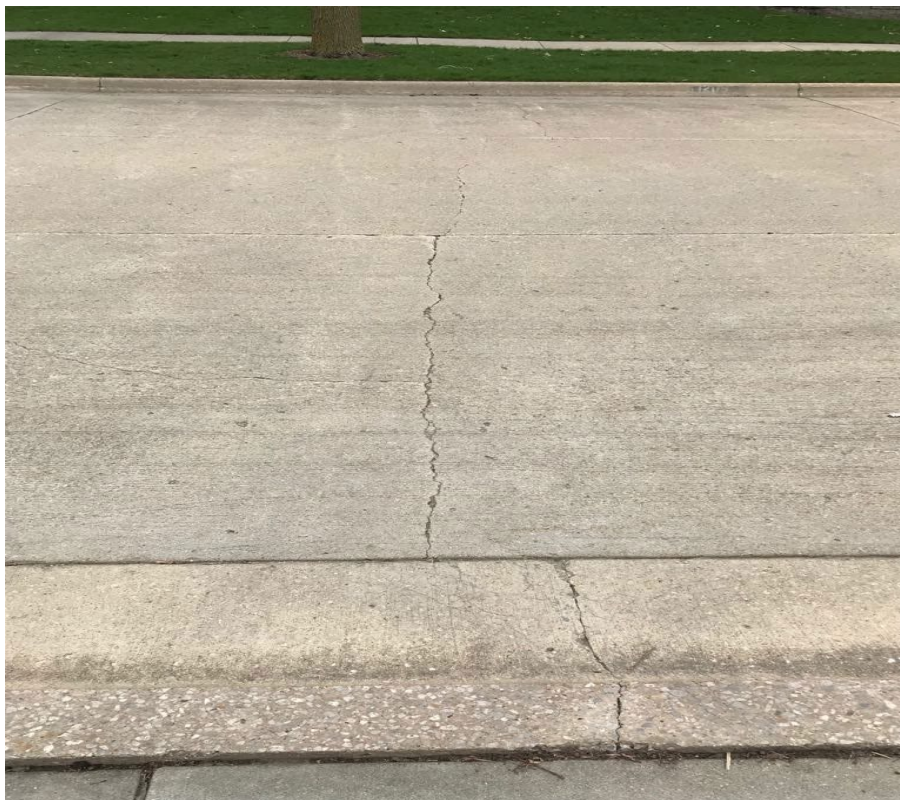
Figure 107. Photos. Chantal Lane.

Thickness (in.)	Panel Length (ft)	Panel Width (ft)	Dowel Bar Spacing (in.)	Tie Bar Spacing (in.)	Lane Configuration	Visual Distress	Additional Observations
Not evaluated	20	9	Not evaluated	Not evaluated	1 lane per direction + central lane	Transverse cracking (>30%)	Construction date ~2000s

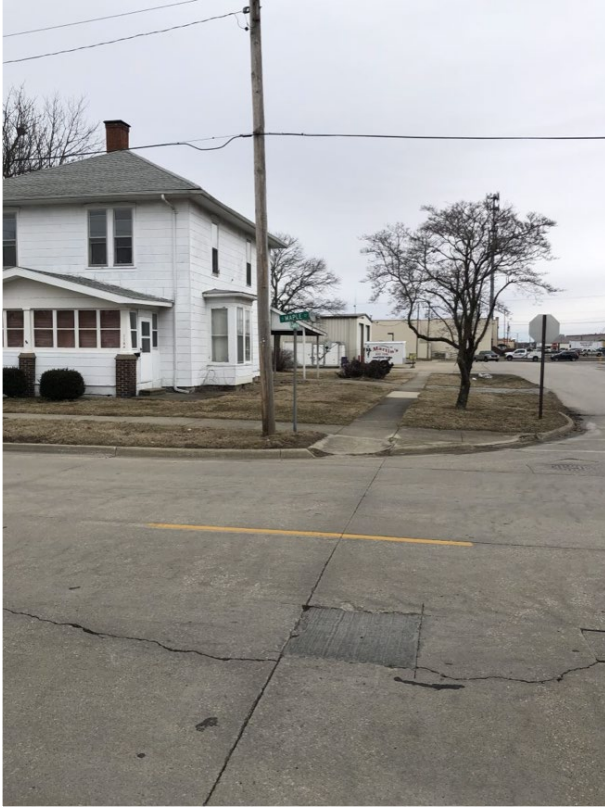
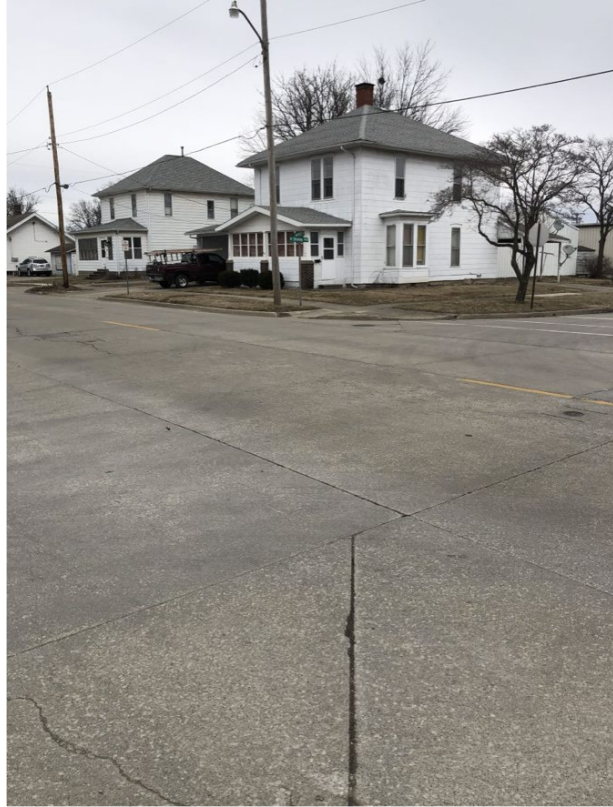
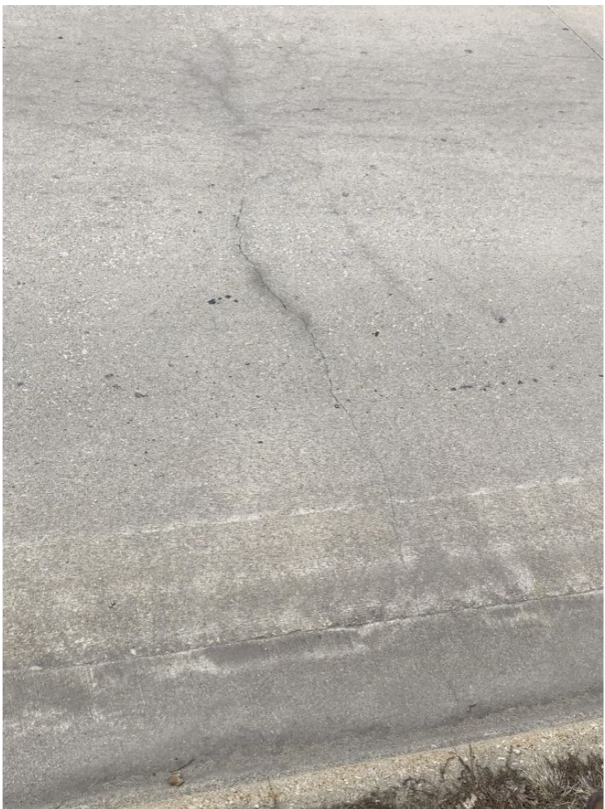
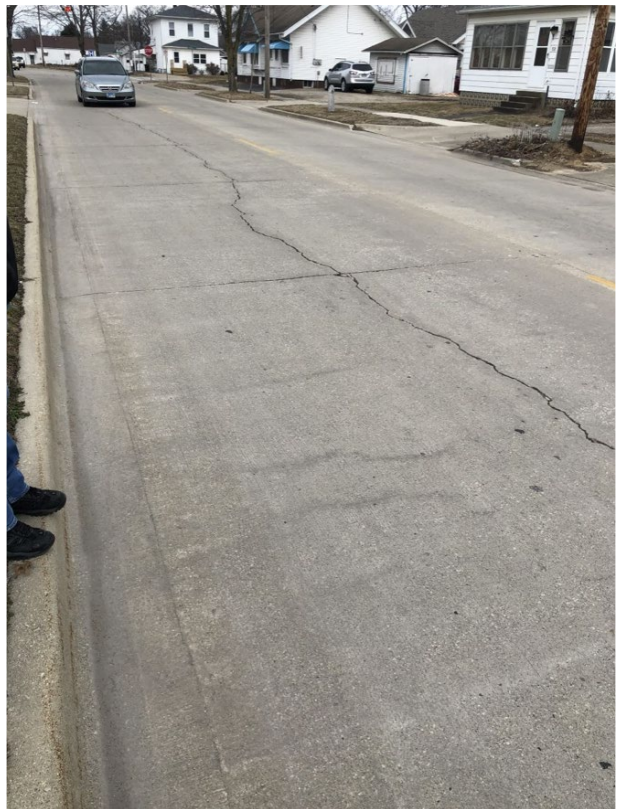
Figure 109. Photos. Maple Street (downtown).

Thickness (in.)	Panel Length (ft)	Panel Width (ft)	Dowel Bar Spacing (in.)	Tie Bar Spacing (in.)	Lane Configuratio n	Visual Distress	Additional Observations
8	15	12	Not observed	Not observed	1 lane per direction	Longitudinal cracking. (>50%)	<i>Construction date ~2000s</i>

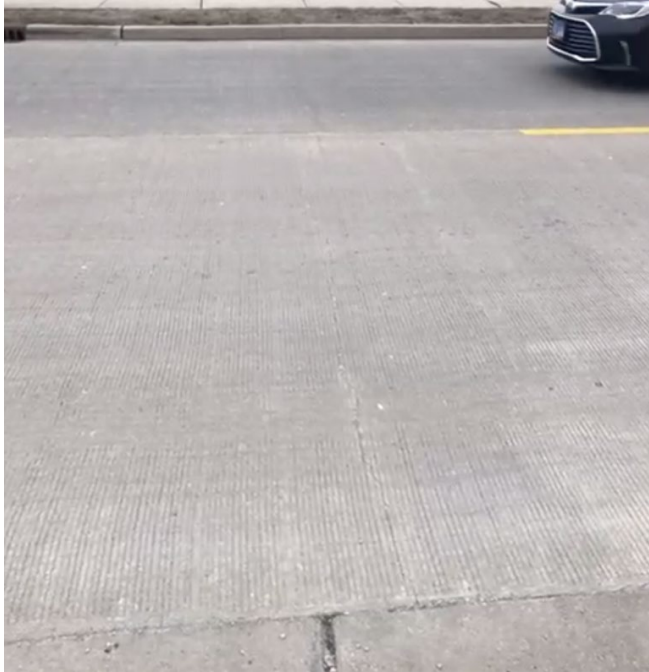
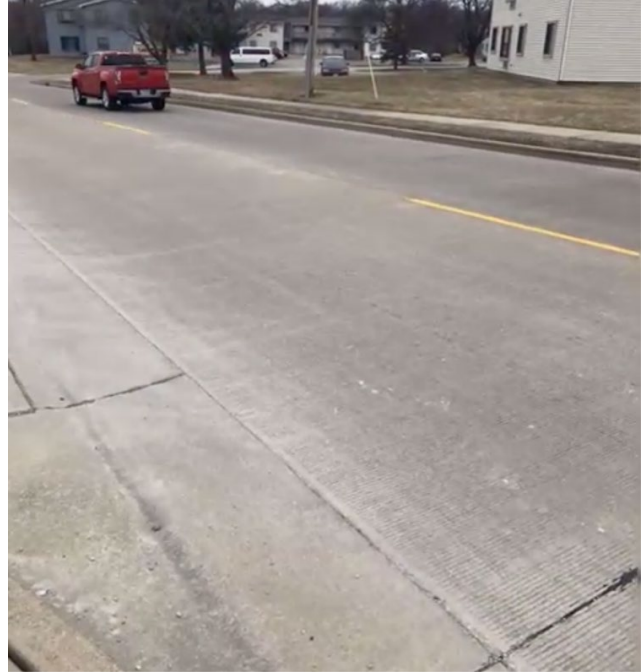
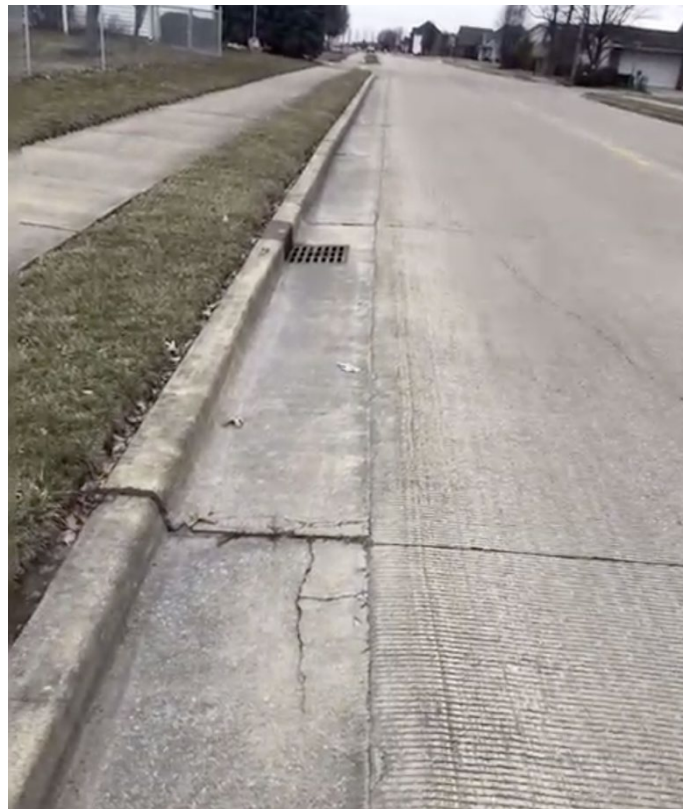
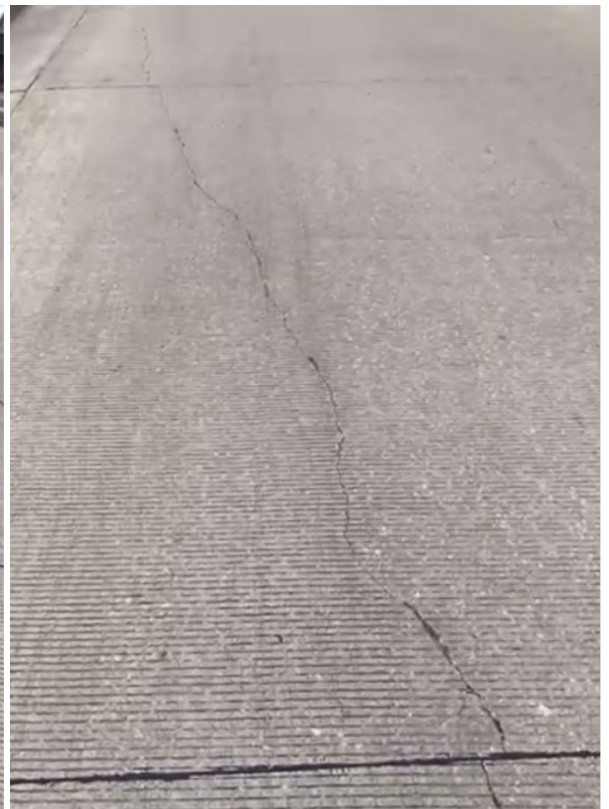
Figure 111. Photos. Maple Street (North).

Thickness (in.)	Panel Length (ft)	Panel Width (ft)	Dowel Bar Spacing (in.)	Tie Bar Spacing (in.)	Lane Configuration	Visual Distress	Additional Observations
8	15	12	Variable	Variable	1 lane per direction	Mid-panel cracking and longitudinal cracks (<30%)	<i>Construction date ~2000s</i>

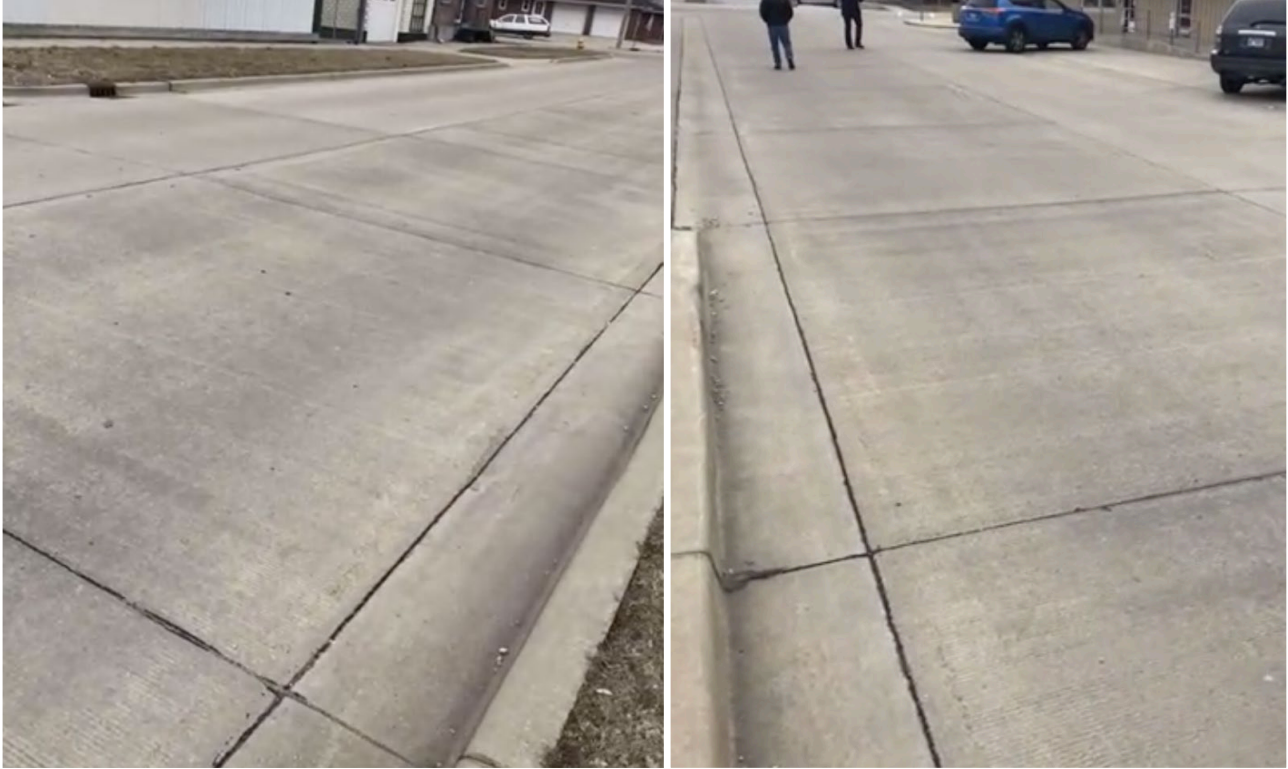
Figure 113. Photos. Ford Street.

Thickness (in.)	Panel Length (ft)	Panel Width (ft)	Dowel Bar Spacing (in.)	Tie Bar Spacing (in.)	Lane Configuration	Visual Distress	Additional Observations
9	13	20	Not observed	Variable	1 lane per direction	Transverse cracking (>30%)	Construction date ~2000s

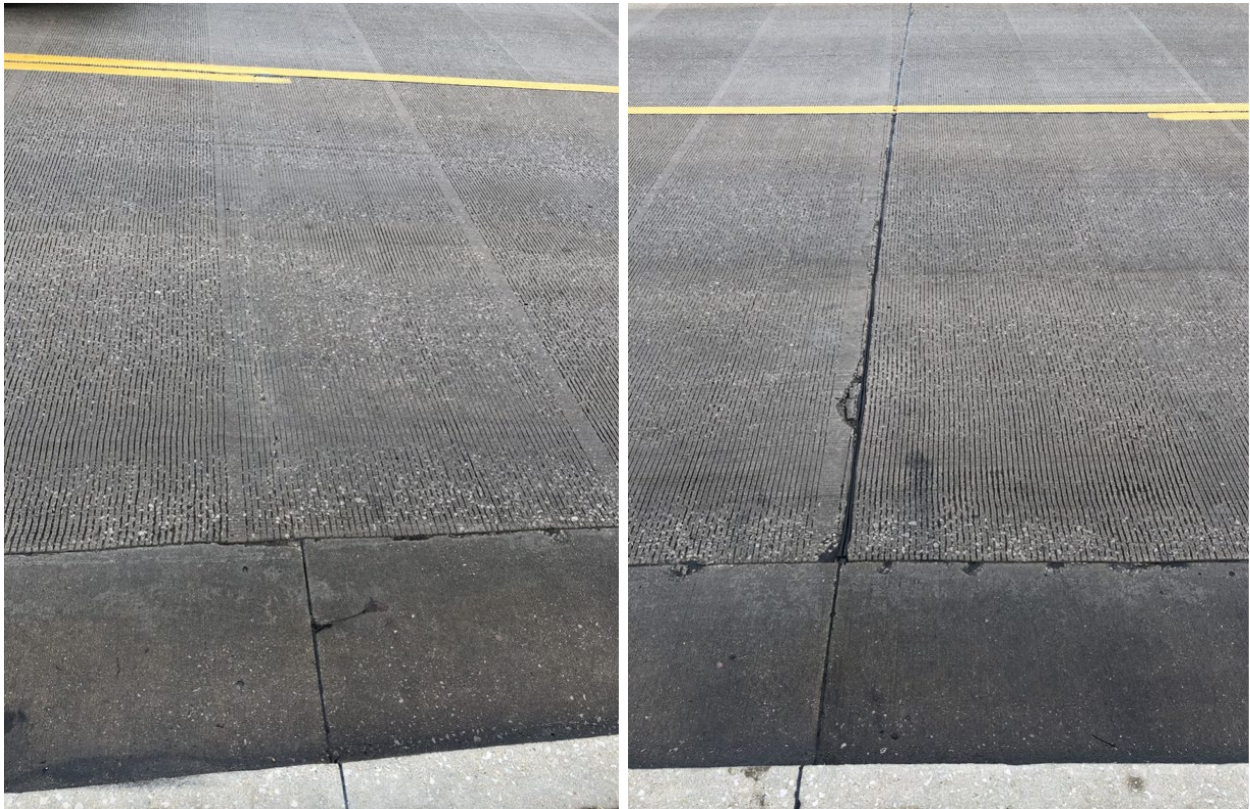
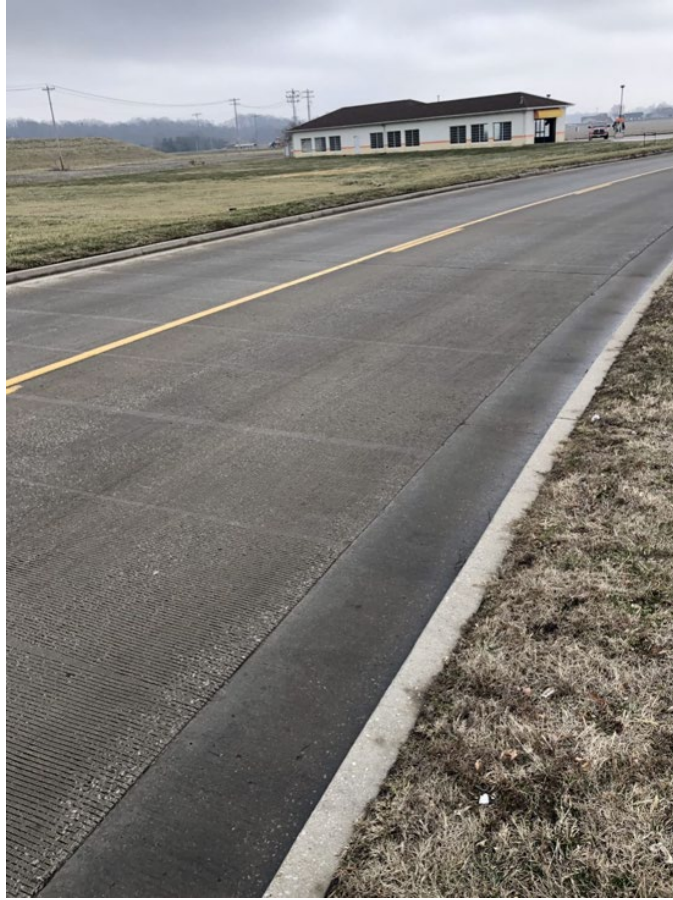
Figure 116. Photos. Harrison Street with Wesley Drive.

Thickness (in.)	Panel Length (ft)	Panel Width (ft)	Dowel Bar Spacing (in.)	Tie Bar Spacing (in.)	Lane Configuration	Visual Distress	Additional Observations
8	45	12	24	Not observed	2 lanes per direction	Transverse cracking and joint deterioration (~98%)	<i>Construction date ~2010s</i>

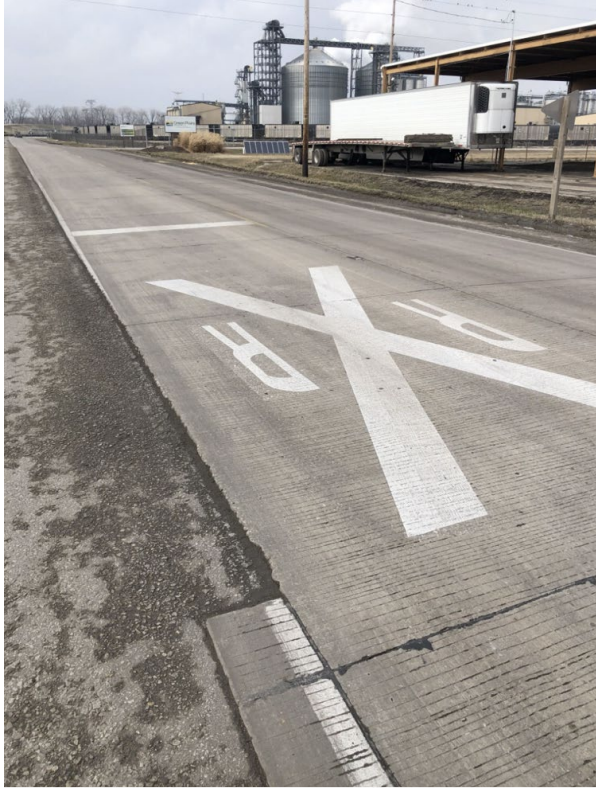
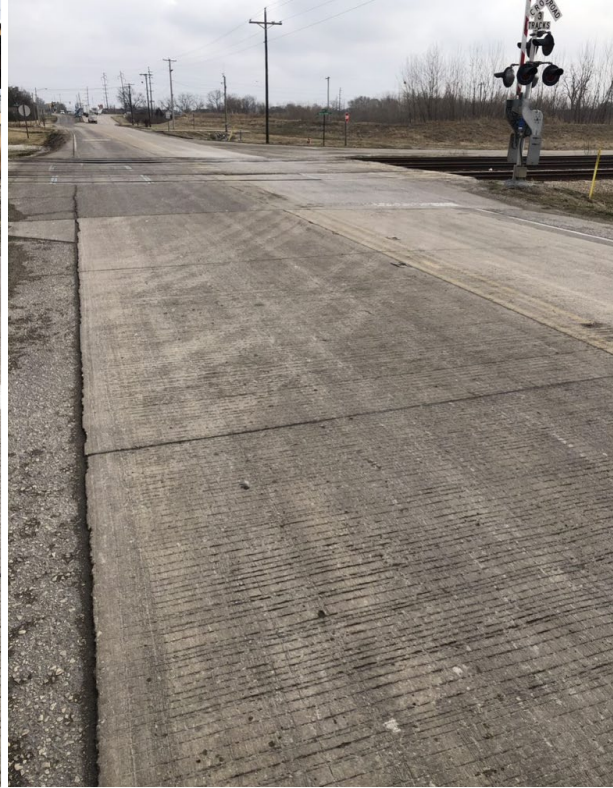
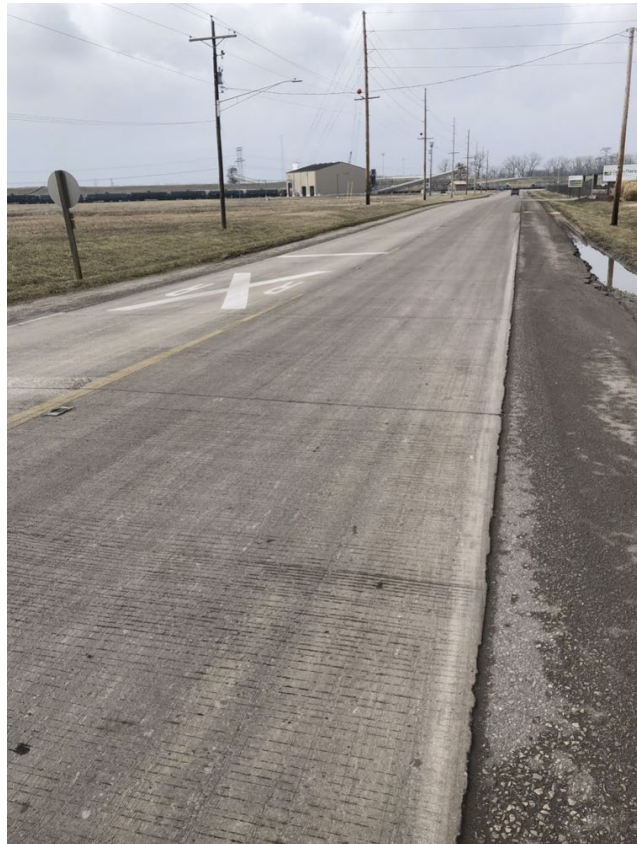
Figure 121. Photos. Bissel Road.

Thickness (in.)	Panel Length (ft)	Panel Width (ft)	Dowel Bar Spacing (in.)	Tie Bar Spacing (in.)	Lane Configuration	Visual Distress	Additional Observations
Variable within 10-12	15	12	24	36	2 lanes per direction	No distress observed	Construction date ~ 2010s

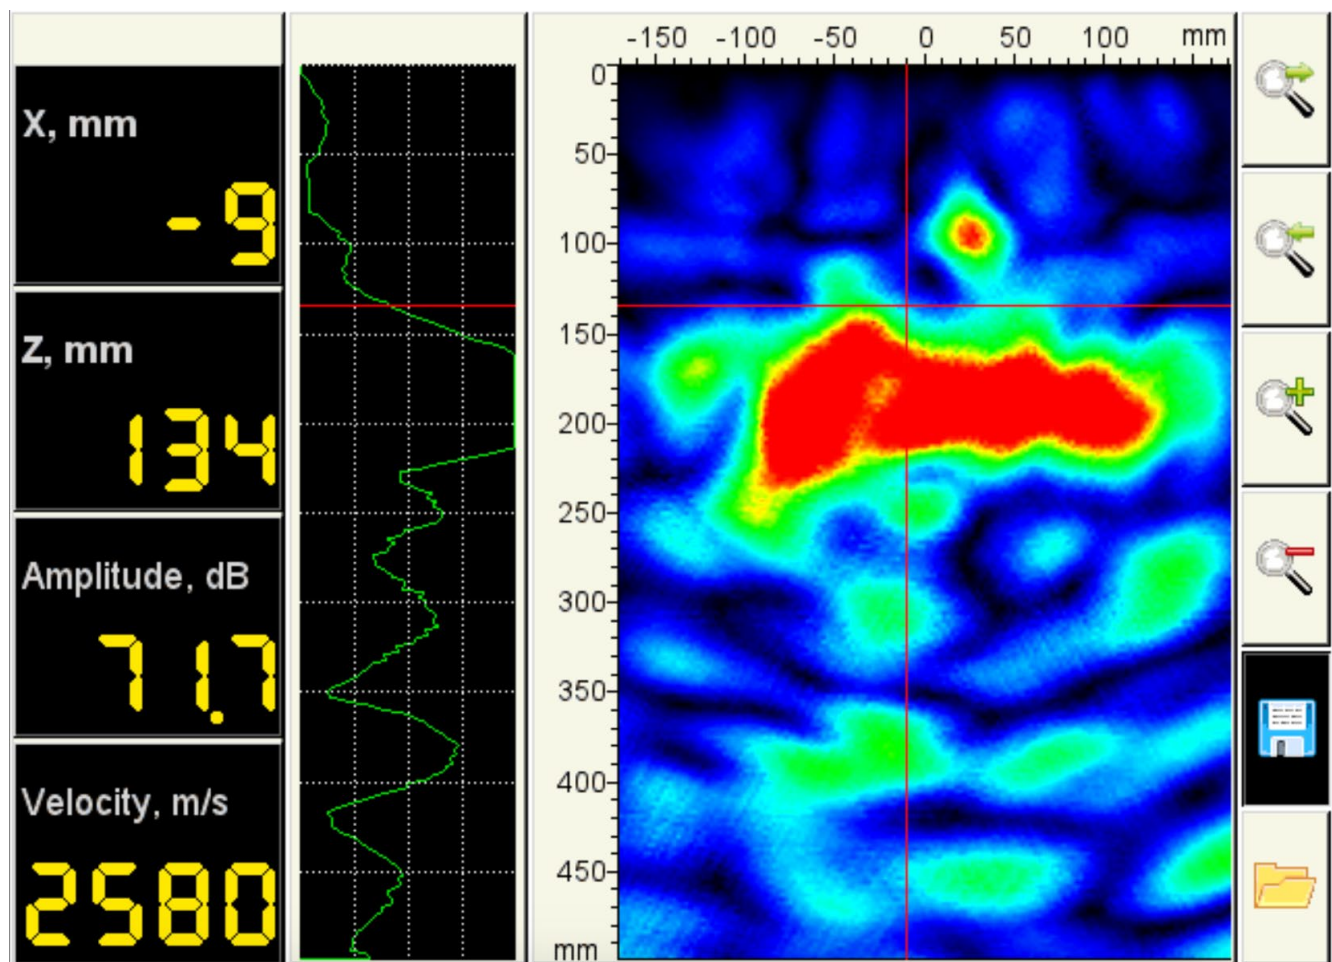
Figure 122. Photos. Ultrasound image of Bissel Road section 2.

Thickness (in.)	Panel Length (ft)	Panel Width (ft)	Dowel Bar Spacing (in.)	Tie Bar Spacing (in.)	Lane Configuration	Visual Distress	Additional Observations
7	18	12	12	72	1 lane per direction	Transverse cracking (>50%)	Construction date ~2010s

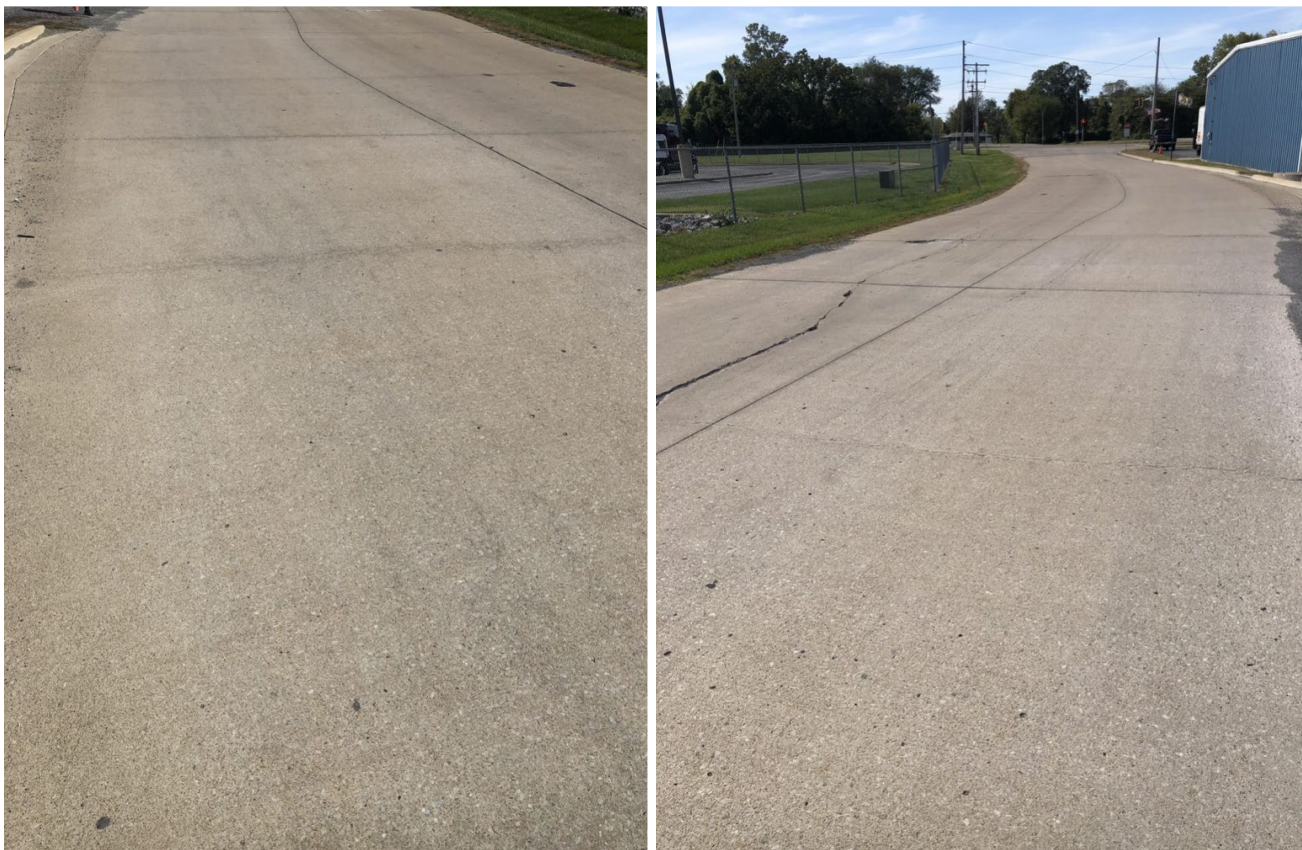
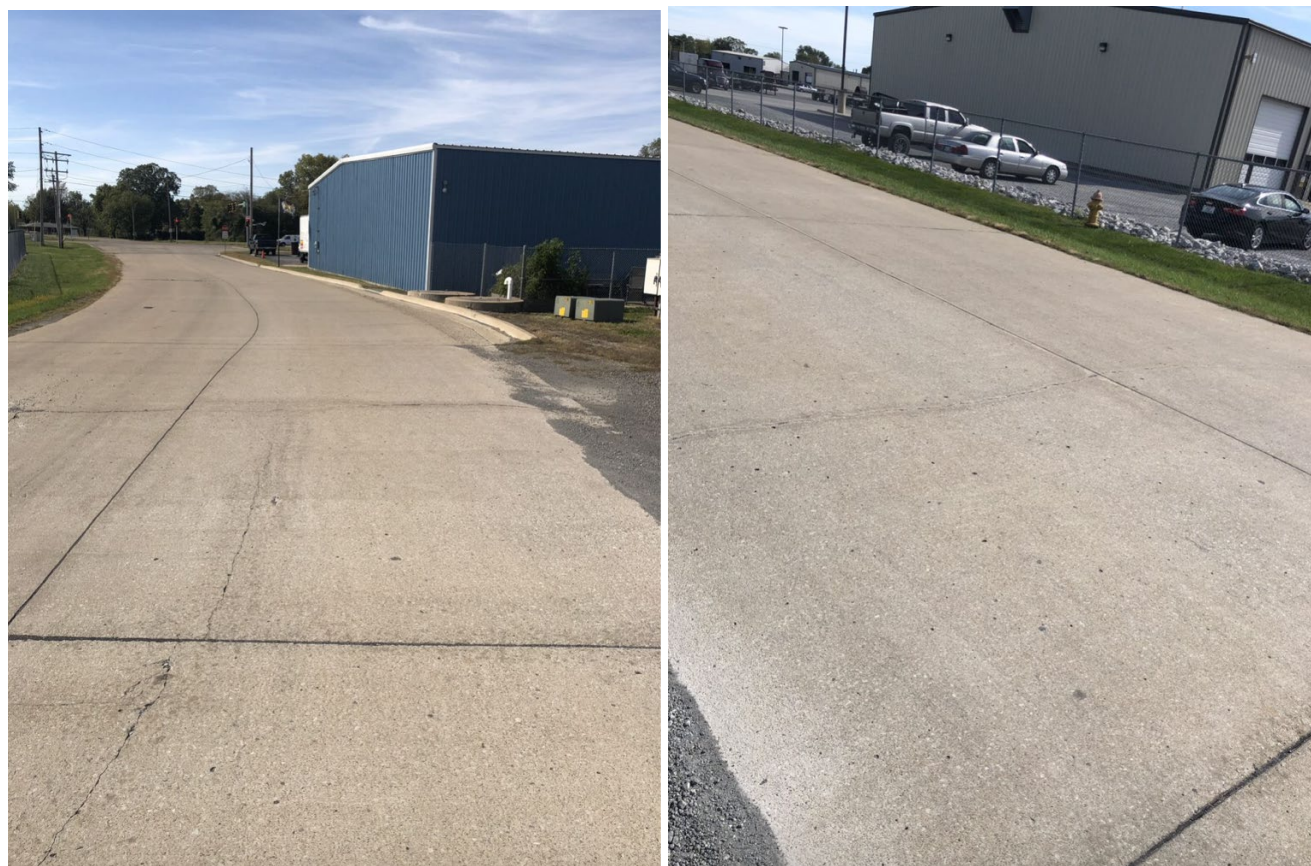
Figure 124. Photos. Central Street.

Thickness (in.)	Panel Length (ft)	Panel Width (ft)	Dowel Bar Spacing (in.)	Tie Bar Spacing (in.)	Lane Configuration	Visual Distress	Additional Observations
8	30	14	12	36	1 lane per direction	Transverse cracking (>50%)	Construction date ~2010s

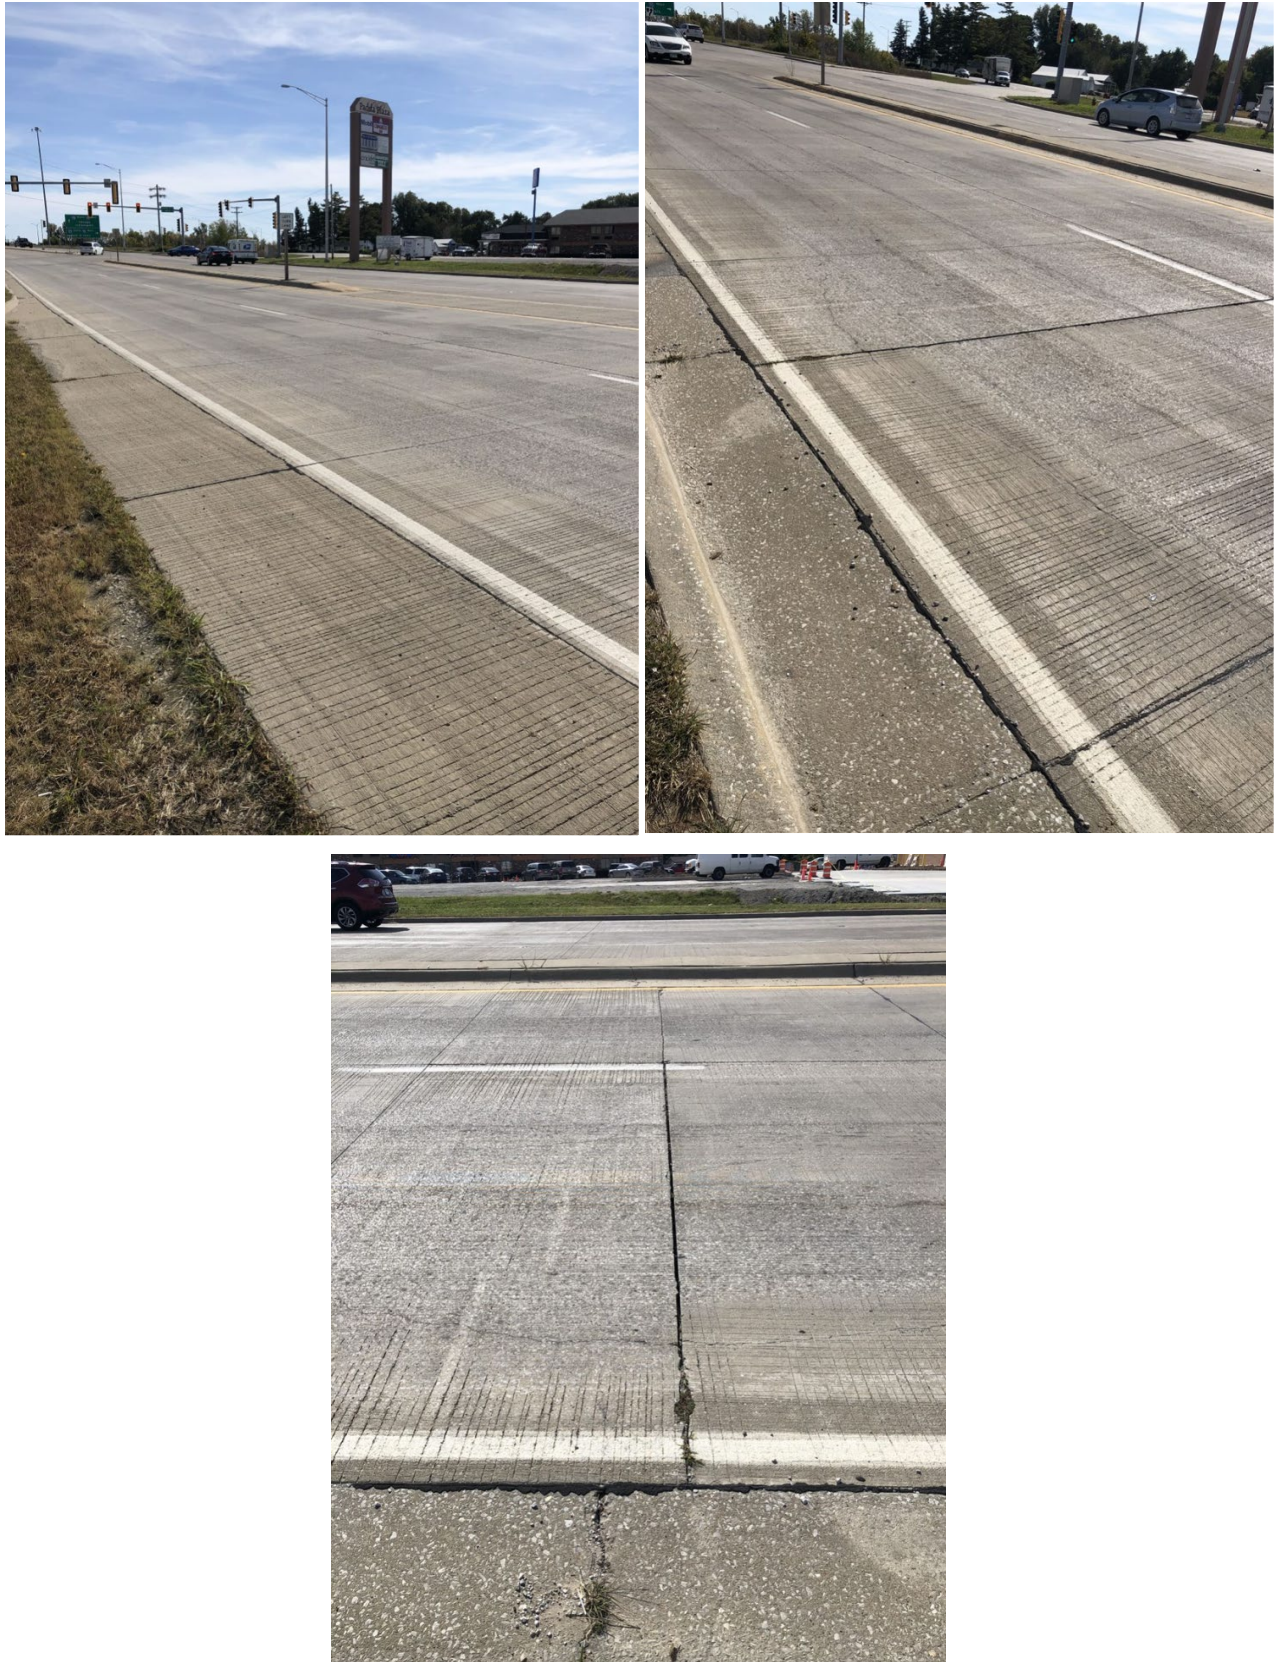
Figure 125. Photos. Troy Avenue.

Thickness (in.)	Panel Length (ft)	Panel Width (ft)	Dowel Bar Spacing (in.)	Tie Bar Spacing (in.)	Lane Configuration	Visual Distress	Additional Observations
10	15	13	12	36	2 lanes per direction + central lane	Longitudinal cracking (>50%)	Construction date ~2000s

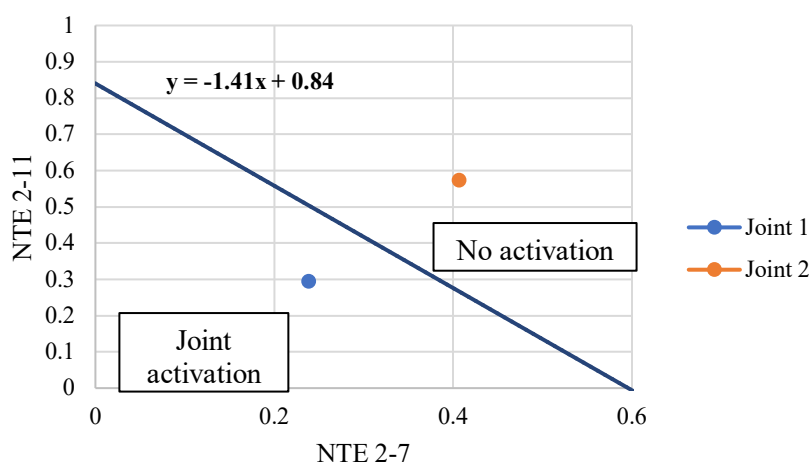
Figure 126. Graph. Healey Street joint activation NTE results—2019.

An investigation was performed on six streets in Champaign, Illinois—Green Street, Healey Street, Gregory Avenue, Armory Drive, Curtis Road, and Logan Street—to check the existing algorithm developed by Tran and Roesler (2020b) and determine the percentage of transverse contraction joints that may not be activated on urban concrete pavements. An initial analysis was performed in 2019 along Healey Street for two adjacent joints that spanned a transverse crack. Figure 126 shows the results of the joint activation analysis between the two adjacent joints from Healey Street. Joint 1 is below the hyperplane, and Joint 2 is above the hyperplane. This can be interpreted as Joint 1 is an activated working joint and Joint 2 is an uncracked contraction joint. This initial analysis shows that some joints may not be activated and could be contributing to premature cracking in urban JPCP sections, which could indicate late sawing, inadequate saw-cut depth, or another reason.

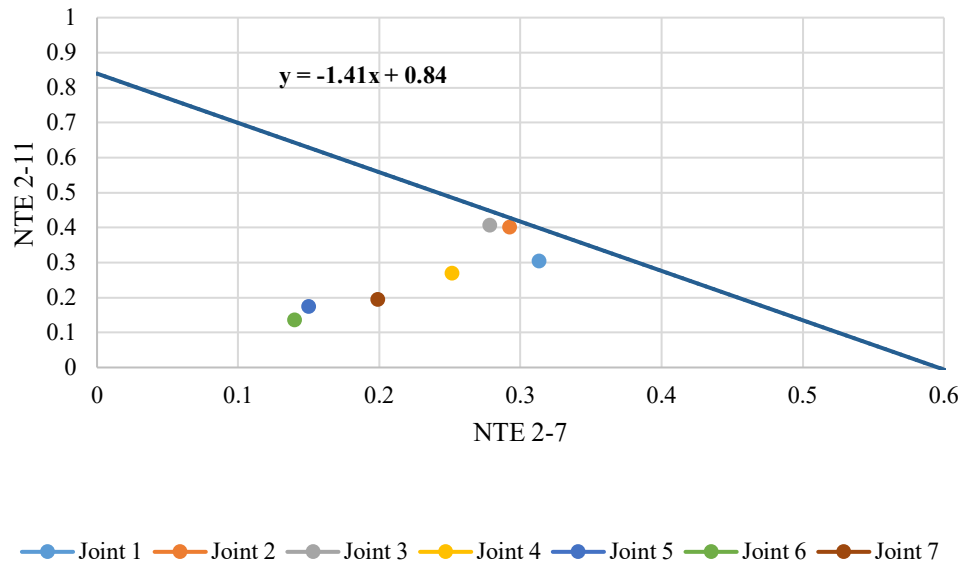
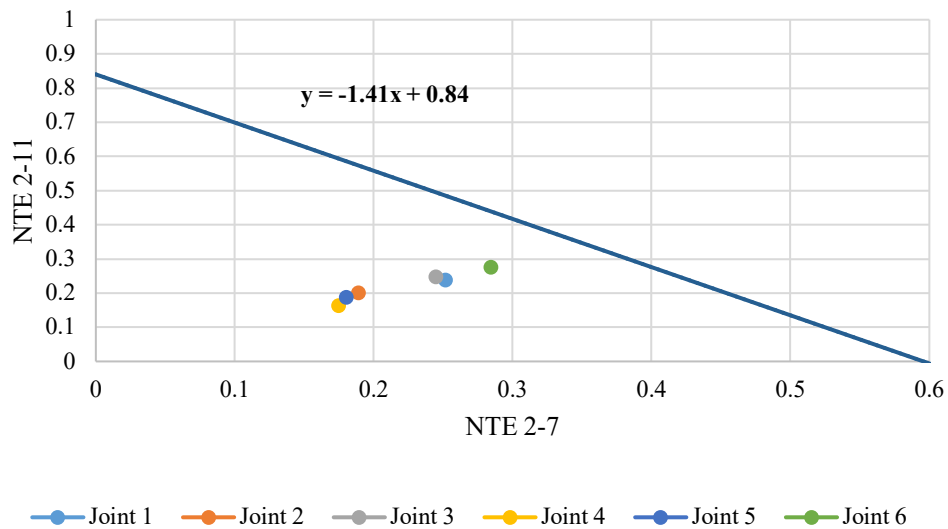
Figure 127. Graphs. Healey Street joint activation analysis NTE results—2020.

Table 91 presents the results obtained from Healey Street. This data includes two different dates of testing: April 7, 2019, and October 21, 2020. Three separate segments of Healey Street were tested, as seen in Figure 127. These segments were separated based on the observed cracking in each segment. The first segment (Healey Street between Second and Third Streets) was used in the initial analysis to assess if joint activation is a potential contributor in premature transverse crack development. The second segment (Healey Street between Fourth and Fifth Streets) appeared to have a transverse crack on every other slab, which is approximately 50% slab cracking. The joint activation analysis resulted in three joints that fall very close to the hyperplane and are reported as

inconclusive, whereas the remaining joints were evaluated as being activated. These joints had widths approximately 0.25 in. with joint sealant (all sealed very well with some joints over-sealed). From visual inspection during testing, Joints 5 and 7 were wider than the other joints, implying active joints. In addition, the transverse crack between Joints 5 and 6 was very tight and low severity.

The third segment (Healey Street between Fifth and Sixth Streets) had very minimal cracking. Only one transverse crack was observed in this segment, between Joints 2 and 3. From the joint activation ultrasonic evaluation, all joints appear to be active and working joints. The transverse crack between Joints 2 and 3 potentially developed directly over the tie bars between the longitudinal construction joint with the curb and gutter shoulder.

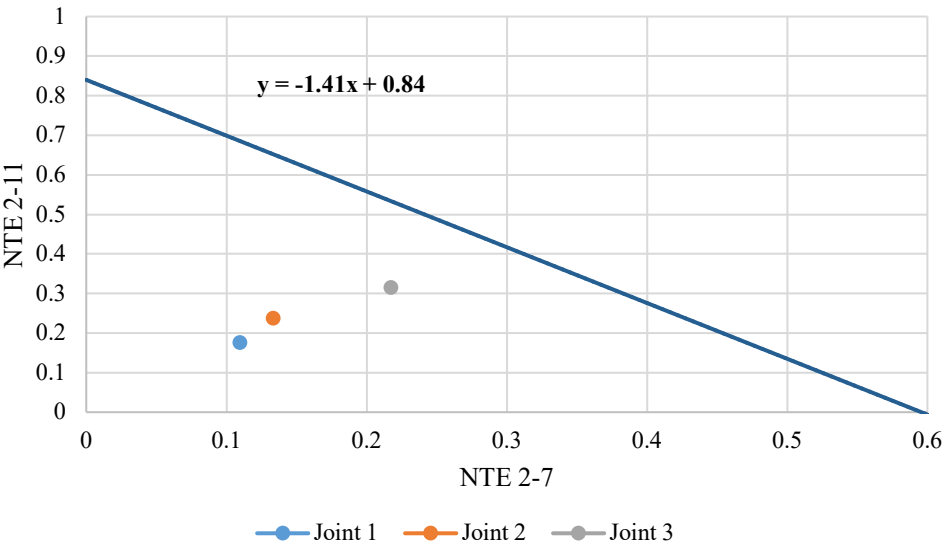
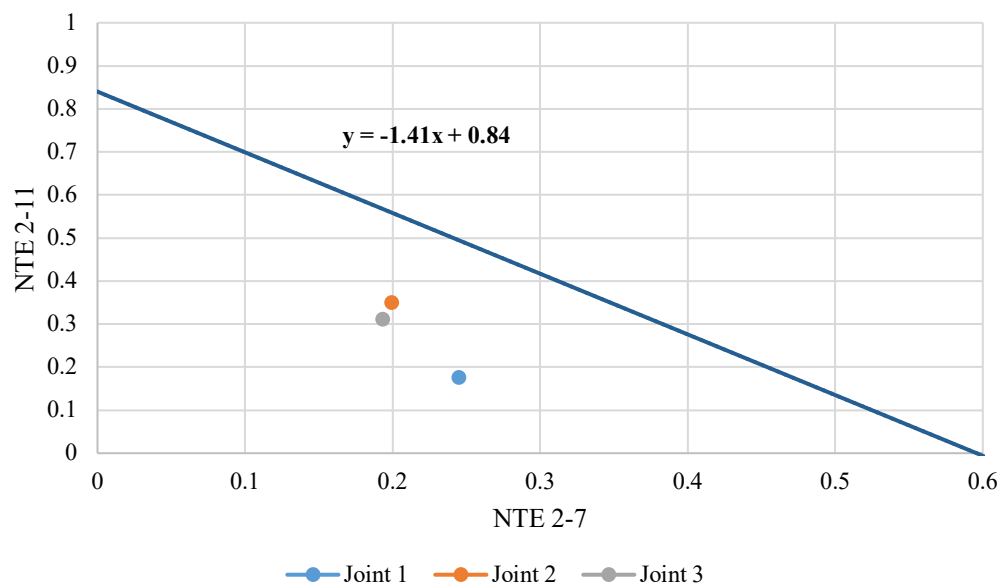
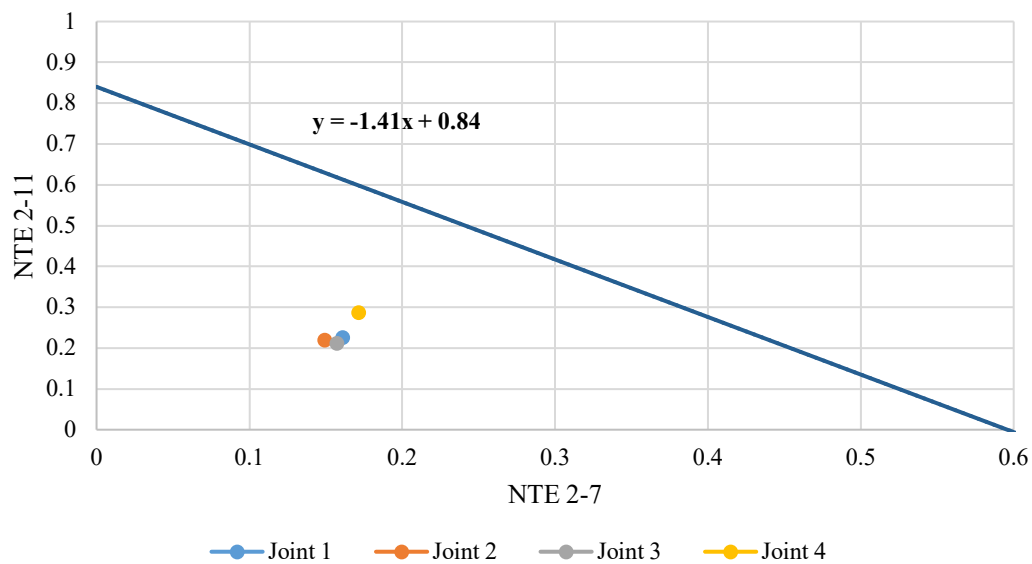
Figure 129. Graphs. Green Street between Wright Street and Fourth Street joint activation analysis NTE results.

Street is a very busy street in Champaign, Illinois, which made testing more challenging than other sections. Therefore, only three to four adjacent joints were able to be evaluated per location. Table 92 summarizes the results of the joint evaluation conducted on the three testing locations on Green Street between Wright Street and Fourth Street in Champaign, Illinois. From this ultrasonic joint analysis, all joints tested along Green Street are activated and are not likely the main contribution to the transverse cracking (see Figure 129).
