Evaluation of Premature Cracking in Urban Concrete Pavement

Research Report No. FHWA-ICT-21-001

A report of the findings of
ICT PROJECT R27-193-4
Premature Cracking Mechanism for
Jointed Plain Concrete Pavement

January 2021

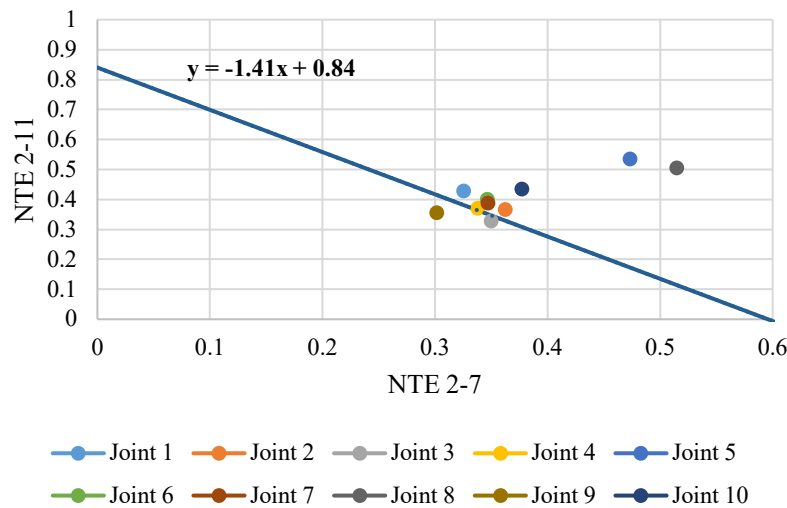
Figure 130. Graph. Green Street near Second Street joint activation analysis NTE results.

Green Street between the intersection of First Street and Fourth Street was constructed at a different date and with a different design than Green Street between Fourth Street and Wright Street. Table 93 summarizes the results of the joint evaluation conducted on Green Street between First Street and Fourth Street in Champaign, Illinois. This section consisted of 15 ft × 9 ft panels (L × W), with a curb and gutter shoulder. This section did not have any cracking present and was performing well. From the ultrasonic joint analysis, all joints tested along Green Street resulted inconclusive or not activated, as seen in Figure 130. Additionally, Joint 8 was concluded as not activated based on the NTE analysis results, but this joint appears to be a construction joint.

² Not activated—Joint 8: This is a construction joint. It is unclear why the NTE results indicate not activated.

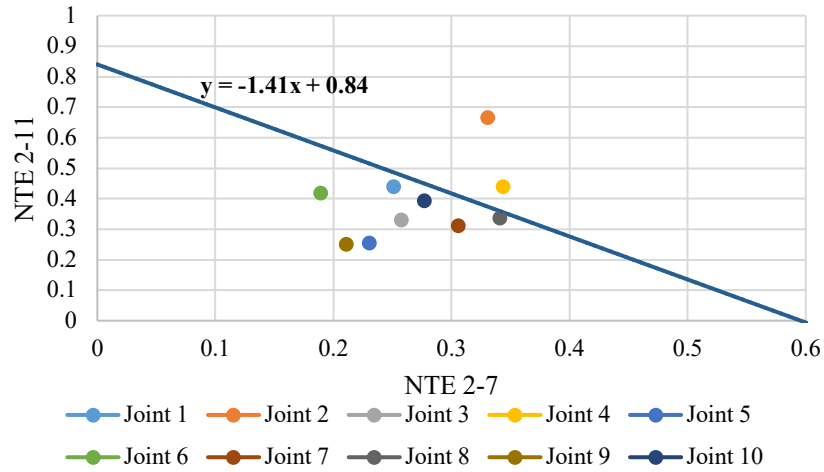
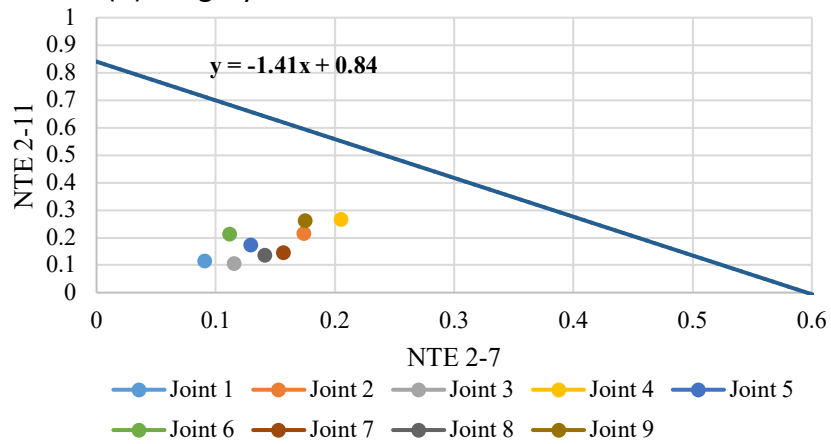
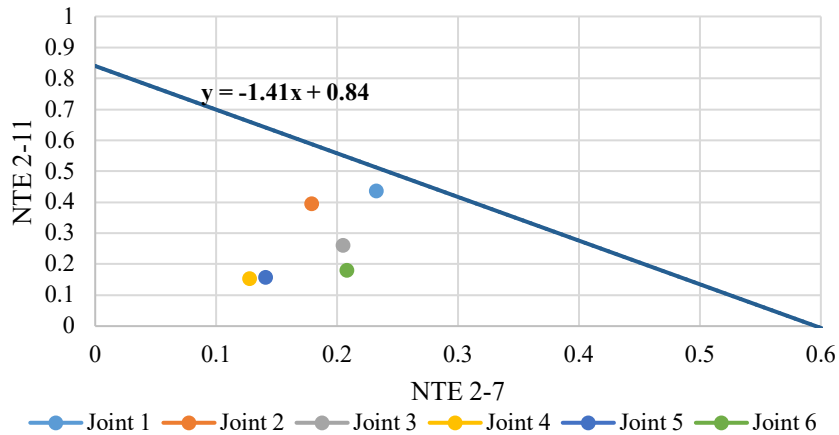
Figure 131. Graphs. Gregory Drive joint activation analysis NTE results.

the results of the joint evaluation conducted along Gregory Drive between Oak Street and First Street in Champaign, Illinois, along with Figure 131-A. The joint spacing was not conventional in this section with 15 ft × 18 ft (L × W) panels. The eastbound lane was tested, and the first panel had a longitudinal crack spanning the slab and intersecting Joint 1. There were no anomalies observed based on dowel bar and tie bar spacing and depths. However, dowels were observed at a depth of 3.15 in. (80 mm) instead of 4 in. (100 mm).

Table 95 summarizes the results of the joint evaluation conducted along Gregory Drive between First Street and Fourth Street in Champaign, Illinois. The joint spacing was nonconventional in this section with 17 ft × 13 ft (L × W) panels and also contained a bike lane in the westbound direction (17 ft by 5 ft) with a curb and gutter shoulder. The westbound lane was tested and included nine consecutive joints. There were several anomalies observed based on the dowel bar and tie bar spacing and depths. Dowels were observed in every other joint (Joint 2, 4, 6, and 8) and spaced at 36 in. on center (100 mm depth). These joints with the dowels had longitudinal cracking developing over the dowels. Joint 2 included dowels; however, they were observed to be at a depth of 2 in. (50 mm); there is a mid-panel transverse crack and a corner break (Approach Joint 3) on the same slab between Joints 2 and 3. For the joints without reinforcement (Joints 1, 3, 5, and 7), transverse joint faulting was observed. These anomalies observed within this section are most likely contributing significantly to the observed distress because all joints observed within the ultrasonic analysis appear to be activated and working joints (See Figure 131-B and Table 95).

section with 15 ft × 11 ft (L × W) panels and also contained a bike lane in the westbound direction (15 ft by 5 ft) with a curb and gutter shoulder. There were no anomalies observed when performing the ultrasonic investigation in this section. All joints observed within this section are believed to be activated, except for Joint 1, which falls near the hyperplane (inconclusive). Figure 131-C presents the NTE results for the joints in this section and show they fall below the hyperplane.

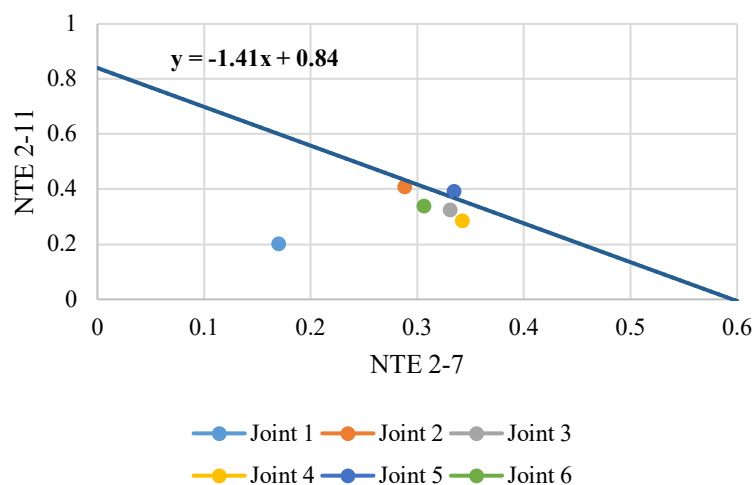
Figure 132. Graph. Logan Street joint activation analysis NTE results.

The analysis performed along Logan Street was conducted between First Street and Neil Street. This section is along a bus route but has minimal traffic volume. Table 97 summarizes the results of the joint evaluation conducted along Logan Street near the intersection of Water Street heading westbound towards the underpass in Champaign, Illinois. The joint spacing in this section was 12.5 ft × 10.5 ft (L × W) panels with a curb and gutter shoulder. There were no anomalies observed based on dowel bar and tie bar spacing and depths. Figure 132 presents the NTE results. It can be observed that Joint 1 is activated; however, the remaining joints were inconclusive as they fall very close to the hyperplane. The three transverse cracks observed were all wide with spalling and were sealed. Based on these widths and apparent age of the joint sealant in the cracks, these cracks developed a number of years ago and, likely, shortly after construction. Inconclusive joints can mean activated joints or nonactivated joints with the transverse cracks are acting as the transverse joints.

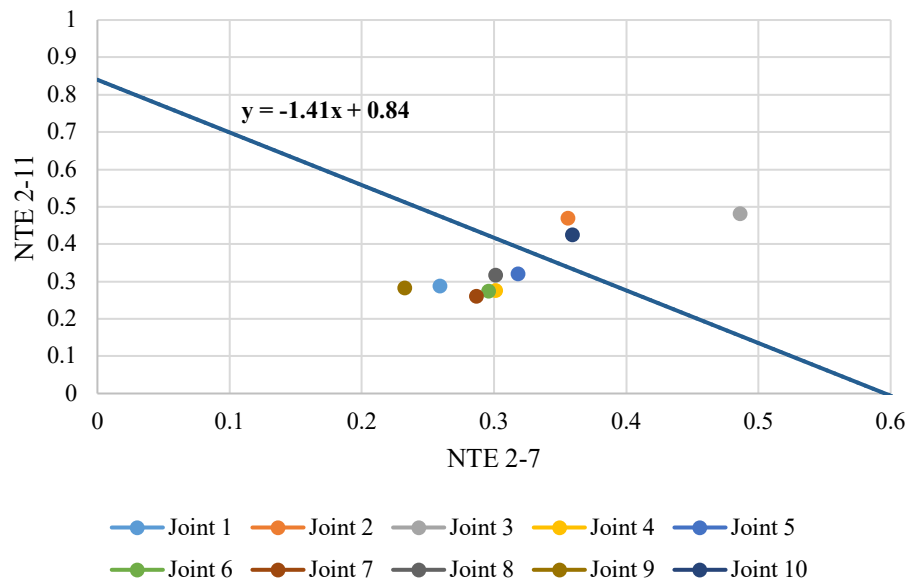
Figure 134. Graph. East Armory Drive joint activation analysis NTE results.

The MIRA measurements were performed along East Armory Drive between Wright Street and Sixth Street. This section is primarily trafficked by buses and delivery trucks. The thickness recorded from ultrasonic testing was between 12 to 13 in. (300–325 mm). Testing was performed heading east in the eastbound lane (one-way street). The joint spacing was 12 ft × 12 ft on average, as the panels were tapered from Sixth Street toward Wright Street. There were no anomalies observed based on dowel bar and tie bar spacing and depths. Table 99 summarizes the results of the joint evaluation conducted along East Armory Drive near Sixth Street in Champaign, Illinois. There were no observed transverse cracks in this newly constructed section. Figure 134 presents the NTE results from the analysis. The results indicate three joints are not activated and the remaining seven are activated. The three joints that were identified as not activated (Joints 2, 3, and 10) spanned a drain. Additionally, Joint 9 was a construction joint. It is possible a transverse crack may develop between Joints 2 and 3.

E. Armory Dr. near 6th St.	10	No crack between Joints 9 and 10	10/28/2020	Not activated
