Longitudinal Cracking Investigation on I-72 Experimental Unbonded Concrete Overlay

Research Report No. FHWA-ICT-22-002

ICT PROJECT R27-SP48

February 2022

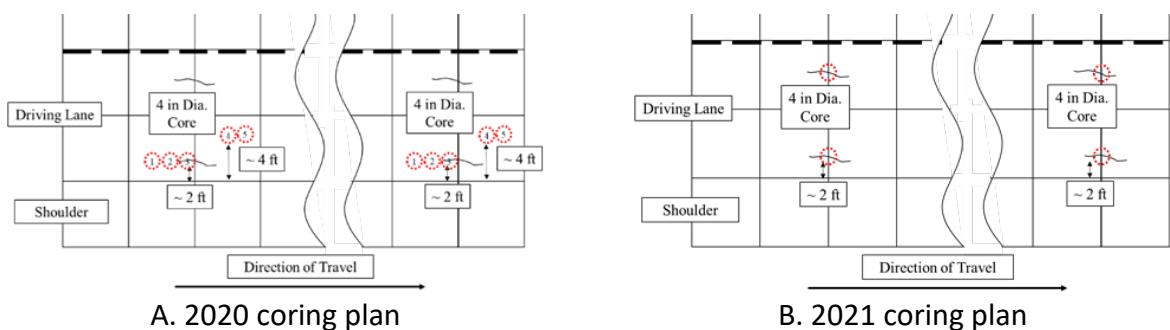
Figure 5. Photos. Proposed coring plan over longitudinal cracking at the transverse joint in (a) 2020 and (b) 2021.

Cores were extracted as part of the forensic examination of the HMA interlayer for erosion, permanent deformation, or debonding from the concrete overlay or existing concrete pavement. Two different coring plans were executed to examine the potential failure mechanisms. Cores were taken in December 2020 in the outer wheel path on the approach slab as well as on the leave slab adjacent to the wheel path (Figure 5-A). This coring strategy was selected to assess if any permanent deformation was occurring in the HMA in the wheel path and causing longitudinal cracking initiation to develop in the concrete overlay at the transverse joint. Coring was performed in three locations. Two locations had longitudinal cracking present, and the third location did not exhibit cracking. A total of 14 cores (4 in. [102 mm] diameter) were obtained. Coring during this site visit was near the joint, approximately 6 in. (152 mm) (on center) away from the joint but not directly over the transverse joint. Table 2 lists the stations for the 2020 coring plan shown in Figure 5-A.

A lack of clarity on the true mechanism resulted in a second set of cores being extracted in June 2021 to eliminate erosion in the interlayer as a primary mechanism. These cores were mostly taken directly over the transverse joints where longitudinal cracking was present. Three distinct stations along the section were cored directly over the transverse joint and in the inner and outer wheel path. A schematic of the coring can be seen in Figure 5-B. Each station location included two cores, resulting in a total of six 4 in. (152 mm) diameter cores in the driving lane. Cores within the first location had longitudinal cracks in both wheel paths, only longitudinal cracking was present in the inner wheel path in the second location, and cracking was only present in the outer wheel path in the third location. Coring was also performed directly over the lane-shoulder longitudinal joint in two eastbound locations to assess the observed longitudinal joint faulting. Table 3 also lists the stations for the 2021 coring plan shown in Figure 5-B.

Outer wheel path (approach joint):
Over longitudinal crack

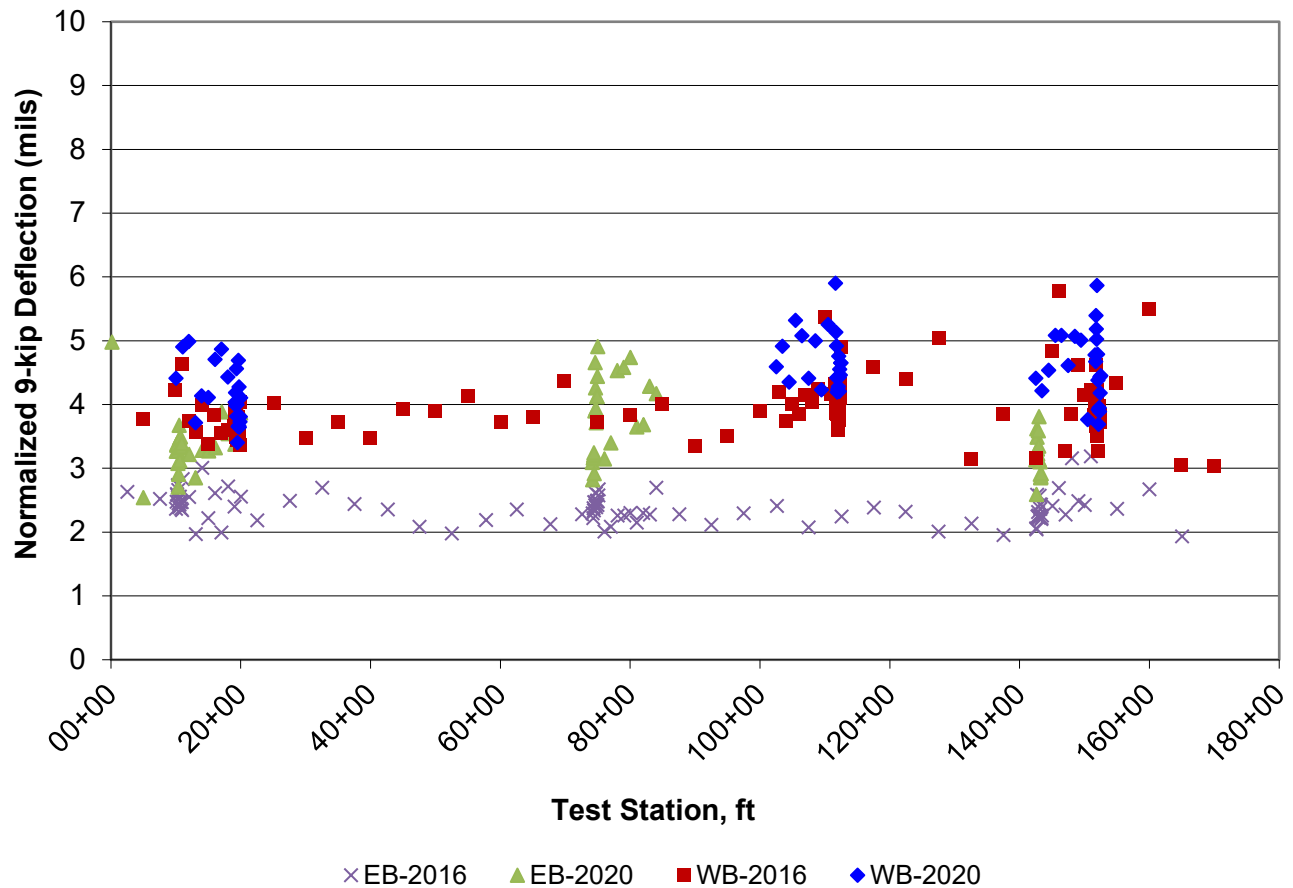
Figure 9. Graph. I-72 normalized 9-kip center deflections.

The first observation in Table 7 and Figure 9 is the westbound deflections are greater than the eastbound despite no observed cracking in the westbound. These increased deflection responses are linked to the compressibility of the NWGF interlayer on the westbound, which will increase the magnitude of deflection relative to the eastbound. I-72 eastbound has developed a significant increase in deflections in all locations. This can be a function of the stiffness of the HMA interlayer. However, evidence of stripping and erosion of this interlayer from the coring results could be the reason for the increase in deflections and decrease in LTE. Center deflections have increased from 2.4 mils (61 microns) in 2016 to 3.5 mils (89 microns) in 2020. I-72 westbound has also shown an increase in deflections as compared to shortly after construction (3.9 mils [99 microns] in 2016 and 4.5 mils [114 microns] in 2020).

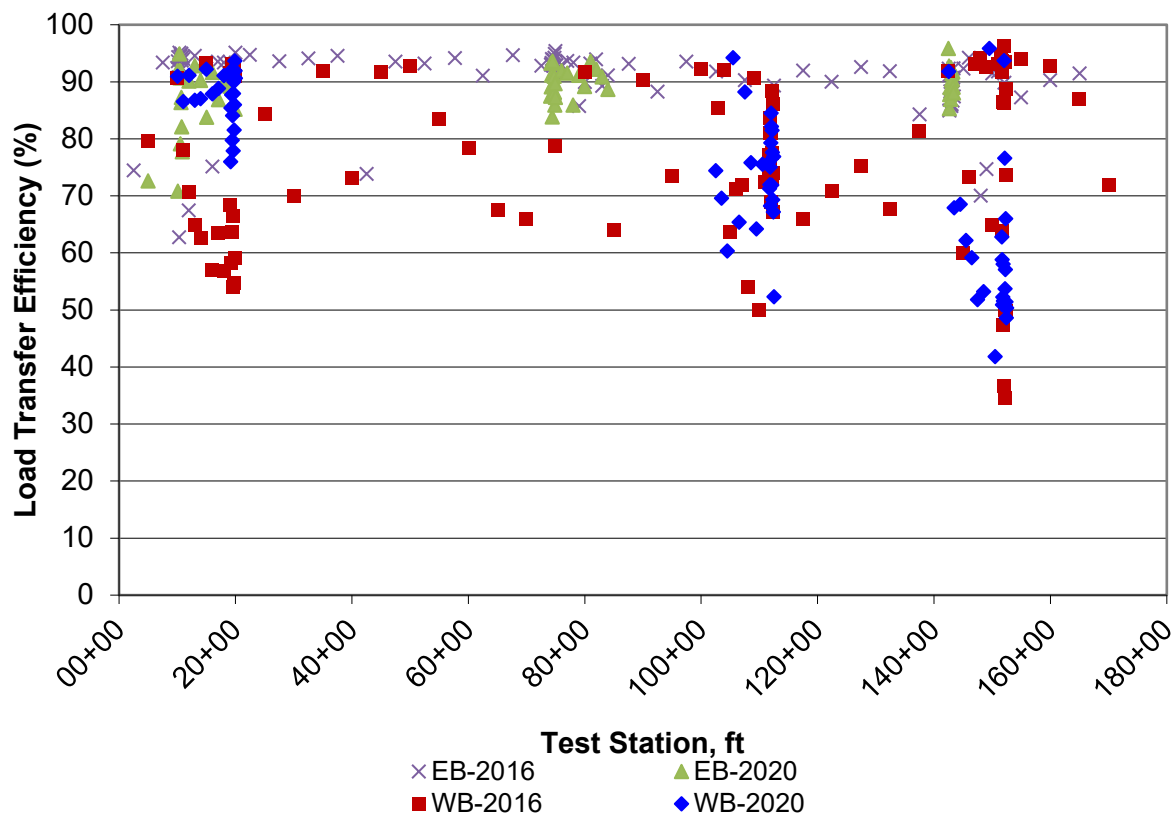
Figure 10. Graph. I-72 transverse joint load transfer efficiency.

The average LTE values are consistent between the two dates of testing for both eastbound and westbound and are approximately 90% and 75%, respectively. However, the transverse joint LTE along the westbound is much more variable. This difference in joint LTE behavior is likely due to the NWGF and its effect on the initial joint formation as well as compressibility during testing at the joint. Additionally, both eastbound and westbound sections are exhibiting some longitudinal faulting across the lane-shoulder longitudinal joint (shoulder greater elevation than driving lane). The LTE across this joint is highly variable and on average was 75% and 45%, respectively, from testing in 2020. The macrofibers present in the concrete and across the longitudinal contraction joint are mostly sheared

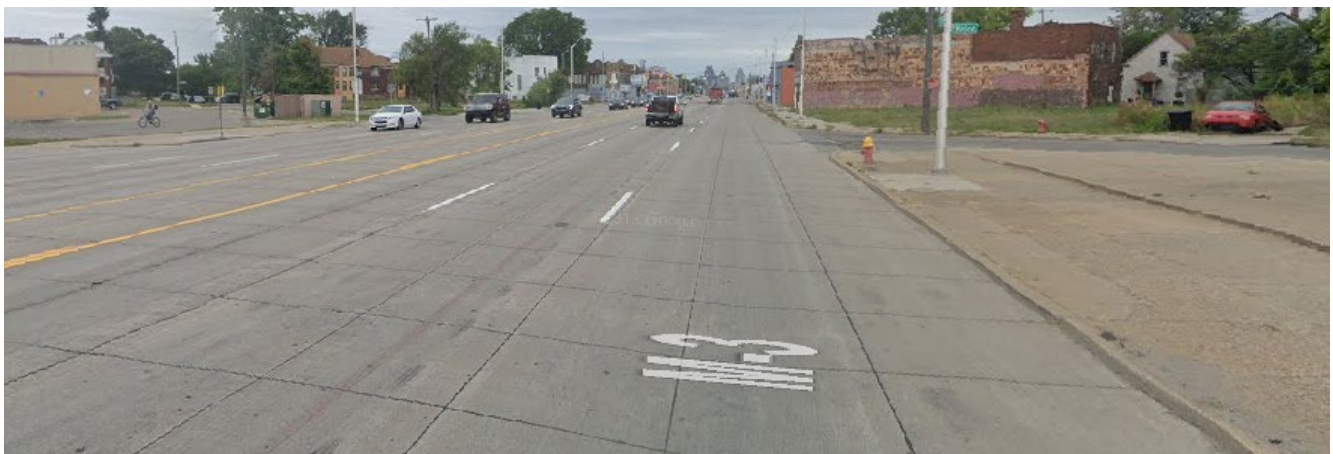
Figure 12. Photo. Gratiot Avenue (southbound) in Detroit, Michigan (UBOL with open-graded [southbound] and dense-graded [northbound] interlayer) (Google Maps 2019).

The second section visited within the Detroit Metropolitan Area was Gratiot Avenue. This was originally a pilot project within the metro area constructed in 2004 and 2005 and was an existing composite pavement that included milling the existing surface and placing an HMA interlayer. Two separate HMA interlayer mixes were used, open graded in the southbound direction and dense graded in the northbound direction. This urban curb-and-gutter roadway section is seven lanes wide (three 12 ft [3.7 m] lanes in each direction and a continuous two-way left-turn lane [TWLTL]) with 6 × 6 ft (1.8 × 1.8 m) panels and a 4 in. (102 mm) PCC overlay. This design was an UBOL without dowels and joint sealant. This is a heavily trafficked arterial that leads directly into Detroit's downtown. The southbound lanes appear to be performing well with minimal observed distress and no joint deterioration along contraction joints. However, the construction joints had more severe joint deterioration. The northbound direction had severe joint deterioration, faulting, observed panel replacement, and overfilled joints with excessive joint sealant from maintenance work. It is possible the open-graded interlayer system is contributing to the better performance in the southbound direction relative to the dense-graded interlayer in the northbound direction. No truck traffic was observed during the site visit in June 2021, which was on a Saturday. Figure 12 shows the southbound driving lane of Gratiot Avenue.

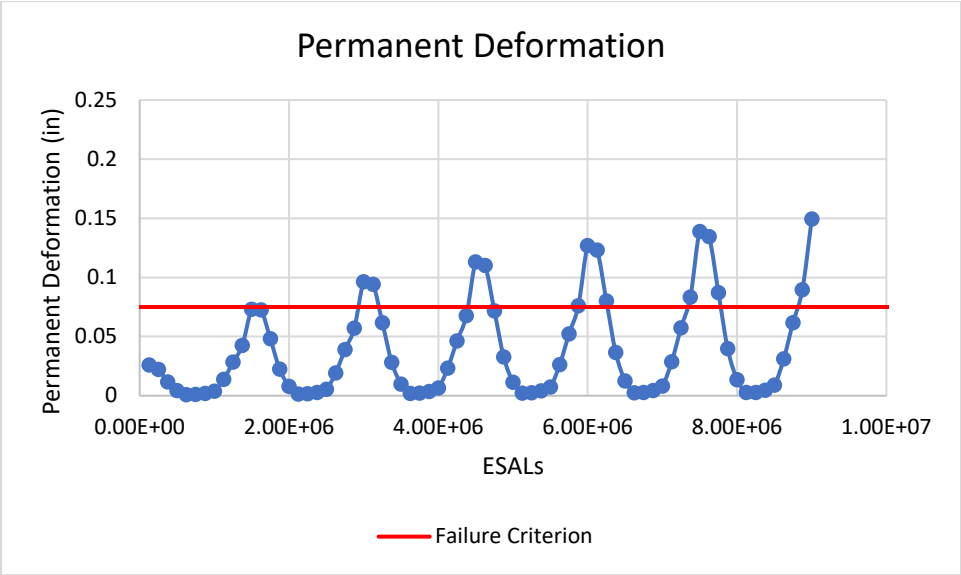
Figure 18. Graph. I-72 HMA permanent deformation prediction (failure criterion is equal to 0.075 in.).

The laboratory experimental results were used to develop a ME permanent deformation model for HMA interlayer systems. Souder et al. (2020) developed a prediction model for one-dimensional densification as a function of temperature, traffic, mixture design, and vertical strain similar to the model presented in the AASHTOWare Pavement ME (ARA Inc., 2004). The model was calibrated with UBOL section data exhibiting longitudinal cracking in the wheel path. The developed ME model was used to assess the repeated loading performance and potential permanent deformation for the I-72 eastbound mixture design and can be seen in Figure 18. The failure criteria threshold established by Souder et al. (2020) is when permanent strain levels reach 0.06 in/in. The permanent deformation failure criteria is the product of the thickness of the HMA interlayer and the permanent strain level criteria. The I-72 eastbound case permanent deformation failure criteria is 0.075 in. (1.9 mm), as the thickness of the HMA interlayer is 1.25 in. (32 mm). With this model, longitudinal cracking of the I-72 HMA interlayer is predicted as a result of permanent deformation after 3 million ESALs. The largest levels of predicted deformation occur during the summer, when the HMA interlayer is at its lowest stiffness. Other mechanisms may have been contributing to the longitudinal cracking in addition to permanent deformation in the sections used for calibration of this model, such as stripping and erosion. No coring was performed for verification of the failure mechanism of the sections used for calibration as they were no longer in-service when the study was performed.

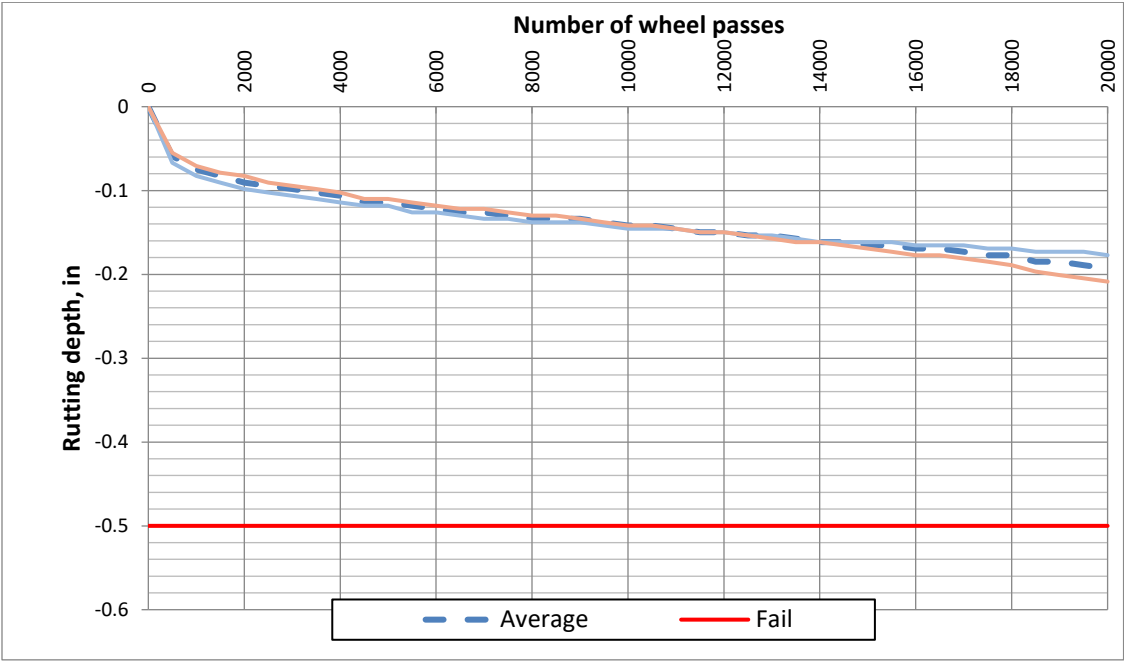
Figure 19. Graph. Hamburg wheel-tracking device I-72 HMA interlayer results (PG 58-28).

Before the I-72 EB construction, the HWTD was used to evaluate the rutting potential of the HMA interlayer. The HWTD was also proposed as a performance test under project ICT-R27-193-6 for assessing the erosion potential of different stabilized base layers under concrete pavements and concrete overlays (DeSantis & Roesler, 2022). Figure 19 presents the I-72 HMA interlayer test results for PG 58-28. According to IDOT standards, a specified plan binder grade of PG 64-22 (as was specified in Contract 72G92) needs to pass a minimum of 7,500 wheel-load cycles and not exceed a rut-depth greater than 0.5 in. (12.5 mm) even though a PG 58-28 binder was substituted to account for FRAP in the mixture. The results indicated the mixture passed 20,000 wheel-load cycles and did

not reach the failure criterion of 0.5 in. (12.5 mm) rut depth. Subsequently, there was no concern on using this HMA mixture as an interlayer in terms of rutting or permanent deformation.

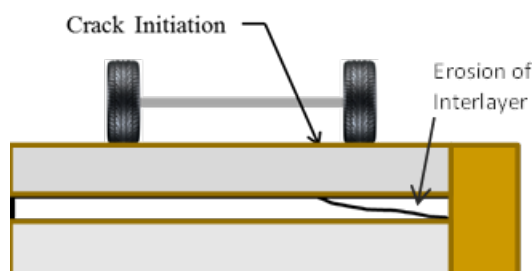
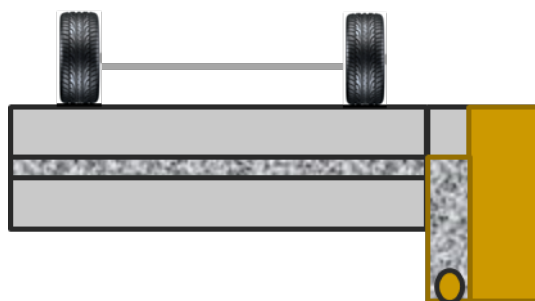
Figure 20. Schematic. Interlayer and lateral drainage system configuration that can lead to erosion or positive drainage condition (Khazanovich et al., 2020; Vandenbossche & DeSantis, 2021).

A. Lateral drainage outlet is not provided, resulting in stripping and erosion.

The third component to consider with UBOL design and construction is minimizing moisture infiltration and/or ensuring a clear drainage path for infiltrated water to exit the system. Regardless of interlayer type, drainage beneath the concrete overlay is important for long-term performance. To minimize erosion potential of the interlayer, sealing of the longitudinal and transverse joints may be a

worthwhile strategy. A properly constructed and installed joint sealant will reduce water infiltration and minimize the condition of a fully saturated joint and interface condition. By providing a drainage path and outlet for water that does infiltrate and contact the interlayer, the stripping and/or erosion susceptibility of the interlayer decreases significantly. Figure 20-A illustrates the effects if there is no lateral pathway for water to escape the system. The water remains trapped and can develop hydraulic pressures under moving traffic loads that can result in loss of support. Figure 20-B illustrates one way a connected interlayer/drainage pathway allows for infiltrated water to escape the system. The I-72 project utilized the existing pipe underdrains and required cleaning of outlets. The other lateral drainage factor is making sure the interlayer/interface has 1.5%–2% cross slope that matches the cross slope of the pavement surface.

B. Interlayer connected to an edge drainage system to limit stripping and erosion.

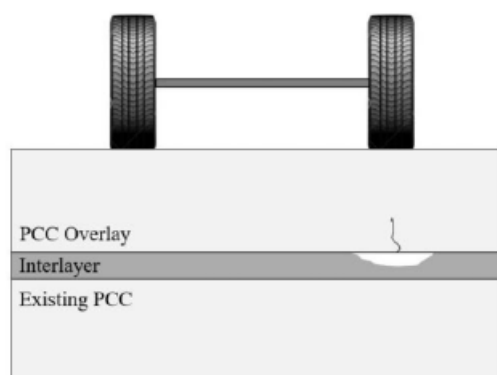
Figure 23. Photos. Short-jointed unbonded concrete overlay (UBOL) on HMA interlayer.

The prominent distress in the EB direction was longitudinal cracks in the wheel paths (WP) of the driving lane (each panel). On average, cracks appear to be 2 ft [0.6 m] in length on each panel and a total of 4 ft [1.2 m] across transverse joints. Longitudinal cracking spanning a full slab or greater was not observed. Approximately 30 locations had longitudinal cracking occurring across the transverse joint (tested two sections of 1,000 ft [305 m] and 3rd section of 100 ft [30.5 m]). This distress has been commonly seen in UBOL with HMA interlayers (Alland et al. 2016 and Souder et al. 2020). A possible mechanism for this distress is permanent deformation in the HMA layer (densification or shear flow) resulting in a void, gap, or settlement beneath the PCC in the wheel path. As traffic accumulates the deformation or gap increases, resulting in an increase in the tensile stress at the bottom of the PCC and eventually leads to a bottom-up crack to develop if the flexural stiffness and strength of concrete is not sufficiently high (See Figure 23-C below). With the lower vertical pressure reaching the HMA interlayer, this mechanism is less likely. The vertical pressure on the interlayer is likely less than 25 psi (172 kPa) if the joint is ignored.

C. Hypothetic mechanism of permanent deformation in HMA resulting in 1D densification or shearing that enables tensile crack to initiate at bottom of PCC overlay
