ENVIRONMENTAL GEOLOGY NOTES

*Bluff Erosion,
Recession Rates,
and
Volumetric Losses
on the Lake Michigan Shore in Illinois*

Richard C. Berg and Charles Collinson

ILLINOIS STATE GEOLOGICAL SURVEY

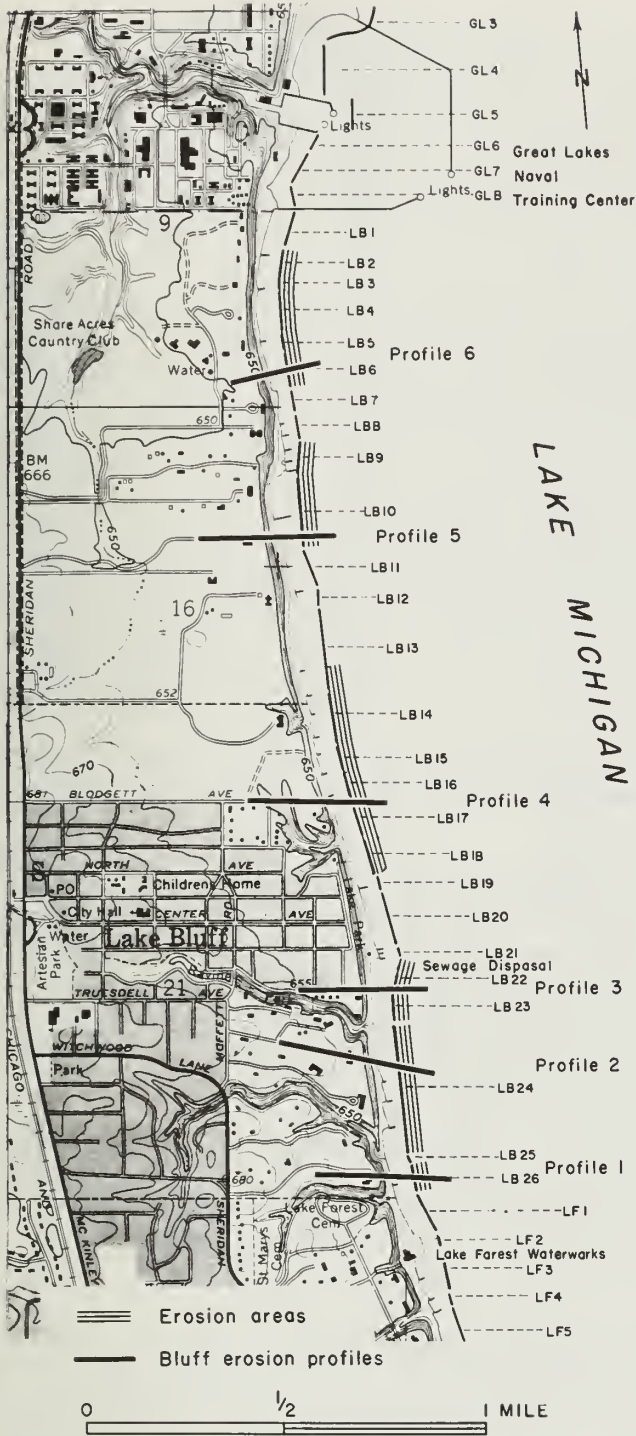
Fig. 1 - The lake shore from Great Lakes Naval Training Center to northern Lake Forest. Bluff recession was measured in detail along the numbered profiles. The profile number also designates the erosion area. Symbols LB1, LB2, and so on, designate segments of shore described by Collinson, Drake, and Anchor (1975).

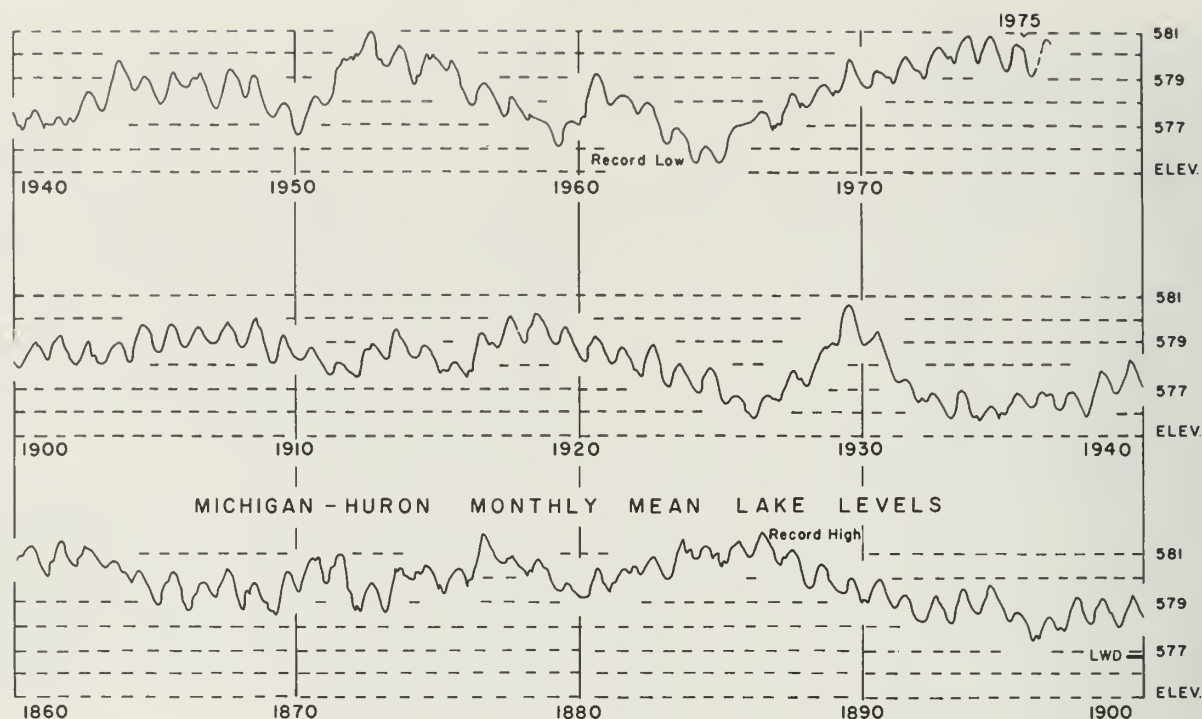
Fig. 2 - Monthly mean lake levels, in feet above mean sea level, measured at Harbor Beach, Michigan (from National Oceanic and Atmospheric Administration, Lake Survey Center, Detroit).

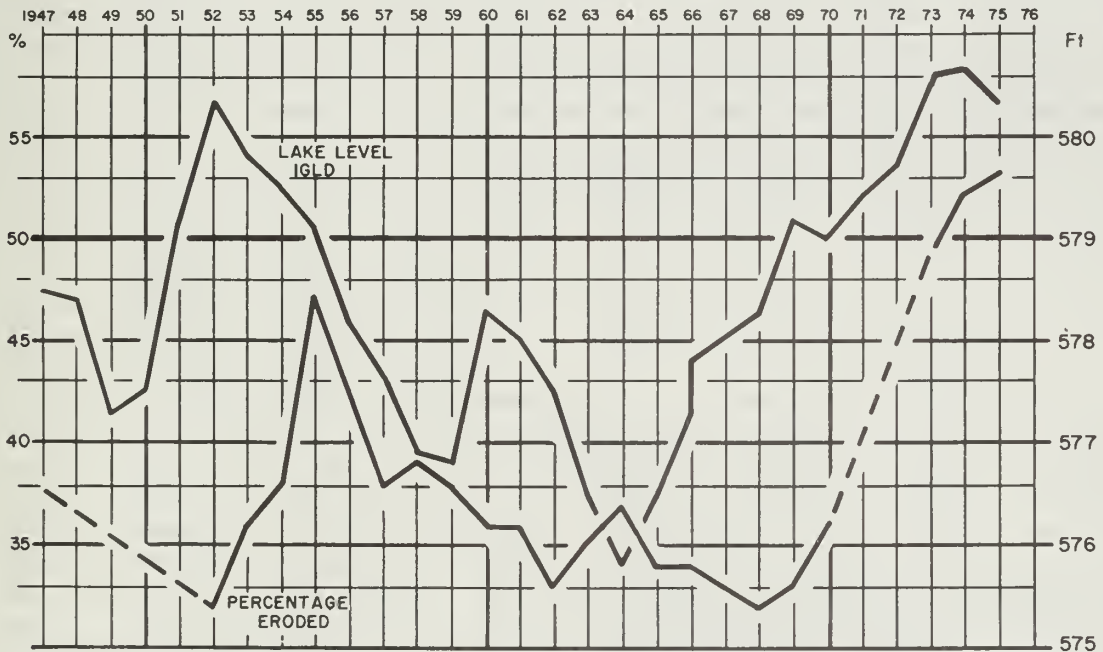
Fig. 3 - Percentage of shore undergoing erosion at Lake Bluff, and yearly mean lake levels of Lake Michigan.

Table 1 and figure 3 show that significant bluff erosion occurs when the annual average lake level reaches 579 feet or higher. As levels drop below 579 feet, stabilization begins and continues if lake levels remain low. Between 1969 and 1975 lake levels were persistently above 579 feet and correlated with the greatly increased erosion of bluffs. The persistence of high levels, abetted by storm activity, further increases the amount of bluff that is exposed and denuded. A shorter period of high levels has a less drastic effect, as was shown by the 1951 to 1955 high (fig. 3).

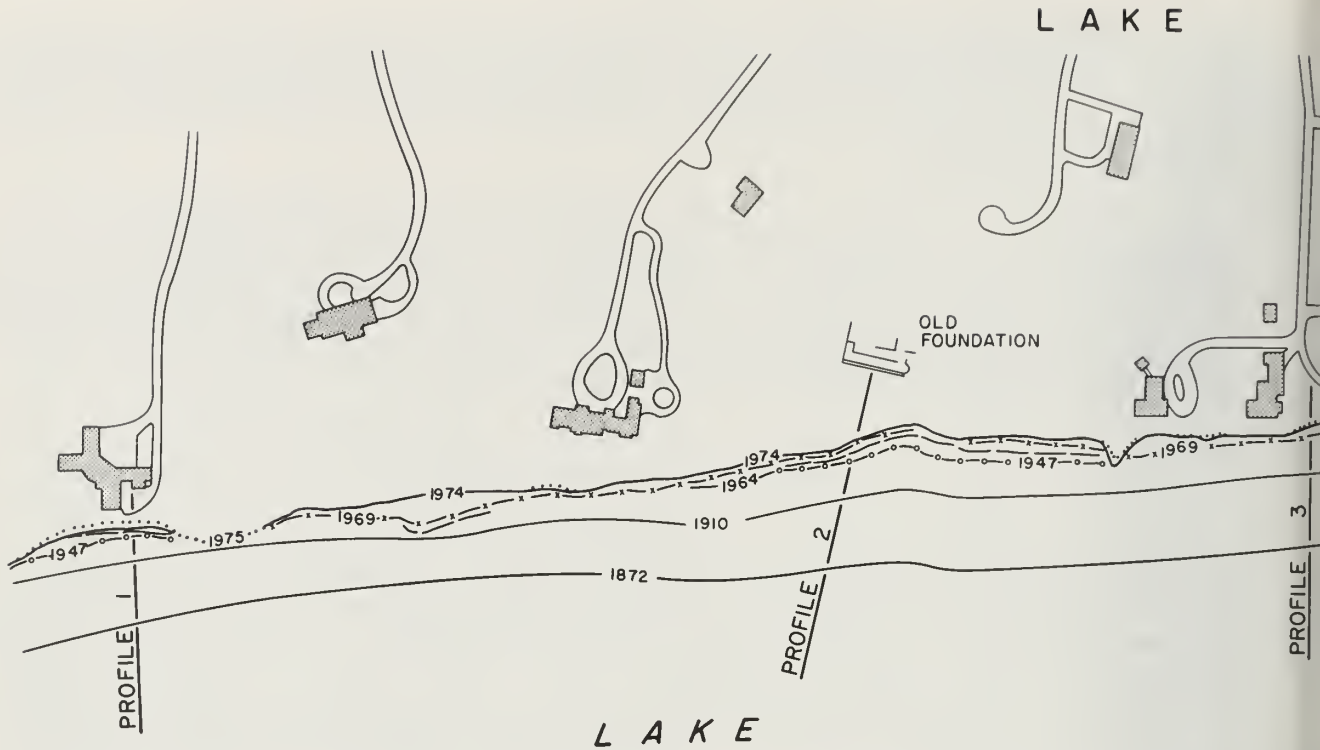
Fig. 4 - Profiles along which bluff recession rates were measured along the southern part of

If the 40-foot recession average is used instead of the 89-foot average for erosion area 6 (fig. 1), the bluff has receded an average of 27.8 feet along the six Lake Bluff profiles since 1965, and 30.5 feet if 1964 is included. Average annual rates were quite consistent, ranging from 1.82 feet per year for erosion area 3 (table 3) to 3.64 feet per year at erosion area 6.

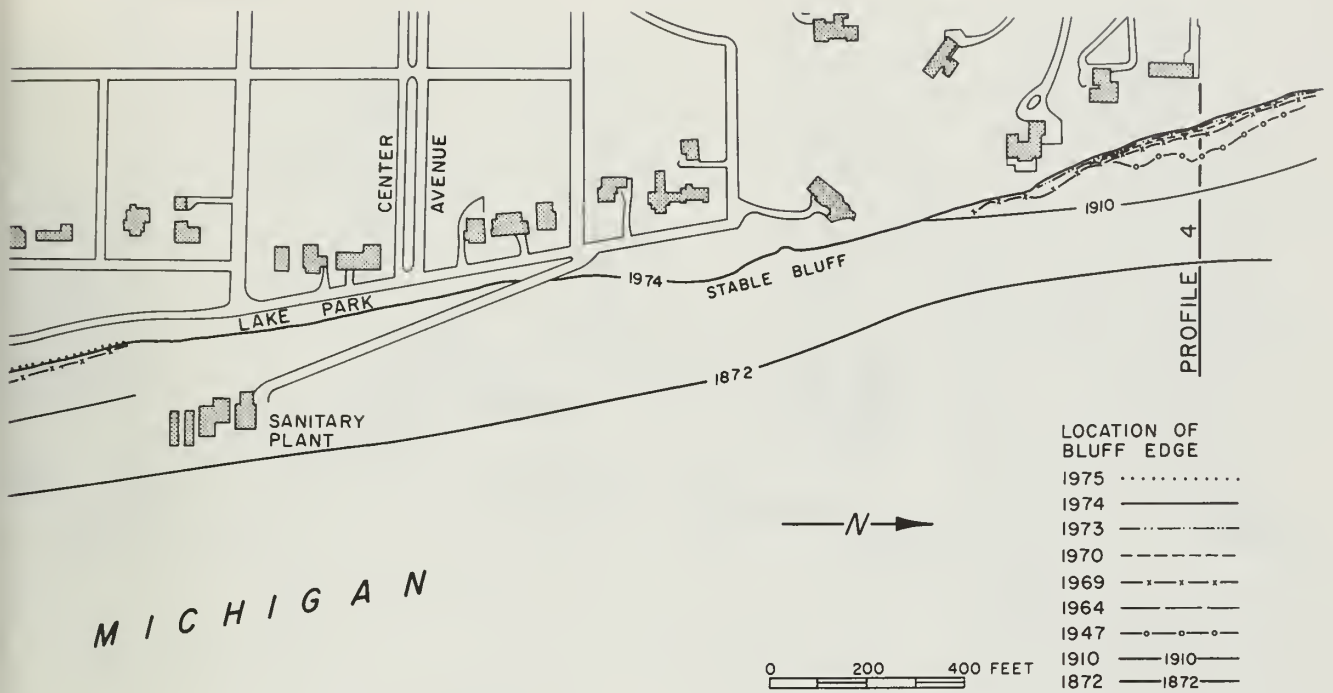
Lake Bluff. The various positions of the edge of the bluff between 1872 and 1975 are shown.

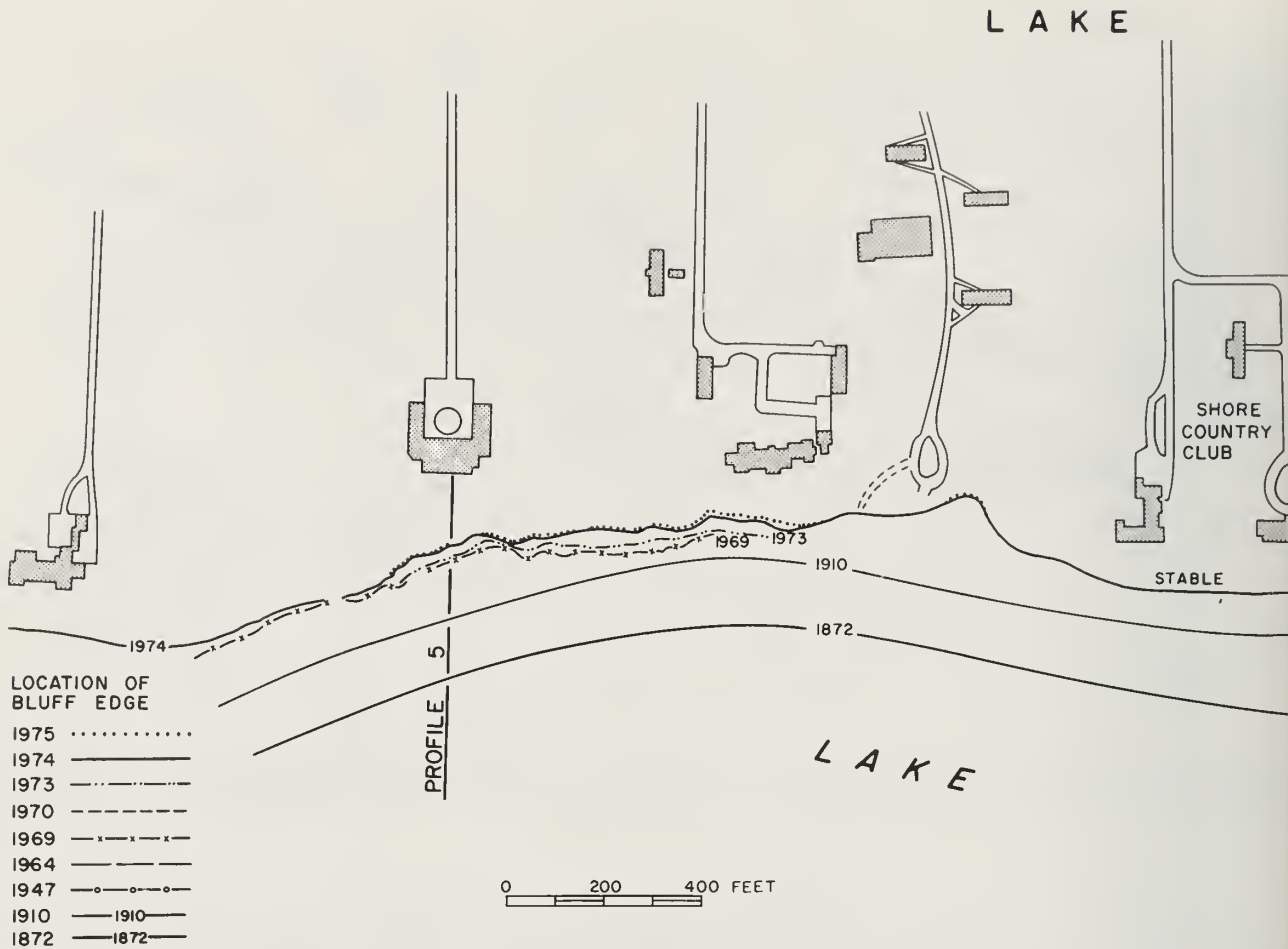
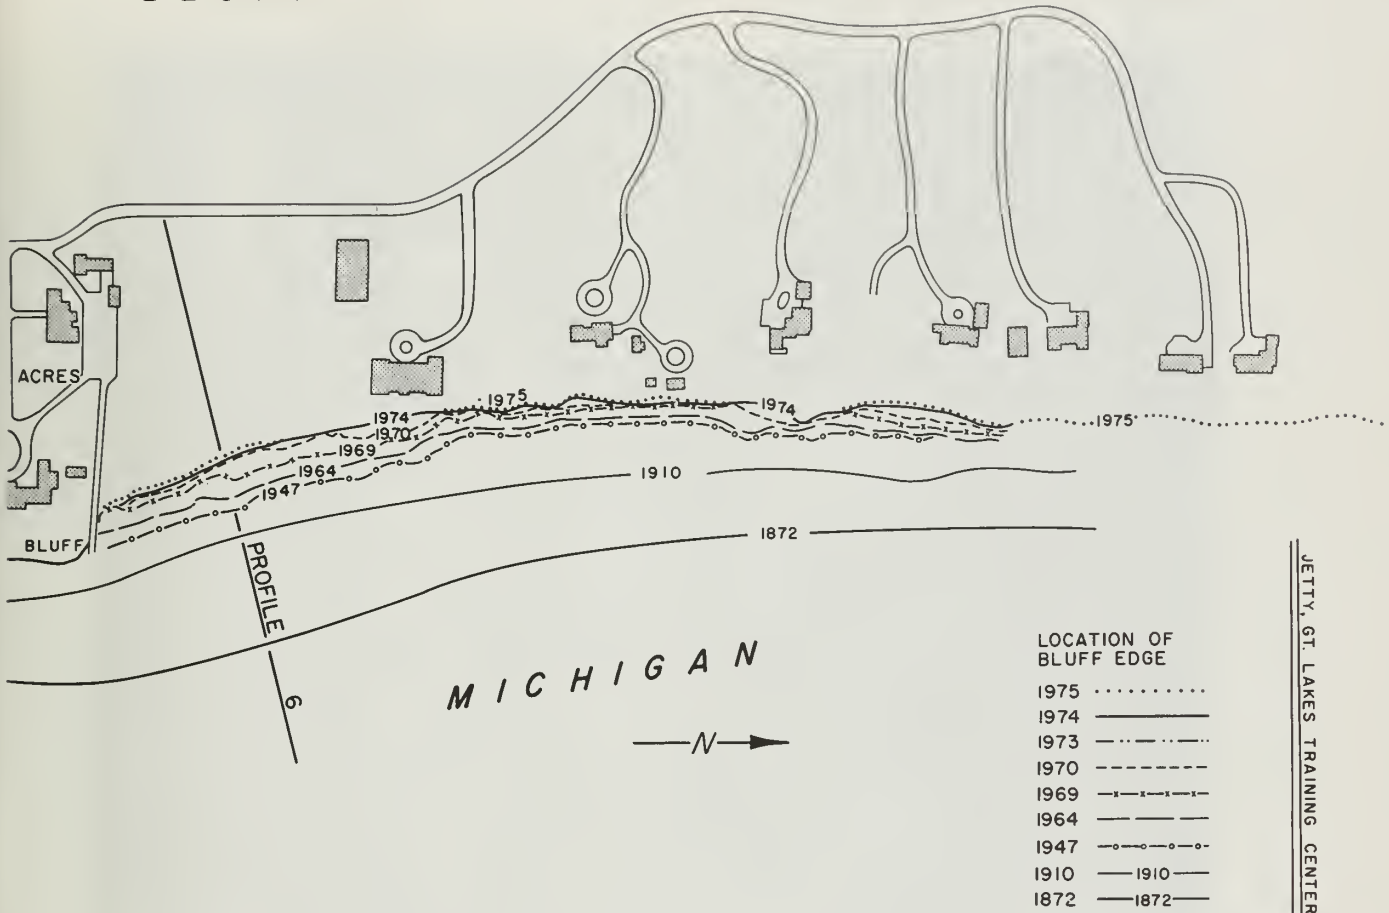
Fig. 5 - Positions of shorelines along northern Lake Bluff between 1872 and

1975. Profiles along which bluff recession was measured are shown.

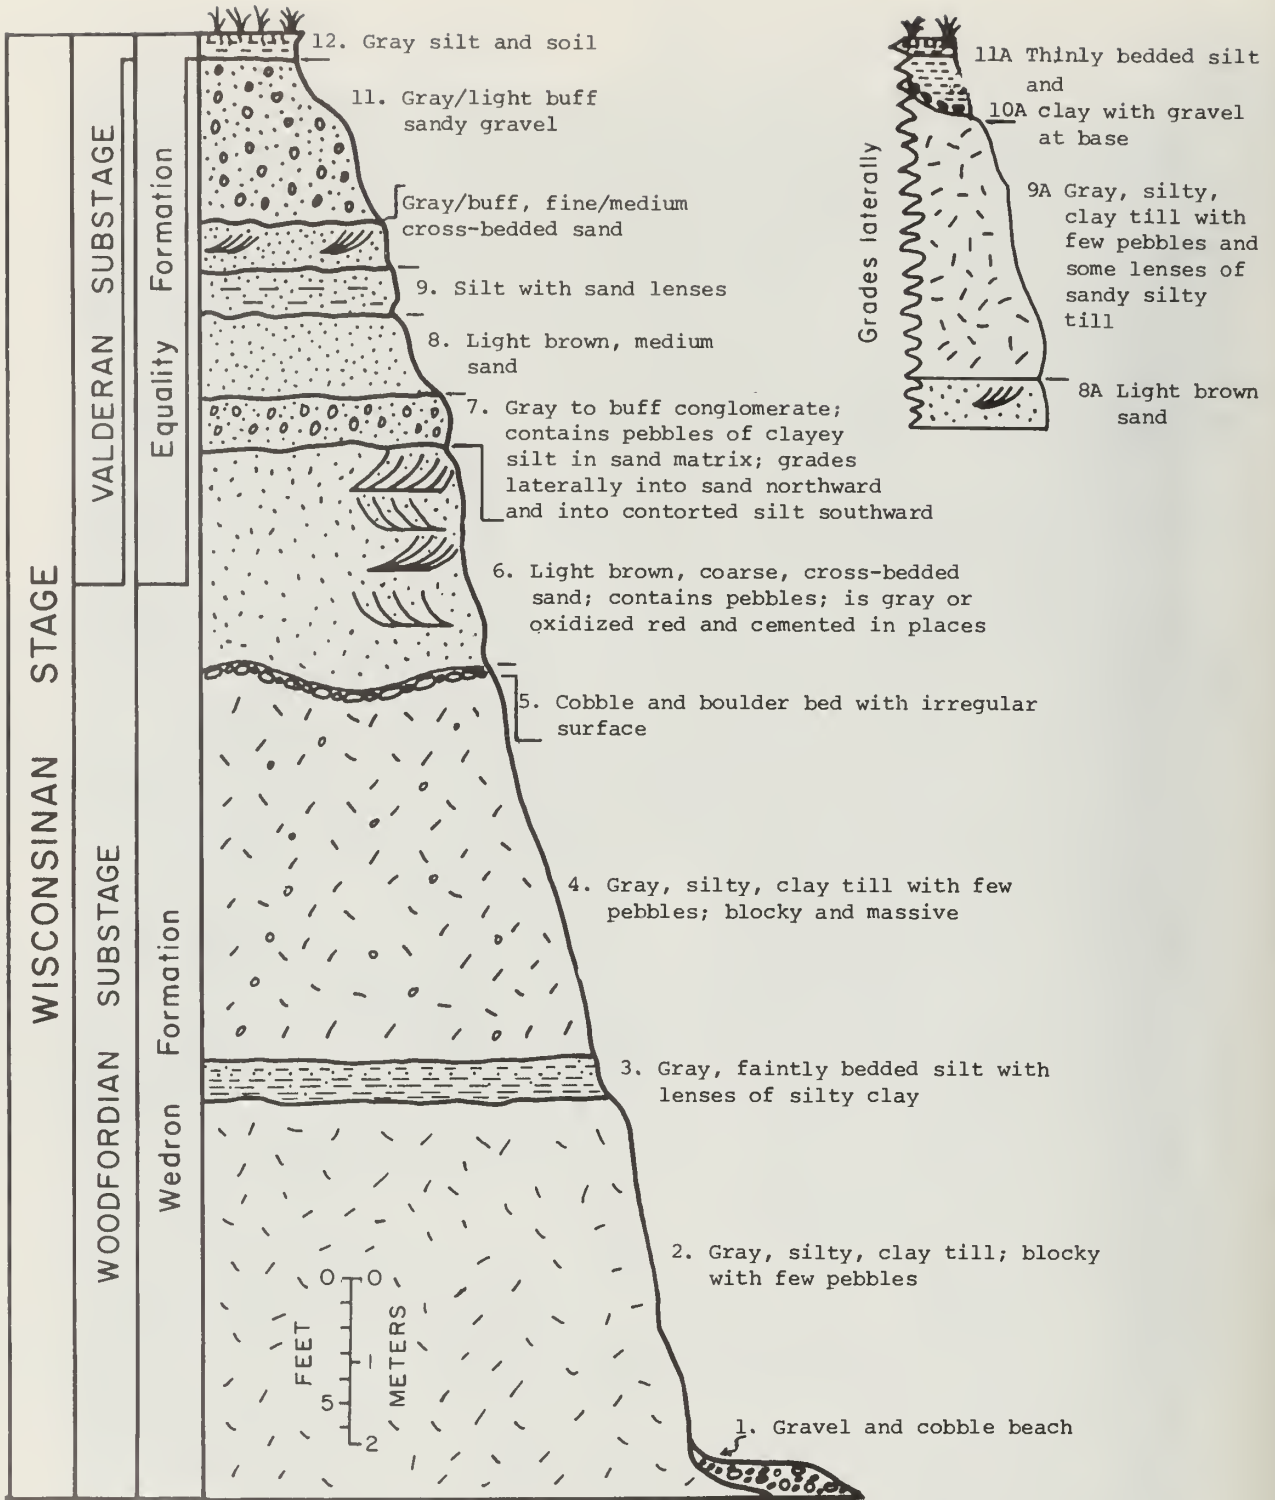
Fig. 6 - Stratigraphic section just south of Lake Bluff Sewage Disposal Plant (SE $\frac{1}{4}$, NE $\frac{1}{4}$, Sec. 21, T. 44 N., R. 12 E., Lake County, Waukegan Quadrangle).

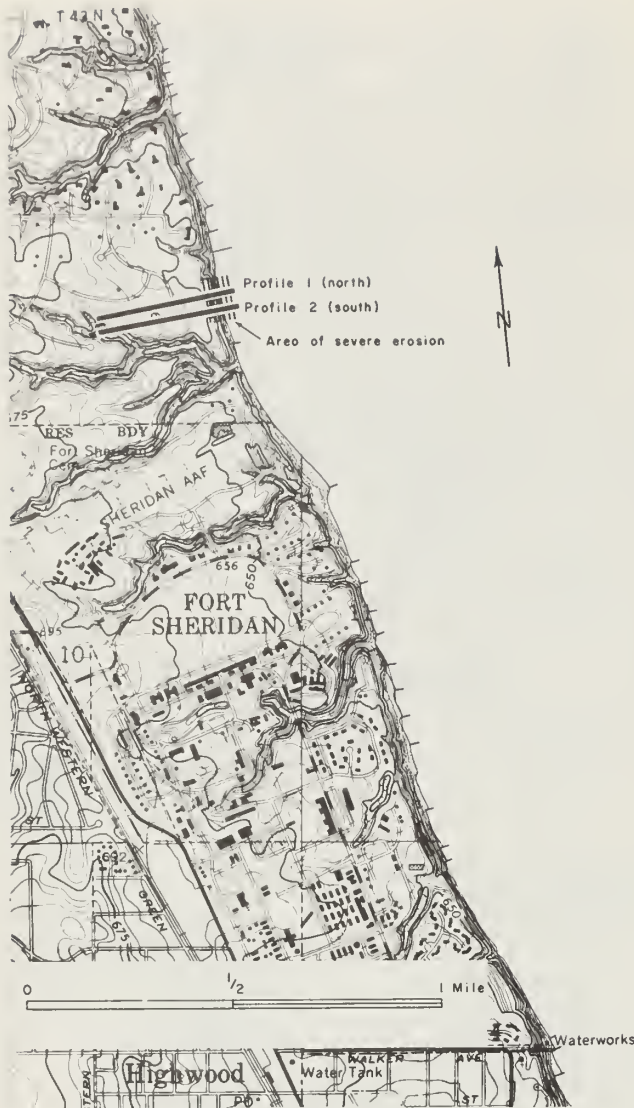
curred between 1973 and 1975 (fig. 9). The bluff recession measured from known cultural features along both profiles is shown in table 9. Along the southern profile, 31 feet of erosion has taken place since 1973, while along the northern profile 35 feet has eroded, a recession average of 33 feet for the 2 years. Bluff changes from 1872 and 1910 to 1958, measured from lake survey charts and topographic quadrangle maps, are shown in table 10.

Fig. 9 - Location of profiles used to calculate erosion rates in south Lake Forest.

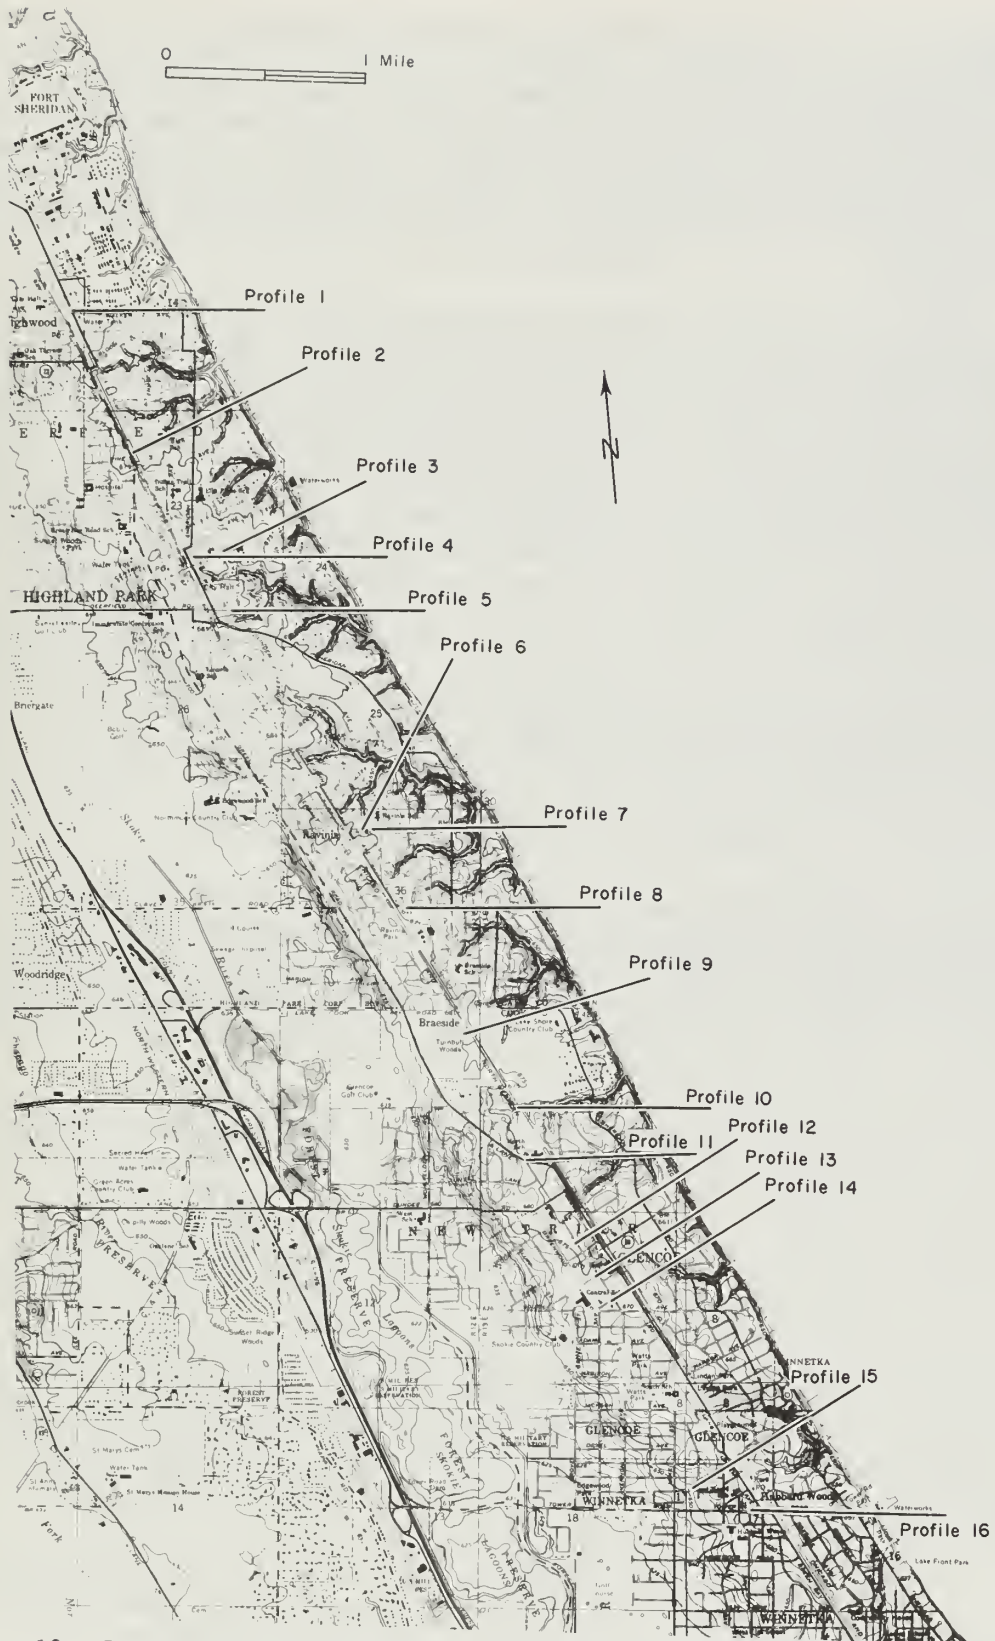
Fig. 10 - Location of profiles used to calculate erosion rates in Highland Park, Glencoe, and Winnetka.

and 1975 and between 1964 and 1975 to determine the area's erosion history. Nine profiles were measured in Highland Park, five in Glencoe, and two in Winnetka. In Highland Park, two profiles showed evidence of significant erosion. At profile 1 (fig. 10), near the Highland Park-Fort Sheridan boundary, recession was caused by the slumping of a single 17-foot block during the early 1970s. At the second site (profile 9) at the southern extremity of Highland Park, approximately 15 feet of recession has occurred since 1964 on a 200-foot reach of shore.

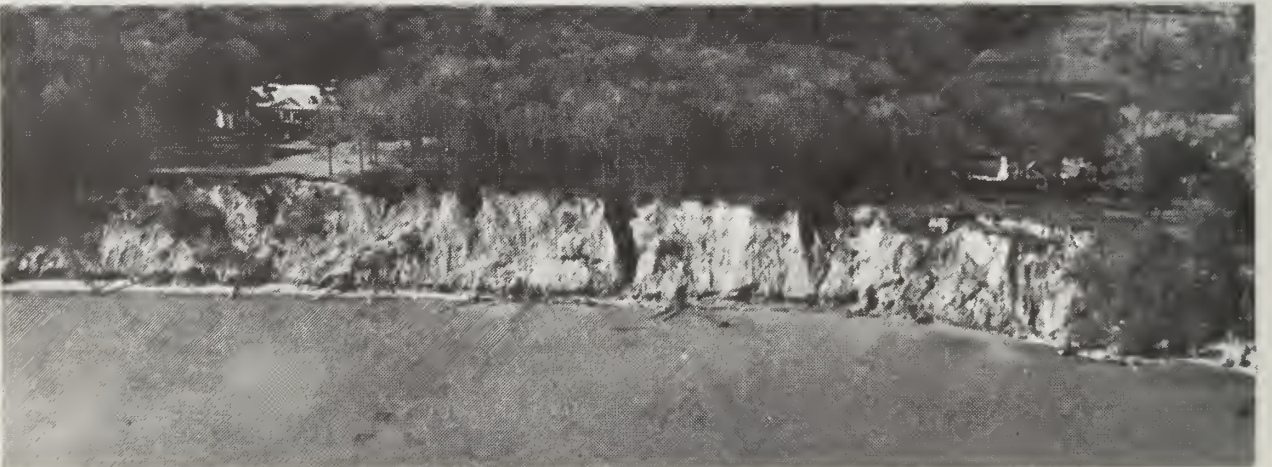
Fig. 11 - Bluff one-eighth of a mile south of Great Lakes Naval Training Center, August 1974, at a lake level near 580 feet. The bluff is more than 70 feet high. The lower part is of homogeneous gray glacial till. Most of the upper half of the bluff consists of weak till, silt, sand, and gravel. The beach house was built before 1947 and has been maintained ever since. Its location indicates the subsequent bluff recession (fig. 5). Numerous seeps can be seen along the entire reach. Fallen trees can be seen on the bluff face and on the narrow beach. More moisture is present below the mouths of truncated gullies than elsewhere. Rubble groins once present along this shore have been damaged and submerged. This location is shown by a vertical aerial view in figure 6.

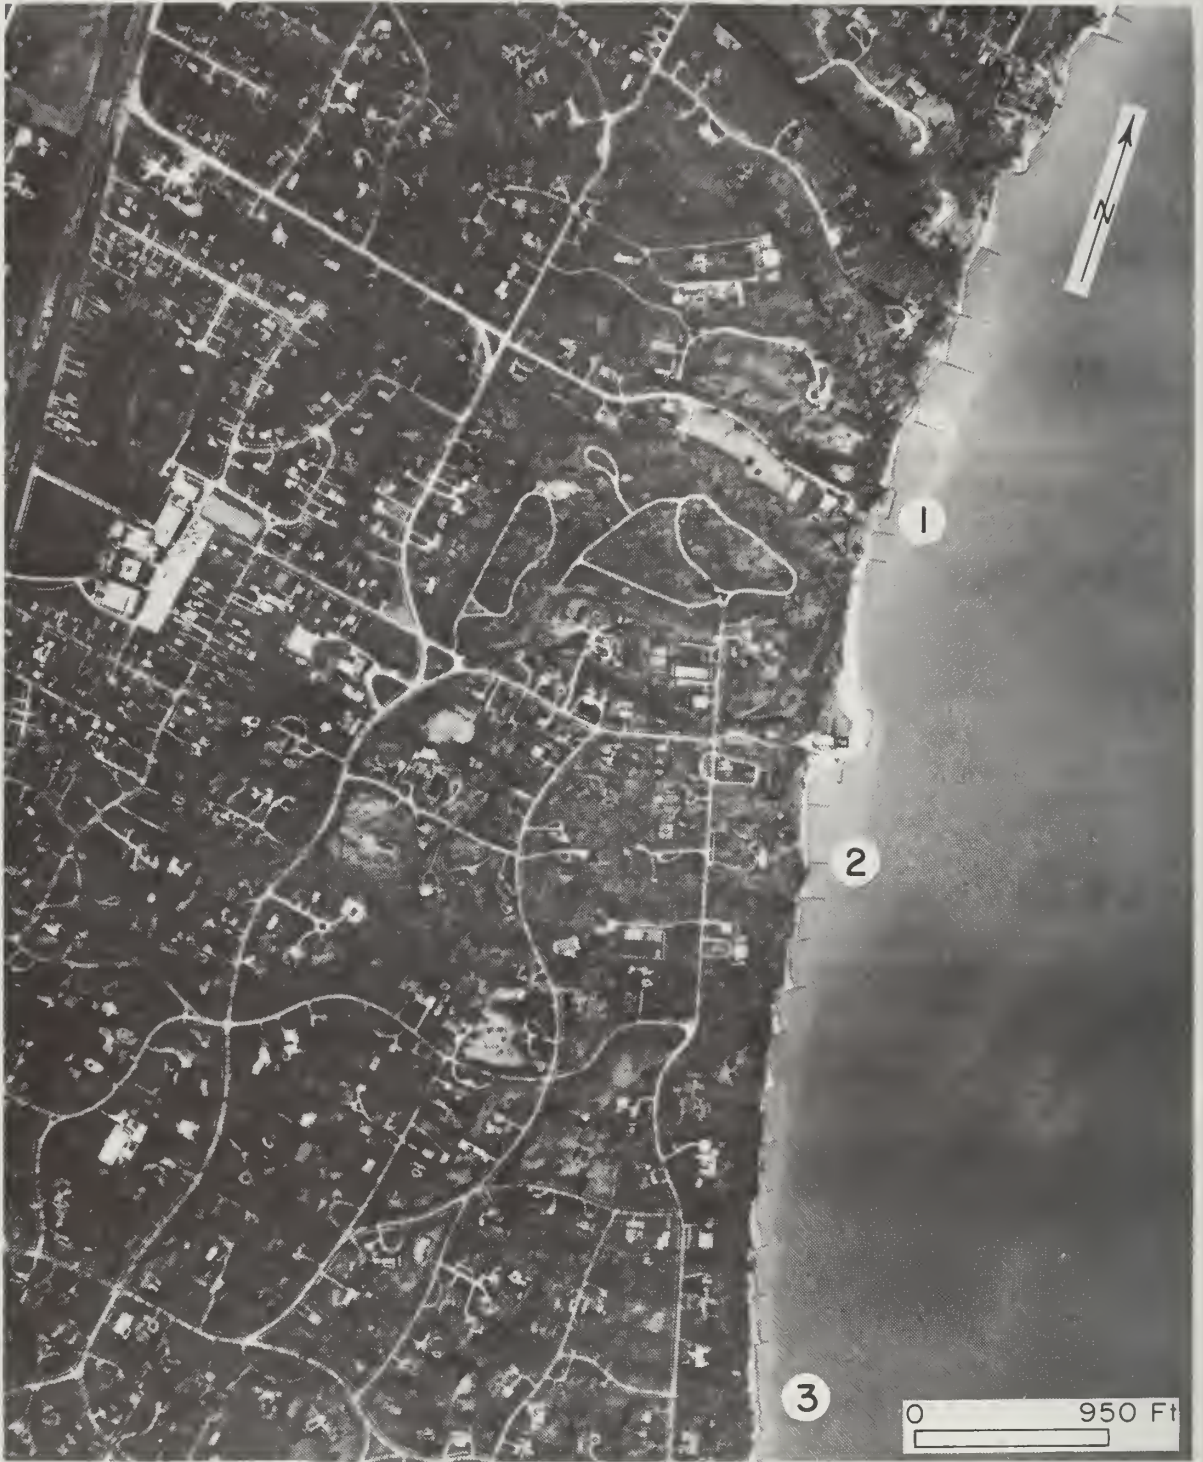
1—Area 1100 feet north of the waterworks where a bulkhead has failed and a set of groins that normally protect the shore (shown here in April at low water) have been flanked, topped, and partly submerged by high water. Consequently, the reach from there northward to the Lake Bluff Sewage Disposal Plant has suffered severe erosion during the present high-water cycle.
