REPORT OF INVESTIGATION NO. 10

THE SILTING OF LAKE BRACKEN
Galesburg, Illinois

B.O.Larson, KM.Smith, ELSauer, and
S.W. Melsted

Illinois State Water Survey Division, Soil Conservation Service,
United States Department of Agriculture, and Illinois
Agricultural Experiment Station, Cooperating

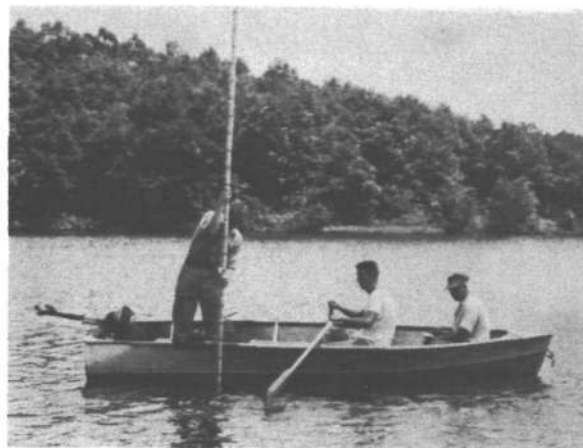
Measurement of Sediment. Thirty ranges were established. Along each of these ranges at intervals of 20 to 25 feet soundings of water depth were taken to locate the elevation of the top of the sediment. The soundings were made with a bell-shaped 5-pound aluminum sounding weight with base diameter of 5 inches and a height of 6 inches. At intervals of approximately 50 feet, or with alternate soundings, the thickness of the sediment was measured with a "spud." In the resurvey of 1949, the water depth and sediment thickness were remeasured with a sounding pole. This consists of a 1 3/4-inch diameter calibrated aluminum pole constructed in three 10-foot sections. This pole is shown in use in Figure 4. The pole is lowered in the water until it rests lightly on the top of the sediment deposit. The pole is then thrust on down through the soft sediment until it strikes the hard soil of the original reservoir bottom. In this manner the present water depth and the sediment thickness are measured. As the boat is rowed across the range, a cross-section of water depth and sediment thickness is obtained. In the resurvey, soundings were taken as nearly as possible in the same locations as they were made in the original survey. A total of 453 sediment measurements were made on the 30 ranges during the 1949 resurvey.

FIG. 4. USE OF SOUNDING POLE.

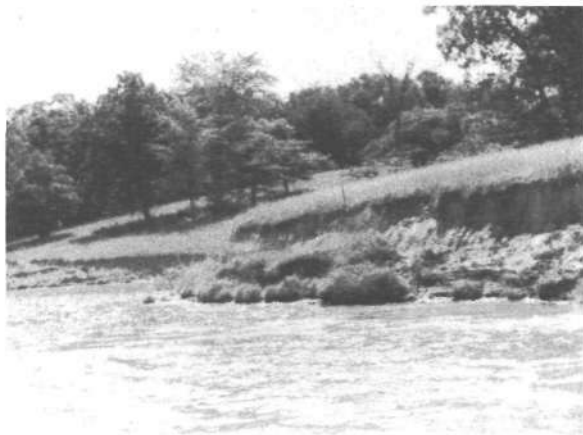
FIG. 5. SHORELINE EROSION, LAKE BRACKEN.

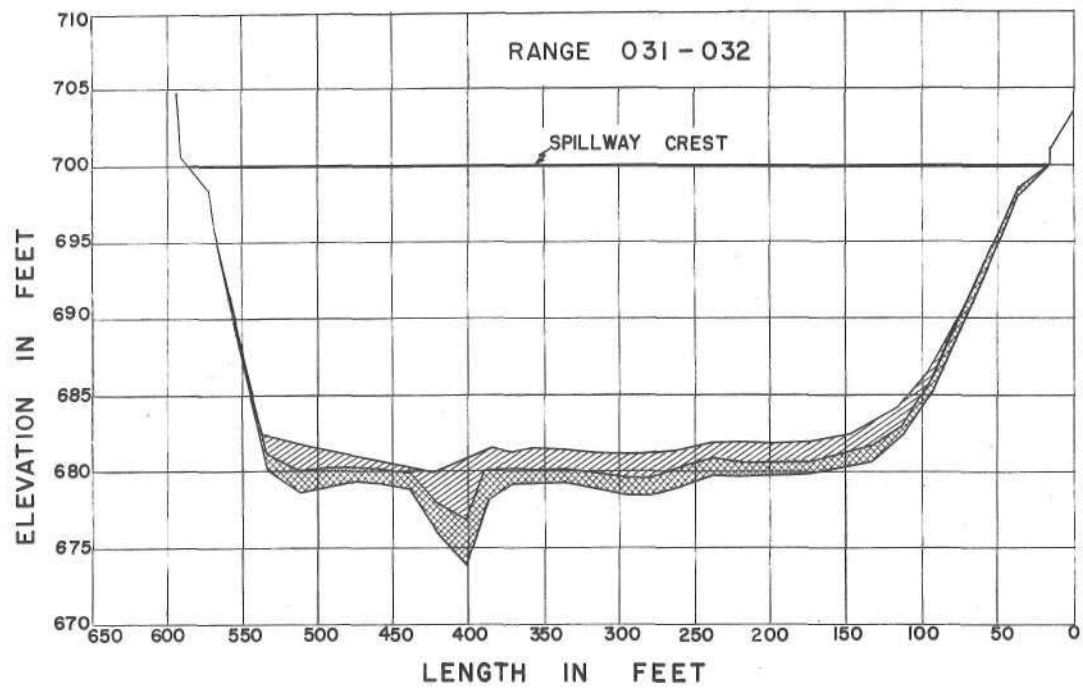
FIG. 7

SILT DEPOSITED FROM 1923 - 1936

The presence of highway fills in segments 9 and 23 has caused a concentration of sediment in the upper ends of the respective arms. Water is ponded there during the floods and finds entrance into the main lake only through small culverts and is thus effectively desilted. As a result, the storage capacity above these fills is being destroyed many times more rapidly than that of the remainder of the lake.

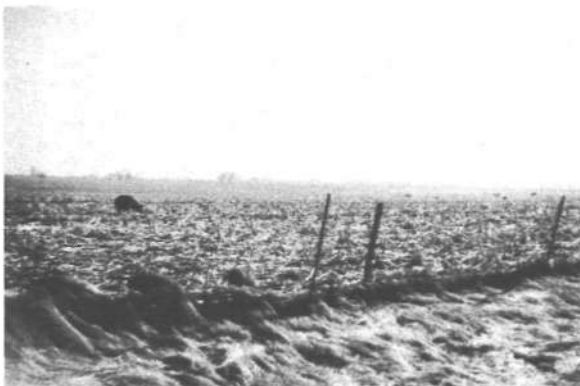
FIG. 10. LEVEL LAND CAN BE CROPPED TO CLEAN-TILLED CROPS HALF-TIME WITH VERY LITTLE SOIL LOSS.

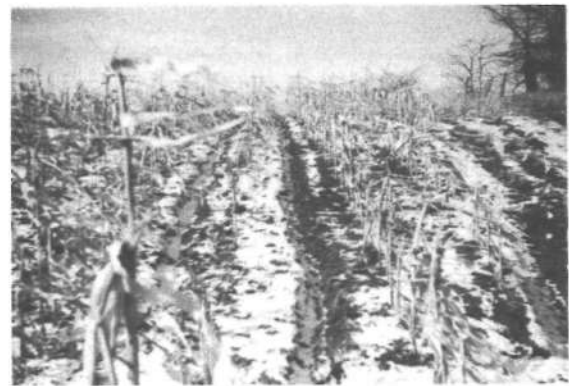
FIG. 11. SOIL LOSSES OF 50 TONS PER ACRE PER YEAR ARE NOT UNCOMMON WHEN SLOPES ARE CROPPED TO CORN AND SOYBEANS.

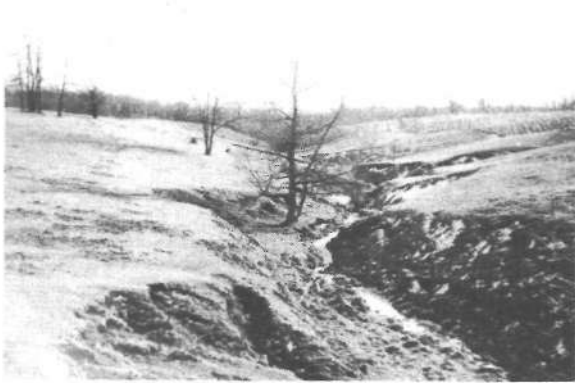
FIG. 12. EXCESSIVE SHEET EROSION RESULTS IN GULLIES BEING FORMED.

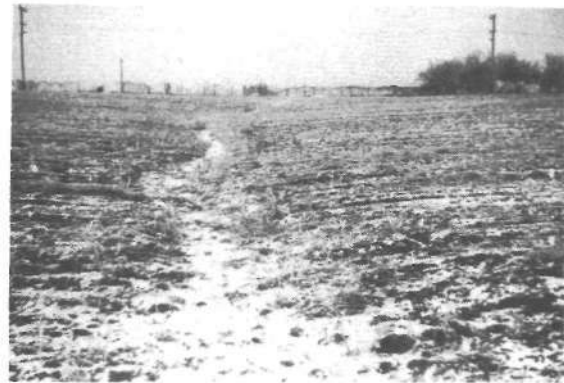
FIG. 13. GRASS WATERWAYS ARE NEEDED IN CULTIVATED FIELDS.

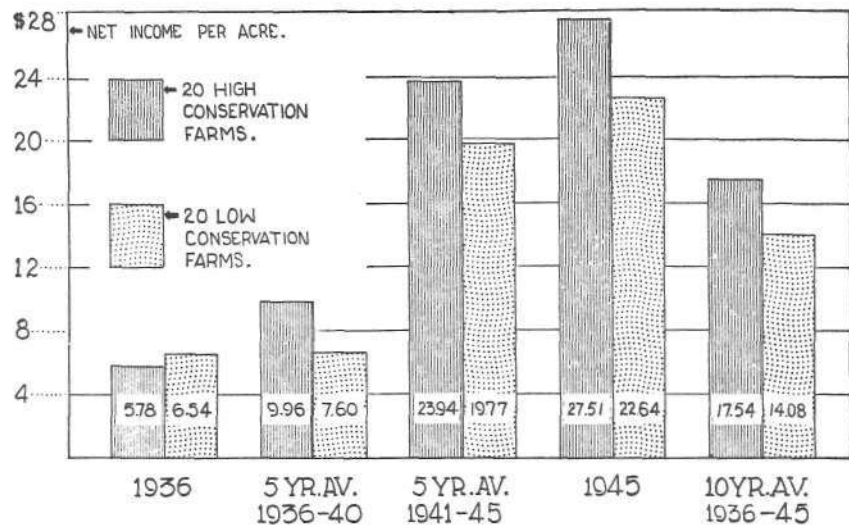
FIG. 14. NET INCOME PER ACRE, IDENTICAL FARMS WITH HIGH AND LOW CONSERVATION SCORES, MCLEAN COUNTY, 1936-1945.

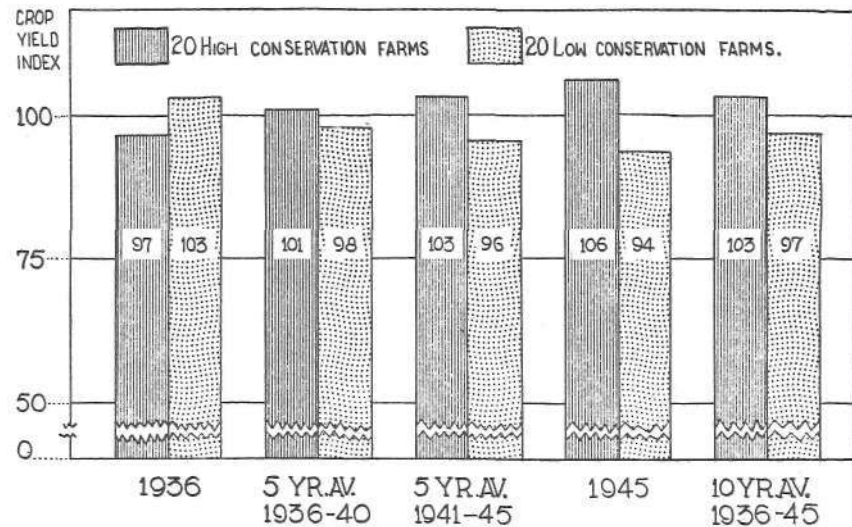
FIG. 15. CROP YIELD INDEX, IDENTICAL FARMS WITH HIGH AND LOW CONSERVATION SCORES, MCLEAN COUNTY, 1936-1945. (AVERAGE YIELDS OF ALL CROPS FOR ALL FARMS EQUALS 100.)
