EVALUATION OF ADAPTIVE SIGNAL CONTROL TECHNOLOGY—FINAL REPORT

Research Report No. FHWA-ICT-19-006

ICT PROJECT R27-127

**Safety and Efficiency Benefits of Implementing
Adaptive Signal Control Technology in Illinois**

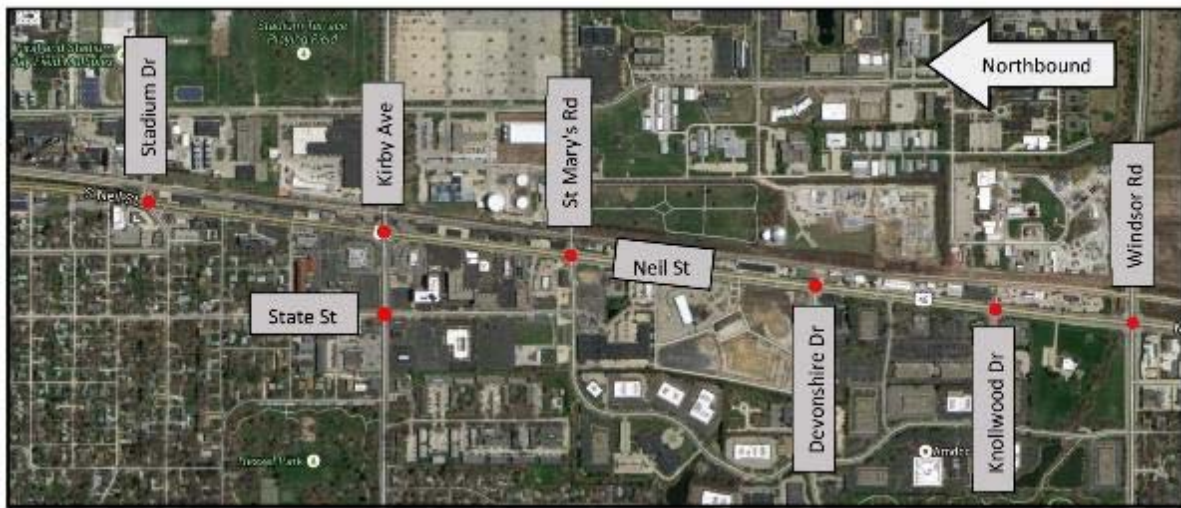
Figure 1. Deployment location on Neil Street in Champaign, Illinois.

- Neil Street and Stadium Drive
- Neil Street and Kirby Avenue
- Neil Street and St. Mary’s Road
- Neil Street and Devonshire Drive
- Neil Street and Knollwood Drive
- Neil Street and Windsor Road

In addition, the traffic signal at Kirby Avenue and State Street was linked to the traffic signal at Kirby and Neil so that they worked in a coordinated manner.

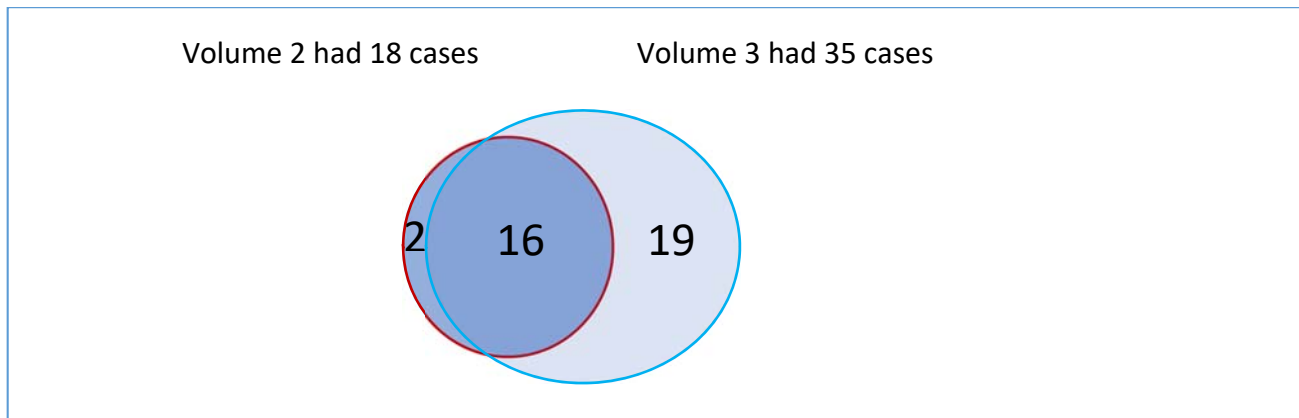
Figure 2. PI deterioration cases in the “first year after” ASCT deployment and the “final year.”

the “first year after” data also showed deterioration in the “final year” data, but PI improved in 2 cases. In the “final year” data, 19 additional cases showed performance deterioration, as schematically shown in the Figure 2 Venn diagram.

In the “final year” data (2017 ASCT, as reported in Volume 3), there were 35 deteriorated cases out of a total of 56 cases. However, there were 18 deteriorated cases out of a total of 56 cases in the “first year after” data (2015 data, as reported in Volume 2). There were 16 cases that showed deterioration in both data sets (the 2017 and 2015 data sets). Thus, 16 out of 18 cases that showed deterioration in

Among the 19 deteriorated cases in the “final year” data, some reasonable explanation for PI deterioration could be found for 8 cases, though not justifying the deterioration of the system performance; but for 11 cases, no reasonable explanation for their PI deterioration was found, (A detailed discussion will be given later.)

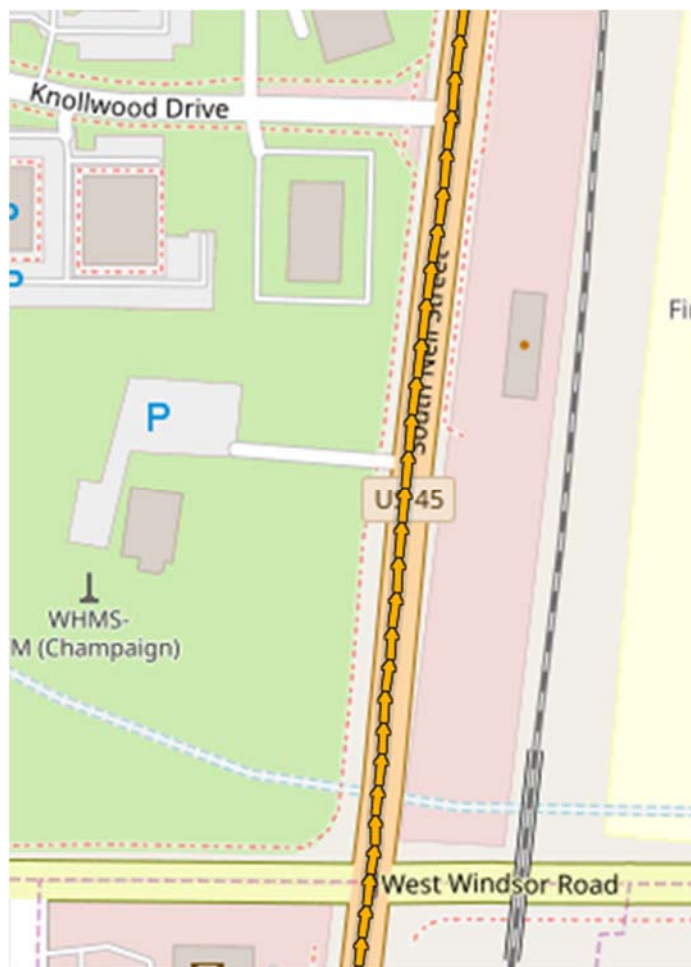
Figure A1. Car trajectory recorded in one-second increments.

Travel times were determined from GPS data. Specifically, a segment was defined as the distance from the middle of one intersection to the middle of the adjacent downstream intersection. Figure A1 presents an example of travel time between Windsor Road and Knollwood Drive. Each arrow represents the distance that the vehicle traveled in one second, if it was not stopped.
