CIVIL ENGINEERING STUDIES
Illinois Center for Transportation Series No. 13-028
UIIU-ENG-2013-2029
ISSN: 0197-9191

FIELD EVALUATION OF SMART SENSOR VEHICLE DETECTORS AT RAILROAD GRADE CROSSINGS—VOLUME 3: PERFORMANCE IN FAVORABLE WEATHER CONDITIONS

Prepared By
Juan C. Medina
Rahim F. Benekohal
University of Illinois at Urbana-Champaign

Research Report FHWA-ICT-13-028

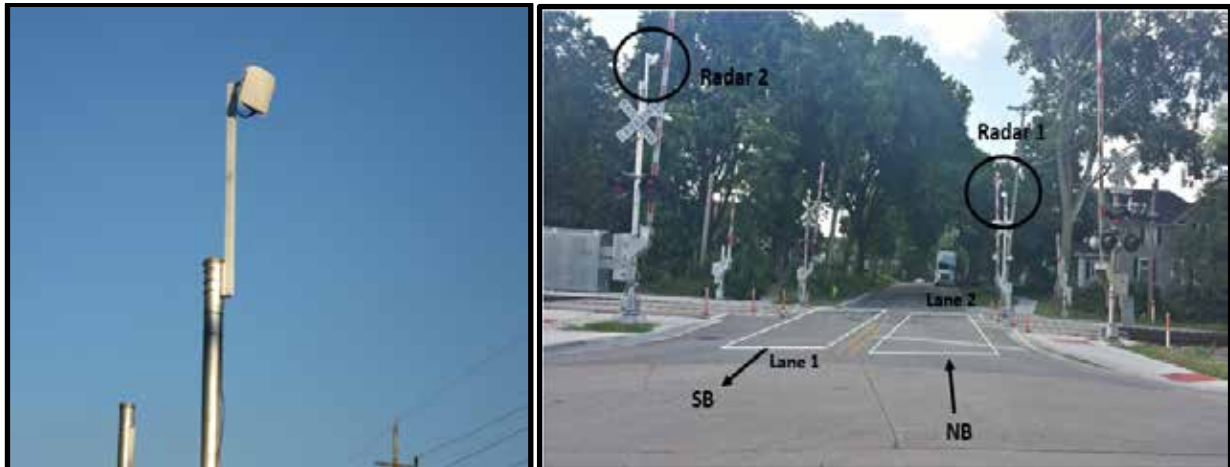
Figure 3. Detail and numbering of microwave radar units and traveled lanes.

The microwave radar vehicle-detection system had two Wavetronix radars aimed at the crossing from two opposing quadrants: the northeast and the southwest corners of the crossing, as shown in Figure 3. The installed units are modified versions of standard Matrix devices, typically used for stop-bar detection at signalized intersections. In addition to the standard detection capabilities of a Matrix sensor, the units installed at the crossing included the following:

The radar system detection was set such that each radar unit generated a single output per lane, covering an area similar to that from the loop detectors. This arrangement resulted in a total of four outputs for the two radar units: Radar1–Lane1, Radar1–Lane2, Radar2–Lane1, and Radar2–Lane2. An illustration of the numbering used for the radar units and the traveled lanes, is shown in Figure 3.

- Rotated southwest-side radar unit (Radar 2) so that the lane positions were optimized within to the detection footprint
- Moved detection zones for Radar 2 to the relocated lane positions
- Tilted Radar 2 upwards to increase marginally the sensor's ability to track vehicles coming down the slope from the north side of the crossing

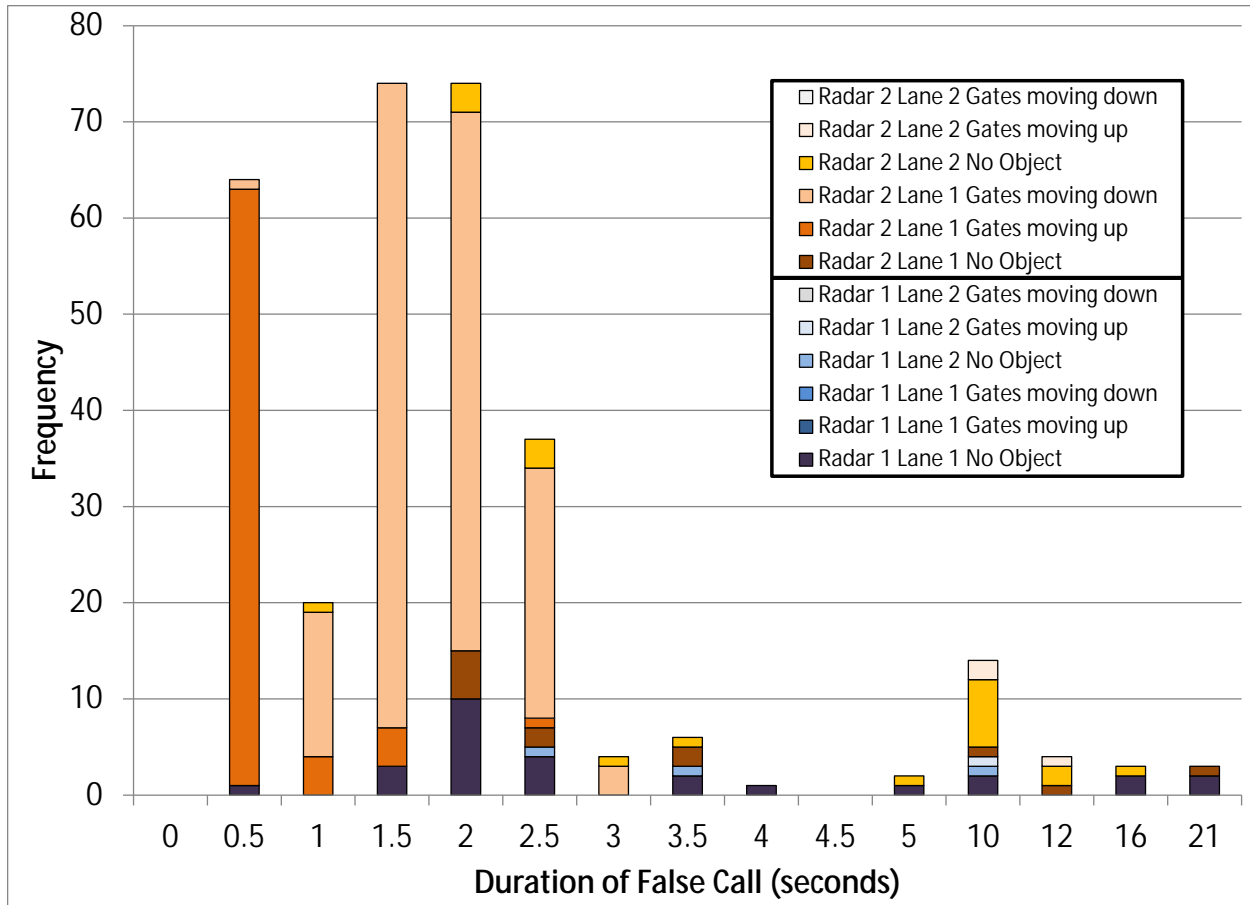
Figure 4. Distribution of false call duration (not including bicycles or pedestrians).

- The duration of false calls varied depending on the situation that generated them. False calls caused by moving gates were shorter, ranging between 0.2 and 11.8 seconds, compared with false calls created without any object moving in the crossing, which lasted between 0.2 and 20.1 seconds. A distribution of the duration of the false calls by type is shown in Table 5 and Figure 4.
