SWS Contract Report 509

**DEWATERING WELL ASSESSMENT FOR THE HIGHWAY DRAINAGE SYSTEM
AT FOUR SITES IN THE EAST ST. LOUIS AREA, ILLINOIS
(PHASE 5)**

Prepared for the
Illinois Department of Transportation

April 1991

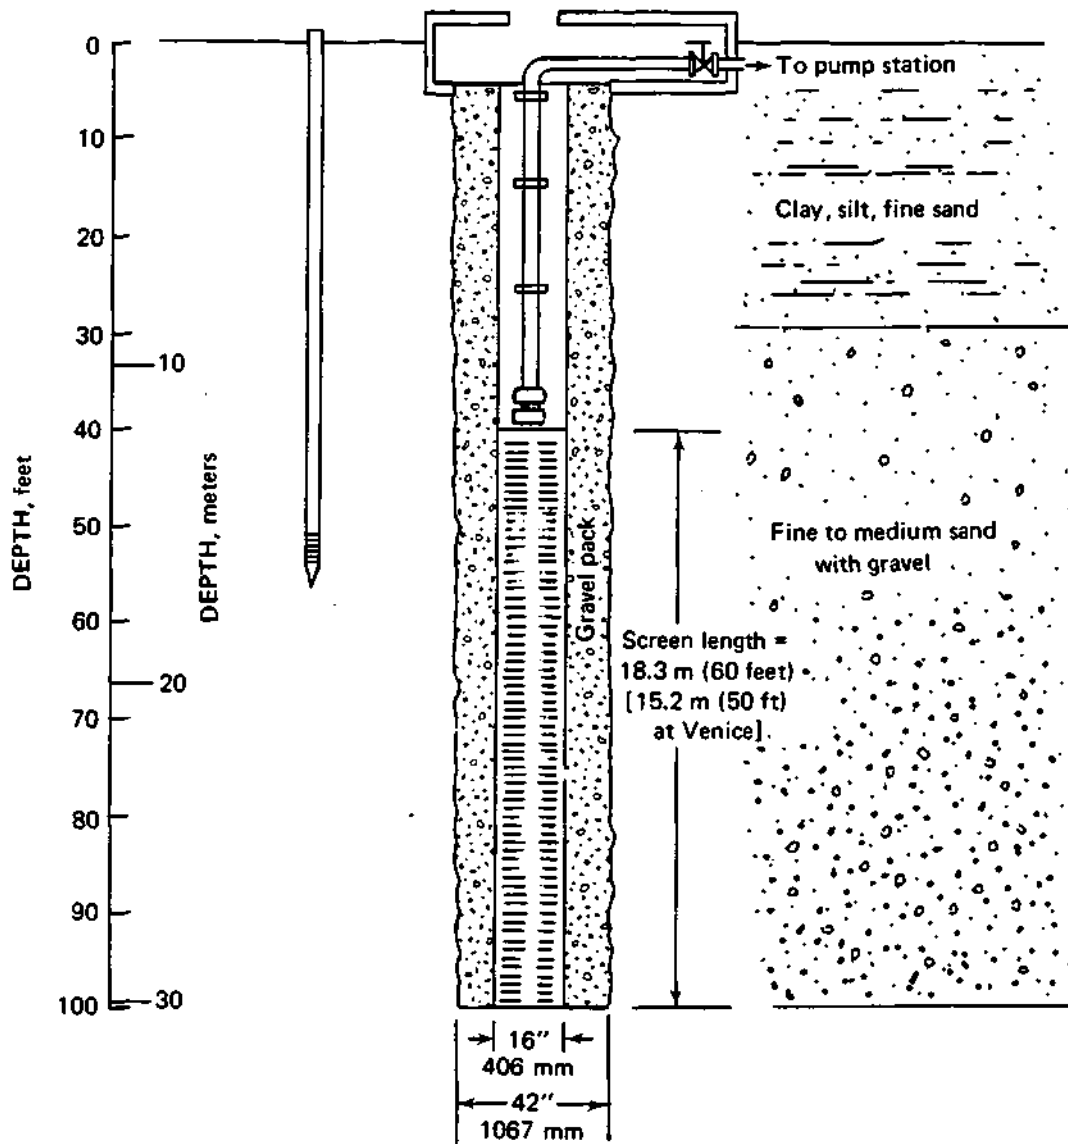
Figure 4. Typical features of a dewatering well

The wells are of similar construction, with 16-inch-diameter stainless steel casing and screen, and 6-inch-diameter stainless steel column pipe (figure 4). Each well is equipped with a 600-gpm submersible pump with bronze impellers, bowls, and jacket motors. The early experience with severe corrosion problems showed that corrosion-resistant materials are required to maximize service life. A total of five 8-inch recorder wells are available to monitor ground-water elevations near critical locations at the four sites. Each of the 48 wells has a 2-inch-diameter piezometer for monitoring individual well performance.

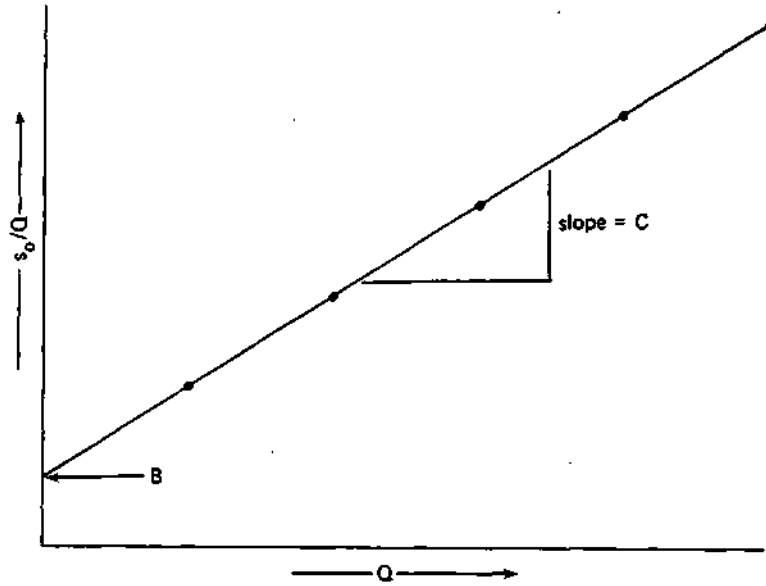
Figure 5. Graphical solution of Jacob's equation for well loss coefficient, C

After this modification, a plot of s_o/Q versus Q can be prepared on arithmetic graph paper from data collected during a step drawdown test, with the observed drawdown, s_o , substituted for s . The slope of a line fitted to these data is equal to C , while the y-intercept is equal to B , as shown in figure 5. If the data do not fall on a straight line but, instead, curve concavely upward, then Rorabaugh's method usually is suggested. The curvature of the plotted data indicates that the 2nd order relationship between Q and s_o is not valid.

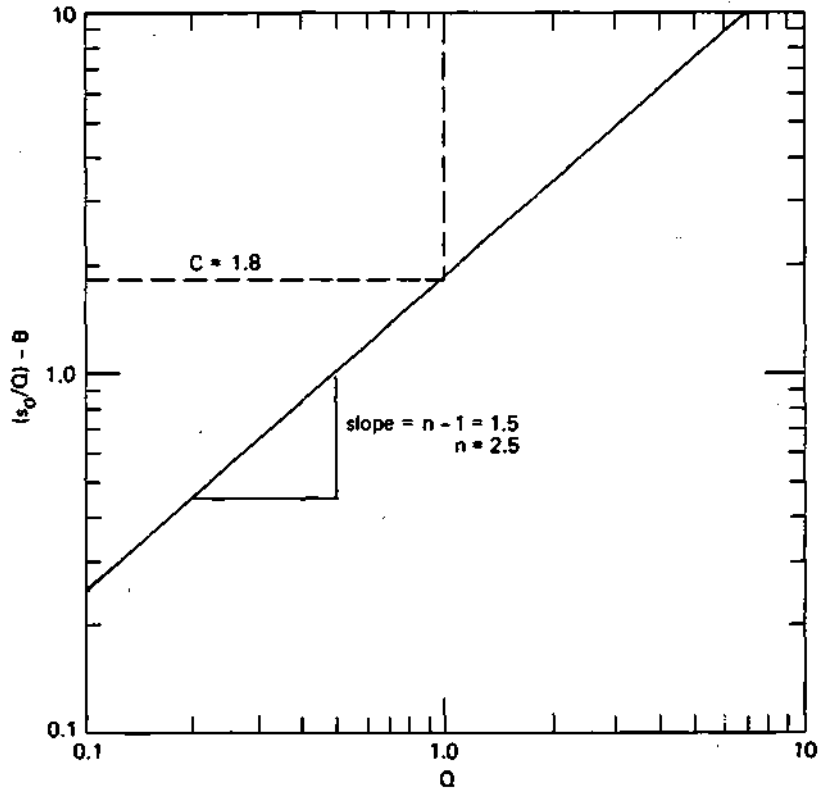
Figure 6. Graphical solution of Rorabaugh's equation for well loss coefficient (C) and exponent (n)

A plot of $(s_0/Q) - B$ versus Q can be made on logarithmic graph paper from step test data, again using s_0 for s . Values of B are tested until the data fall on a straight line (figure 6). The slope of the line equals $n - 1$, from which n can be found. The value of C is determined from the y-intercept at $Q = 1$. In the example shown, the graphical procedure is facilitated if Q is plotted as cubic feet per second and $(s_0/Q) - B$ is plotted as seconds per foot squared. It is also convenient (although not mandatory) to use these same units in the Jacob method.

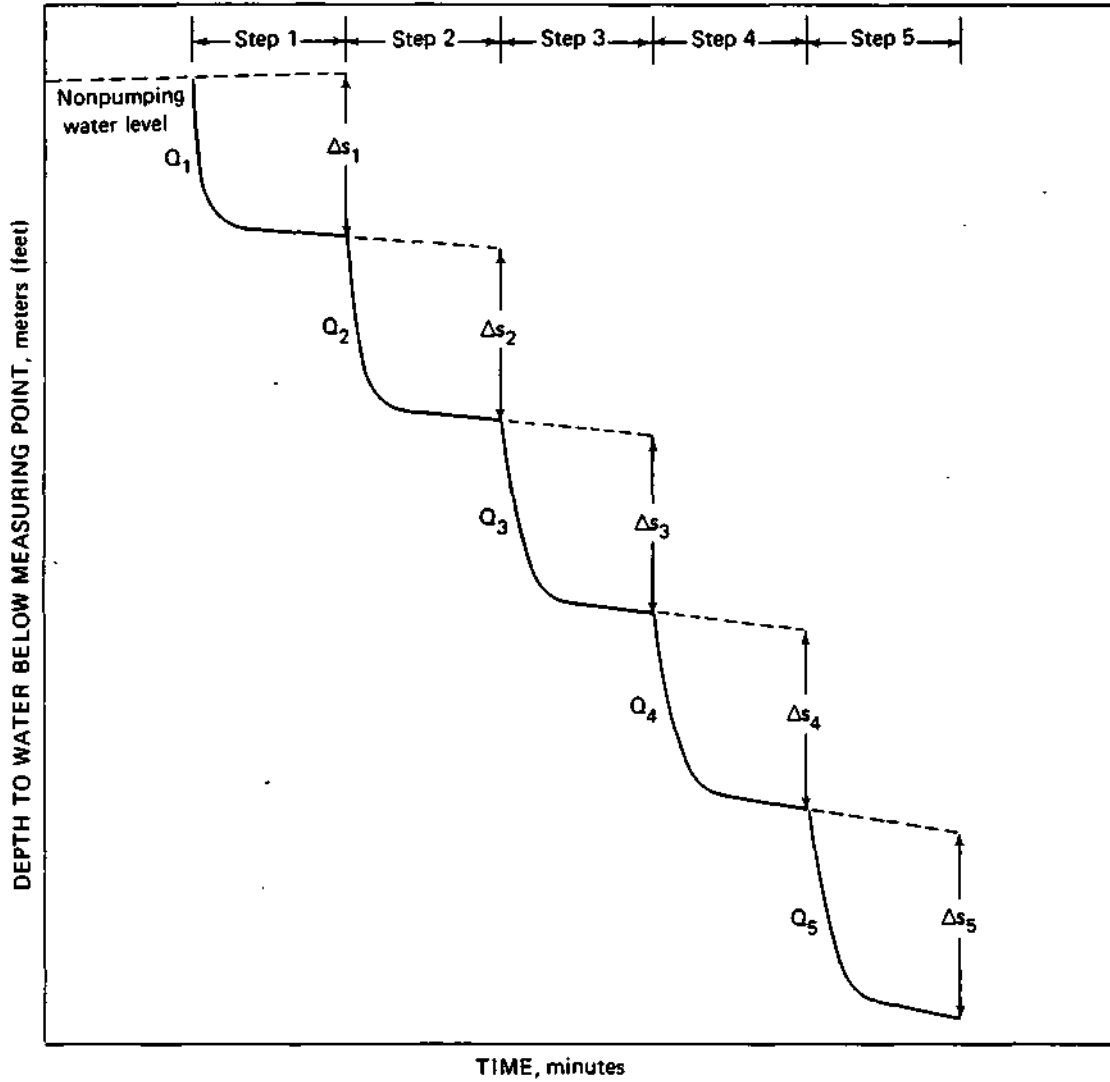
Figure 7. Relationship between time and water level during a five-step drawdown test

Schematically, the relationship between time and water level resembles that shown for a five-step test in figure 7. Drawdowns for each step (shown as s_i) are measured as the distance between the extrapolated water levels from the previous step and the final water level of the current step. For step 1, the nonpumping water-level trend prior to the start of the test is extrapolated, and s_1 is measured from this datum. All data extrapolations should be performed on semilog graph paper for the most accurate results. For the purpose of plotting s_0/Q versus Q or $(s_0/Q) - B$ versus Q , values of observed drawdown s_0 are equal to the sum of As_i for the step of interest. Thus, for step 3, $s_0 = s_1 + s_2 + s_3$.

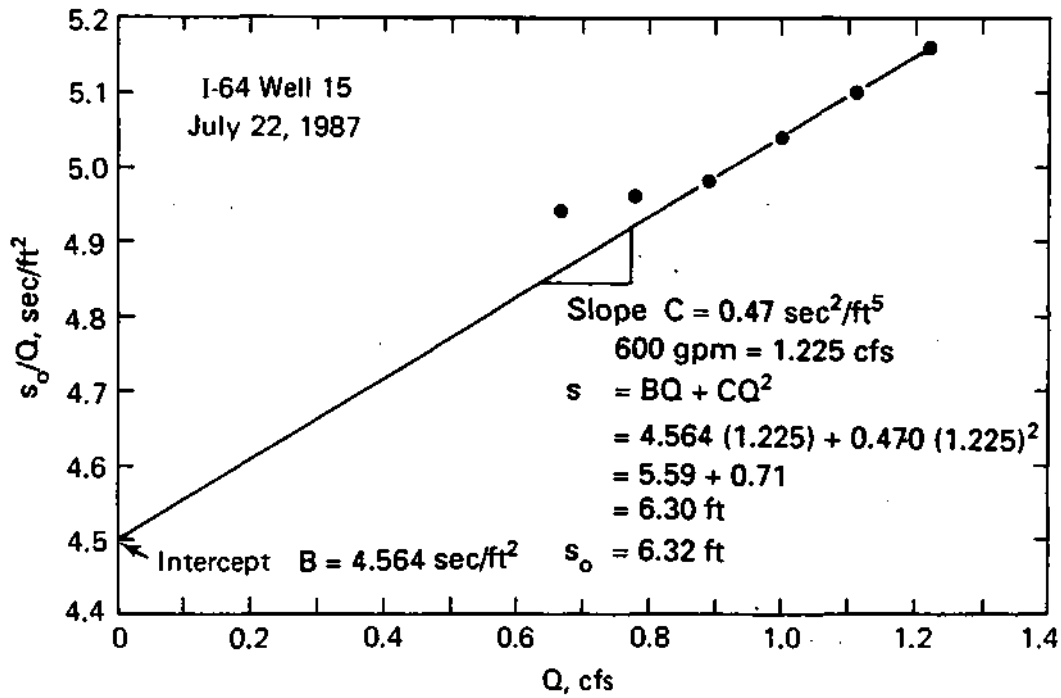
Figure 8. Graphical analysis for I-64 Well 15

To verify the C value, a plot of s_o versus Q is used (figure 9). When $C = 0$, equation 2 becomes $s = BQ$, which would plot as a straight line through the origin. If $C \neq 0$, then the non-linear CQ^2 term will cause the line to curve upward increasingly as Q increases. The amount of displacement from the straight line is the amount of well loss at each pumping rate. In our case, $C \neq 0$. Using $s - CQ^2 = BQ$, and substituting s_o for s , we should be able to subtract the CQ^2 from each value of drawdown, leaving the value of BQ . If our evaluation of C is correct, the BQ values should plot on a straight line through the origin. Each of these lines is plotted in figure 9. One is labeled s_o , and the other is labeled $s_o - CQ^2 = BQ$. As can be seen, the BQ line is a straight line through the origin, which verifies that $C = 0.470$, obtained from figure 8, is a good estimate for C .

The analysis indicates that at a rate of 600 gpm, the portion of drawdown caused by turbulent well losses at the well screen and inside the

well would be 0.84 feet or 12.0% of the total drawdown for I-64 Well 15. This is a moderate amount of well loss, although the well is apparently in good hydraulic condition, as shown by its 86.5 gpm/ft specific capacity at 600 gpm and the water-level differences observed between the well and its nearby piezometer during the step test.

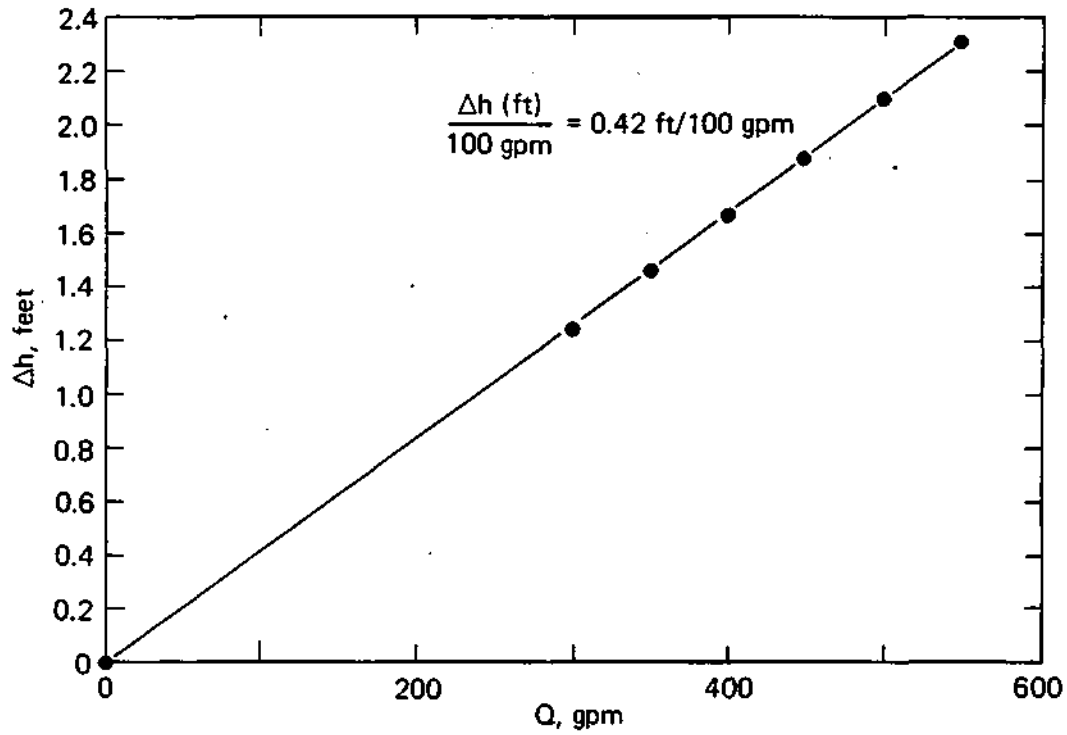
Figure 10. Head difference, Δh , between piezometer and pumped well versus discharge, Q , I-64 Well 15

Figure 10 shows water-level differences (Ah) between I-64 Well 15 and its nearby piezometer during the test. The apparently linear relationship suggests that turbulent losses in the vicinity of the well are small. This is corroborated by a plot of drawdowns at the piezometer versus pumpage, which also show a linear relationship. The average Ah for I-64 Well 15 was 0.42 ft per 100 gpm. The results of analyses performed on data gathered from the nine step tests conducted during Phase 5 are summarized in table 2.

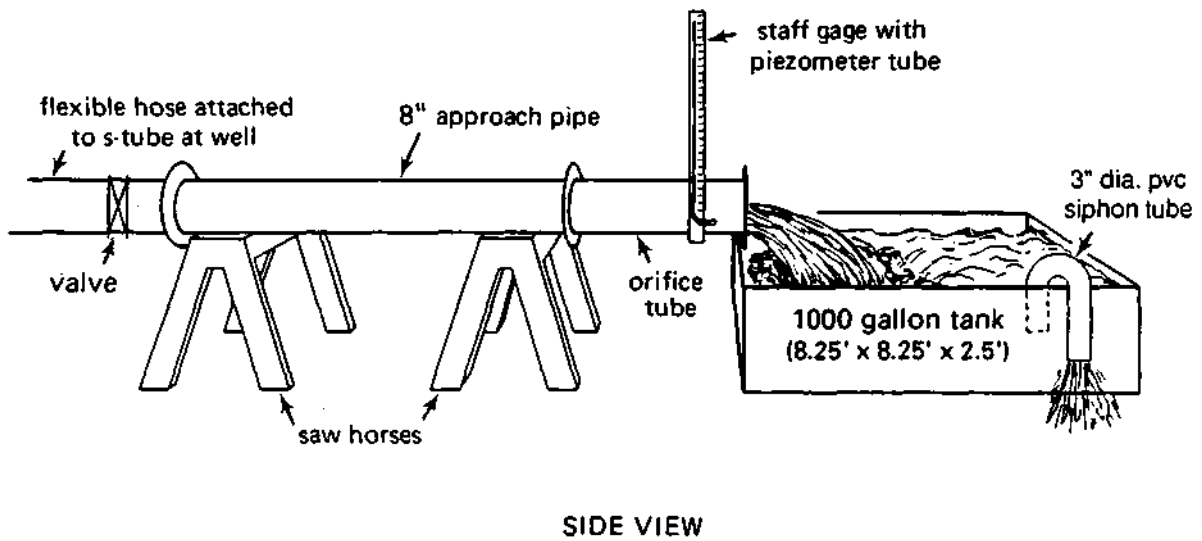
Figure 12. Sand pumpage test setup

During Phase 4, I-70 Well 9 was discovered to be pumping a substantial amount of fine sand, necessitating its shutdown for all but emergency use. It is now awaiting replacement. To address concerns that the other wells might be pumping sand, the possibility of sand pumpage was investigated at I-70 Well 2, I-70 Well 8, and Venice Well 6 during Phase 5. During the step tests at these wells, the water was discharged from an orifice tube into a portable 1000-gallon tank. Siphon tubes were

The 1000-gallon tank acts as a sedimentation basin that, under ideal conditions, should allow sand with minimum grain diameters of no more than 0.1 mm to settle out at the design pumping rates of the wells (600 to 800 gpm). Usually 80 to 90% or more of the aquifer material in the screened interval of the wells exceeds the 0.1 mm grain size.

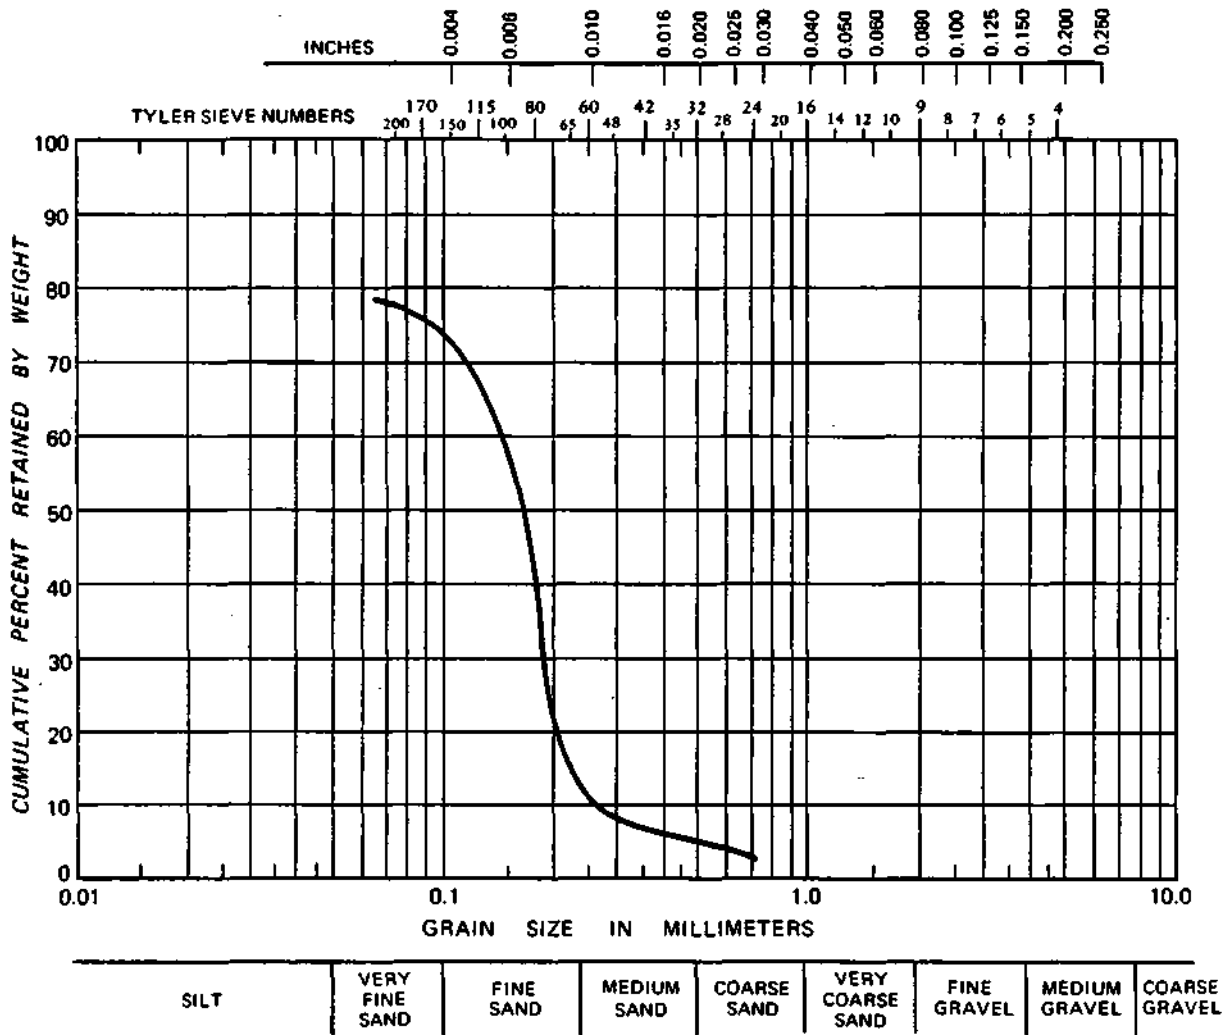
Figure 13. Sieve analysis of sand pumped from I-70 Well 2

The sieve results for I-70 Wells 2 and 8 are very comparable to those obtained from I-70 Well 9 during Phase 4 (Wilson et al., 1990), although the sand sample from I-70 Well 2 is somewhat finer. Review of this information, the limited original well construction data, and sieve data from the Tri-Level borings indicates that fine aquifer material above about elevation 340 to 350 feet could be the source of the sand pumped from these two wells. Given these conditions, 10 to 20 feet of the upper well screen and an even longer interval of the gravel pack would be opposite the suspect source material.

Based on the gravel pack originally recommended for use in the I-70 wells and on our well design criteria, it appears that the aquifer material in zones above elevation 340 to 350 feet is fine enough to migrate through the pack. If the above assumptions are valid, a liner could be installed, blanking off the upper 10 to 20 feet of well screen, as was suggested for I-70 Well 9 (see figure 16, Phase 4, Wilson et al., 1990), to attempt to remediate the condition. Other possibilities to be considered are inspection of the wells with underwater video equipment under pumping conditions and borings drilled next to each well (for formation sampling and grain size analysis) to help verify where the sand is entering the wells. Given the volume of sand pumped during the step test, the recurring settlement problems reported by IDOT around this well, and the relative importance of its location, Well 8 requires attention or replacement in the near future.

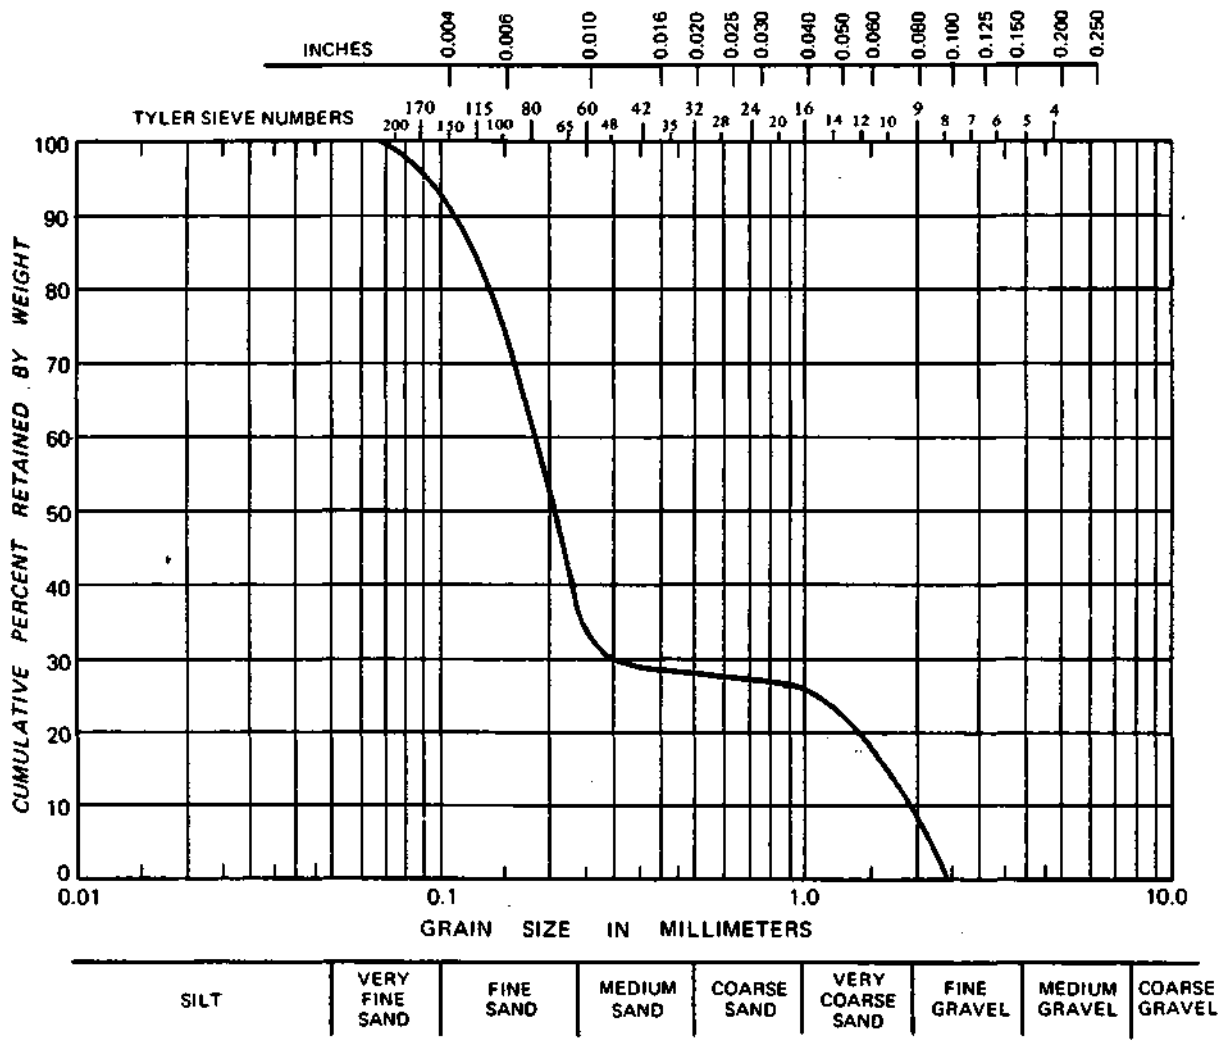
Figure 15. Sieve analysis of sand pumped from Venice Well 6

The scenario is much different for Venice Well 6, as seen in figure 15. The bimodal distribution indicates two distinct sizes of sand, suggesting that both formation material and gravel pack were pumped. It also appeared from visual inspection of the sample that the coarser fraction of sand is gravel-pack material. Unlike the pumpage of fine sand, the presence of gravel pack in the discharge from Venice Well 6 indicates a problem with the well screen or casing such as would be caused by an opening or crack. As previously discussed, this well exhibited other puzzling symptoms following treatment. In this case, it is not

possible to determine whether the sand pumpage is related to the treatment activities; but historically, we are not aware of any reports of settlement at this well site. Although replacement of this well may be the only option, the recommended course of action would be first to inspect the well with underwater video equipment to determine whether repairs are possible.

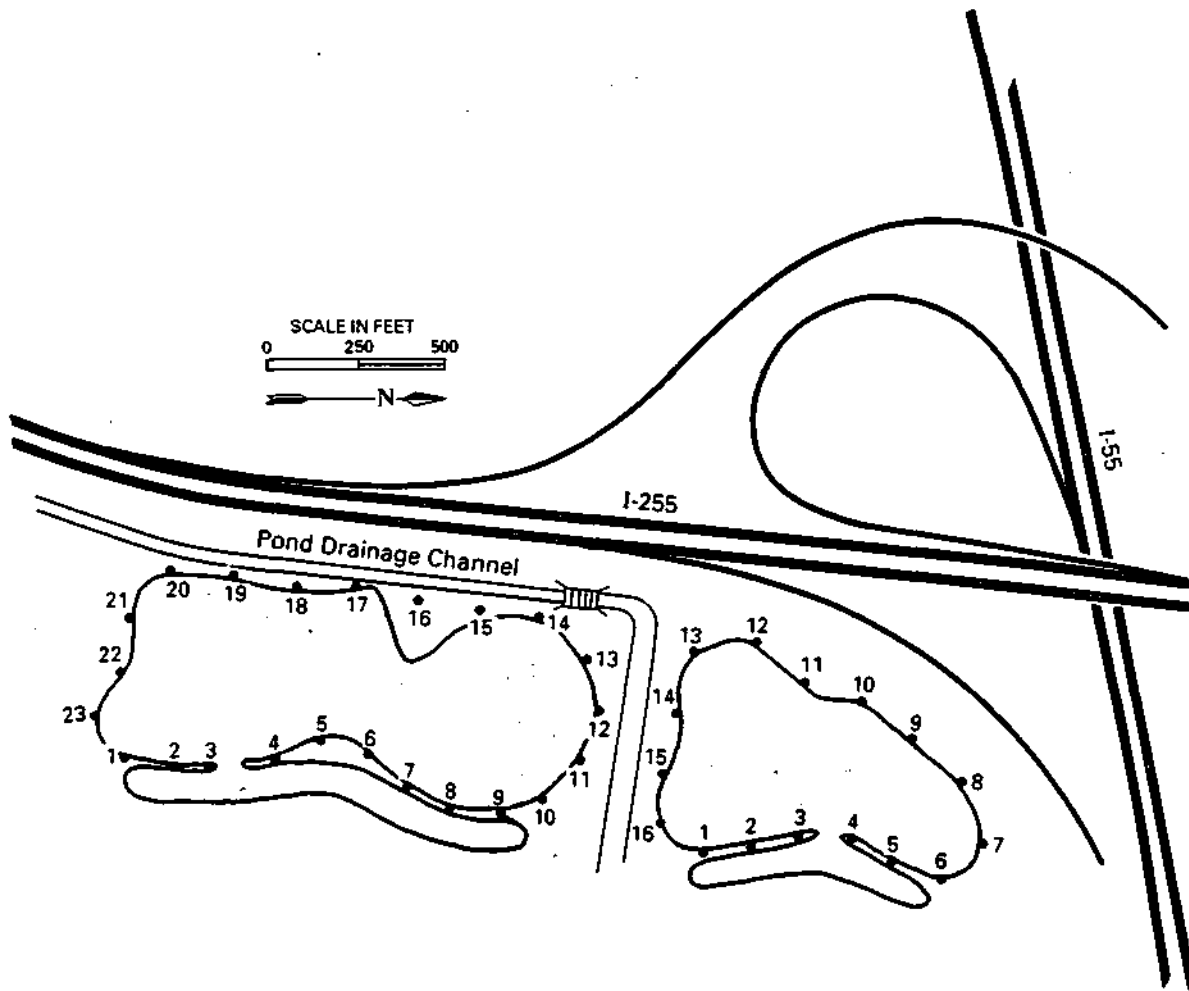
IDOT maintains two stormwater detention ponds southeast of the intersection of I-255 and I-55/I-70. To help maintain stability of the reservoir berms and bottoms and to mitigate other problems at the site caused by high ground-water levels, 39 relief wells were built around the ponds (figure 16) during February-April 1985. Typical construction features of the relief wells are depicted in figure 17.

Figure 16. Locations of relief wells around two stormwater detention ponds
 (Adapted from John Mathes and Associates, Inc., 1986)

At the north detention pond, Relief Well (RW) 13 and RW 16 were inspected. Approximately 2.5 feet of water was in the bottom of each vault, covering the well-head check valves and basin outlet pipes. A set of steps are attached to the vault caissons to allow entry into the pit; however, the vault cover prevents safe access to the steps. A ladder will need to be inserted into the vaults before the well heads can be reached.

It was observed that the discharge pipes from the vaults to the pond are not equipped with valves. Use of valves would allow the relief wells to be isolated from water in the pond during inspection and maintenance activities. During this inspection, water levels in the vaults were at the same elevation as the pond water level. Thus the vault bottom and outlet pipes are at a low enough elevation to receive backflow from the pond. Some type of temporary valving and pumping equipment probably will

At the south detention pond, RW 13 and RW 19 were inspected. The conditions found were similar to those for the wells at the north pond. Approximately 1.9 feet of water was in the vault bottom of RW 13, and 2.3 feet of water was in RW 19. The vault water levels were at the same elevation as the pond (406.58 feet). Both well heads were submerged, but the top was visible at RW 13. From ground level there was no apparent sign of biological activity or other operational problems in either vault.
