# Remodeling and Expanding Carnegie-Era Library Buildings

FRED SCHLIPF

One of the most satisfying undertakings in library building design can be the expansion and remodeling of historic public libraries from the early twentieth century. However, although the logic of preservation and conservation leads to strong public interest in the reuse of existing structures, the costs can be extremely high and the results can be functionally disappointing. Among the major problems frequently faced are modern building codes, load-bearing walls, the difficulty of installing modern HVAC systems, flimsy original construction materials, locations that no longer meet community needs, poor electrical wiring, elderly windows, historic brickwork that is difficult to match, inadequate sites, total inaccessibility for users with disabilities, bad modern lighting, and basements with low ceilings. However, many of these problems can be solved—or at least dealt with—with careful programming and planning, and expansion projects can result in handsome libraries that can serve for a second century.

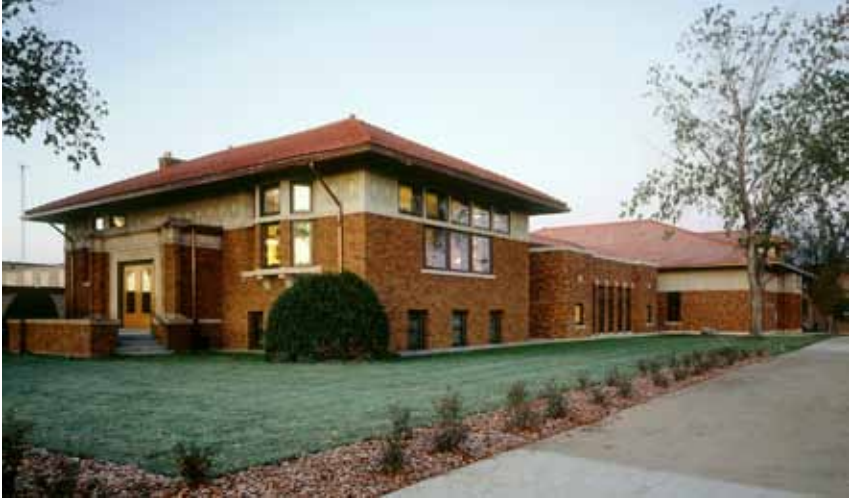
Figure 1. The Detroit Lakes, Minnesota, Public Library is one of a several libraries built using the same plans. It was expanded by MS&R (Meyer Scherer & Rockcastle), architects, Minneapolis, who designed an addition at grade level, making it possible for users to enter the building without using stairs or an elevator and improving exit control. Photograph by Lea Babcock Scherer courtesy of MS&R.

While most additions to Carnegie-era libraries match the floors of the original buildings, another approach is to build a grade-level addition adjacent to the library, with a new grade-level entrance in the new addition. This arrangement makes it possible to have a single service desk that controls all accessible access to the building. The resulting split-level structure may have open stairs leading from the new addition to the historic first floor (and to the basement, if codes permit), greatly reducing the isolation of these older floors in the expanded building (figs. 1 & 2).

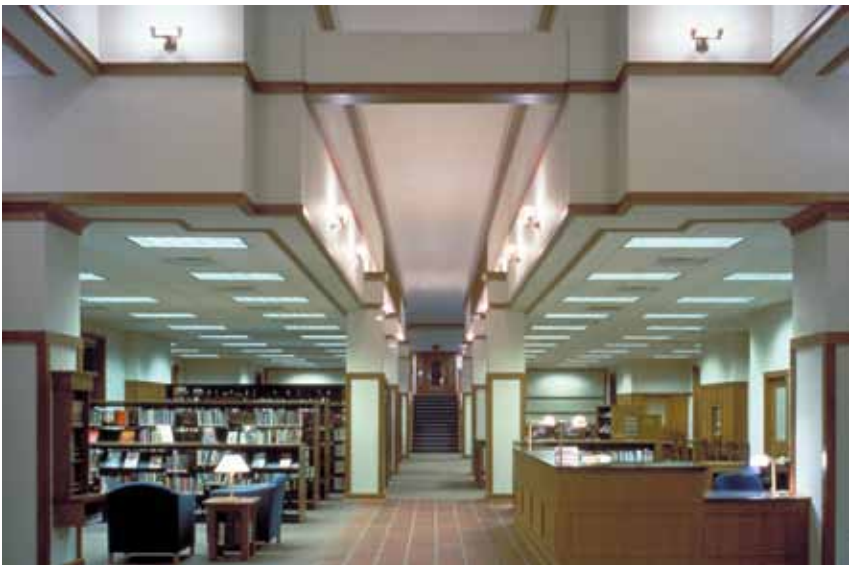
Figure 2. A view of the interior of the new addition to the Detroit lakes Public Library. Steps up to the original first floor are visible at the rear. The elevator and the steps to the basement cannot be seen from this angle. Photograph by Lea Babcock Scherer courtesy of MS&R.

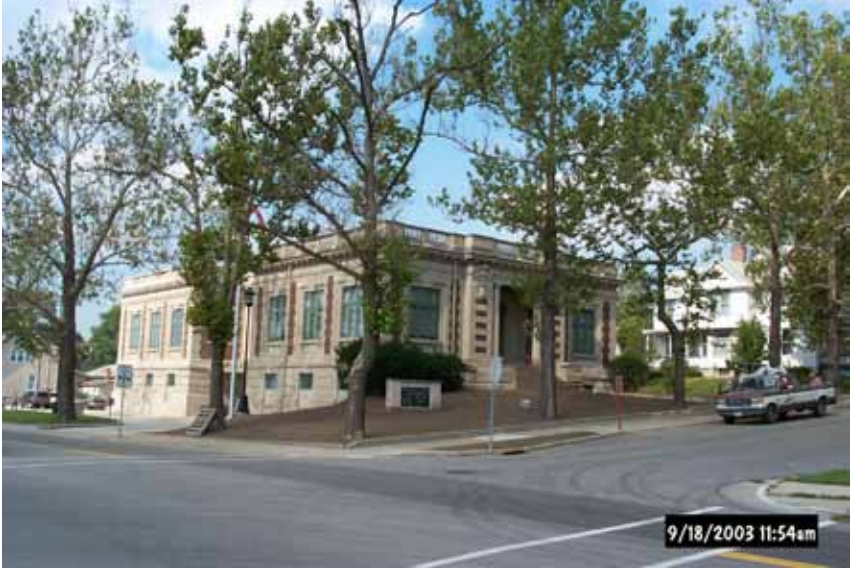
Figure 3. The LaSalle, Illinois, Public Library was located on a sloping site that allowed a new two-story addition to have a grade level entry to the basement. Photograph courtesy of apaceDesign, architects and engineers, Peoria.

The same single grade-level entrance can sometimes be created with a two-story addition if the site slopes, making it possible for users approaching the library from another side of the building to walk directly into the basement or first floor (fig. 3).

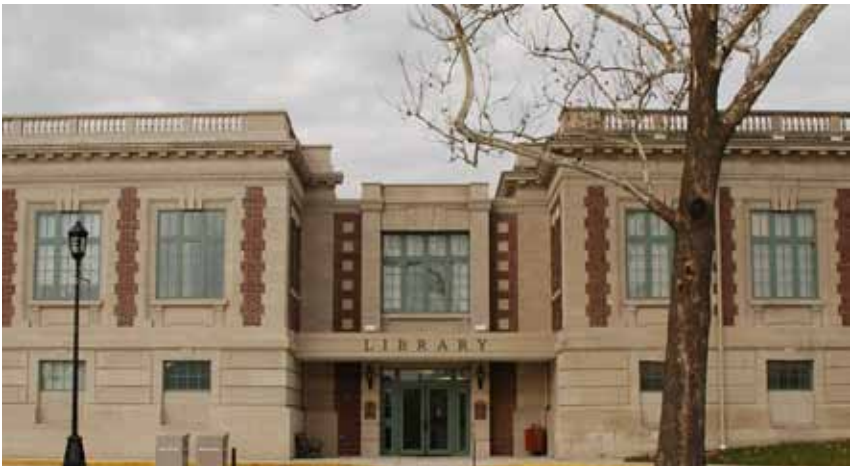
Figure 4. The brickwork of the new wing of the expanded LaSalle Public Library closely matches the building's original brickwork, but any difference is made less noticeable by separating the two areas of brickwork by the new, accessible entrance. The original building is on the right. Photograph courtesy of apaceDesign, architects and engineers, Peoria.

Matching exterior brickwork is a special problem, since many types of brick used a century ago are not easily available. For example, the slender Roman bricks with thin horizontal mortar joints that are sometimes found in late nineteenth and early twentieth century buildings are particularly hard to match. Taking the time to thoroughly investigate brick sources is important, and the rush to select brick quickly may lead to gross mismatching that grates on the eyes forever. One standard approach to satisfactory expansions of historic buildings is to never place new and old bricks directly adjacent to each other. If a new architectural element perhaps 10 to 20 feet wide separates the two areas of brick, it is much harder to tell that the two types of brick do not match (Fig. 4).

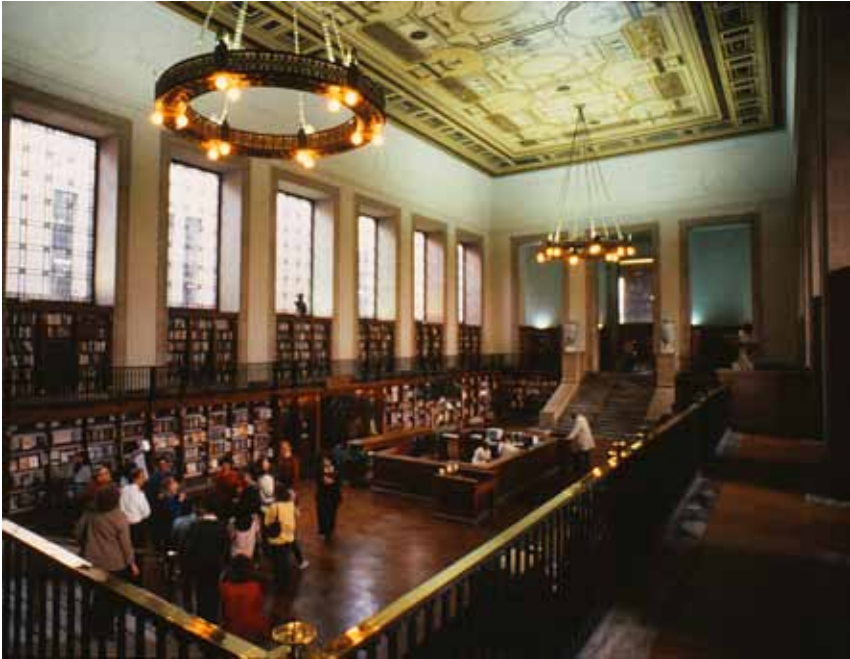
Figure 5. The Indianapolis and Marion County Public Library. The room's chandeliers combine intense uplighting with decorative visible light bulbs. Photograph by Fred Schlipf.
