CIVIL ENGINEERING STUDIES
Structural Research Series No. 581

SEISMIC RESPONSE OF TILT-UP CONSTRUCTION

James W. Carter III
Neil M. Hawkins
and
Sharon L. Wood

December 1993

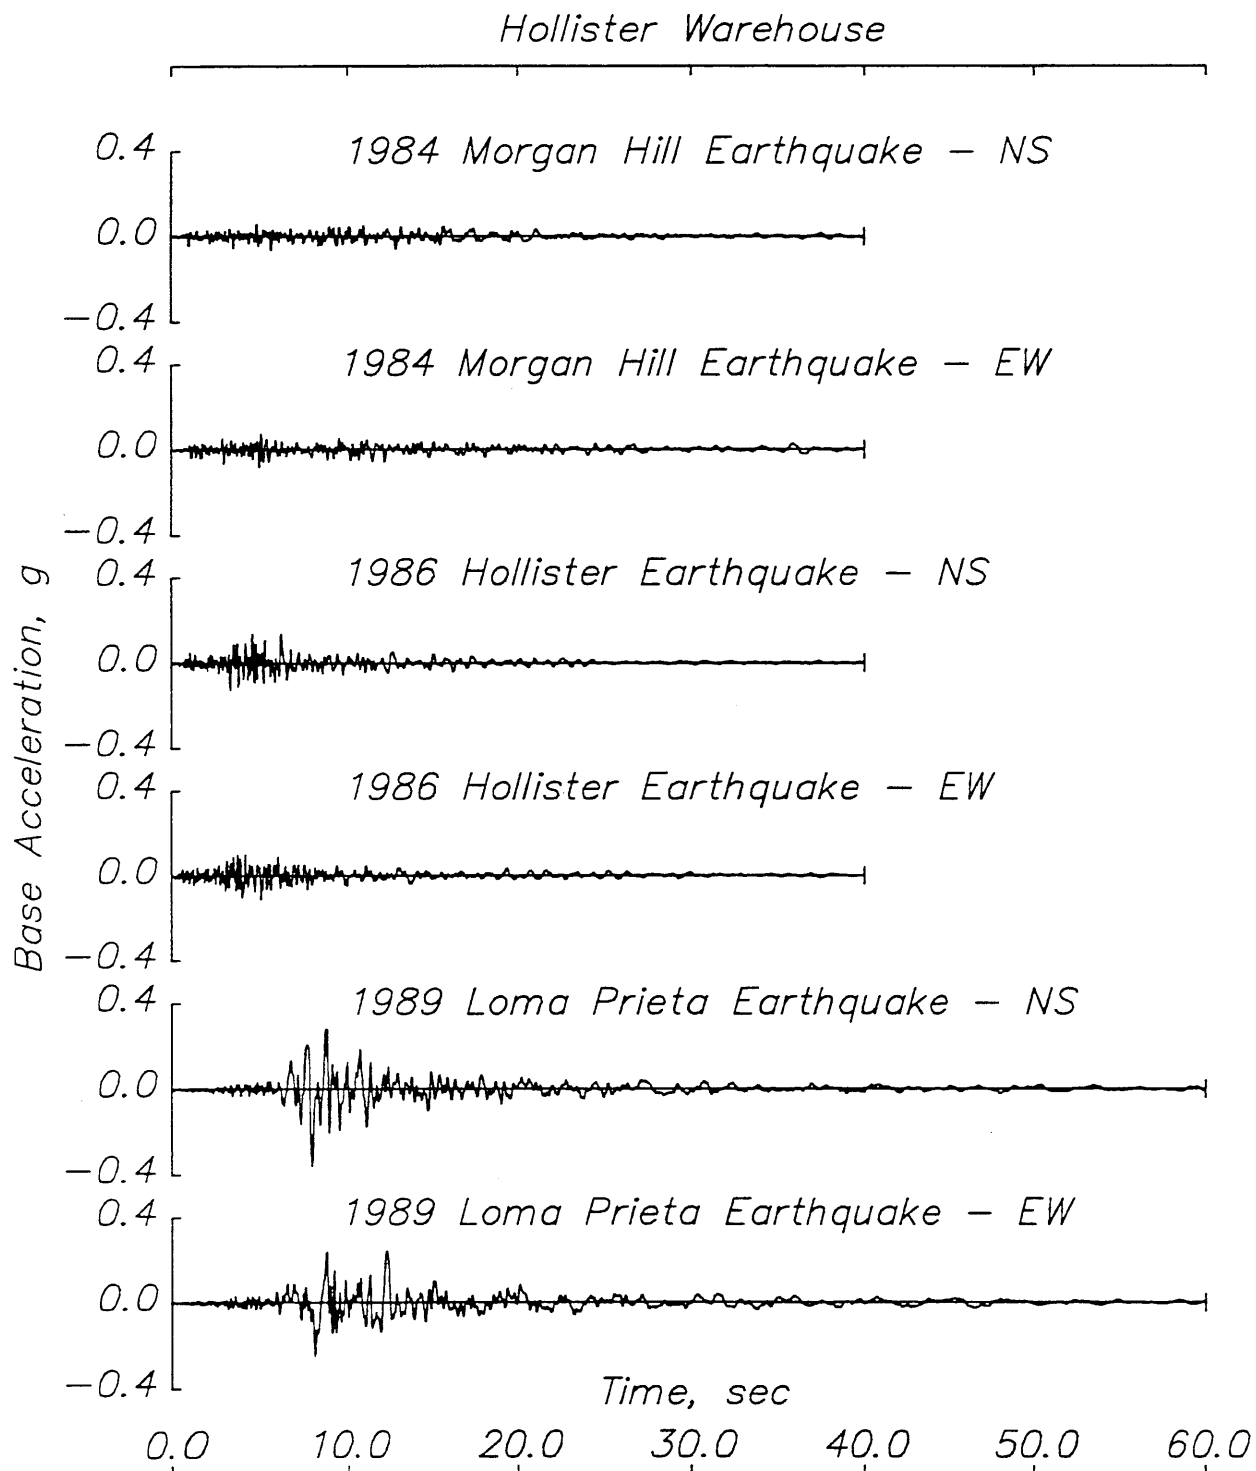
Fig. 5.7 Measured ground accelerations – Hollister warehouse.

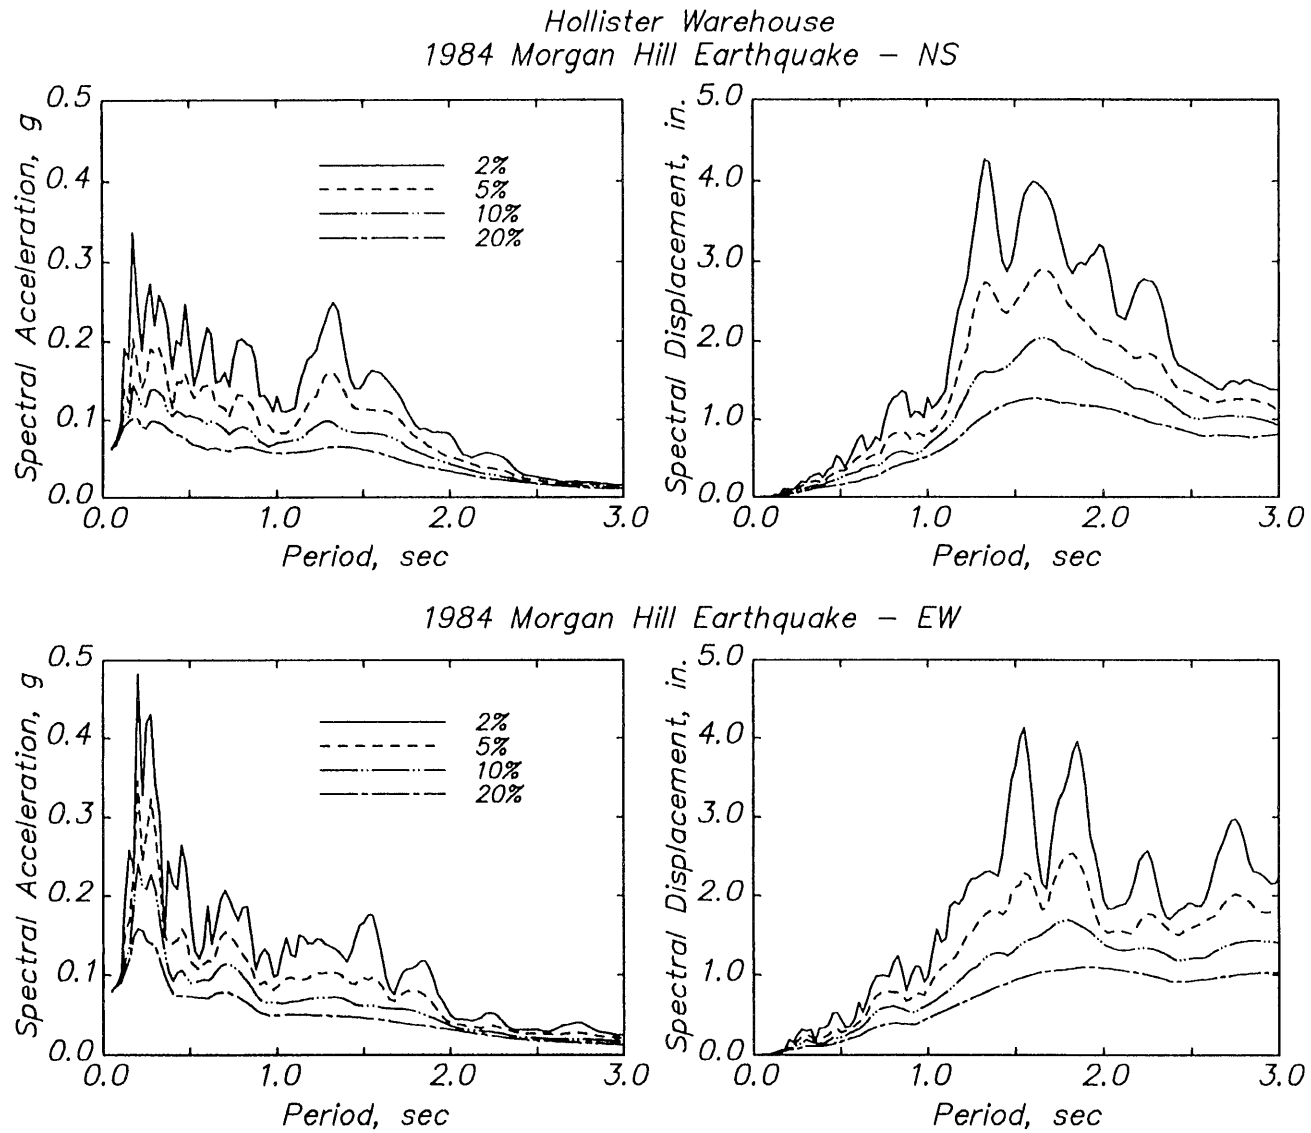
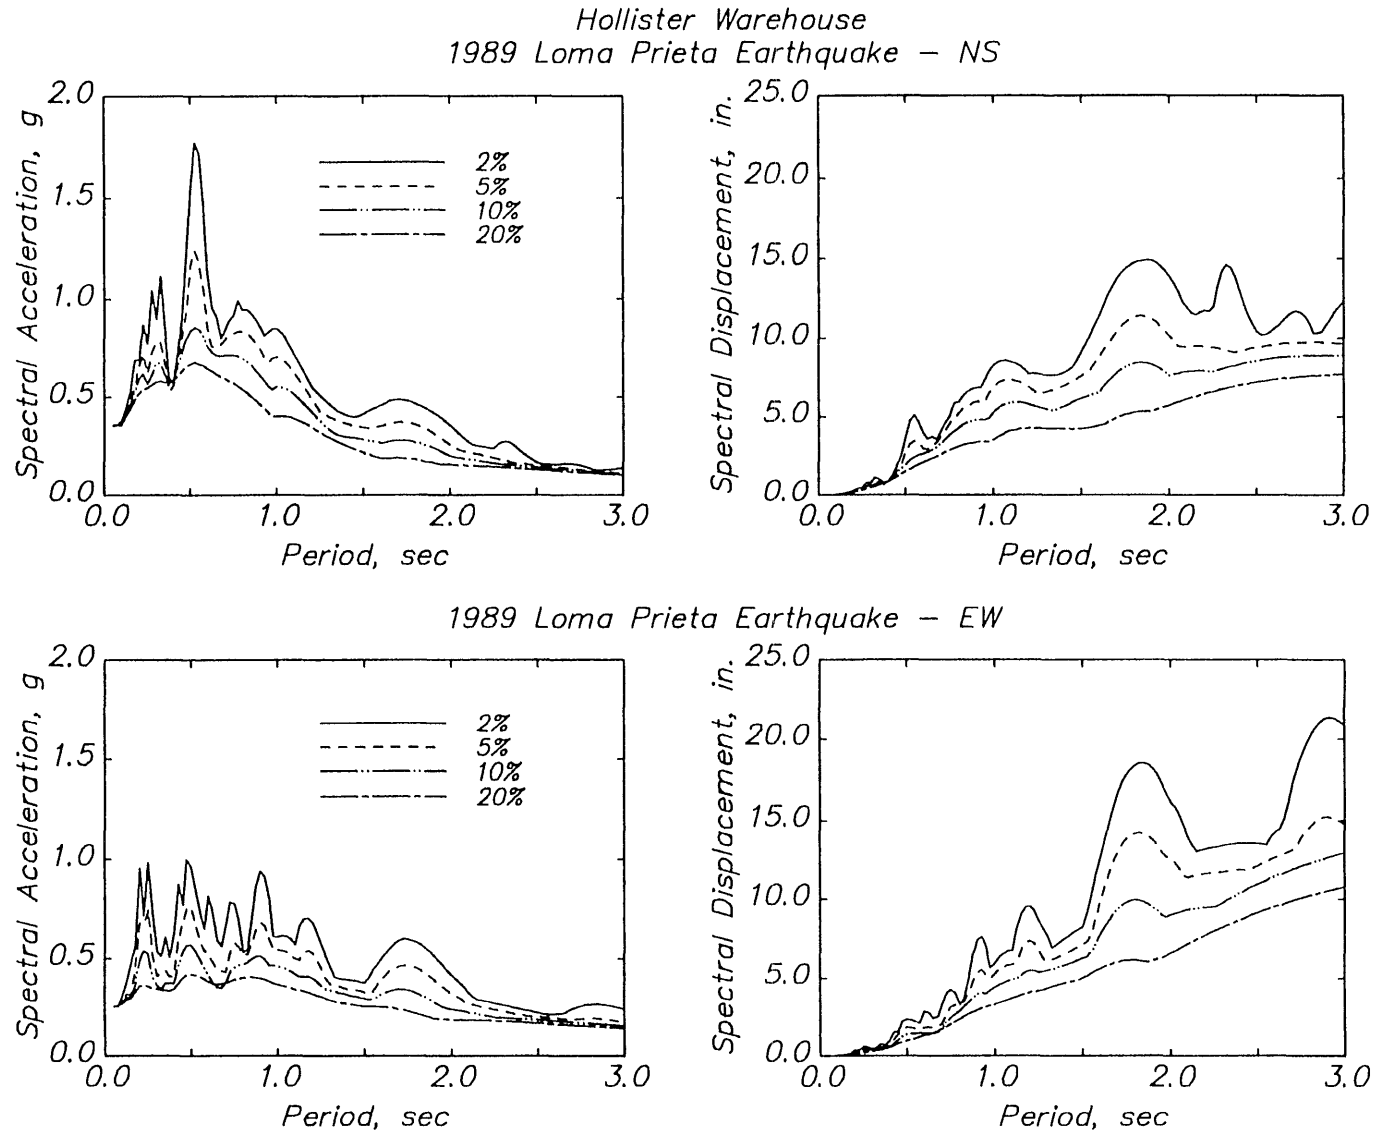
Fig. 5.8 Linear response spectra – Hollister warehouse.

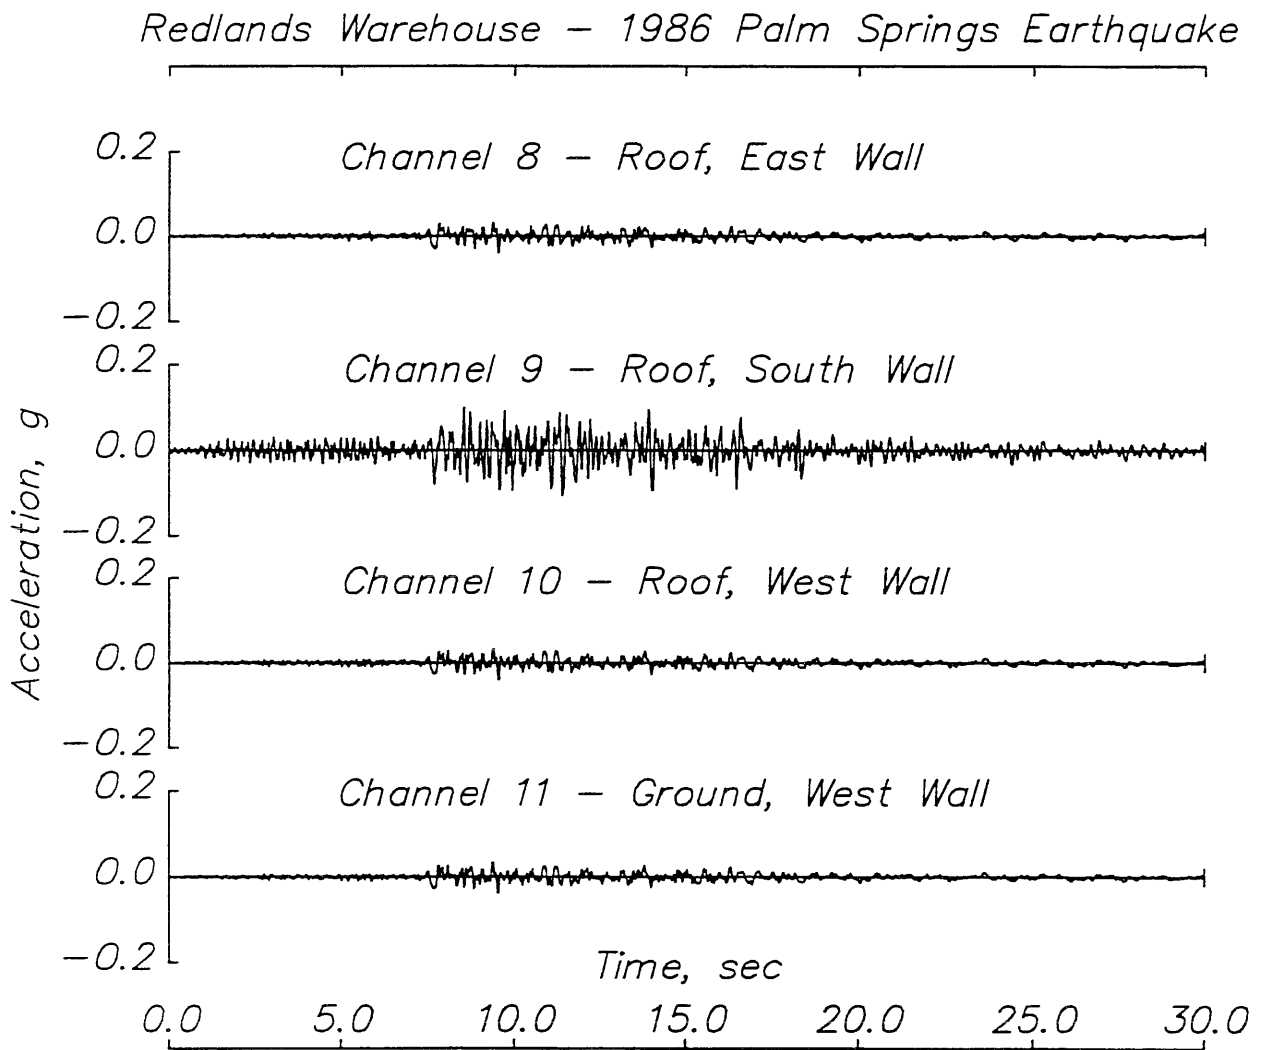
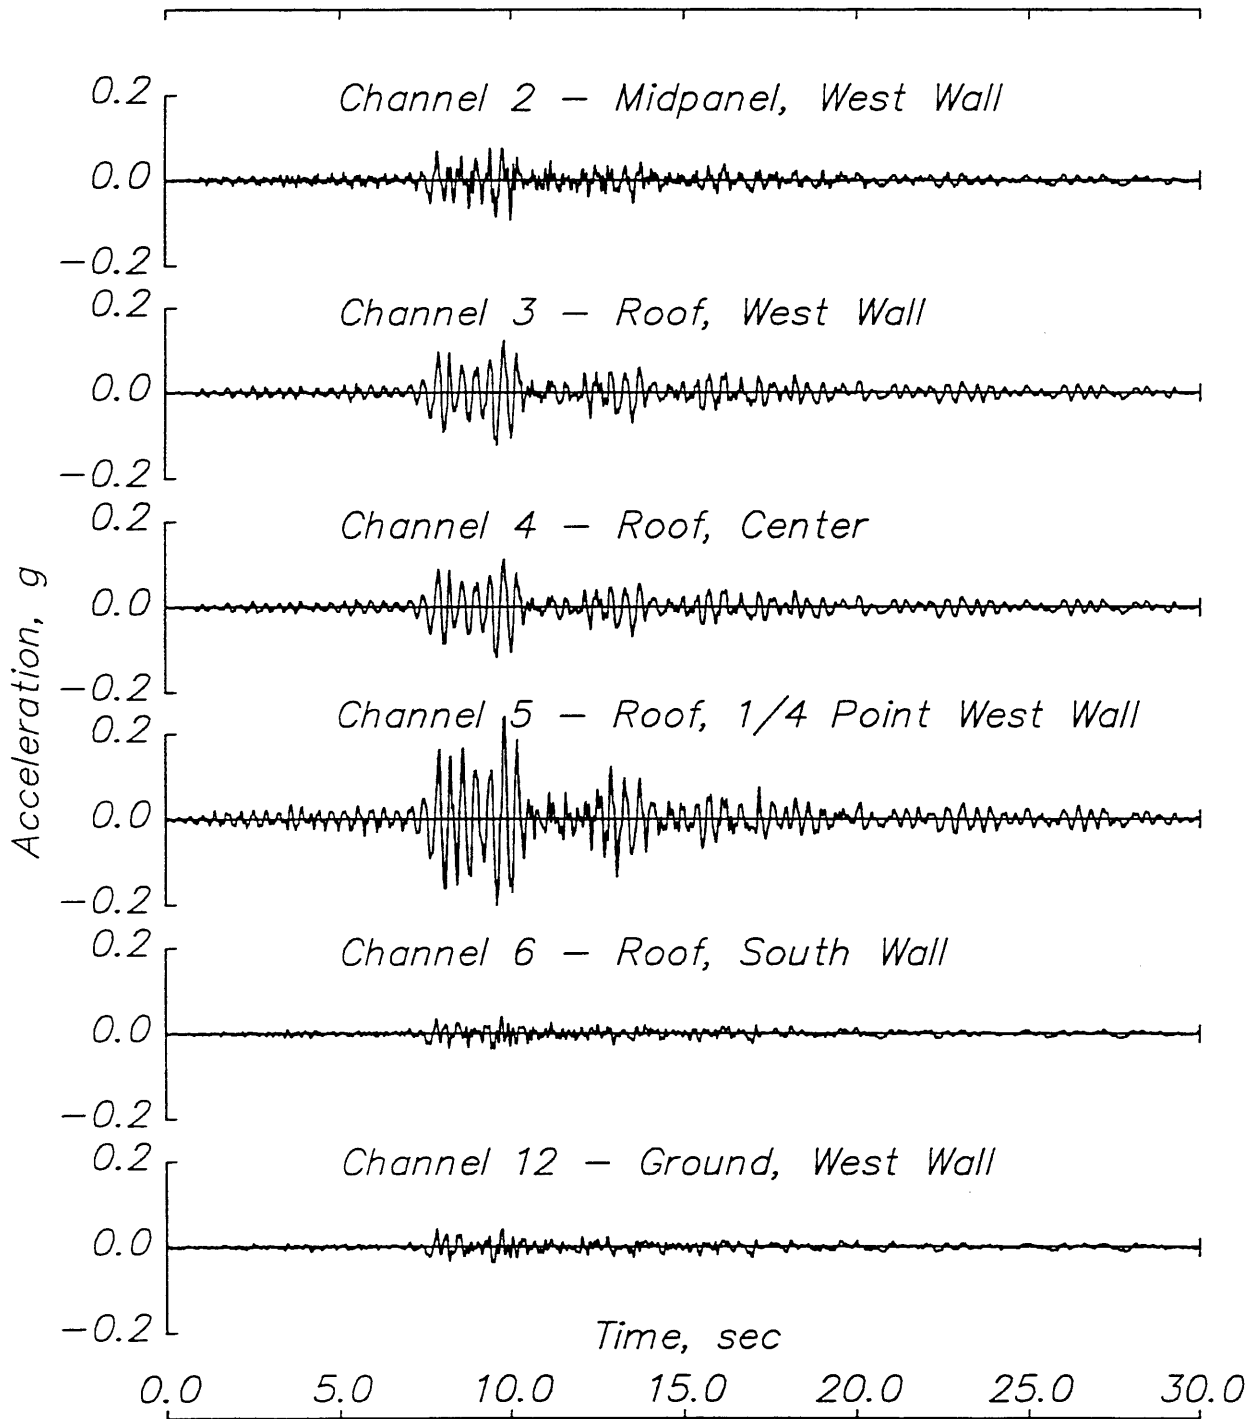
Fig. 5.26 Redlands warehouse – 1986 Palm Springs earthquake.
 (b) Longitudinal acceleration response.

Fig. 5.26 Redlands warehouse – 1986 Palm Springs earthquake.
(a) Transverse acceleration response.

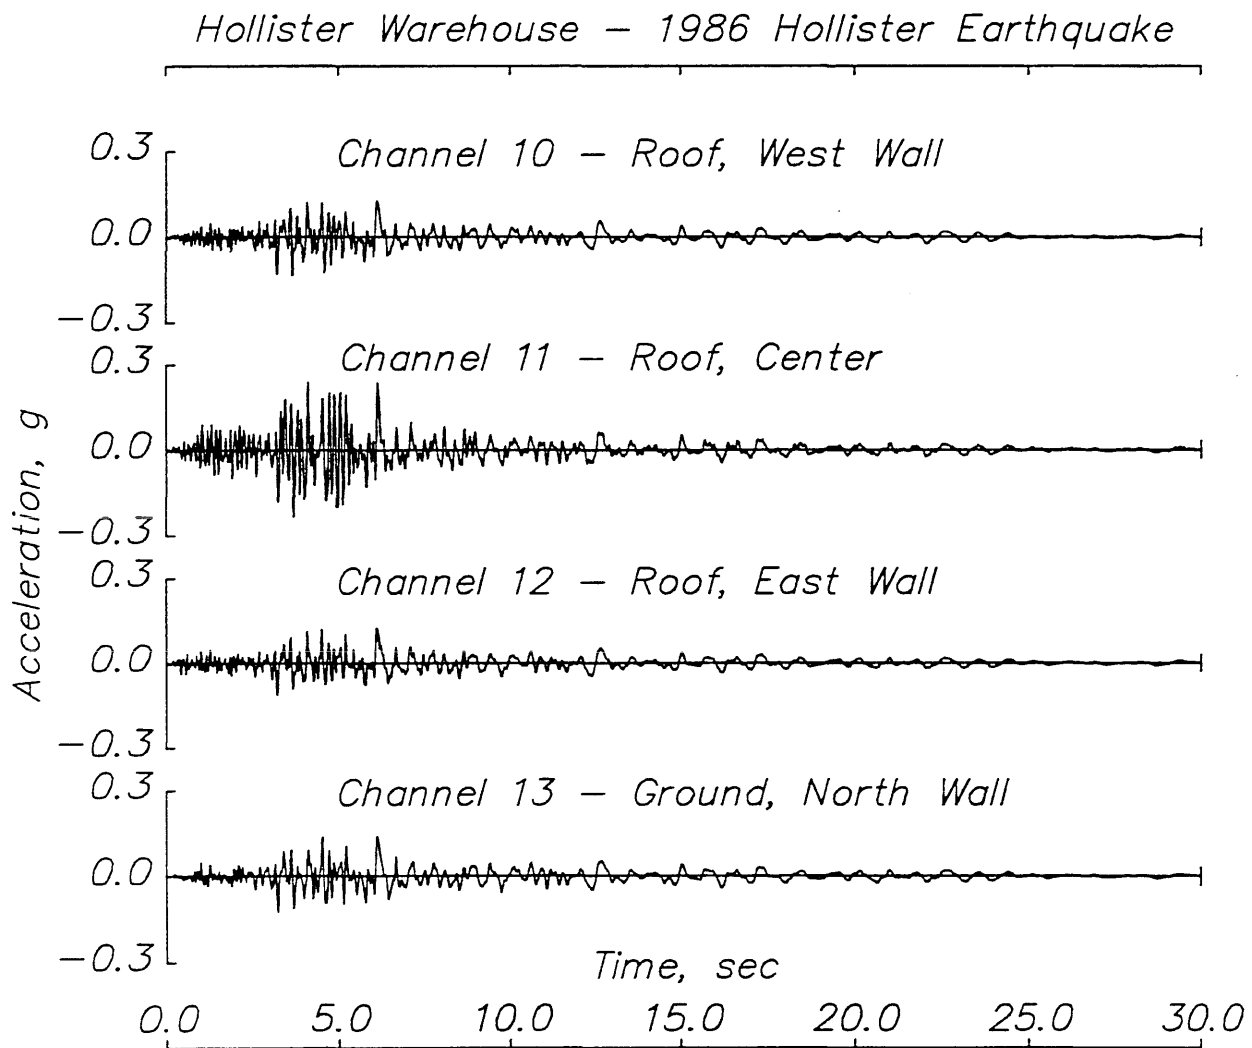
Fig. 5.10 Hollister warehouse – 1986 Hollister earthquake.

(a) Transverse acceleration response.

Fig. 5.10 (cont.) Hollister warehouse – 1986 Hollister earthquake.
 (b) Longitudinal acceleration response.

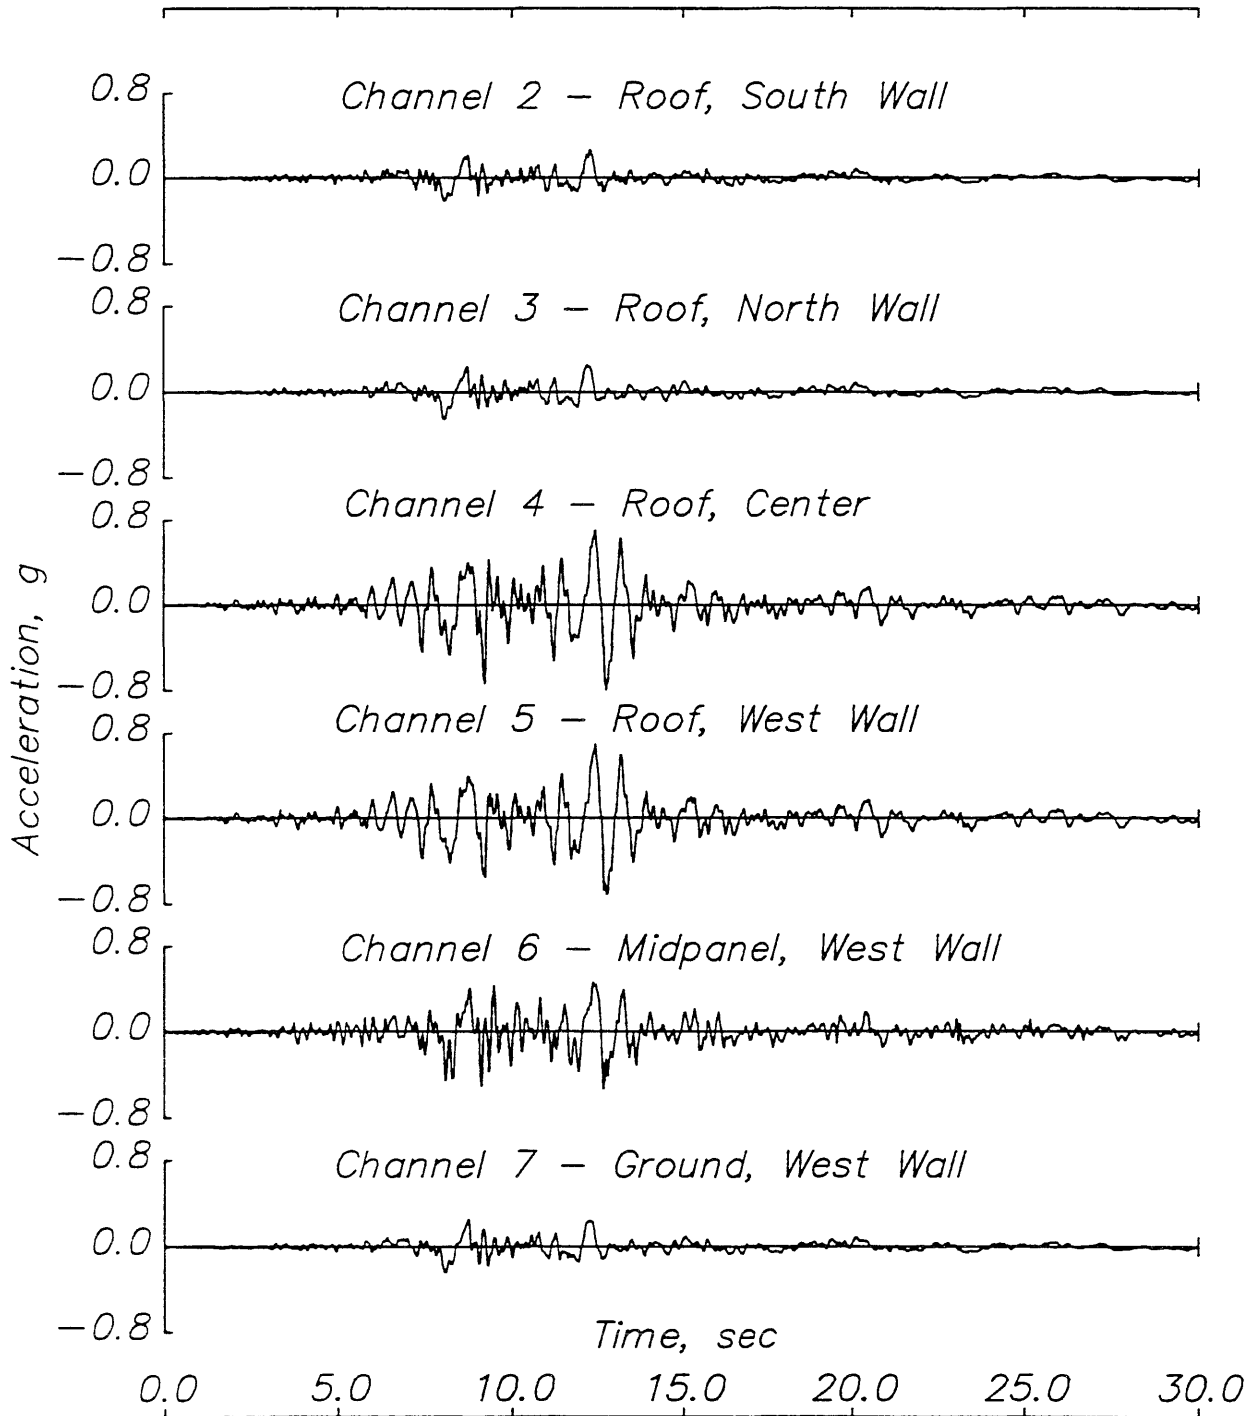
Fig. 5.11 Hollister warehouse – 1989 Loma Prieta earthquake.

(a) Transverse acceleration response.

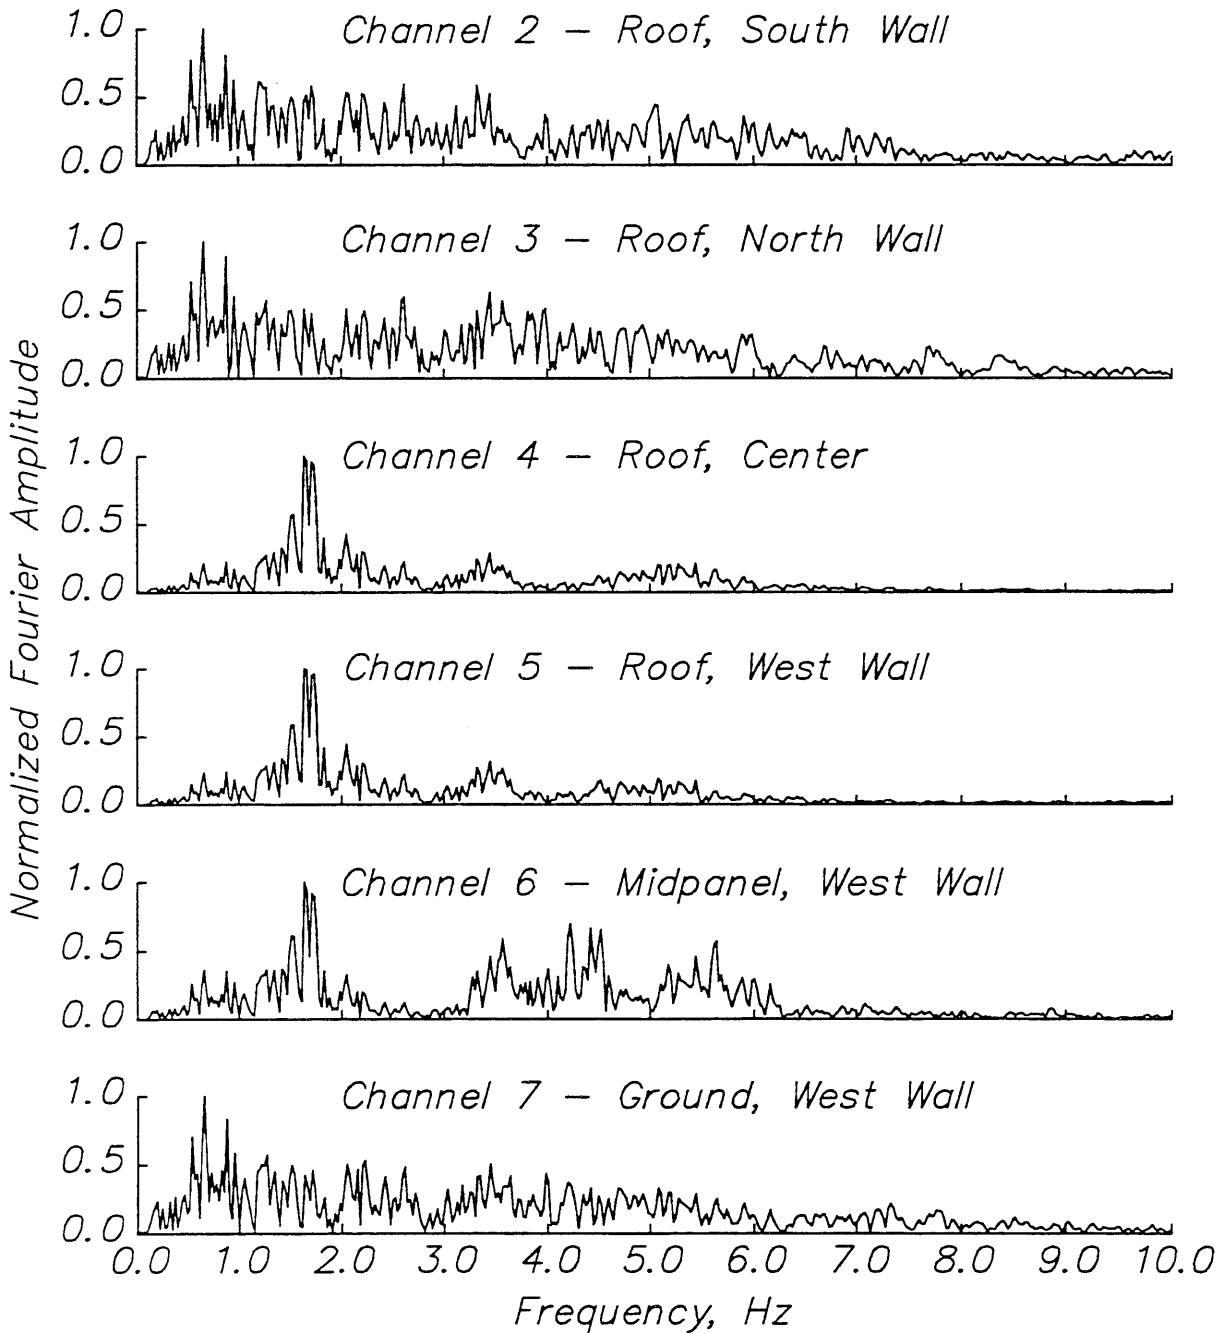
Fig. 5.12 Hollister warehouse – 1984 Morgan Hill earthquake.

(a) Normalized Fourier amplitude spectra of transverse acceleration response.

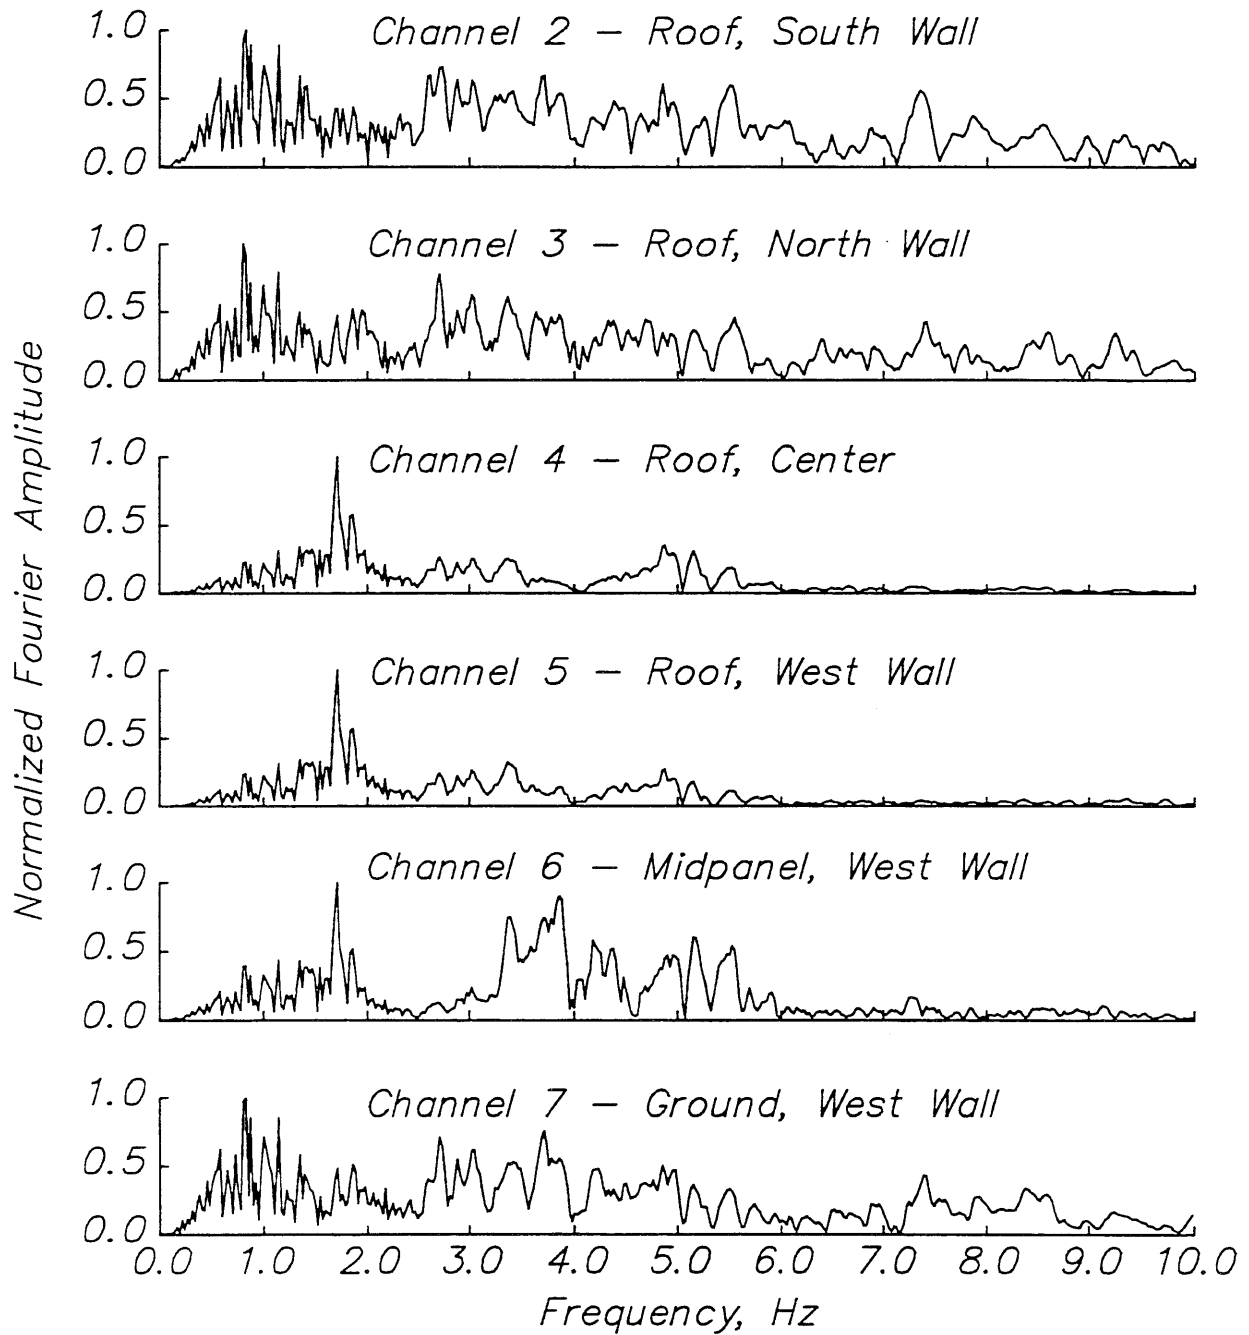
Fig. 5.13 Hollister warehouse – 1986 Hollister earthquake.

(a) Normalized Fourier amplitude spectra of transverse acceleration response.

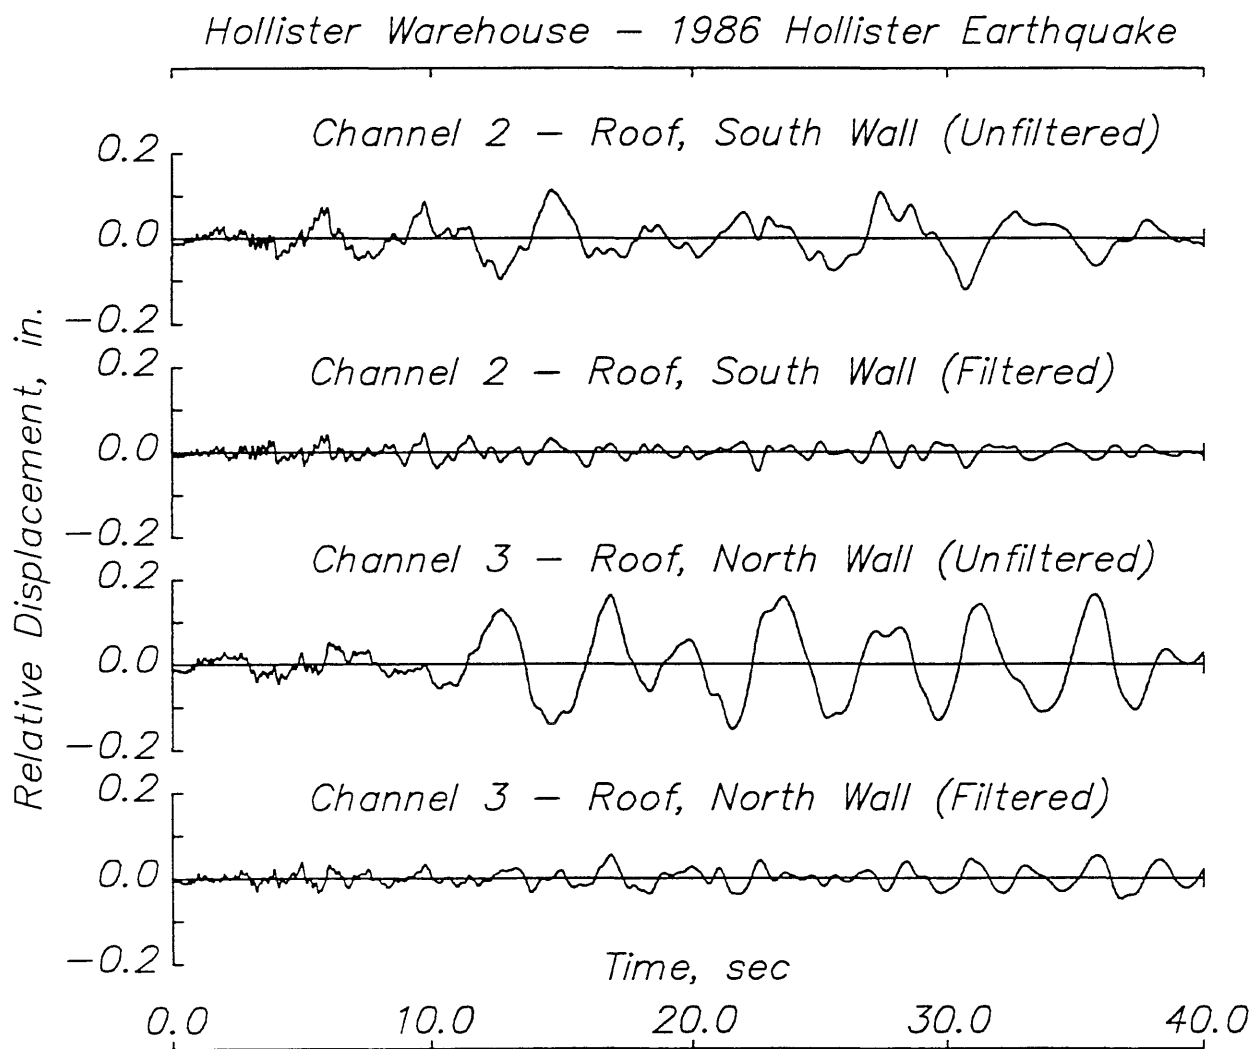
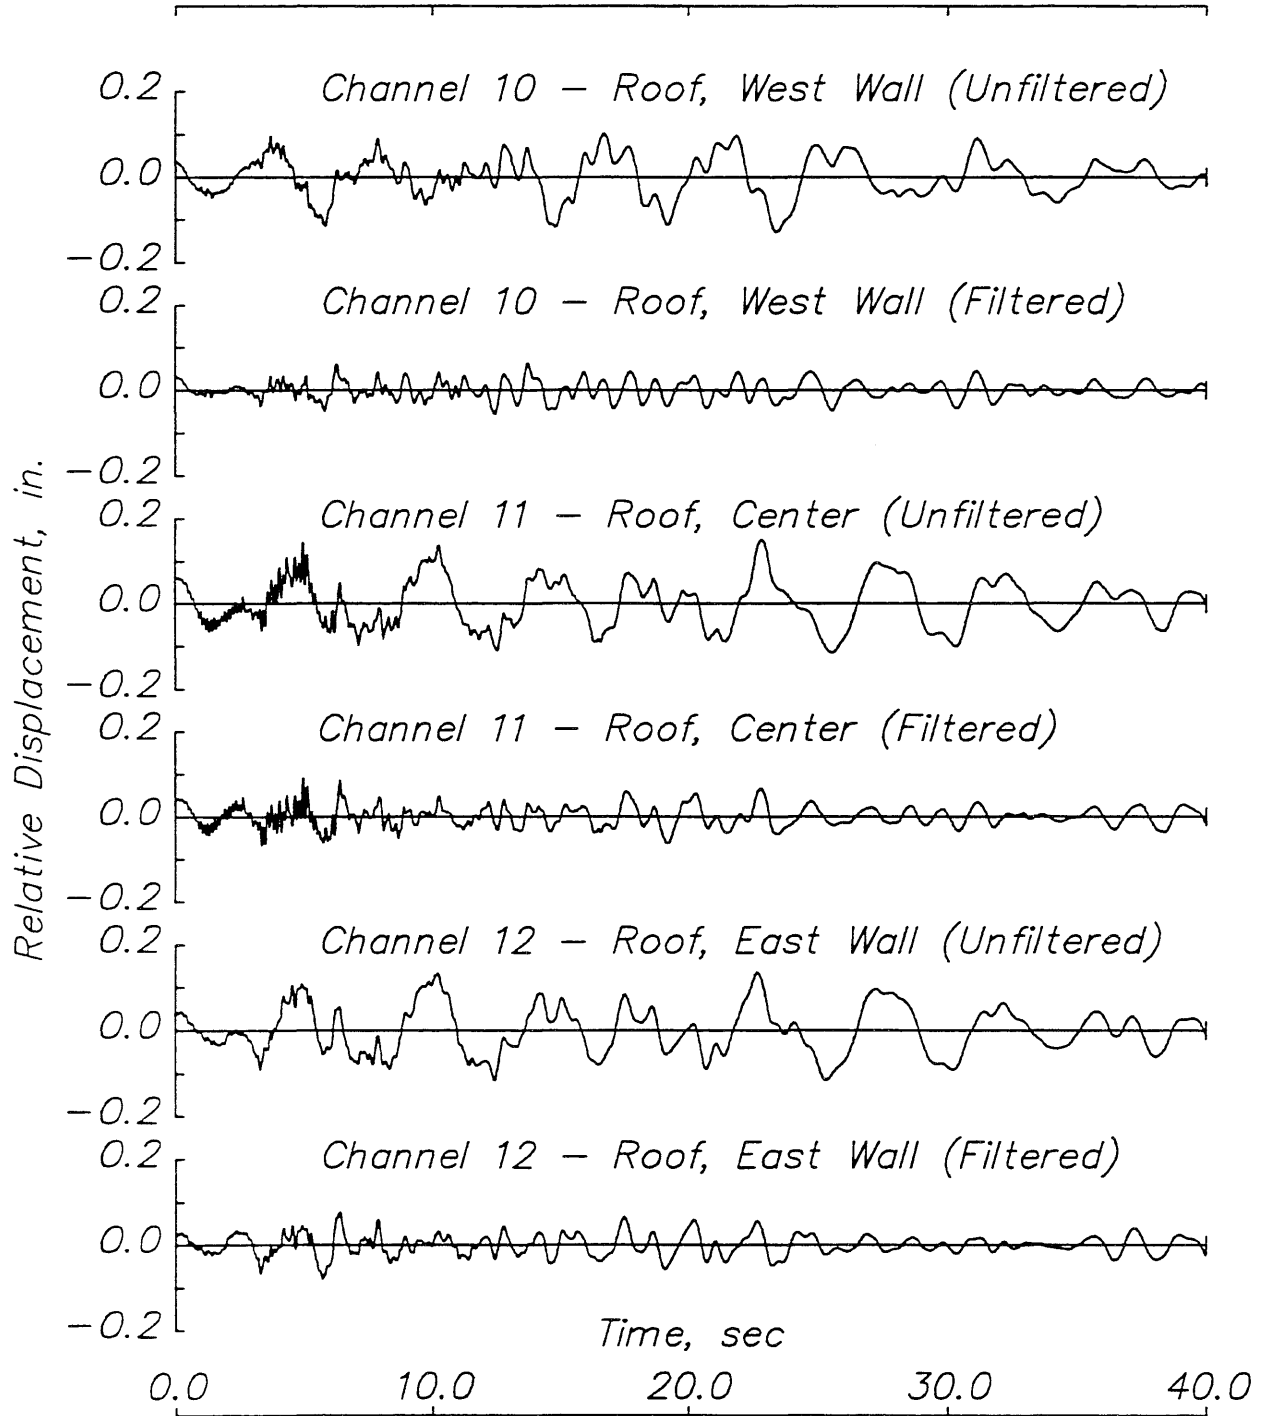
Fig. 5.17 Hollister warehouse – 1986 Hollister earthquake.

(a) Transverse relative displacement response.

Fig. 5.17 (cont.) Hollister warehouse – 1986 Hollister earthquake.
(b) Longitudinal relative displacement response.

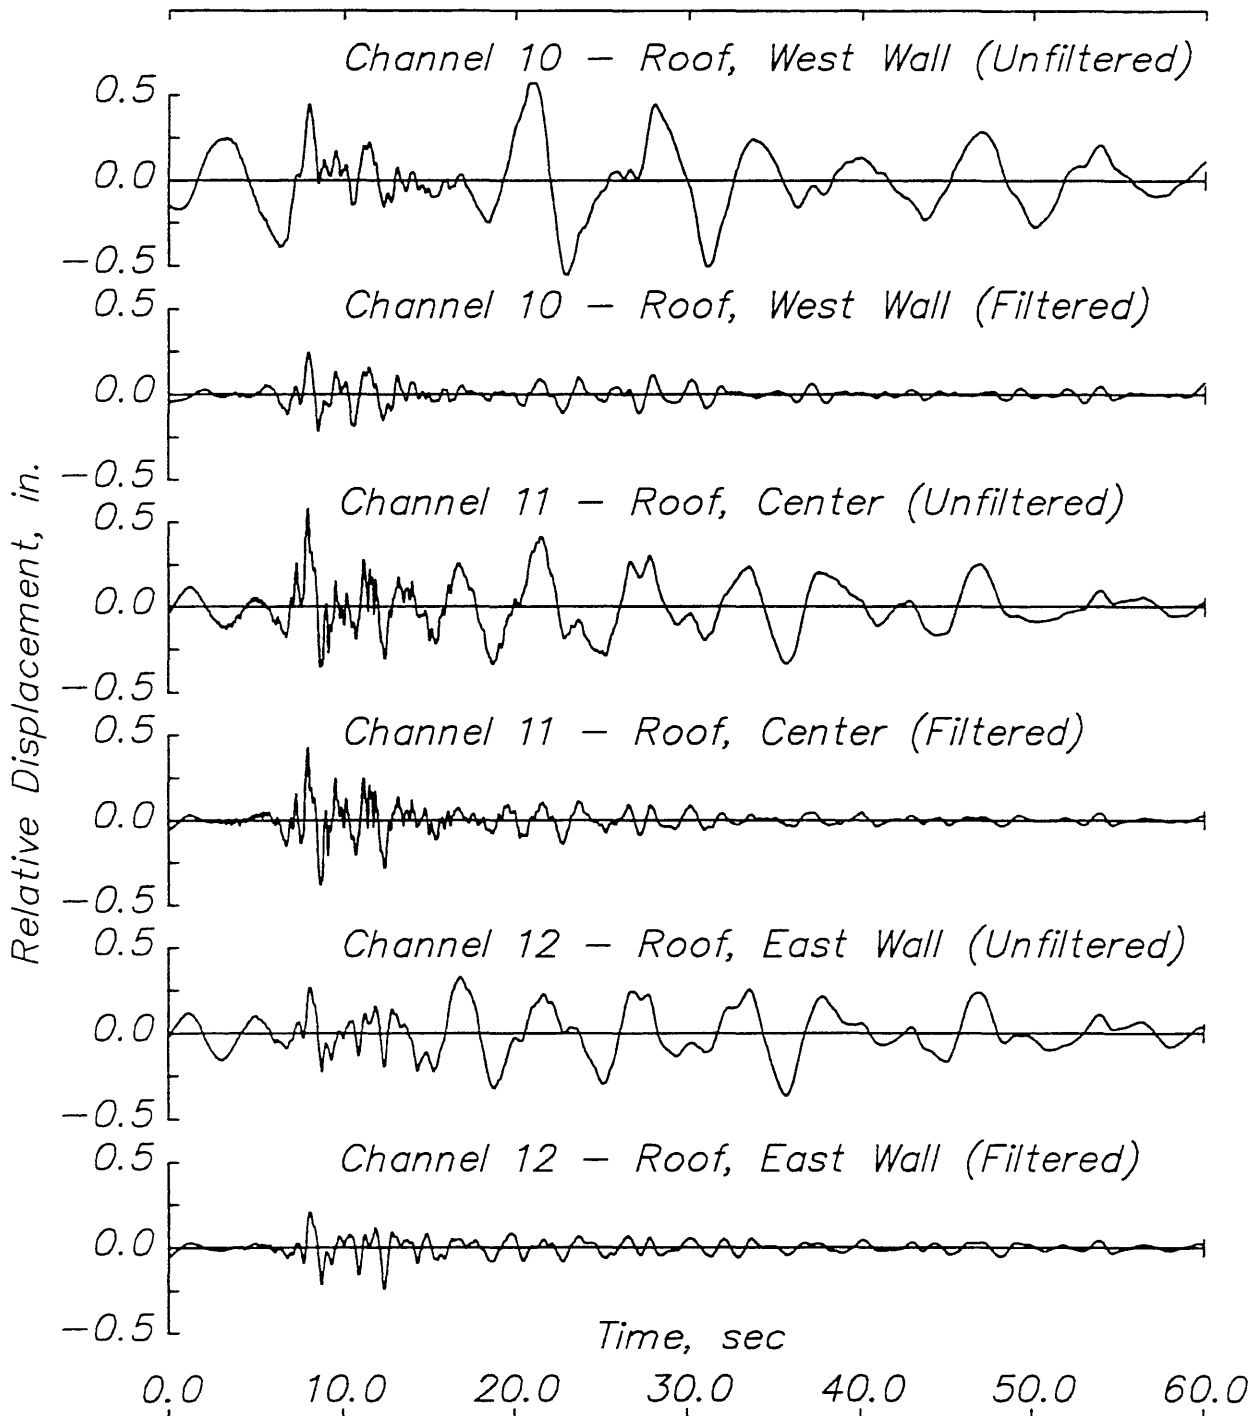
Fig. 5.18 Hollister warehouse – 1989 Loma Prieta earthquake.

(a) Transverse relative displacement response.

Fig. 5.18 (cont.) Hollister warehouse – 1989 Loma Prieta earthquake.
(b) Longitudinal relative displacement response.
