CIVIL ENGINEERING STUDIES
Structural Research Series No. 581

SEISMIC RESPONSE OF TILT-UP CONSTRUCTION

James W. Carter III
Neil M. Hawkins
and
Sharon L. Wood

December 1993

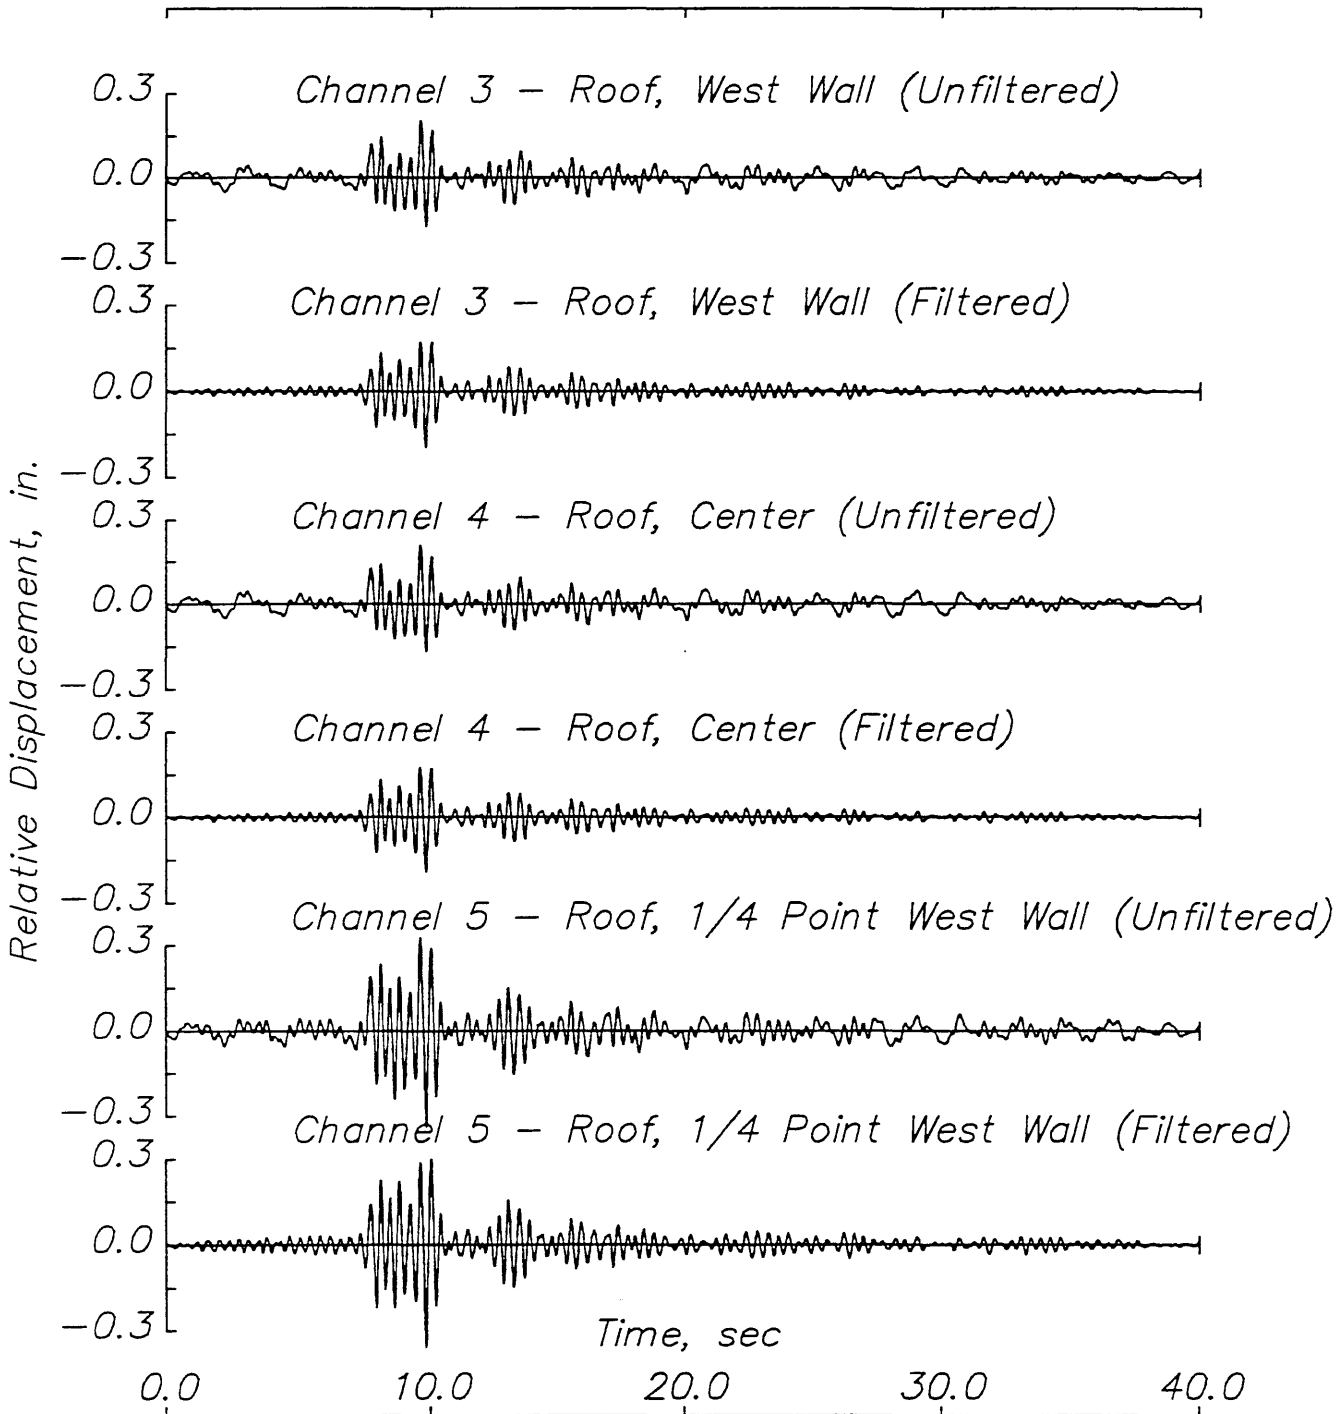
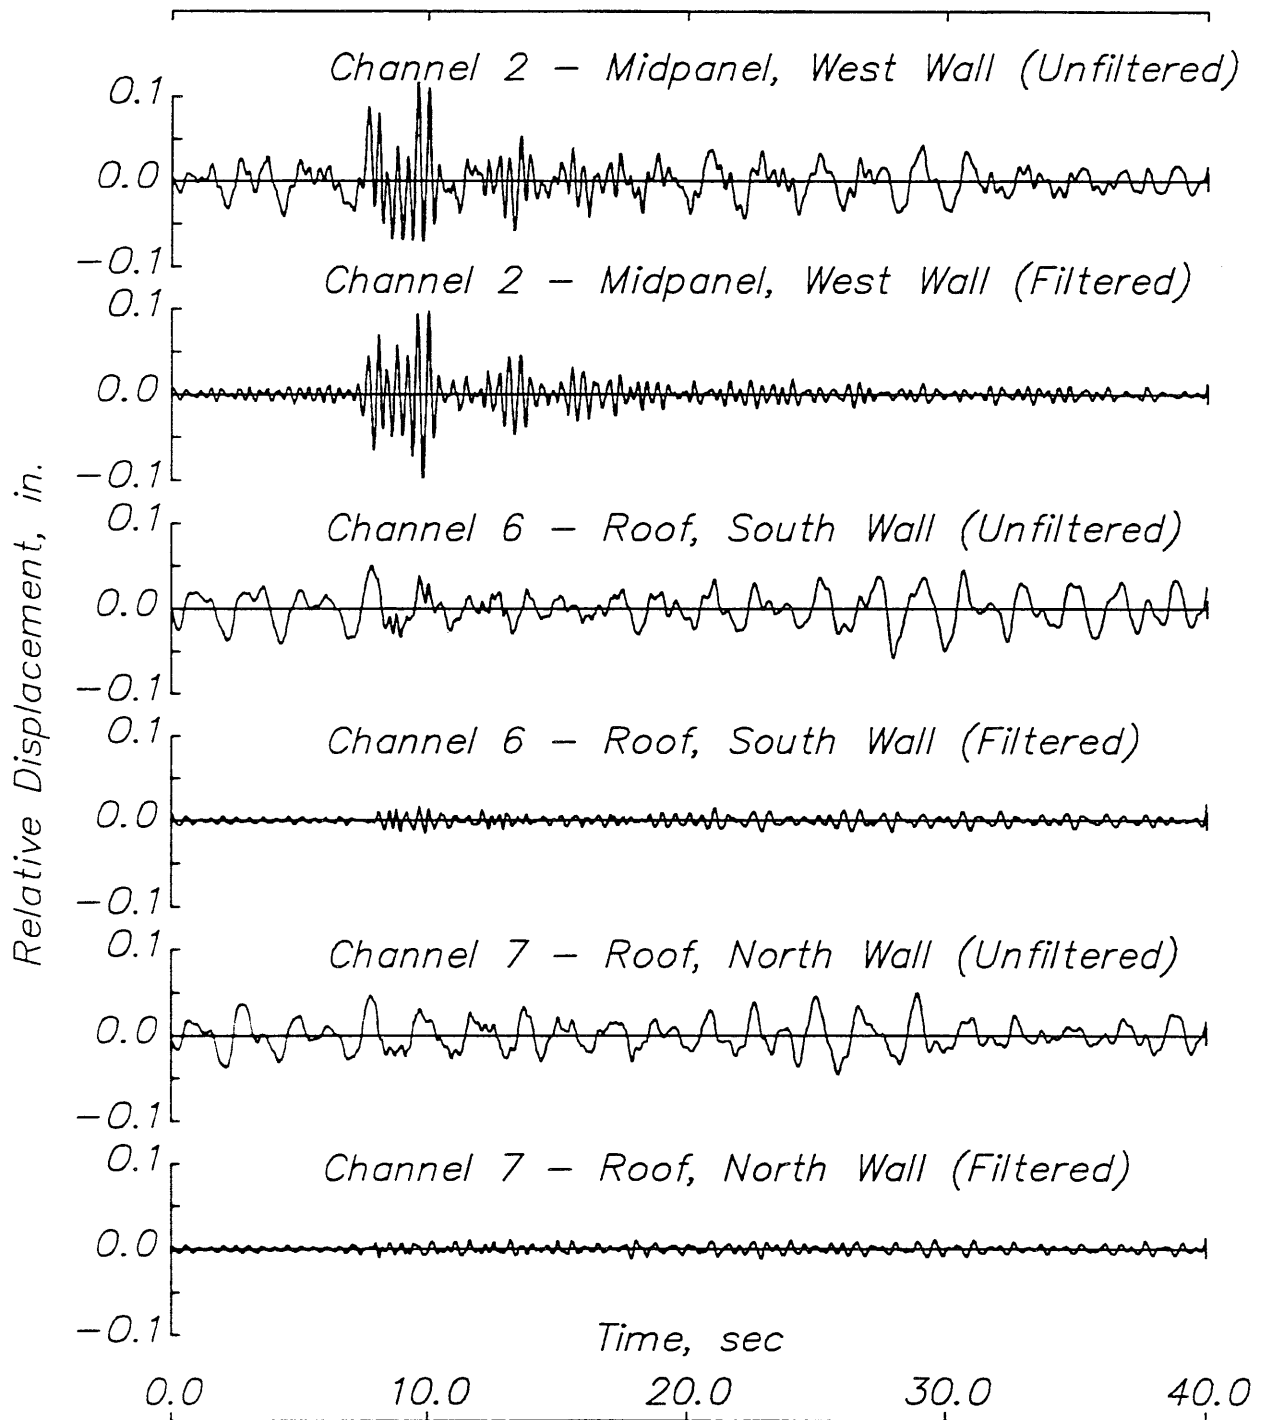
Fig. 5.31 Redlands warehouse – 1986 Palm Springs earthquake.

(a) Transverse relative displacement response.

Fig. 5.31 (cont.) Redlands warehouse – 1986 Palm Springs earthquake.
(b) Longitudinal relative displacement response.

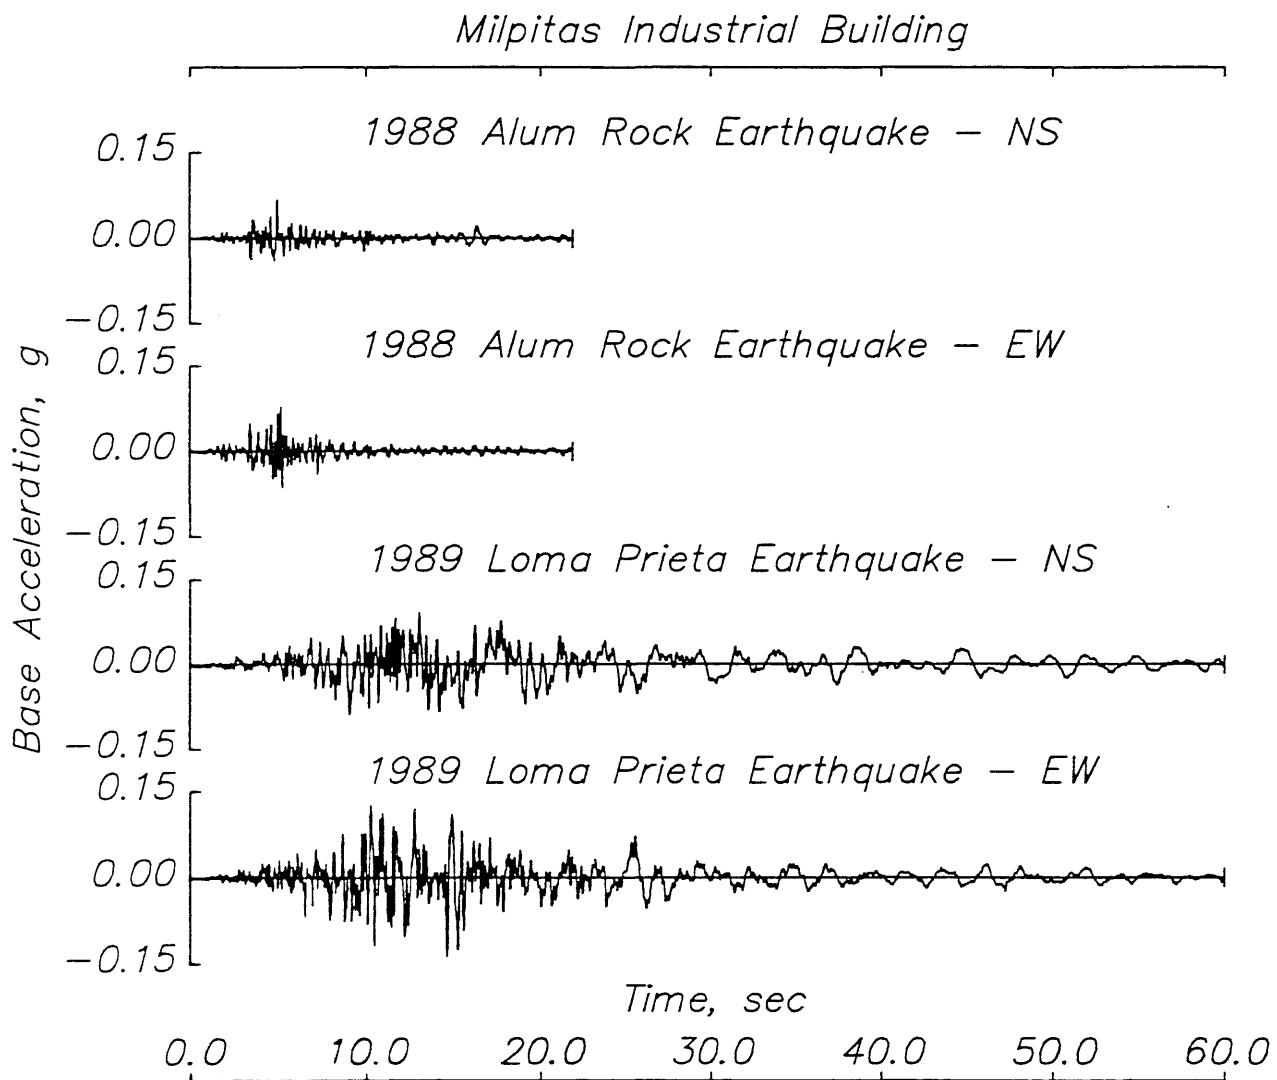
Fig. 5.36 Measured ground accelerations – Milpitas industrial building.

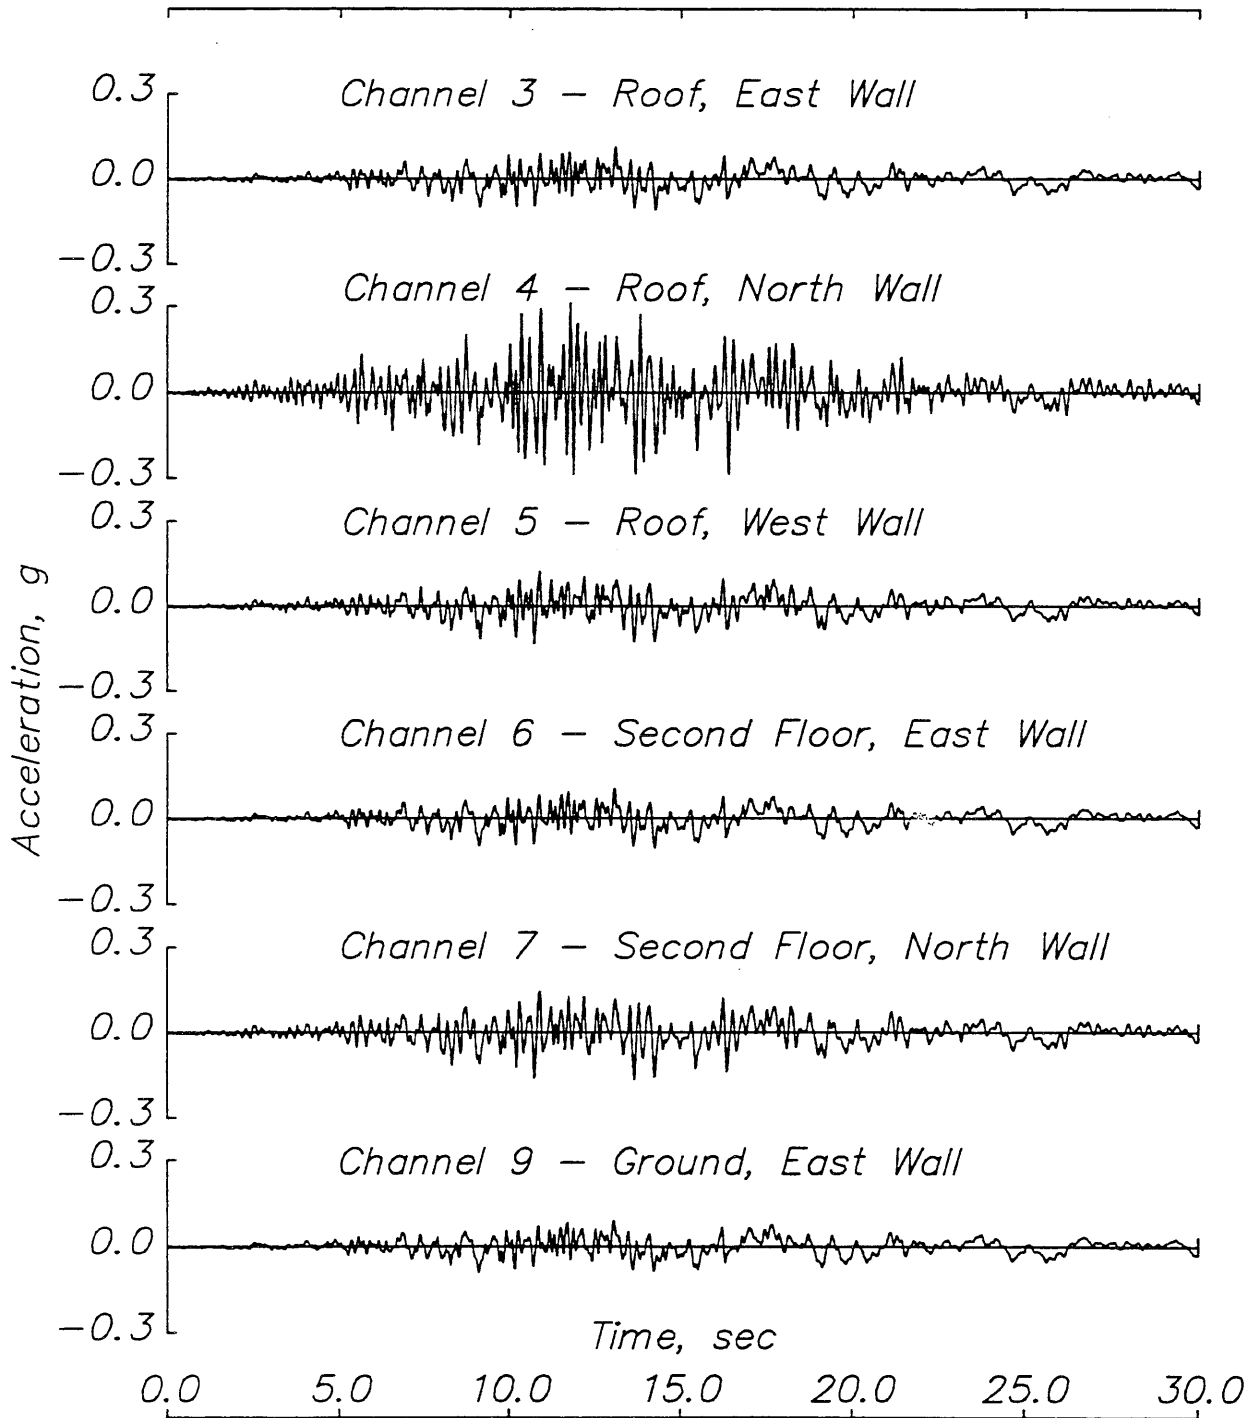
Fig. 5.39 Milpitas industrial building – 1989 Loma Prieta earthquake.
(a) Transverse acceleration response.

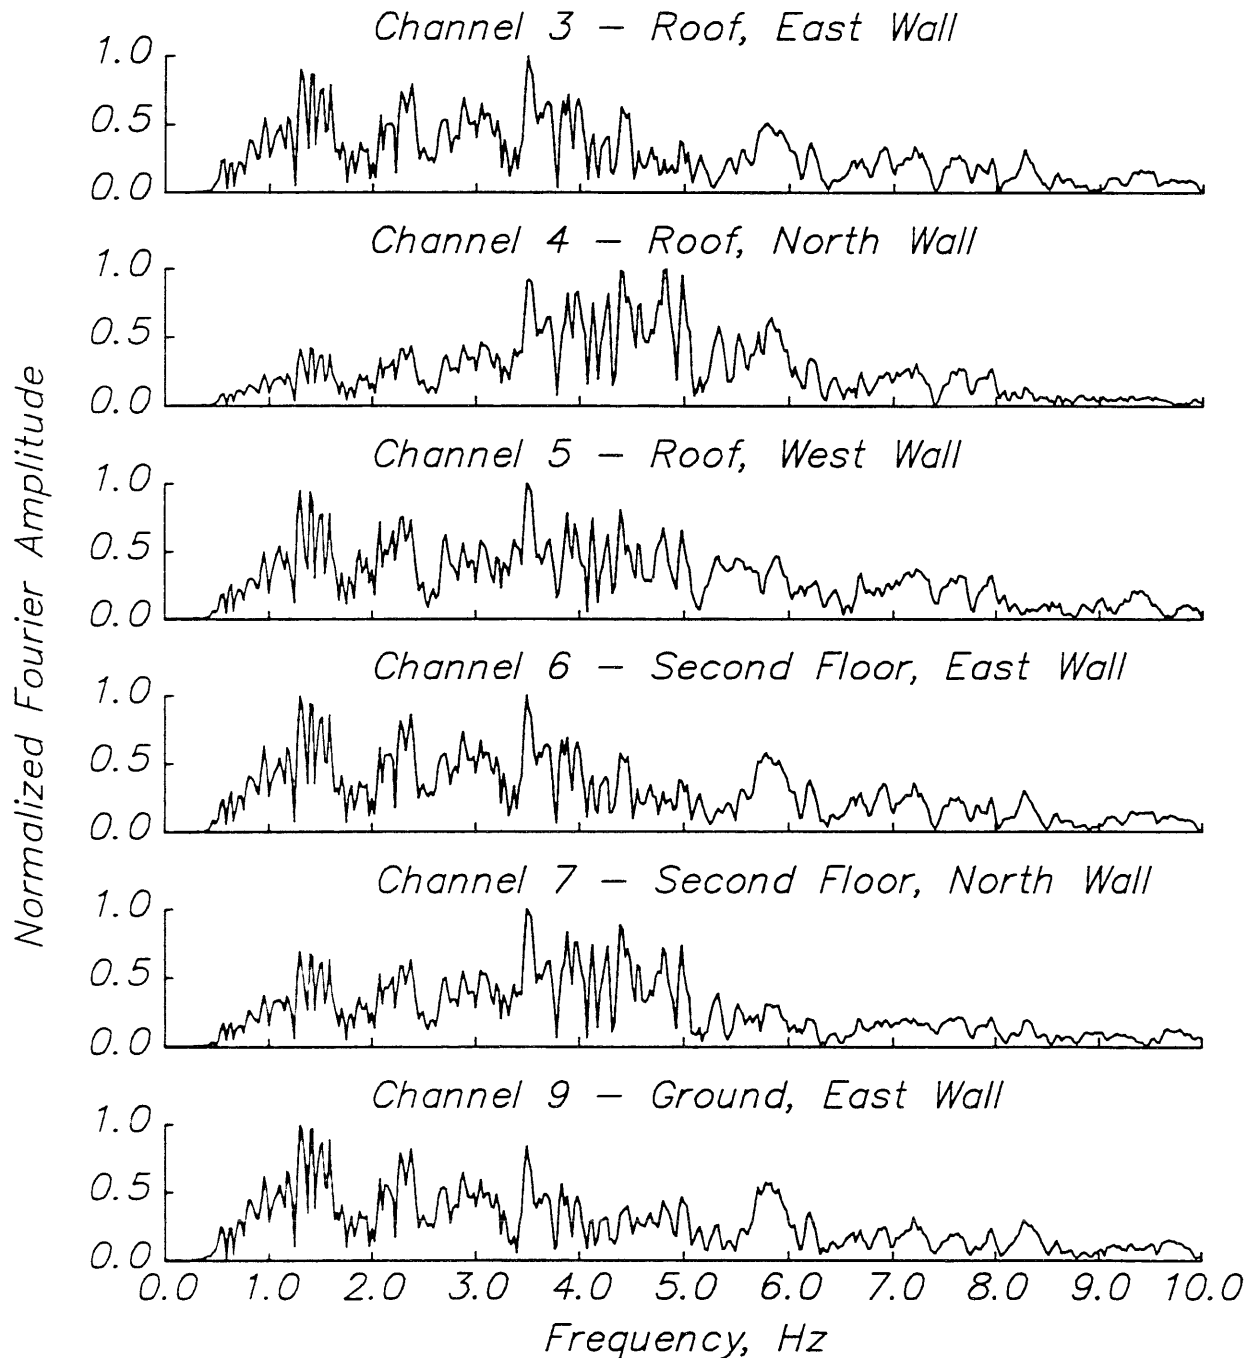
Fig. 5.40 Milpitas industrial building – 1988 Alum Rock earthquake.
(a) Normalized Fourier amplitude spectra of transverse acceleration response.

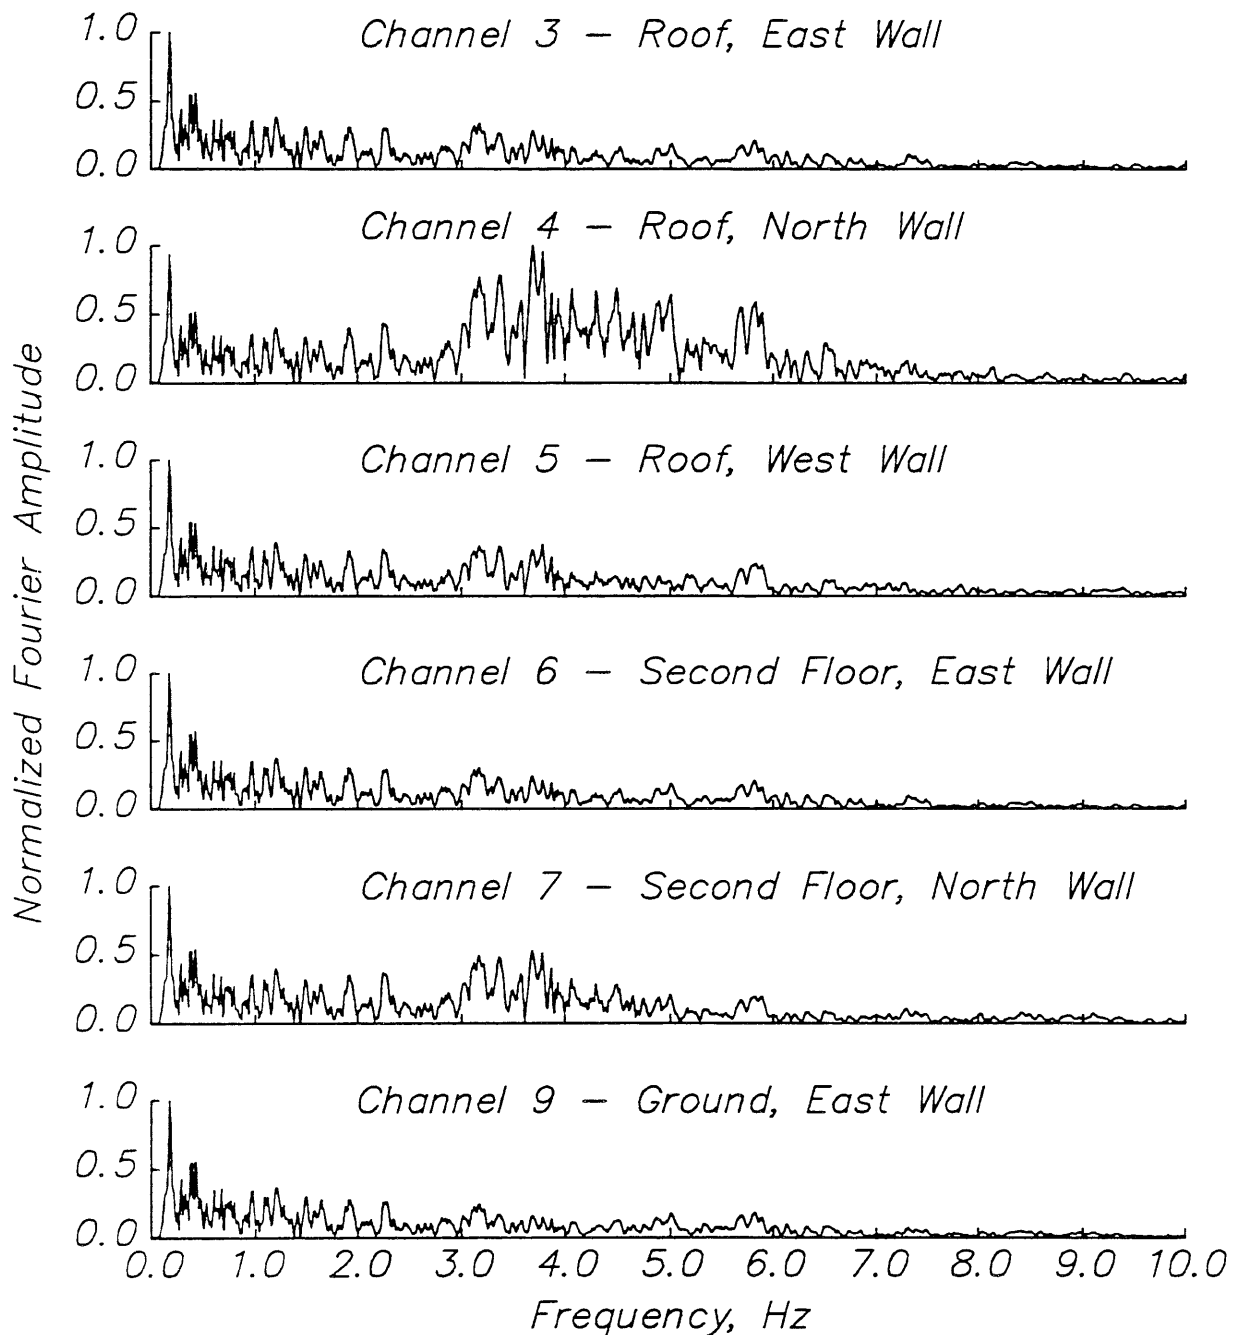
Fig. 5.41 Milpitas industrial building – 1989 Loma Prieta earthquake.
(a) Normalized Fourier amplitude spectra of transverse acceleration response.

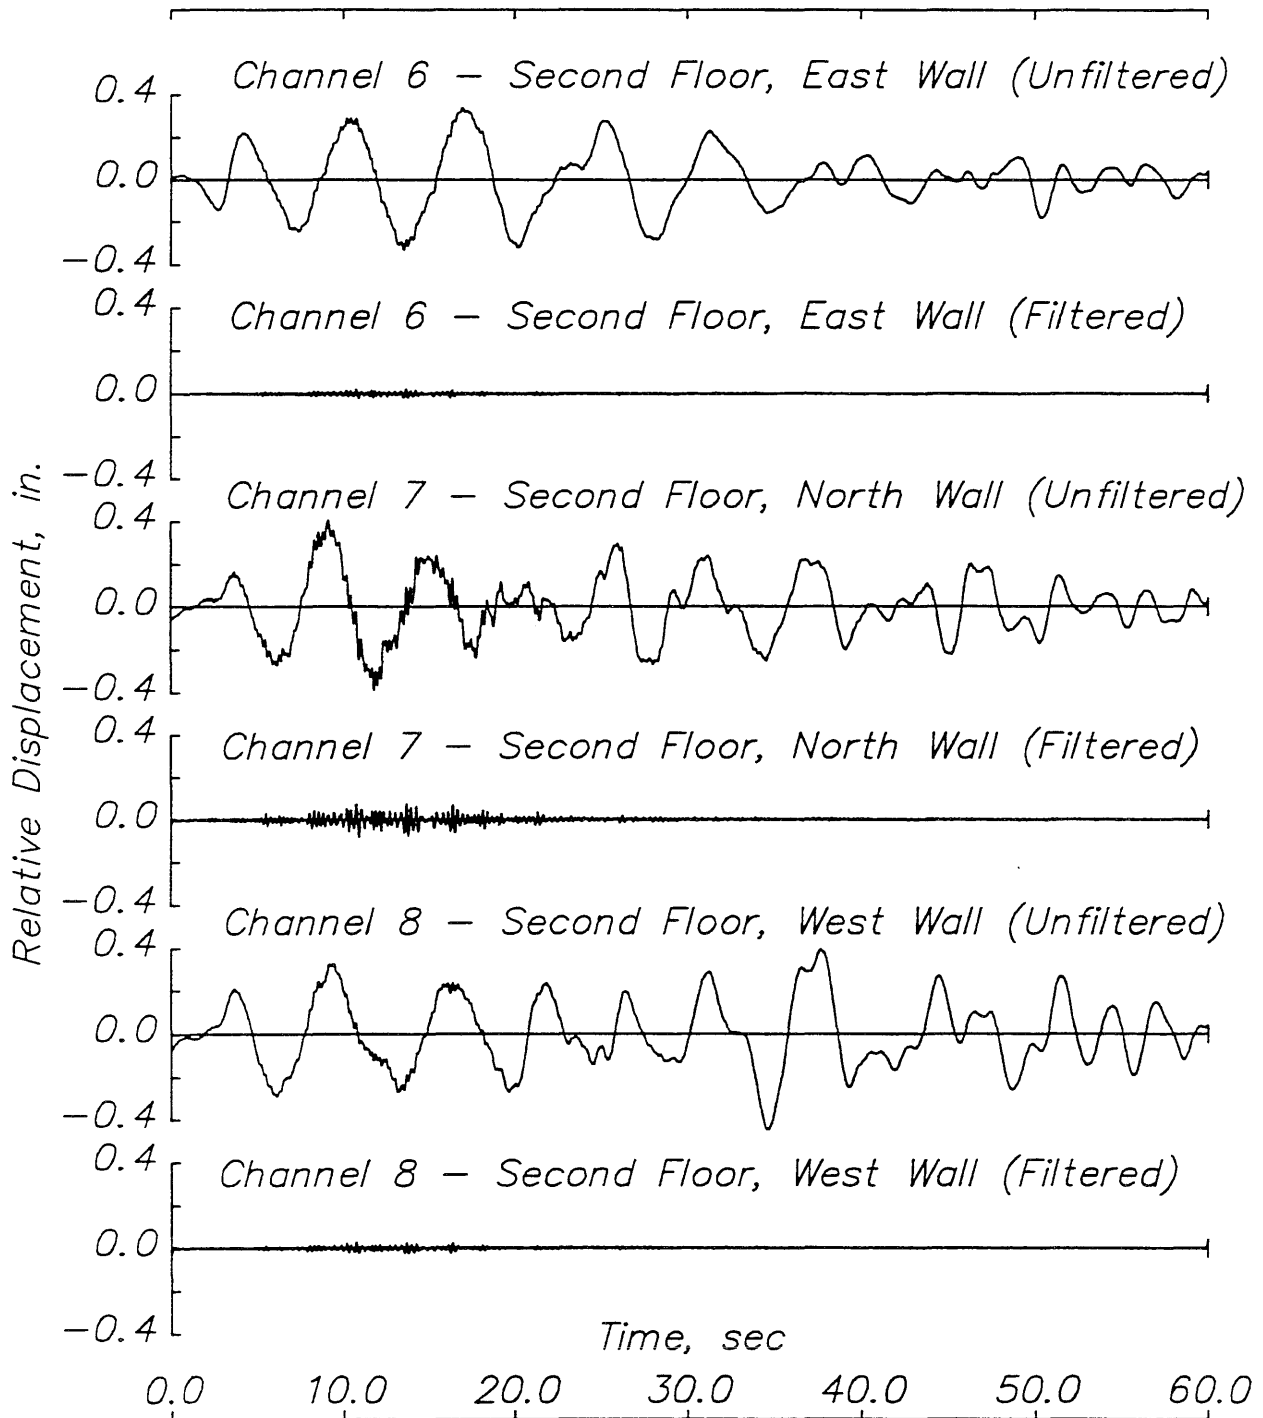
Fig. 5.44 Milpitas industrial building – 1989 Loma Prieta earthquake.
(a) Transverse relative displacement response.

Fig. 5.44 (cont.) Milpitas industrial building – 1989 Loma Prieta earthquake.
